*Report No. BC/MB/06.19.05.*

# **Mining Risk Assessment: Land at Plymouth House, Merthyr Tydfil.**

***Mr and Mrs D. Rees***

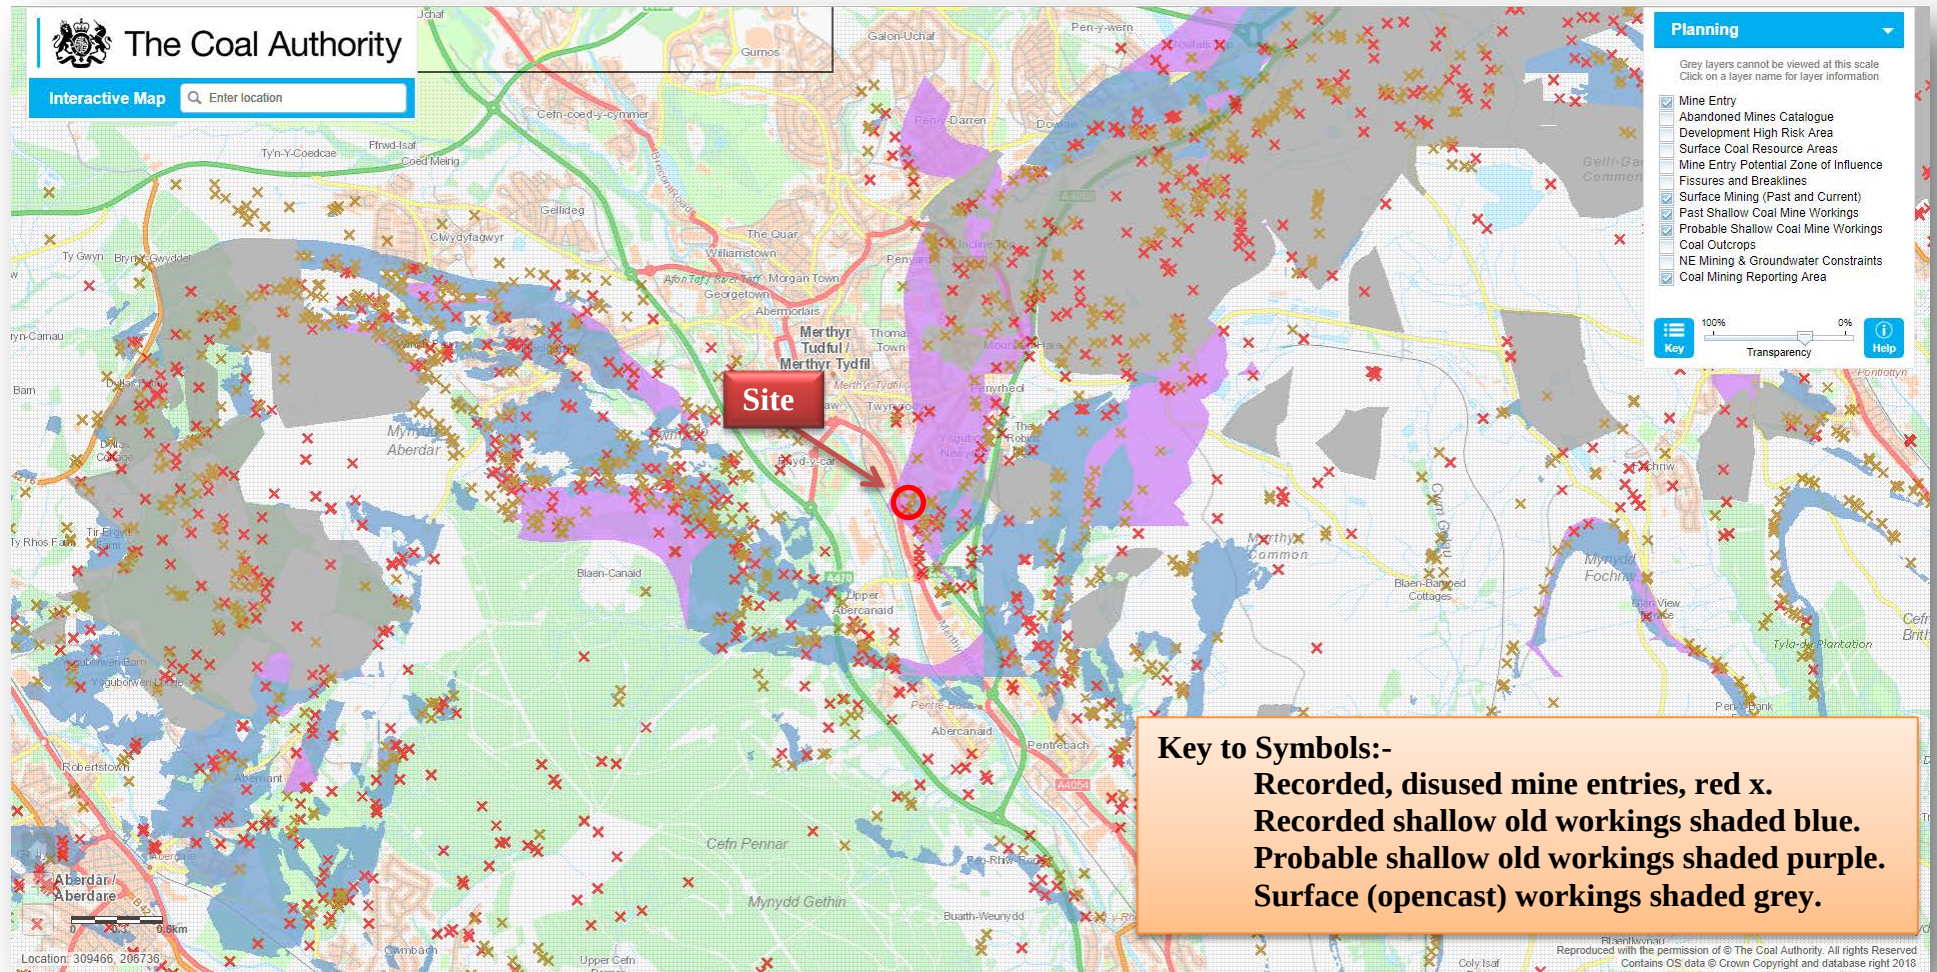
**Figure 3**  
**Print-out of The Coal Authority's Interactive Map**  
 (Accessed 18<sup>th</sup> June 2019)

The general area has experienced extensive underground mining operations for coal and for ironstone dating back at least to the very earliest part of the nineteenth century. The workings were prosecuted from a number of adits driven into the valley sides at or near the outcrops of coal seams and ironstone veins and were supplemented with many shafts, principally to act as a source of air. Our searches identified that there are no records of underground coal workings within influencing distance of the Site. The mining records held by The Coal Authority are known to be incomplete, particularly in respect of older mining operations. The Coal Authority's interactive map shows 'probable' mine workings underlying the Site *i.e.* unrecorded shallow mine workings (see Figure 3).

Our searches identified one disused mine entry, an adit, within the confines of the Site or within 20m of its boundaries. The adit is situated approximately 8m west of the Site (see *Detailed Location Plan, drawing no. BC/MB/06.19.05.03*) and the mining operations associated with the adit would have developed eastwards and northwards beneath the area where the Site is

located. The location of the adit is consistent with The Coal Authority's reference to the ironstone workings at shallow depth in the vicinity of the Site.

The locality has experienced extensive mining operations for both coal and ironstone and the Site lies within an area that could be affected by underground mining in one the ironstone veins at shallow depth. It is recommended that a programme of exploration boreholes is drilled on the Site with a view to determining the depth and nature of any shallow mine workings that may be present.

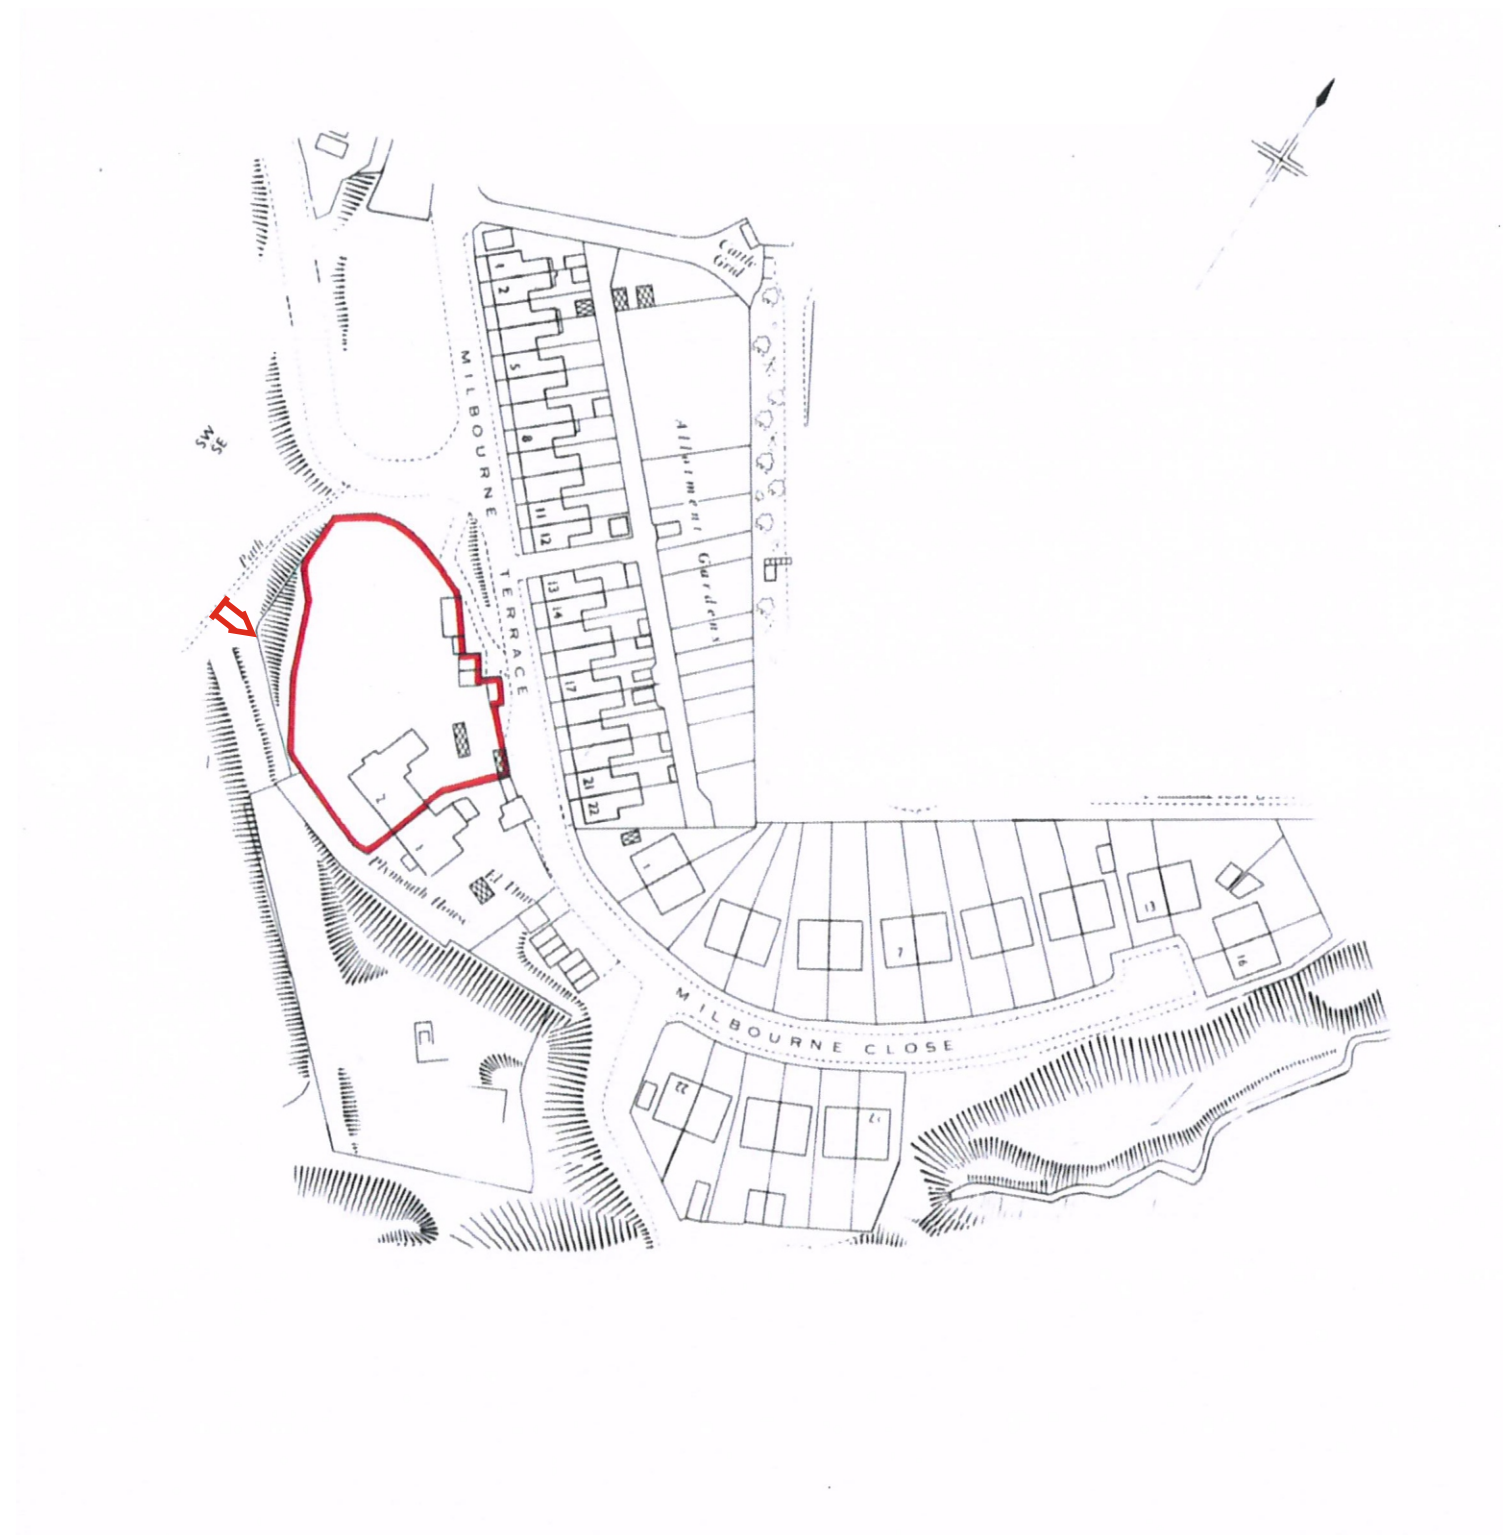
## *Detailed Location Plan.*

Our searches found one recorded, disused mine entry within the bounds of the Site or within 20m of its boundary. The adit is situated approximately 8m west of the Site and its orientation is such that any shallow underground roadways extending from the adit will be present beneath the Site. The recommended exploratory programme should be designed to include an assessment of the risk from the adit.

➤ Approximate position of disused mine adit.

A programme of exploration boreholes should be drilled on the Site in order to examine in greater detail the risks from shallow mine workings and from the nearby adit; the boreholes should be monitored for the presence of mine gases. The boreholes should be designed and supervised by a Chartered Geologist and will require a permit from The Coal Authority.

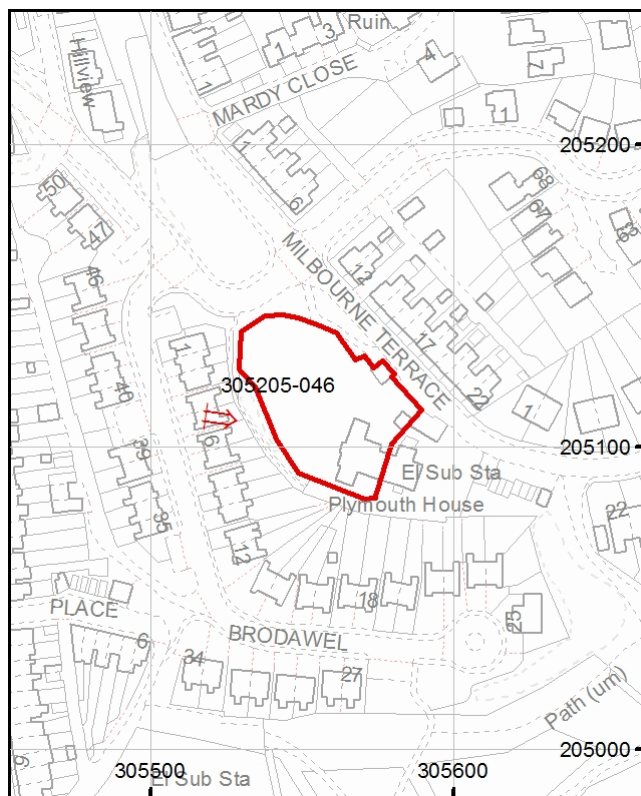
# Enquiry boundary

Disused adit

Within, or within 20 metres of, the boundary of the property there is 1 mine entry, the approximate position of which is shown on the enquiry boundary plot. For reasons of clarity, mine entry symbols may not be drawn to the same scale as the plan.

There is no record of what steps, if any, have been taken to treat the mine entry.
