# 6.2019

## BS5837 2012 Tree Information Plymouth House

Mr Dai Rees  
Plymouth House  
Milbourne Terrace  
Merthyr Tydfil  
CF47 0UL

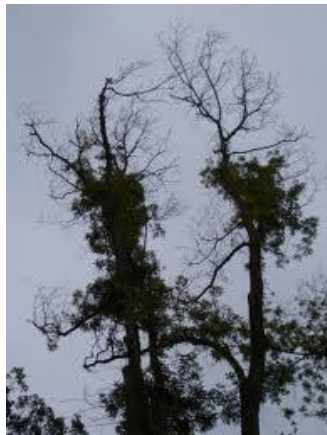
The picture to the right shows the years after the completion of a development site. Operators will often mention how they have driven over them. This is what happens once they leave.

die back of foliage several years after the completion of a development site. Machine operators have dug roots or driven over them.

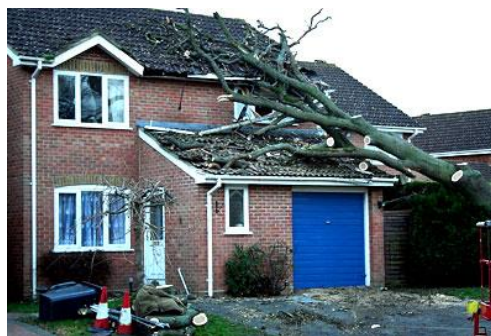
If adequate protection is not given the disaster below is not far behind!

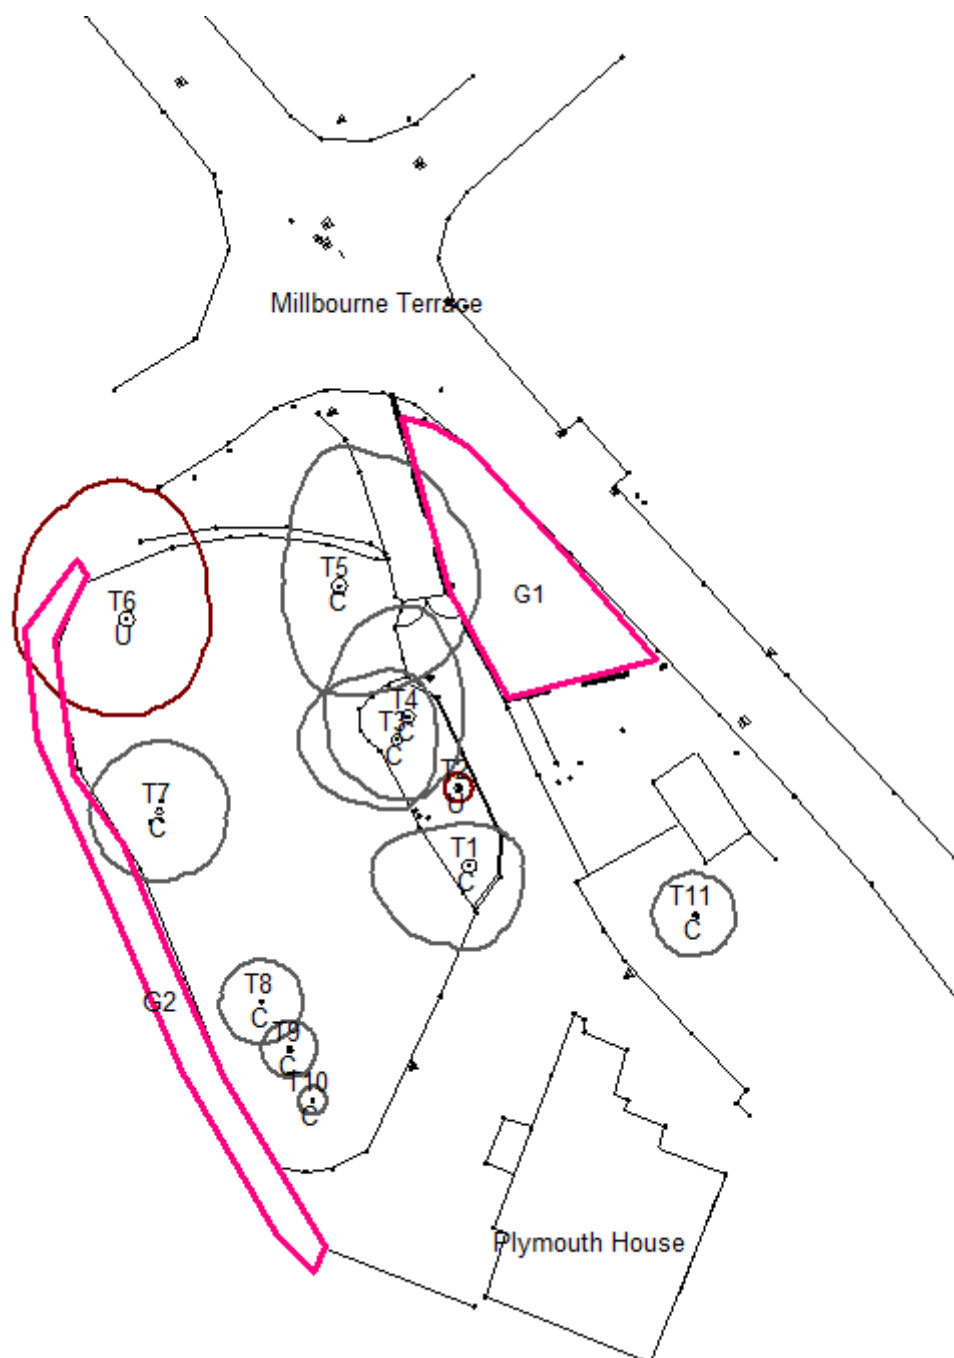
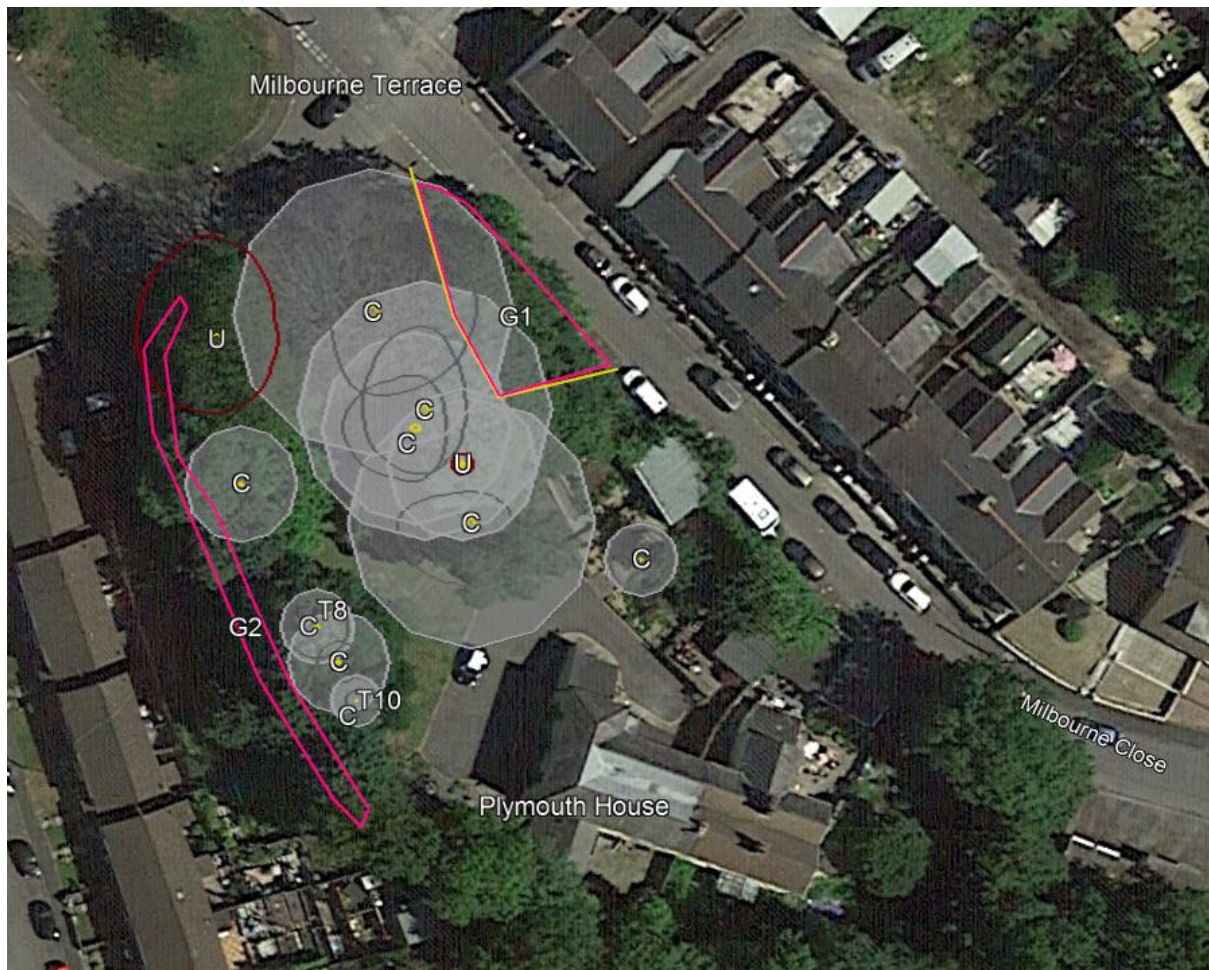
**Site Plan screen grab – please see scale pdf plan also**

Trees that were subject to Tree Preservation Orders on site along the north boundary have been recently felled due to advanced physiological decline/death. It was noted at the time of survey that T5 and T6 are now also in structural and physiological decline – both trees are subject to a TPO and T6 is in the worst condition. What is not obvious from outside the site is the extensive historical wounding around the low stem/basal flare of these trees. Both trees are pretty much ring barked (appears to be by grazing animals in years gone by). Cambium is exposed and dead for most of both trees stem circumference. This poses a threat to overall tree health and stability as the inner stem wood is colonized by decay fungi and starts to degrade posing a risk to all within falling distance of the trees and the highway x2. Both trees suffer altered exposure due to the felling of adjacent dead trees. Replacement of both trees is expected within 5 years regardless of planning outcomes.

Trees 1 to 4 are various stages of sycamore that are located in a raised bed with limited rooting area. T1 has suffered recent failures from a degraded scaffold limb following decay in a pollard section. T2 is a monolithed stump serving no real purpose after braches failing in storms from the previous pollard sections. T3 leans out over the garden and has a historical steel cable restriction around the low stem. This will effectively start to ring bark the tree and lead to significant decline/hazard. T4 has a low stem wound/decay, crown off centre and small leaves – I believe this tree to also be in decline. Each tree in the group will badly suffer altered exposure if T1, T3 or T4 is removed. Remaining trees would look precarious and the historical pollard nature of the trees is leading to failures of scaffold limbs. I feel the group is best removed but suitable landscape re planting takes place.

T7 is a wide spreading laurel that has various limb defects and will suffer hazard beam splitting of limbs if not managed significantly – coppicing is the best option.

T8, 9 and 10 are a mix of holly and oak. The oak is not the most attractive specimen and can easily be replaced with a semi mature, good form tree in any final landscaping. The hollies are original plantings but also have defects. Specimen holly replacement should be included within the landscaping. T11 is a lone apple tree that again can be easily replaced. It is unlikely to survive all changes around its RPA.

G1 is to be retained. G2 has many defects in many of the individual self-set trees and I feel that after appropriate pruning/management to resolve the defects, significant landscape value will be lost. On this basis G2 would be better replaced with a manageable native species hedge containing standard trees.
