*Report No. BC/MB/11.20.04.*

# **Preliminary Site Investigation: Land at Colliers Row, Merthyr Tydfil.**

**Maxiom Developments Ltd.**

## **Preliminary Site Investigation Report: Land at Colliers Row, Merthyr Tydfil.**

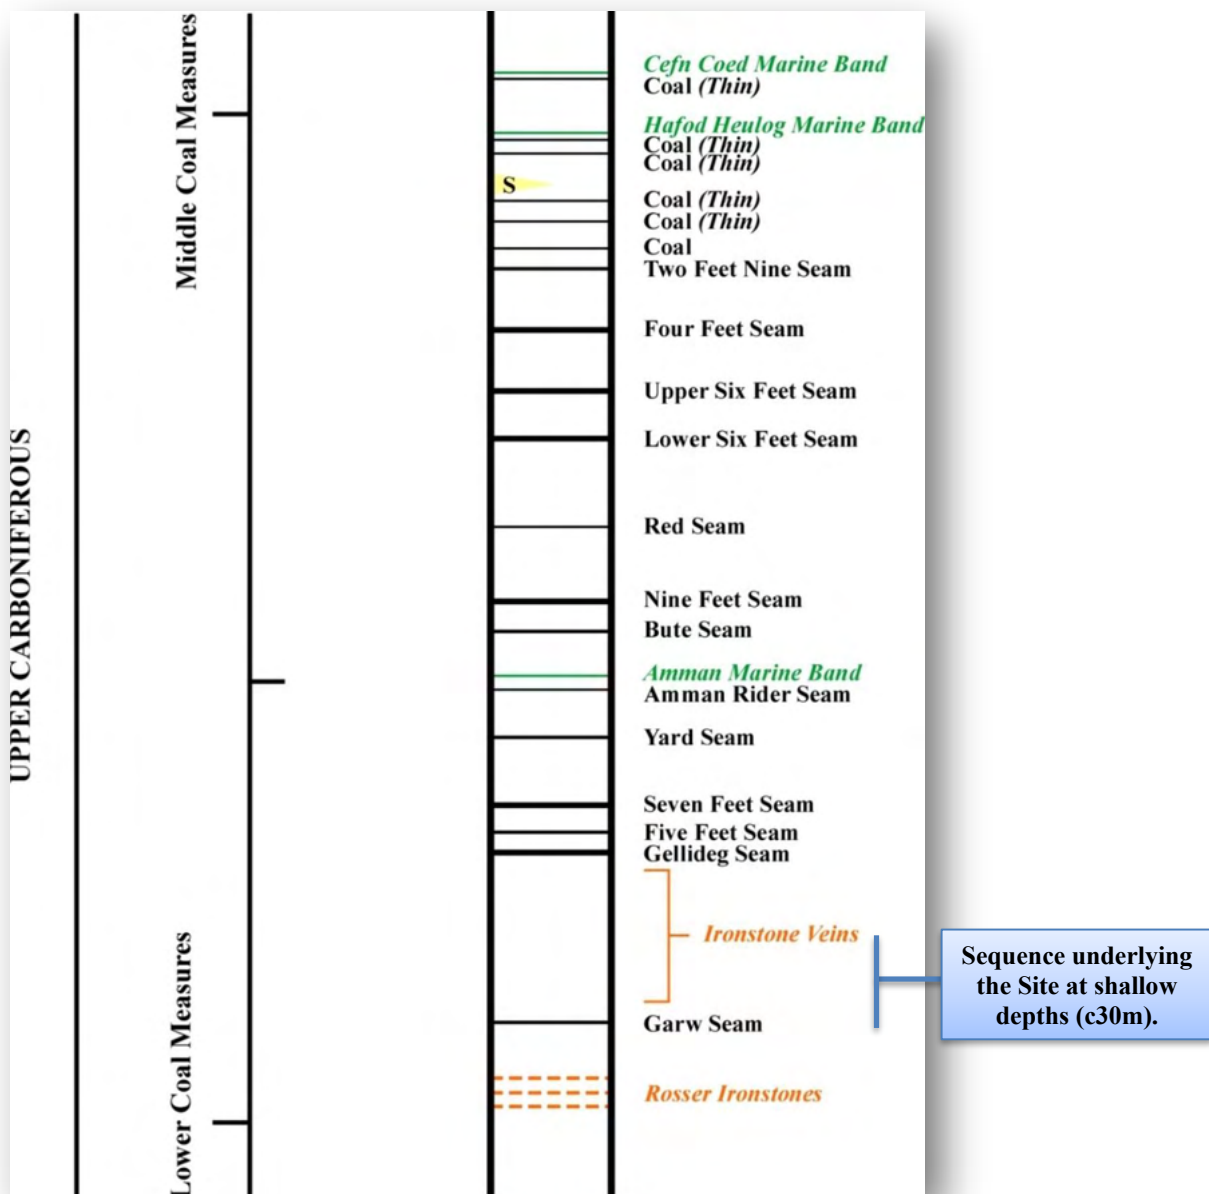
**Figure 2**  
**Part of the Stratigraphic Column.**

(SO 00 NW) shows the inferred positions of the outcrop of the Garw Seam to pass through the Site (see *Geology Plan, drawing no. BC/MB/11.20.04.02*). However, mining records indicate that the outcrops are south-east of the positions shown on the published geological sheet such that the outcrop of the Five Feet/Gellideg Seam passes through the south-west corner of the Site (see *Plan of Old Workings in the Five Feet/Gellideg Seam, drawing no. BC/MB/11.20.04.04*). A number of ironstone bands are present within the coal measures, occurring above and below the Garw Seam (see Figure 2, Part of the Stratigraphic Column).

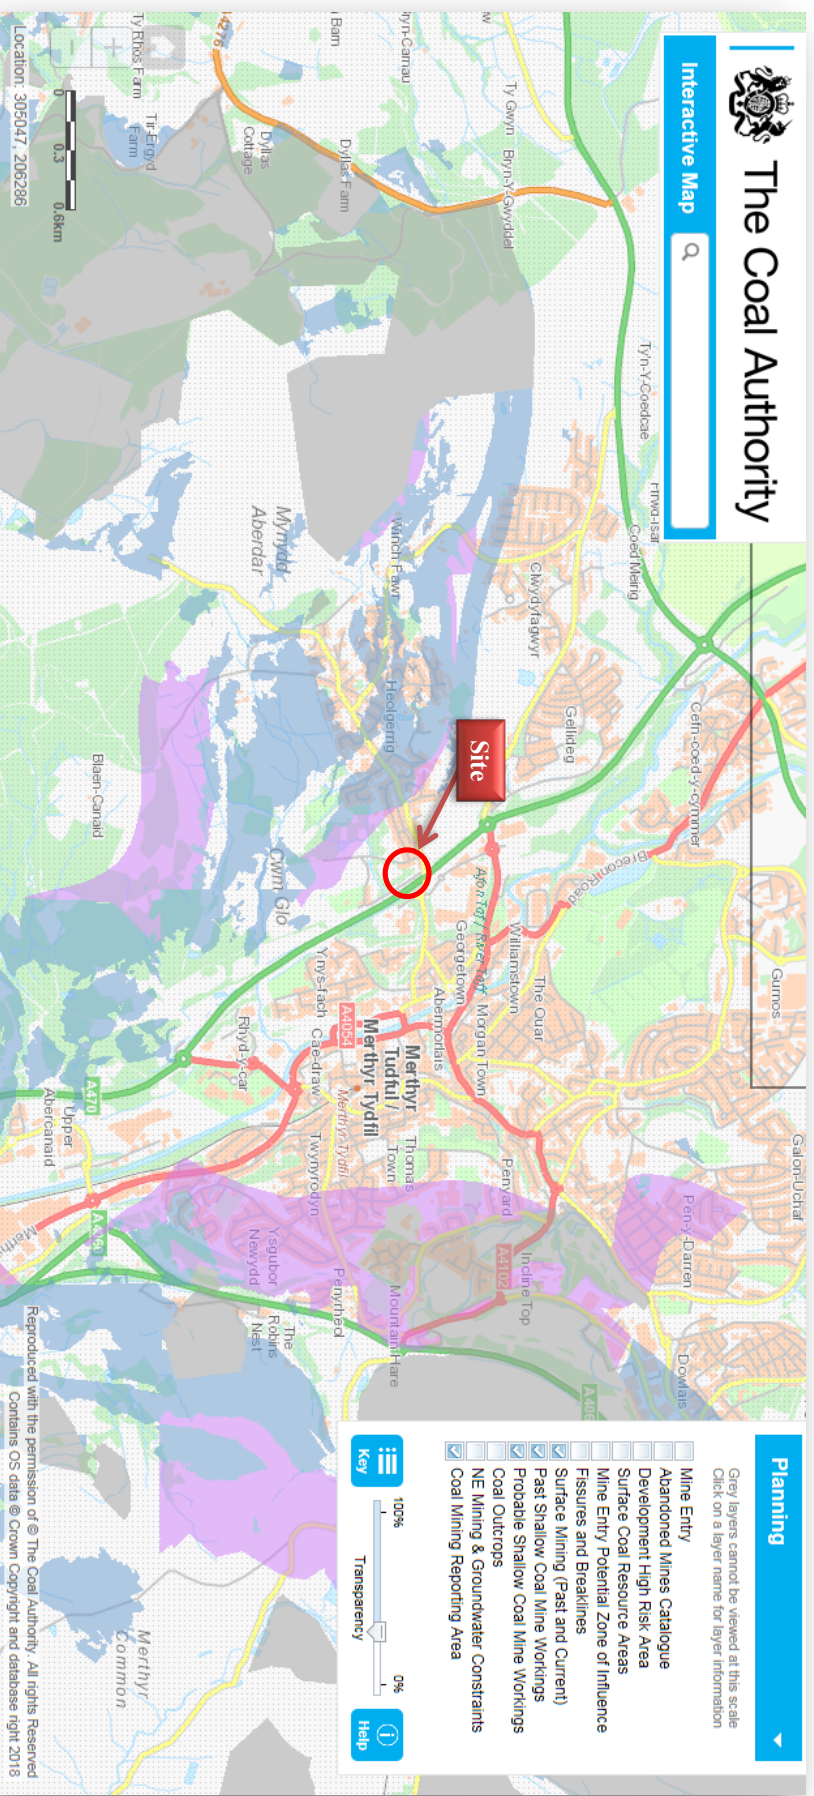
**Figure 3**  
**Print from The Coal Authority's Interactive Map**  
(accessed 21<sup>st</sup> August 2019)

Coal Authority's interactive map identifies that the inclusion of the finger of land along the lane does not alter any of the findings of The Coal Authority's report.

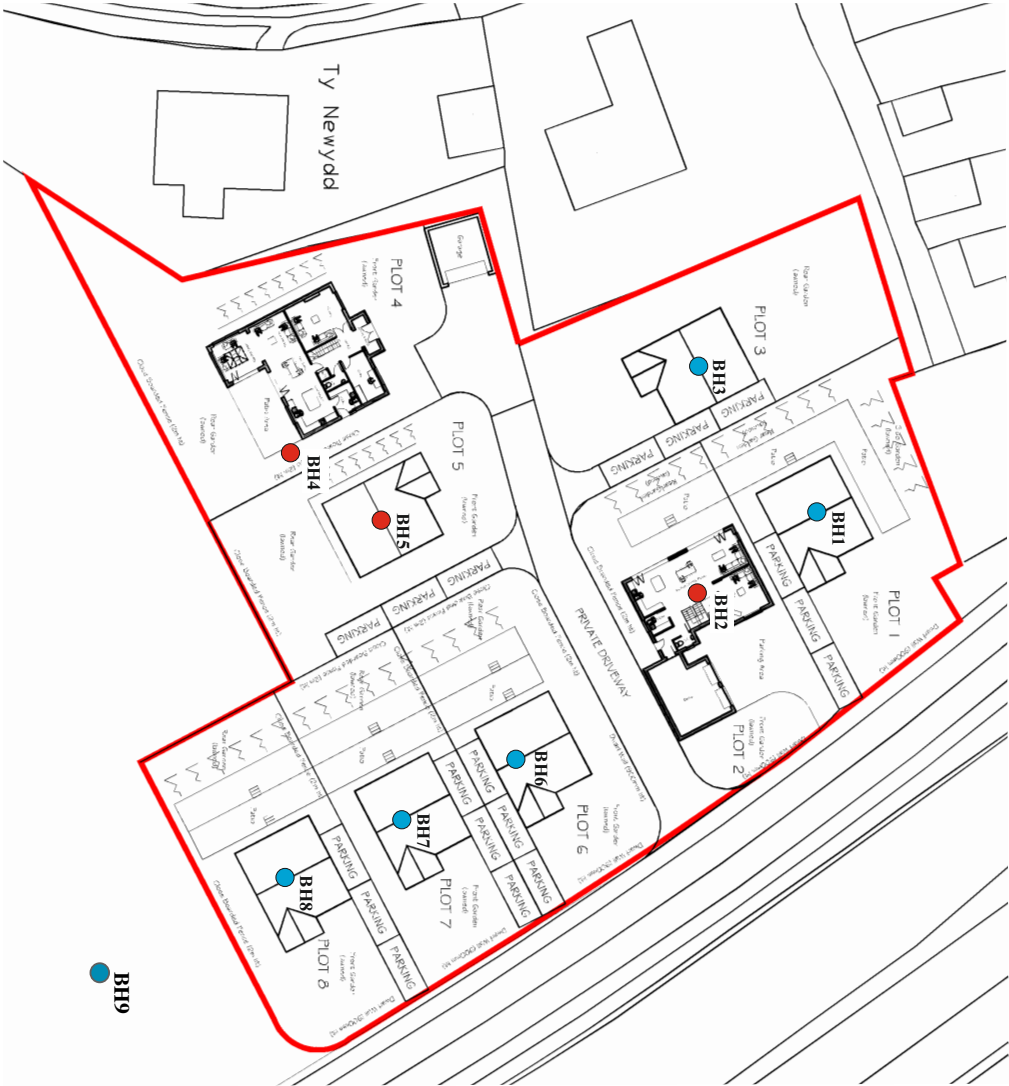
*Borehole Location Plan.*

The borehole positions are shown on the *Borehole Location Plan*, drawing no. BC/MB/11.20.04.05 and the graphic logs of the boreholes are contained at Appendix III.

The borehole provings are summarised in Table 1. Made Ground believed to be colliery spoil was encountered in all fourteen boreholes where its thickness was found to vary between 5.5m and 8.0m. Beneath the Made Ground Glacial Till was encountered in all the boreholes where the driller variously described it as Boulder Clay and elsewhere as Sand and Gravel. The Till was found to vary in thickness between 3.5m and 7.0m. Two ironstone vein horizons were encountered in the boreholes, the Blue and the Big Blue. Old workings were encountered in both ironstone veins in at least some of the boreholes.

It is recommended that as a minimum, where no old workings have been encountered on a given plot that a pattern of five boreholes is completed to confirm that no old workings are present beneath the footprint of the building. For buildings longer than 10m the number of boreholes should be increased to eight. If a borehole encounters old workings at the depths that pose a risk of them collapsing to the surface, then the borehole pattern should be modified to provide a grid suitable for the injection of grout to stabilise the old workings. For plots where the preliminary drilling has encountered old workings, the old workings underlying the plot should be stabilised by means of a drilling and grouting programme.

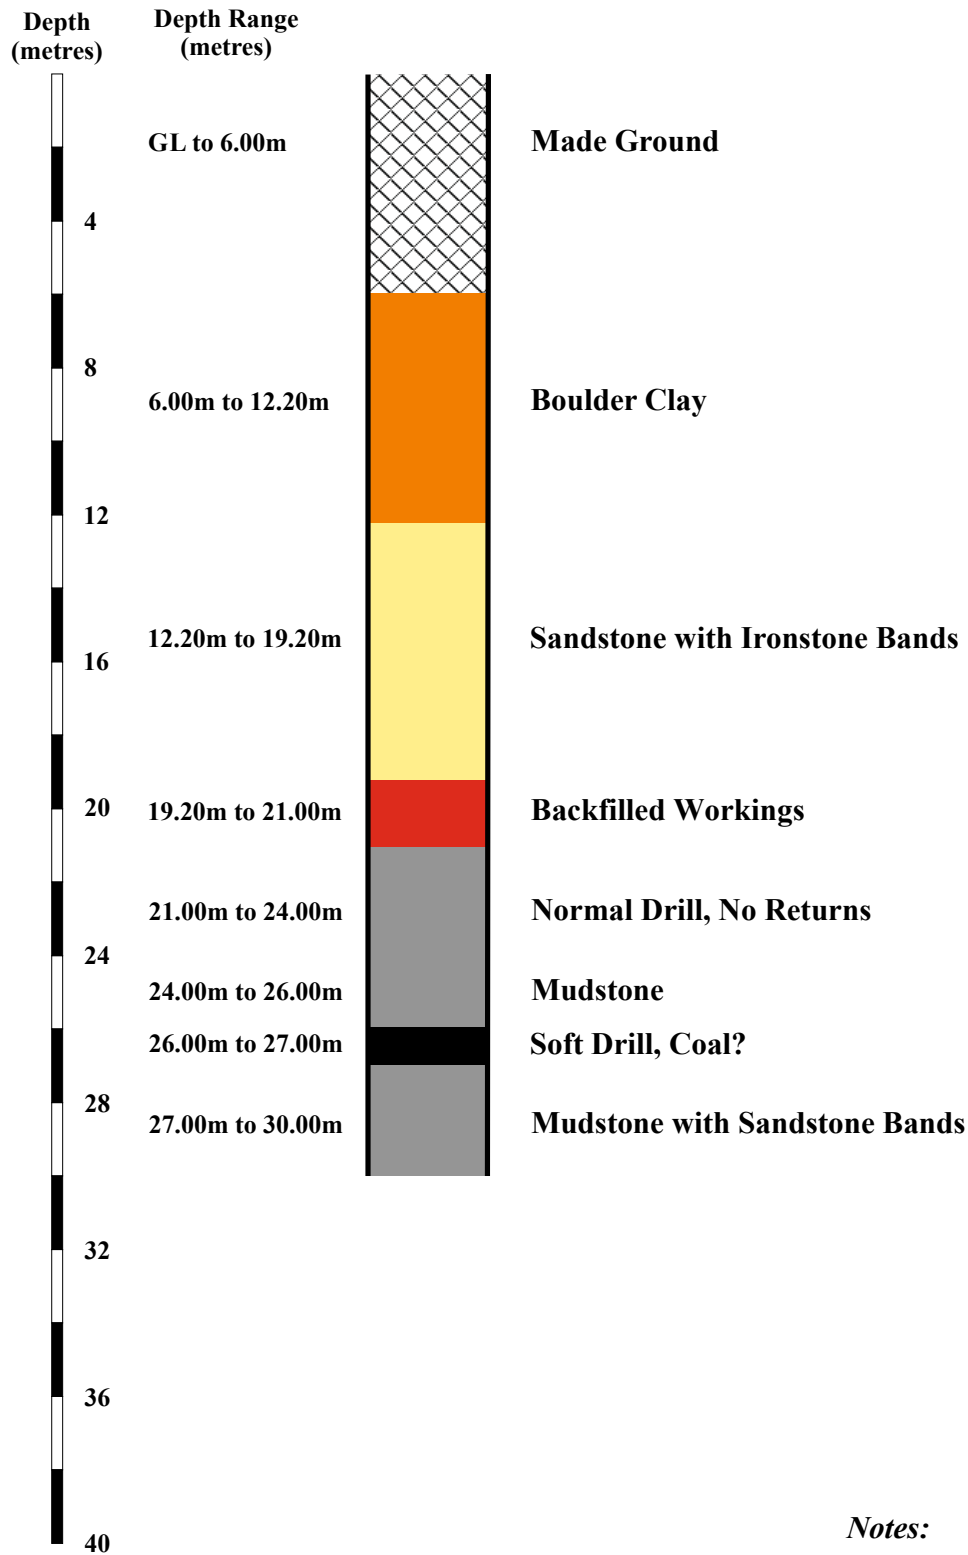
### Borehole No. 4

The Garw Seam was encountered at depths to the top of the coal of between 28.0m and 28.5m, the thickness of the coal seam was found to vary between 0.2m and 0.8m. Old workings were encountered in the Seam in Borehole 4, they were found to be 1.0m thickness of soft drill taken to be backfilled old workings.
