PHASE 1 ASSESSMENT  
ST TYDFIL'S HOSPITAL  
MERTHYR TYDFIL  
ST TYDFIL'S DEVELOPMENTS LLP  
DS-21988-19-321 REVA  
AUGUST 2020

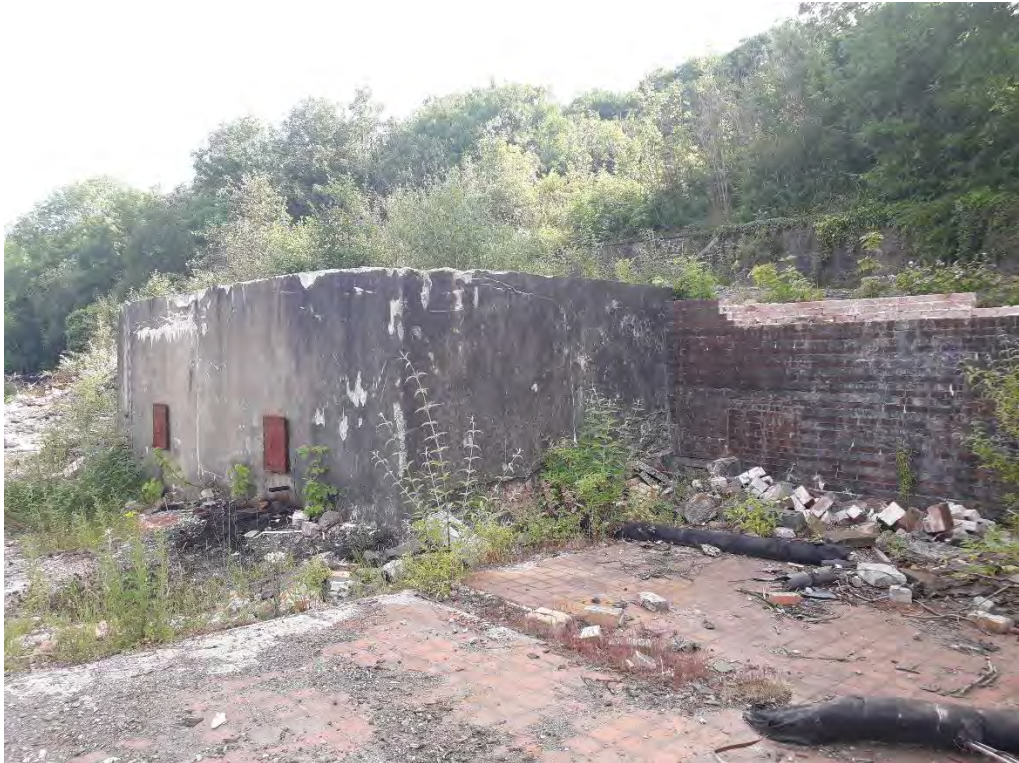
Bund exterior

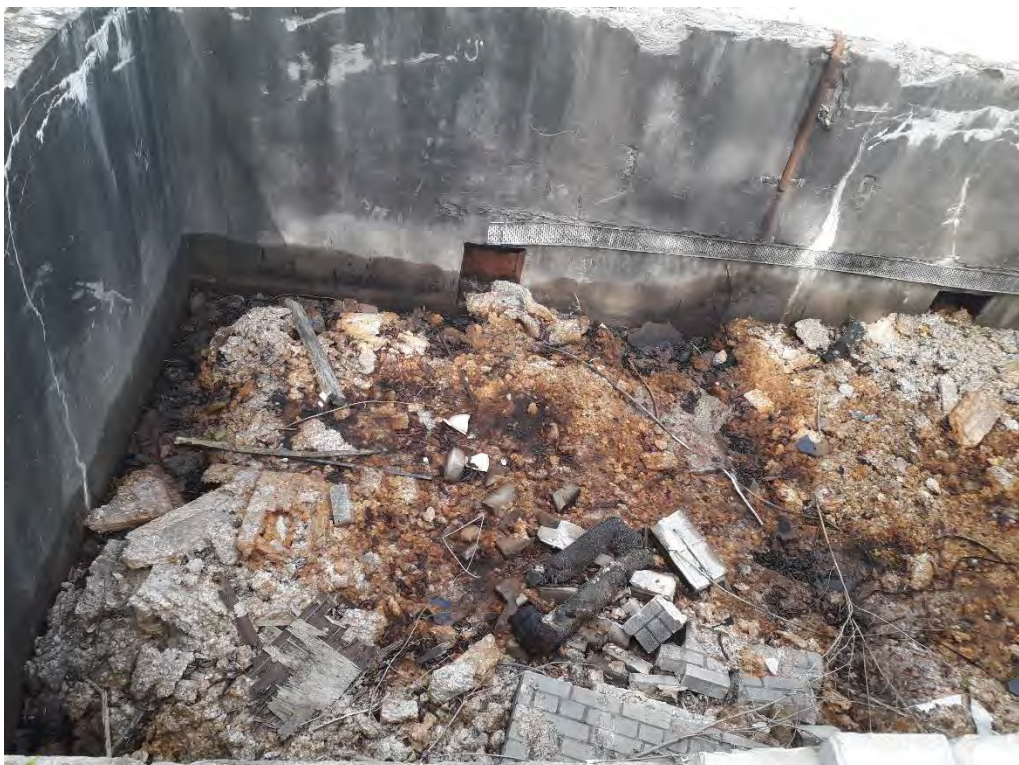
Bund interior

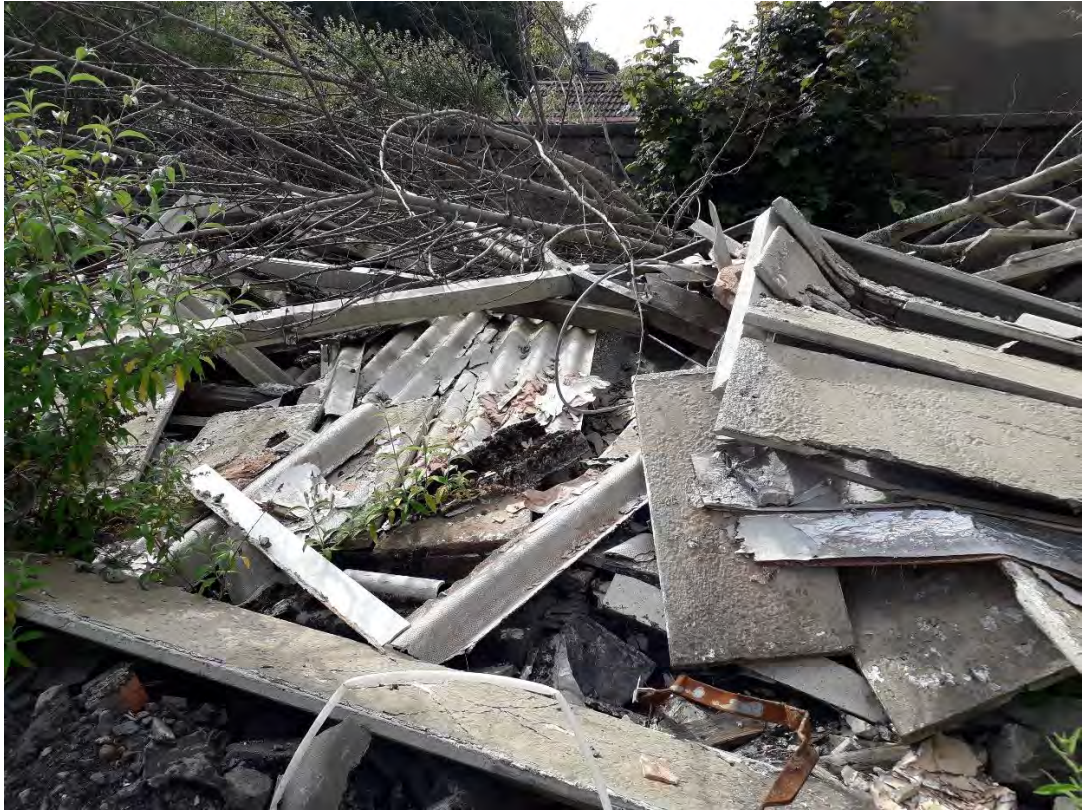
Asbestos sheets

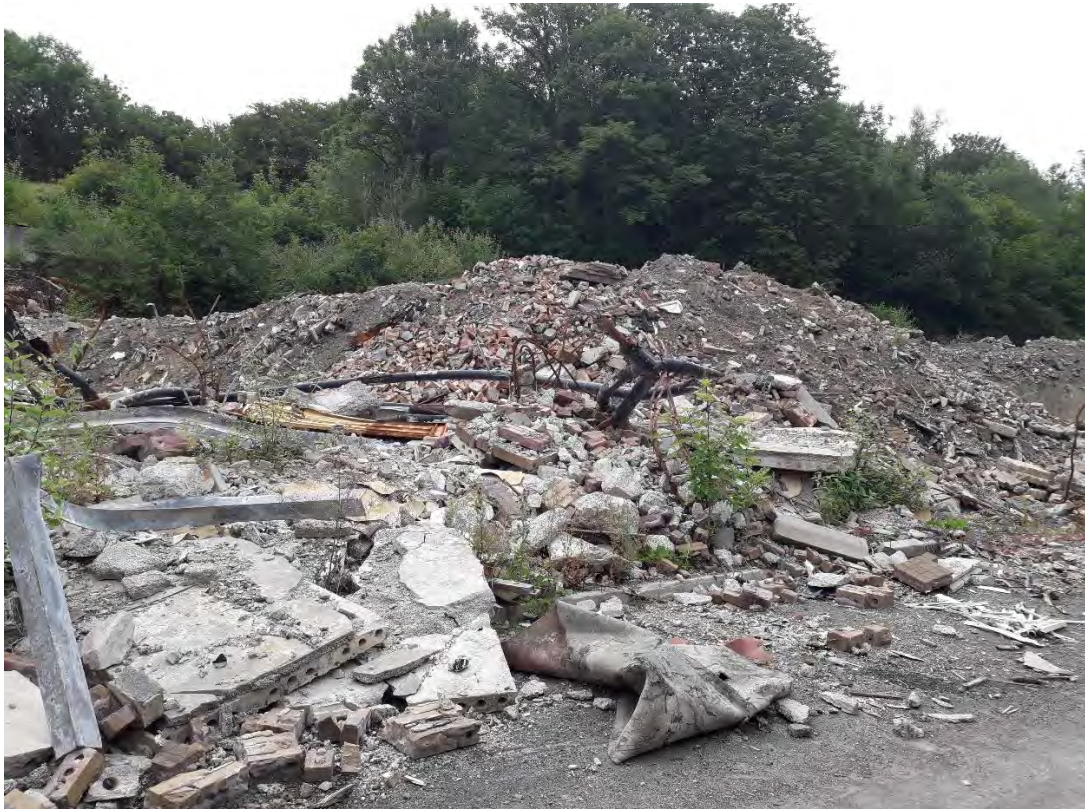
Unprocessed demolition waste stockpile

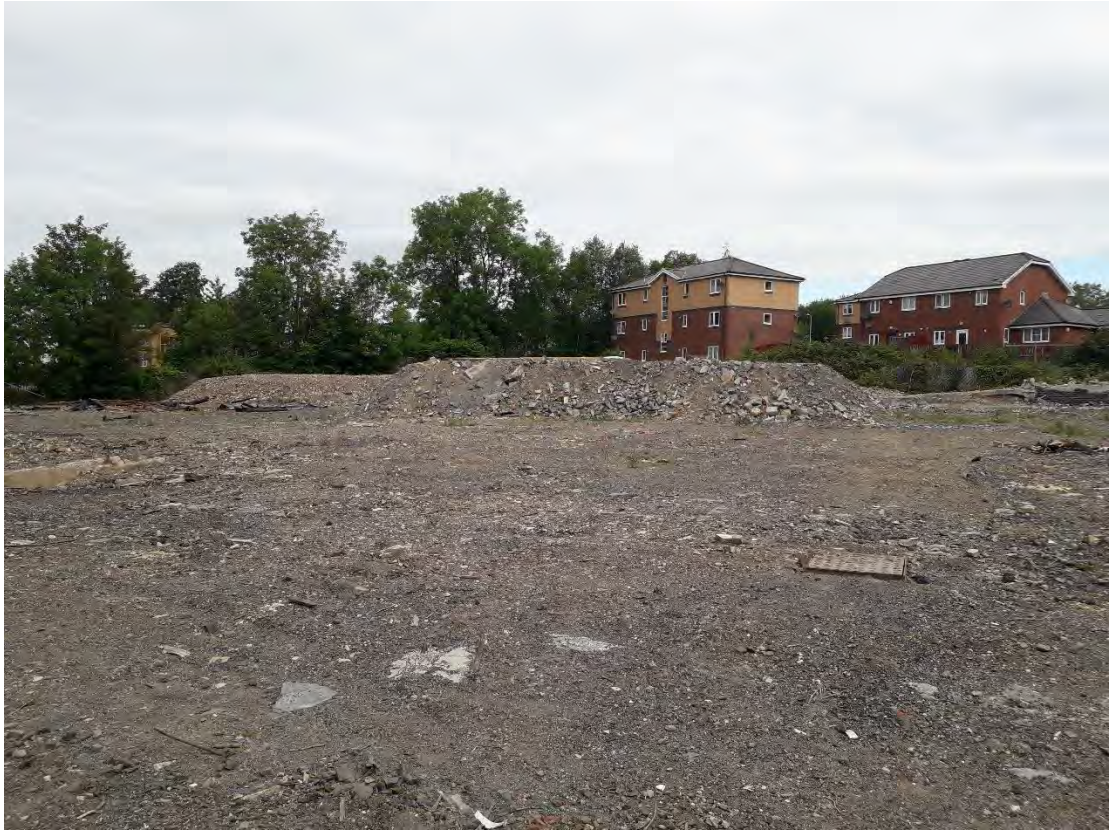
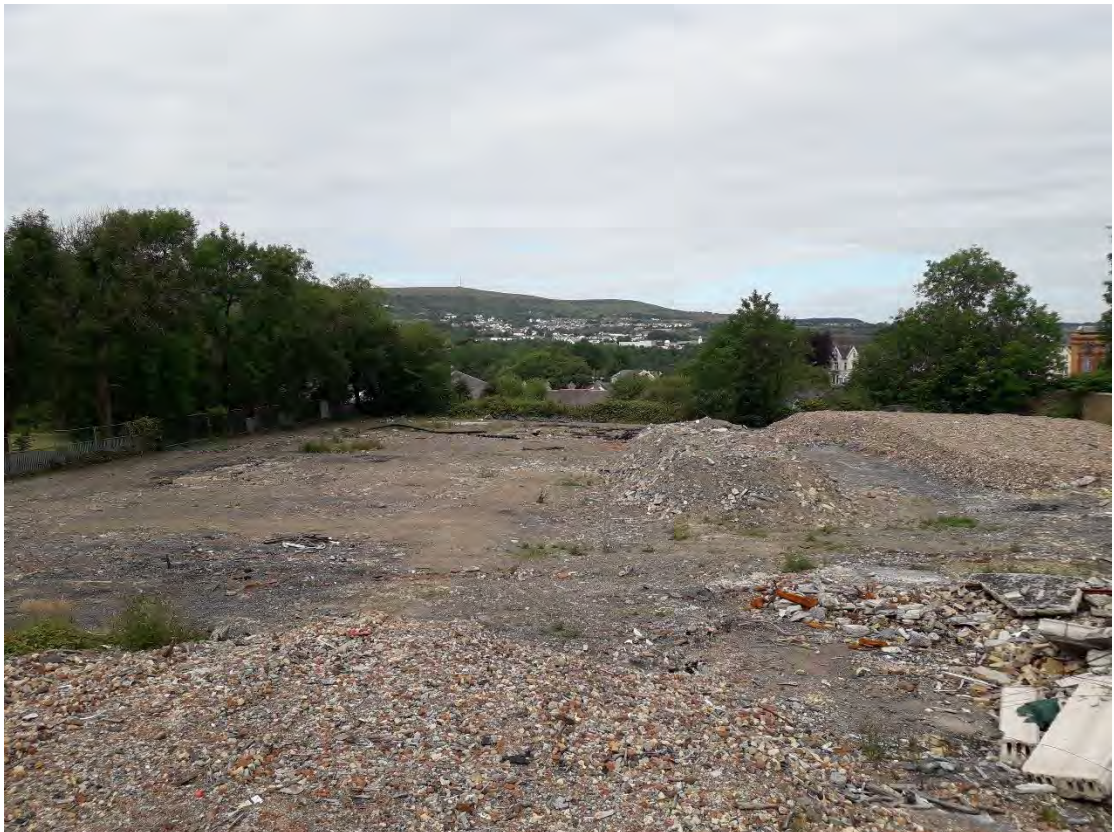
Processed demolition waste stockpiles

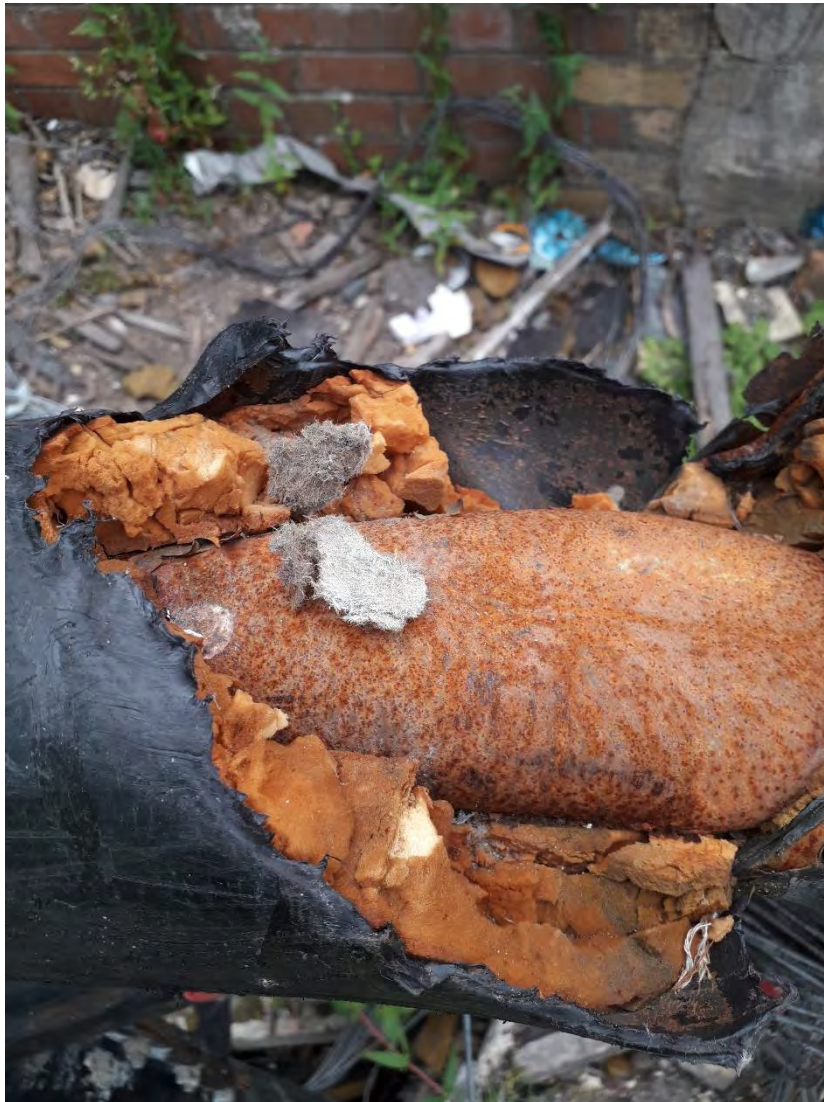
Pipe showing lagging
