## INSTALLATION OF NEW SKYLIGHTS/VELUX WINDOWS

JAH-JIREH CARE HOME, A465 MERTHYR

### BUILDING INSPECTION REPORT (PROTECTED SPECIES)

Document Ref: E25136001 Doc 01 September 2025

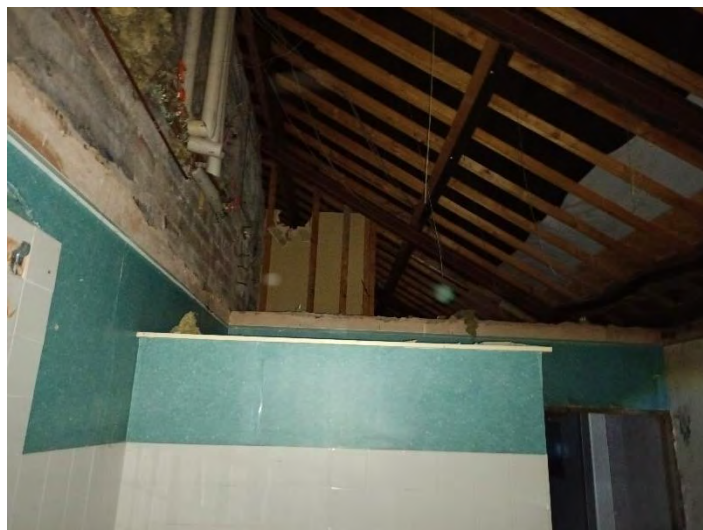
**Plate 4-View Looking Up at Ceiling From Room G-Exposed Roofing Felt/ Battens and Joists**

3.11 The remaining rooms (E-G) are located within the pitched roof section and where the proposed Velux window/skylights are to be installed. The ceiling has largely been removed and the roofing felt, battens and joists visible from most of the rooms. There is a brick wall present separating the roof space from the remainder of the building/roof. There is a small section of roof that was boarded up and inaccessible (Plate 4)

- 3.12 The roofing felt appeared to be Bitumen 1F and was in a good state of repair i.e. no rips/tears. Rooms D-G were completely dark with no external light ingress noted. There was a small area of light ingress noted in room C (TN5) which corresponds with the damaged render noted in the north eastern corner. This was the only potential entry point observed during the daytime inspection.

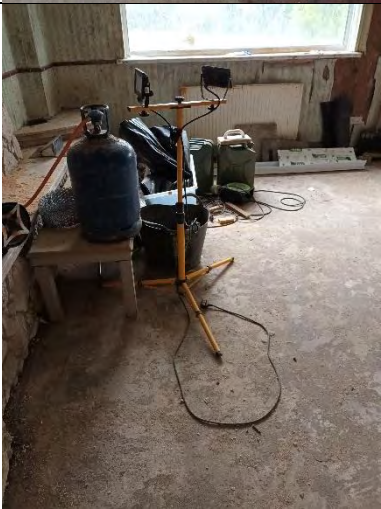
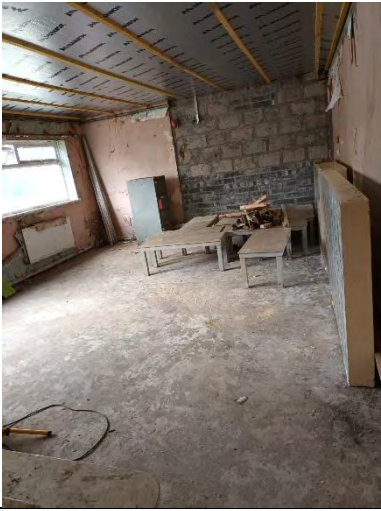
| TN4 | <br> | <p>Room B-within flat roof section of the building. Insultation boards on ceiling.</p> <p>No evidence of bat use e.g. droppings on windowsill/surfaces etc.</p> |

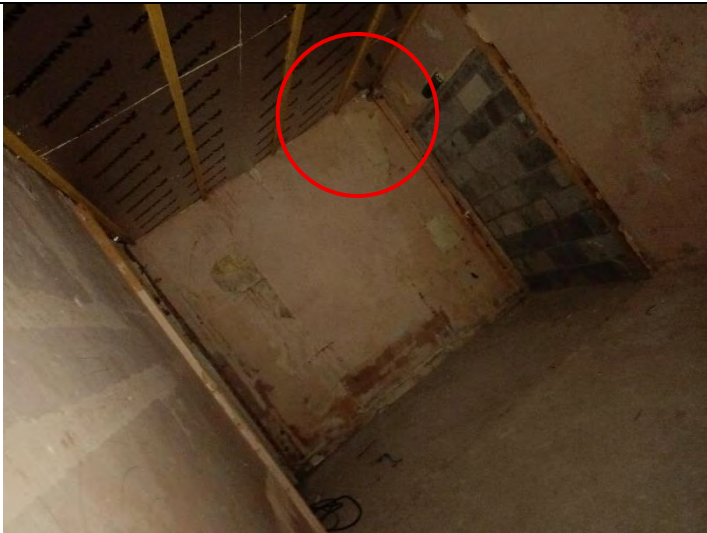
TN5

Roof C-partially within flat roof section of the building.

Insulation boards on ceiling.  
Previous doorway has been blocked up.

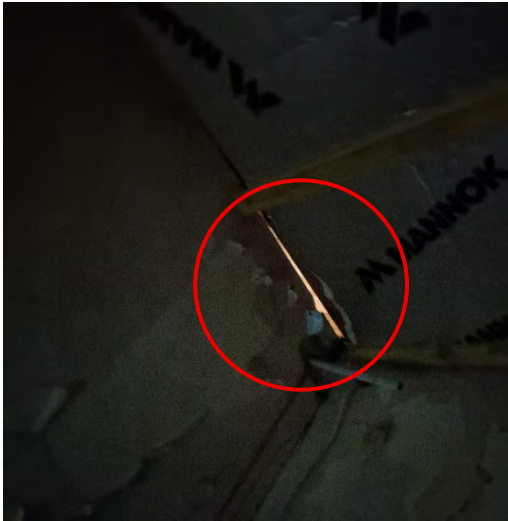
Small area of light ingress in the corner.

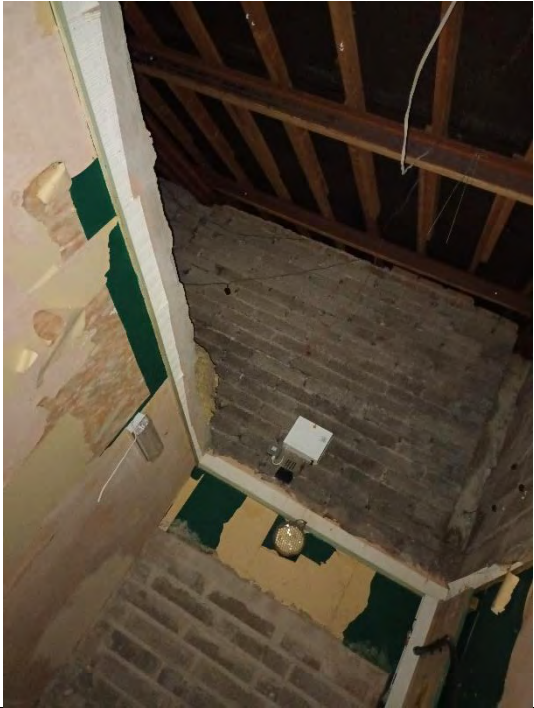
Roofing felt and battens etc visible.

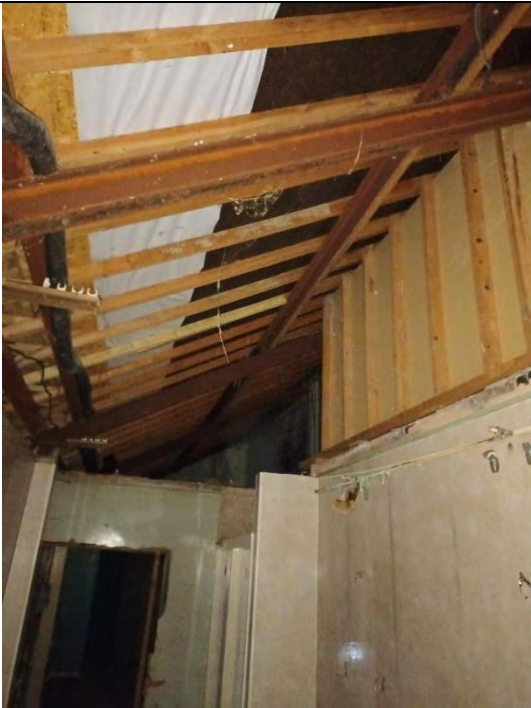
| TN8 | | <p>Room F-former toilet.</p> <p>Boarded section of roof space(right hand side of photograph)</p> <p>Roofing felt and batten exposed with no external light ingress noted.</p> <p>Roofing felt appears to be bitumen 1f and good condition.</p> |

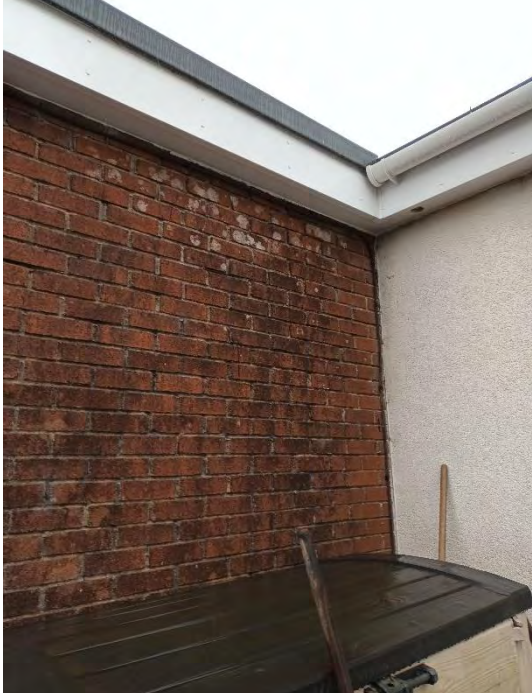
| TN10 | | <p>Red bricked wall. Flat roof.</p> <p>Facias/barge boards appear relatively new and intact. No obvious entry points.</p> |

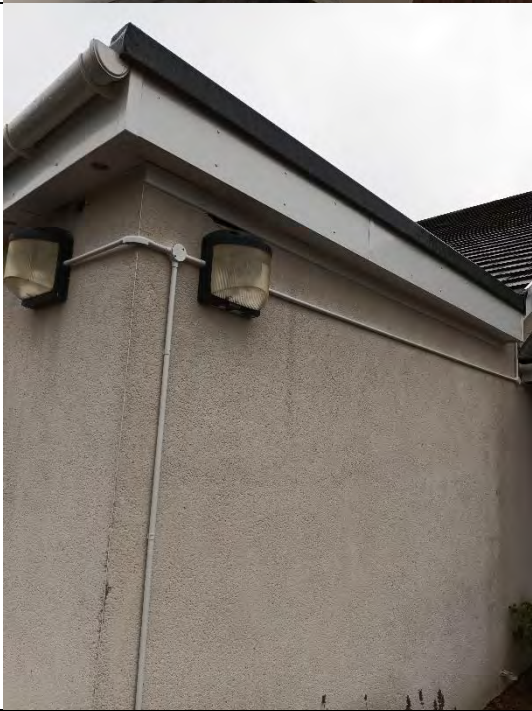
| TN12 | A photograph of the exterior wall of a building. The wall is a light beige color. There are two security lights mounted on the wall. Above the right security light, there is a small gap in the masonry. The roofline is visible at the top of the image. | <p>Small gap in masonry above the security light corresponding to the light ingress noted from within the building.</p> |

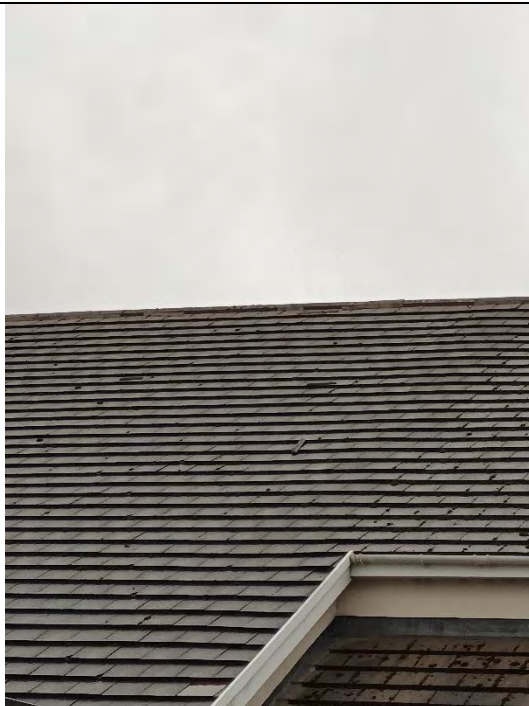
TN13

Some raised/loose bit of cement present along the ridge of the roof.

No obvious raised/damaged tiles.
