**Tree condition survey on land adjacent to 80 Westwood Drive,  
Treharris CF46 5BL**

**Date:**  
4<sup>th</sup> December 2019

**Document ref:**  
PC19-192

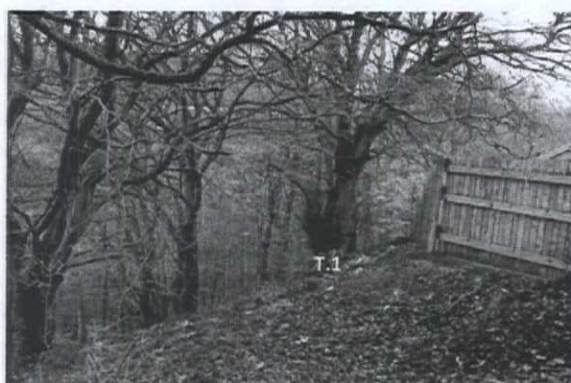
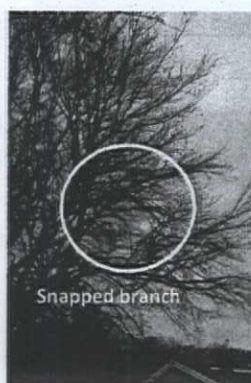
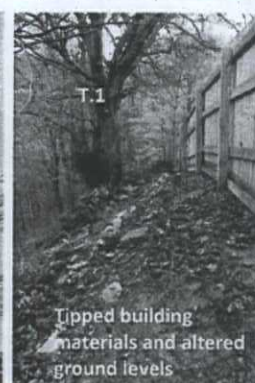
| Tree number | Species | Comments | Failure foreseeable? | Intervention required? | Within what timeframe? |
|---|---|---|---|---|---|
| T.1 | Beech | <p>A high value mature tree growing on steeply sloping ground adjacent to property boundary. Single stem dividing into 4 significant stems at 1.5m. Building materials from property's driveway construction tipped around base and ground levels altered; top layer of ground easily displaced. East half of crown extends over property of 80 Westwood Drive. Deadwood in crown, 75mm diameter x 4.5m long, and snapped hung-up branch over driveway. Good bud density throughout crown with some foliage in autumn colour still attached. No critical defects observed, tree appears healthy with good vitality.</p> <p><b>Specific target:</b> 80 Westwood Drive occupants and visitors</p> | <p>Yes – deadwood and snapped branch only</p> <p><b>Risk of harm:</b><br/>Low</p> | <p>Yes</p> <p>Remove deadwood and snapped branch</p> <p>Clear building materials away from trees</p> | 12 months |

To ease the intimidation, reduce the concerns and help prevent future safety issues arising, we recommend the branches overhanging the bungalow and drive are reduced by approximately 4m (from 12.5m to 8.5m). Finished cuts to be made at viable growth points, with pruning wounds no larger than 50mm diameter to help prevent significant damage to the tree's health.
