## **David Wiltshire. TechArborA**

### **Arboricultural Evaluation**

**Ash Tree to Rear of Cherry Tree Way, Trelewis**

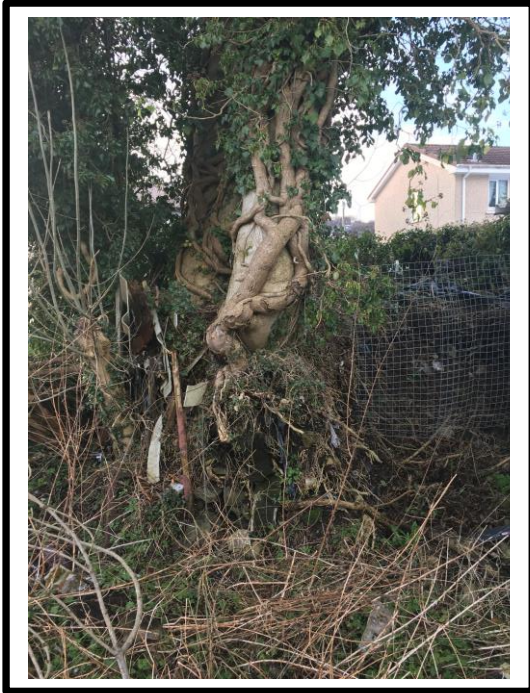
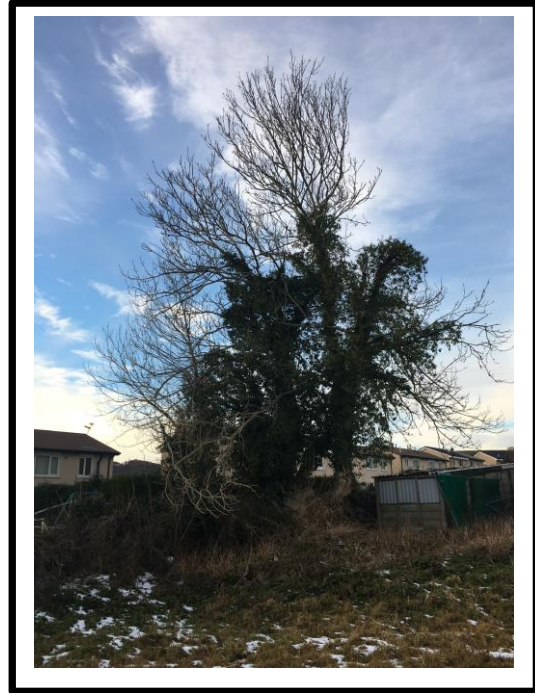
**Species:** T1 Multi Stem Ash      **Age Class:** Mature.      **Height:** 15 Metres.

Large mature tree with severe root damage and decay due to historical excavation work. This may have left tree unstable.

The western stem closest to neighbouring property is bifurcated at approximately 450mm with some evidence of included bark. This may lead to a weak union.

There is a limb at approximately 5 metres that appears to be split and this is more than likely storm damage.

Large dead wood is present throughout the upper crown with a number of limbs already lost or hung up.

A number of limbs are showing symptoms of Ash dieback and the tree may already be close to category 3 Ash dieback. This is difficult to fully ascertain fully due to the time of year.

Scaffold limb on north west side of crown is heavily end loaded.

Main stem and some of the upper crown is Ivy covered.

I strongly believe the tree is in decline.

**Hazard rating:** Medium-High

With all the physiological defects and the severed decayed roots, the tree has limited or no future growth potential and is potentially unstable.

Remove tree.
