Project: Merthyr Synagogue
Job No: 9684
Subject: Comments on further investigations
Made by: JB
Date: 20/02/24
Ref: 9684_SK10
Rev: A

8.3.1 Existing Steps at the Rear - Options Assessment

Project No: **Merthyr Synagogue**
Potential Approaches to Rear Area
Project: **9684**Engineer: **Joshua Bird**Date of Issue: **15/01/2024**Revision: **A**

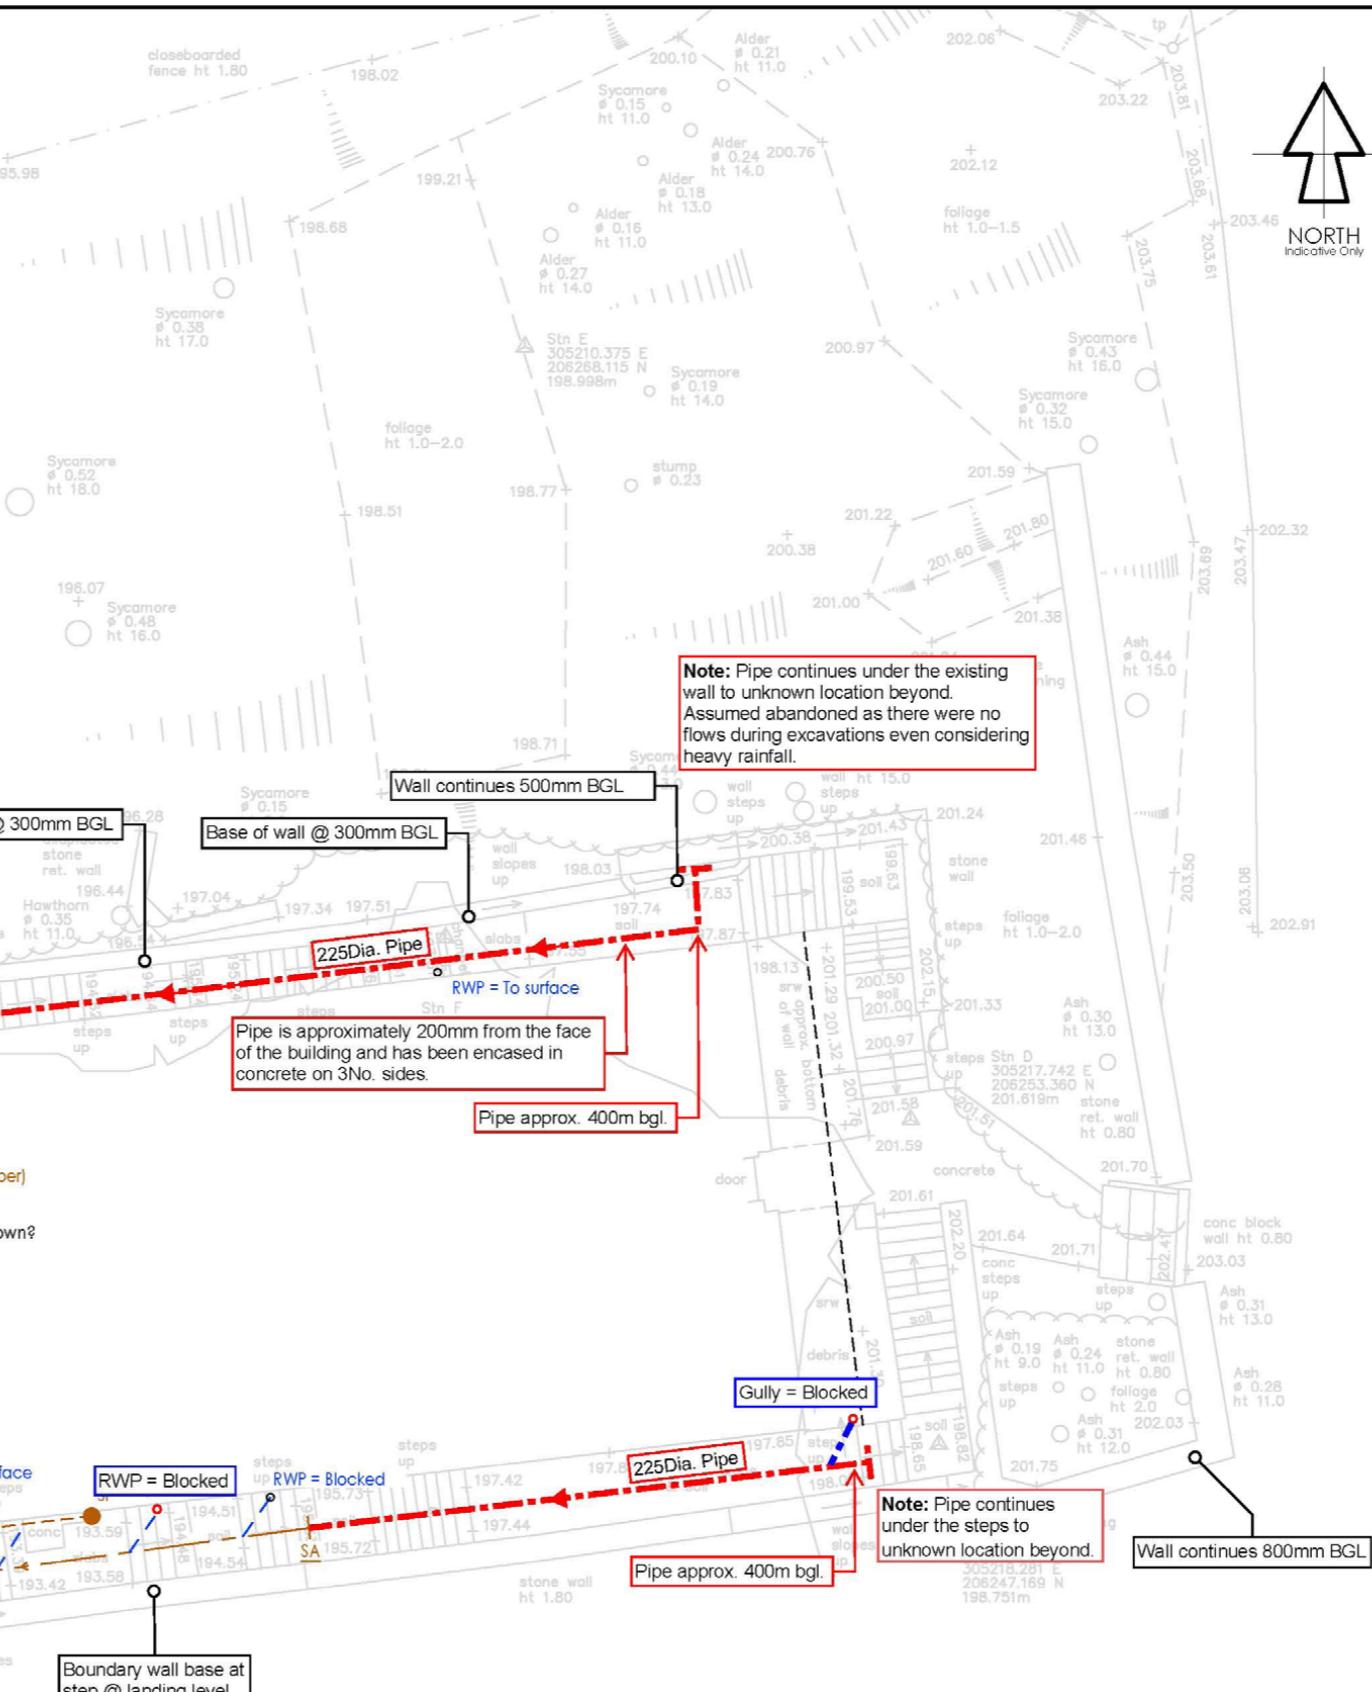
Drainage - As part of the inspections we undertook a quick exercise to try and establish whether the drains still run. This was done by pouring water into holes created in the upper ends of the pipe (on the upper landing) and inspecting whether flow was visible at the bottom.

The North pipe is notably flowing well however there was some evidence of silts within the pipe which may have restricted the flow.

The South pipe flows however at a noticeably slower rate therefore we suspect there may be some localised trapped materials / vegetation which may be restricting the flow.

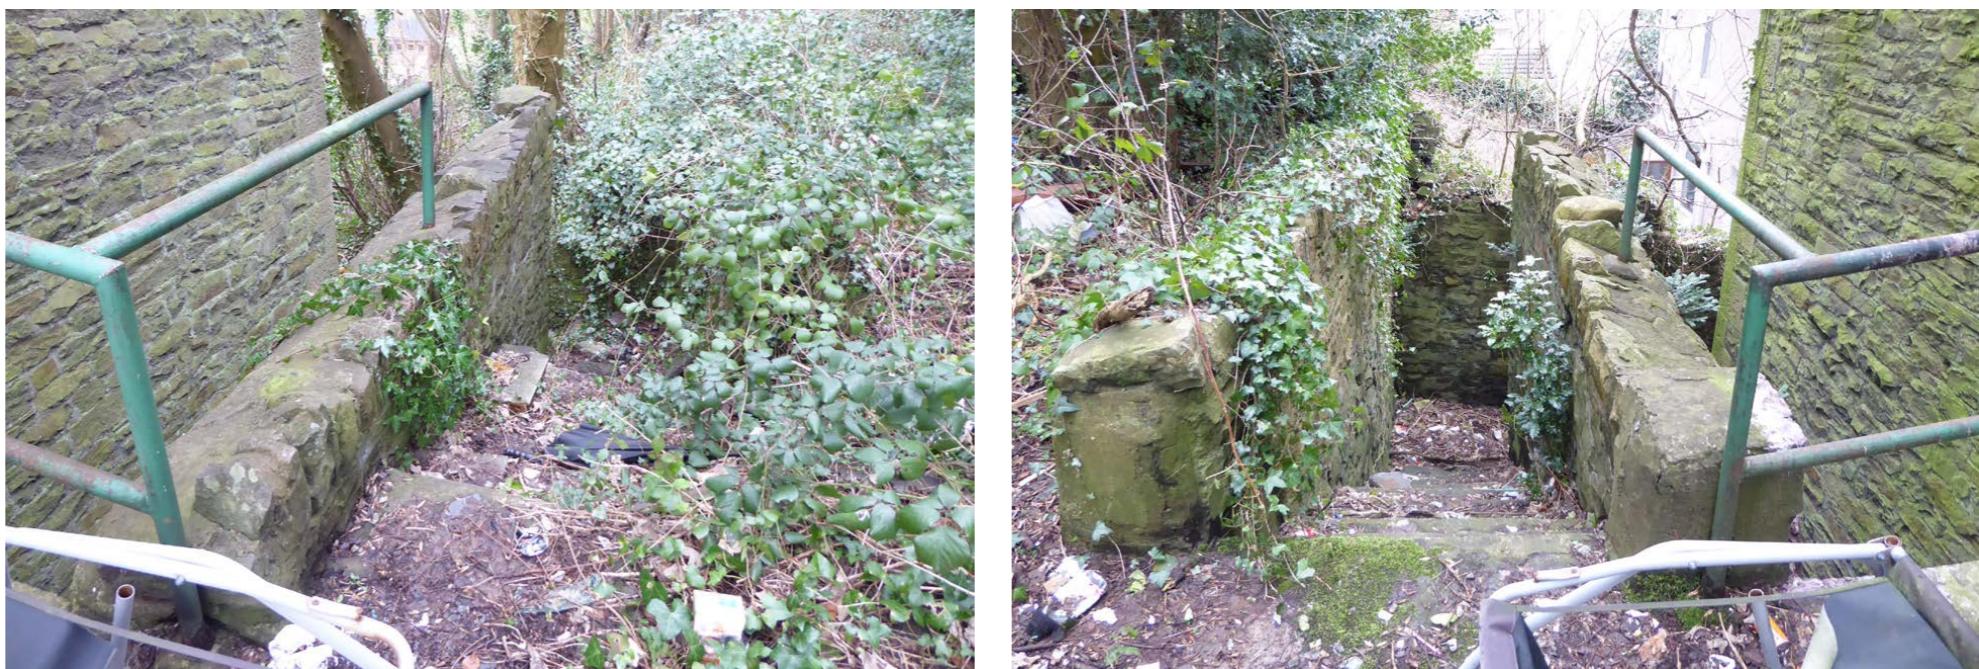
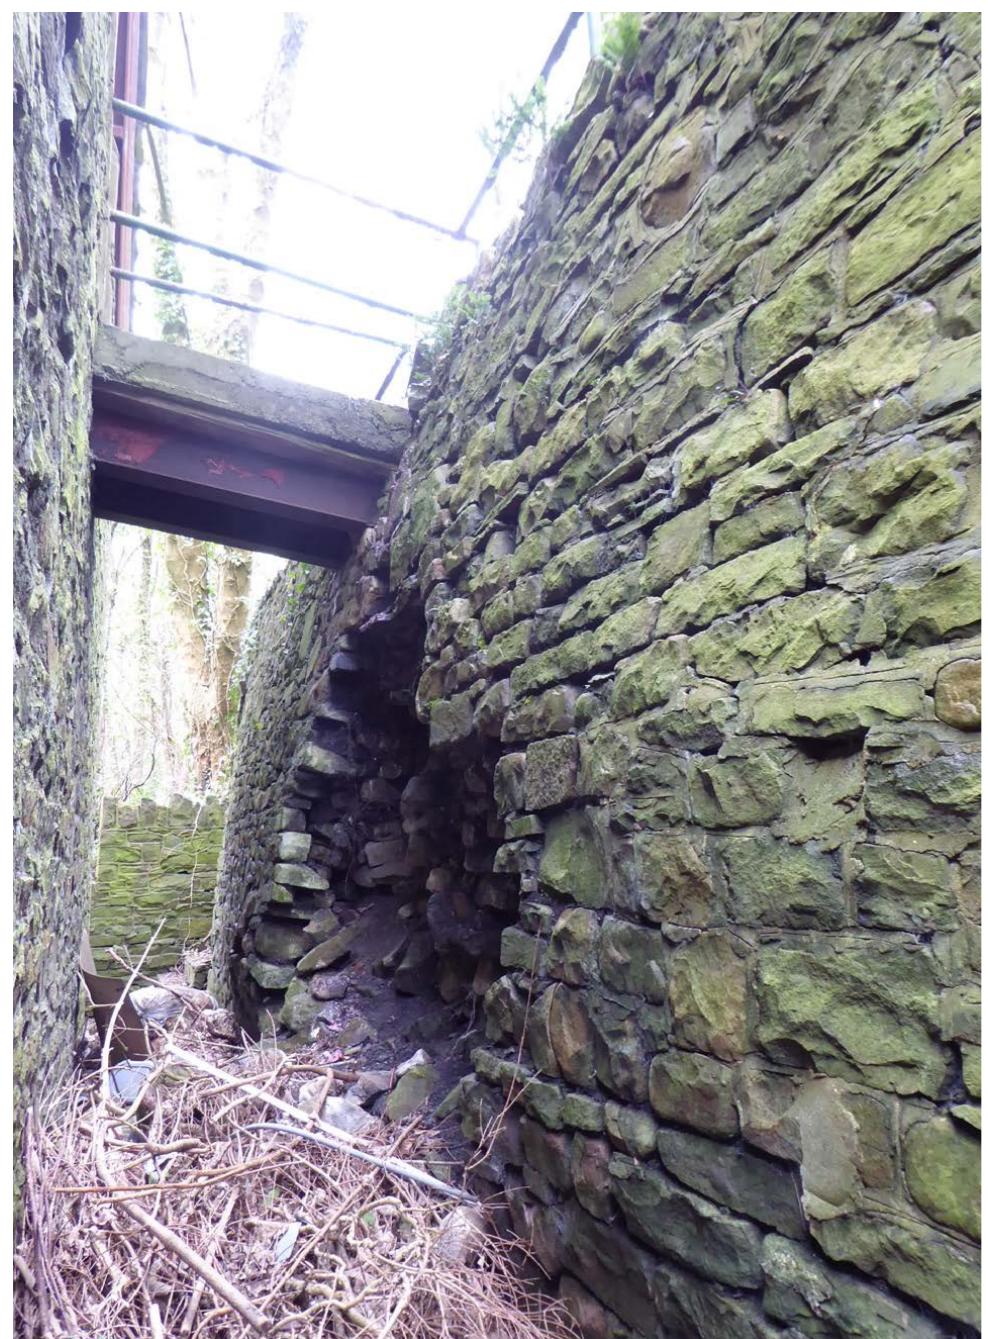
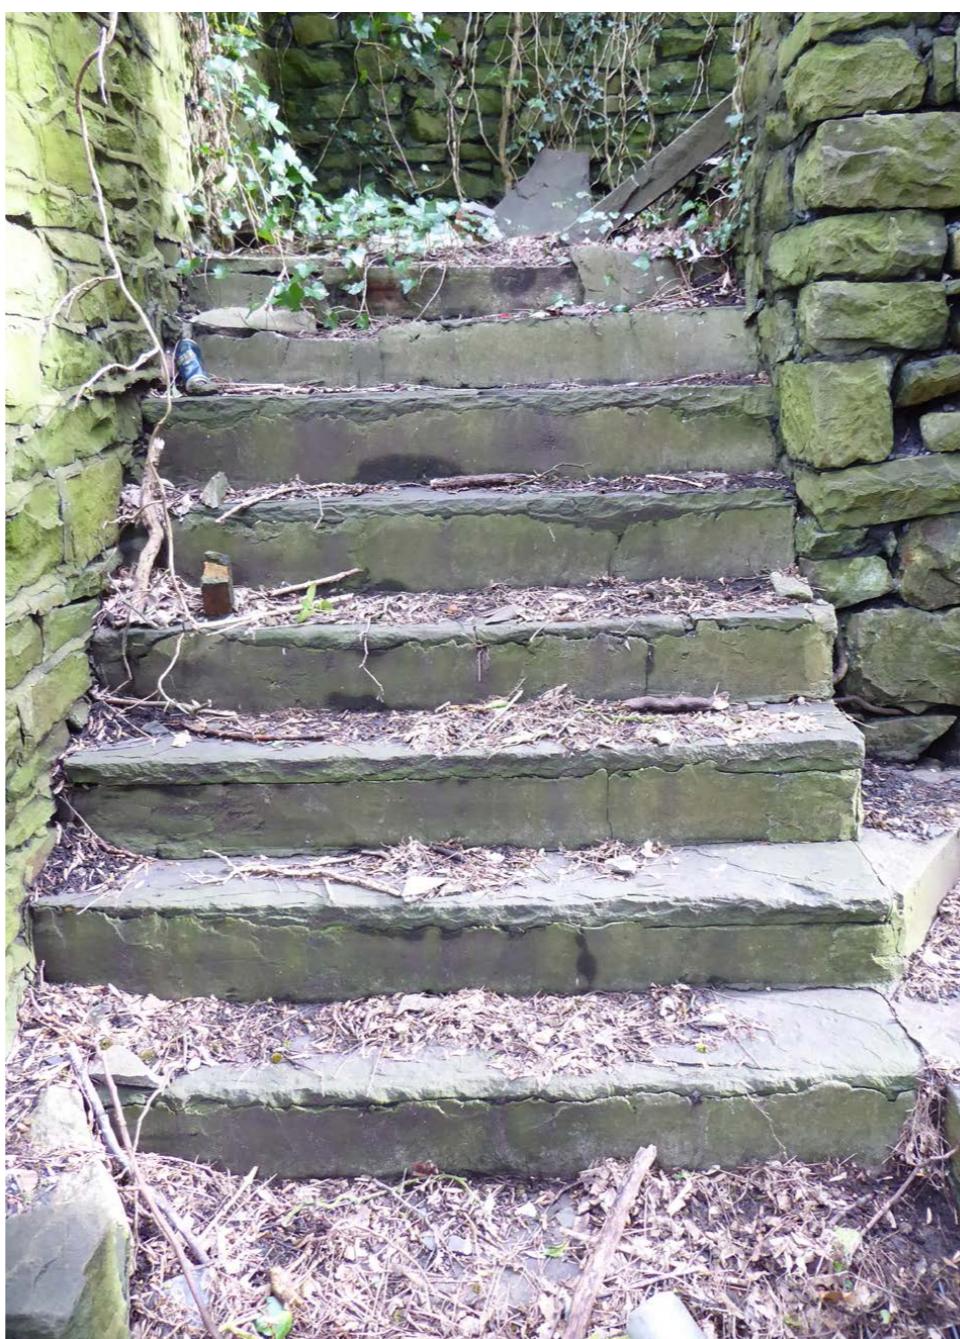
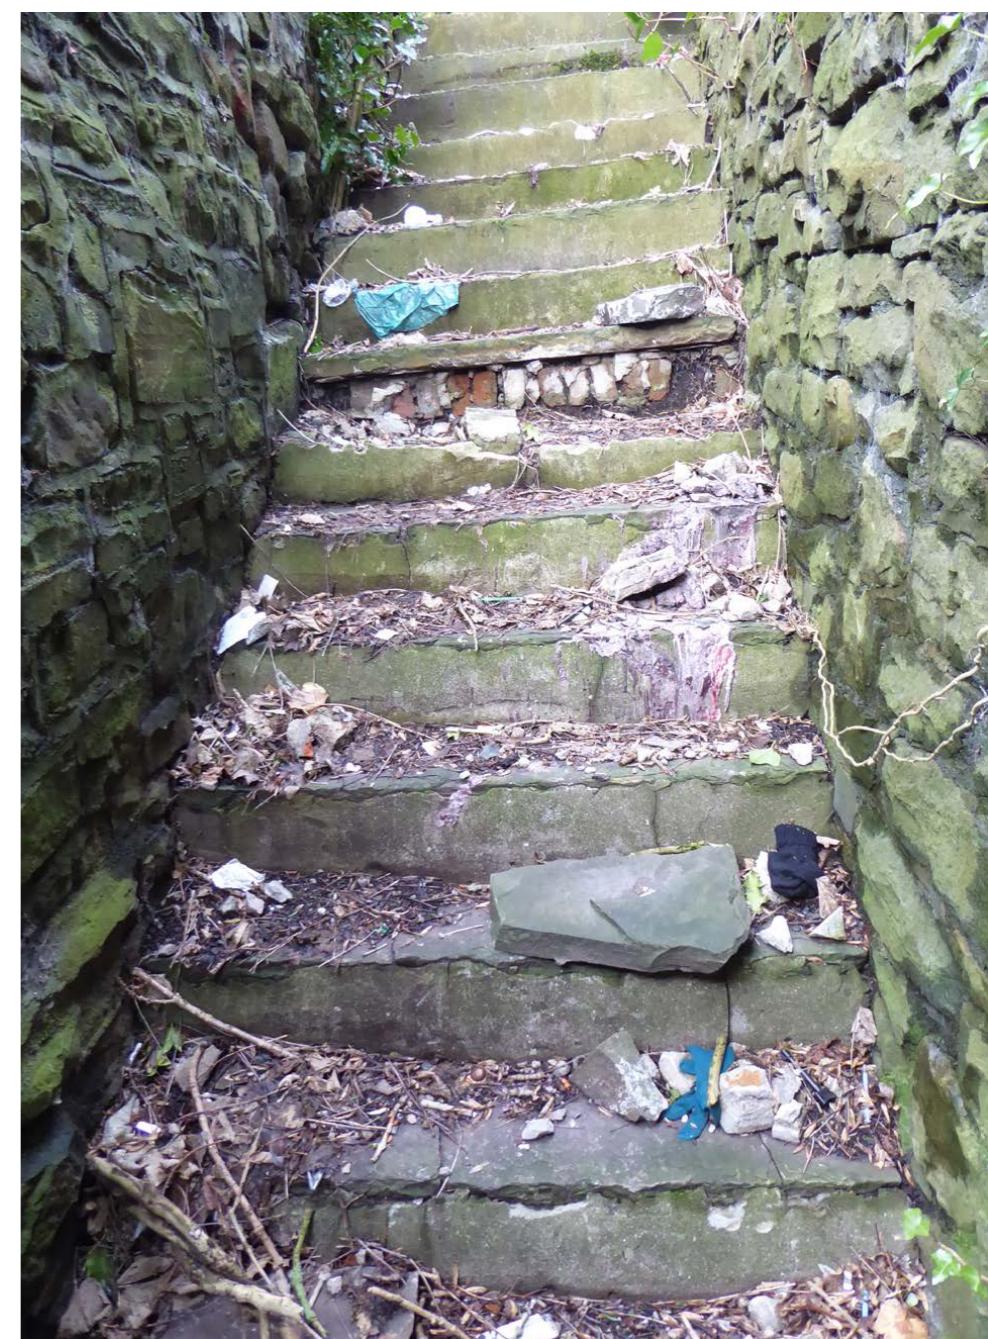
Pursuant to that essential shoring up of the retaining wall and the localised taking down of the tops of the wall, the photos on this page show the steps and wall as they are in 2025.

Despite some stabilisation work (which was only temporary), the steps and retaining wall remains at significant risk of collapse. There is no options for doing nothing. However, the first questions were:
