## Supporting photographs

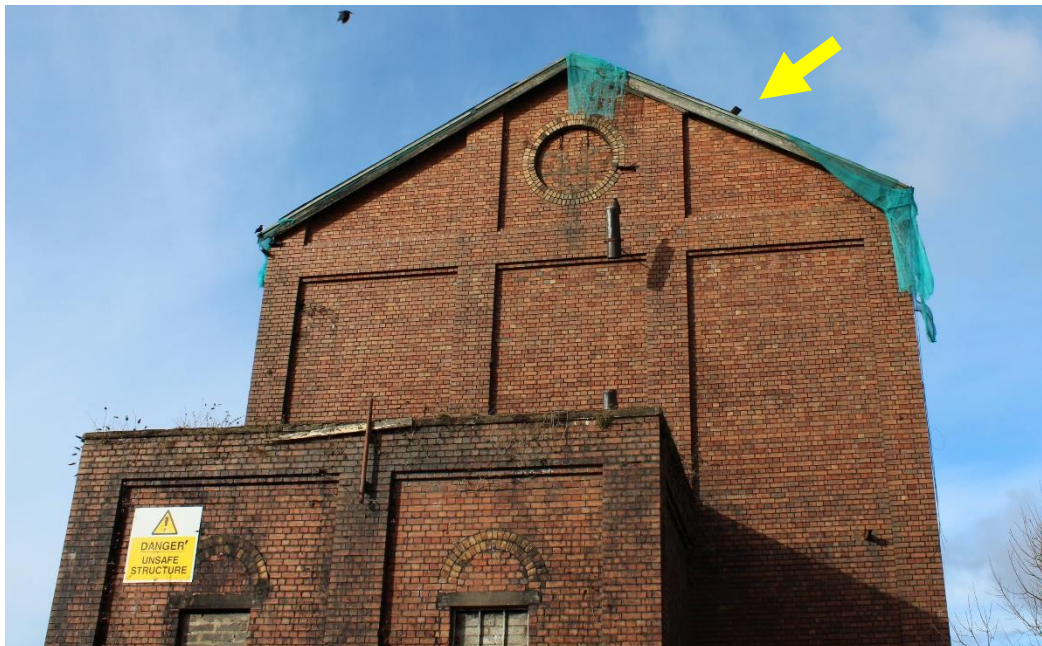
**Photograph 5 ~ End east elevation overhanging slate arrowed**

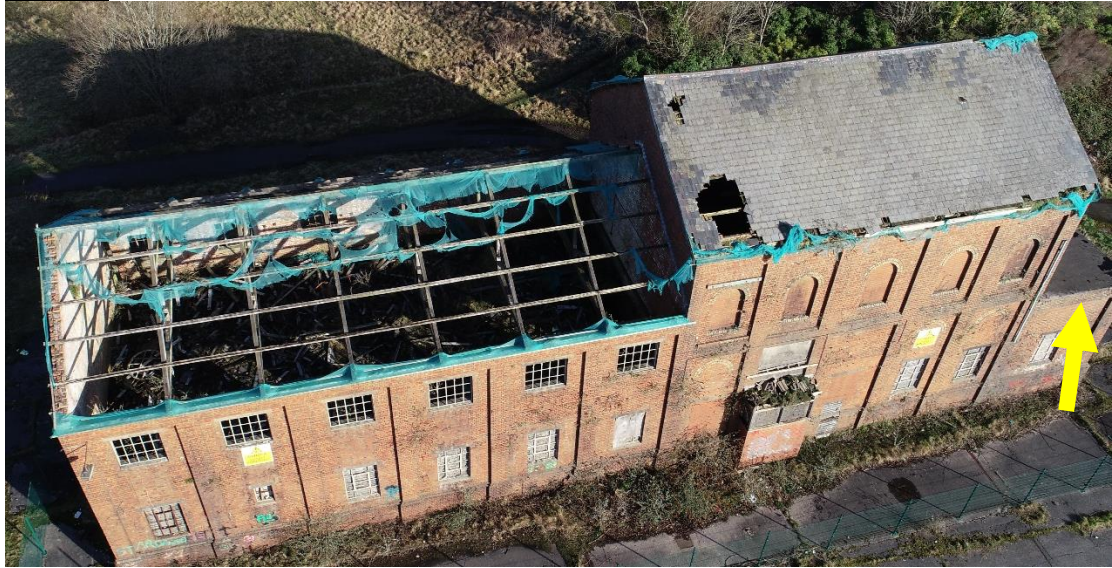
**Photograph 12 ~ Roof lower west end to LHS and upper east end to RHS flat roof arrowed**

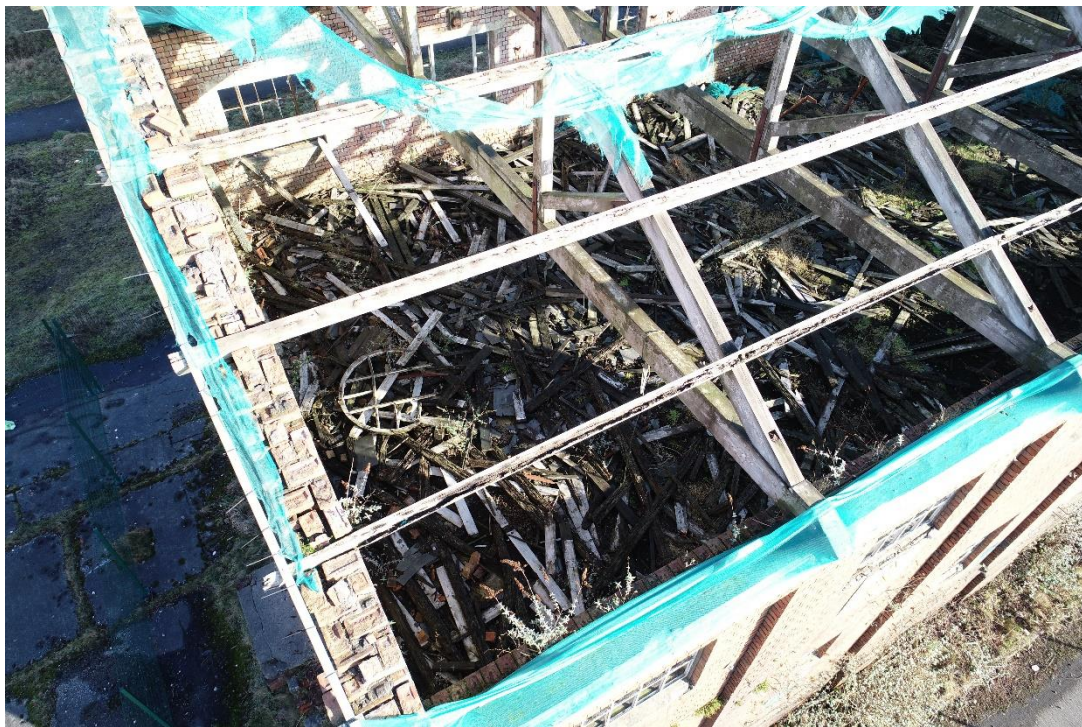
**Photograph 13 ~ Roof debris on first floor level to west end**

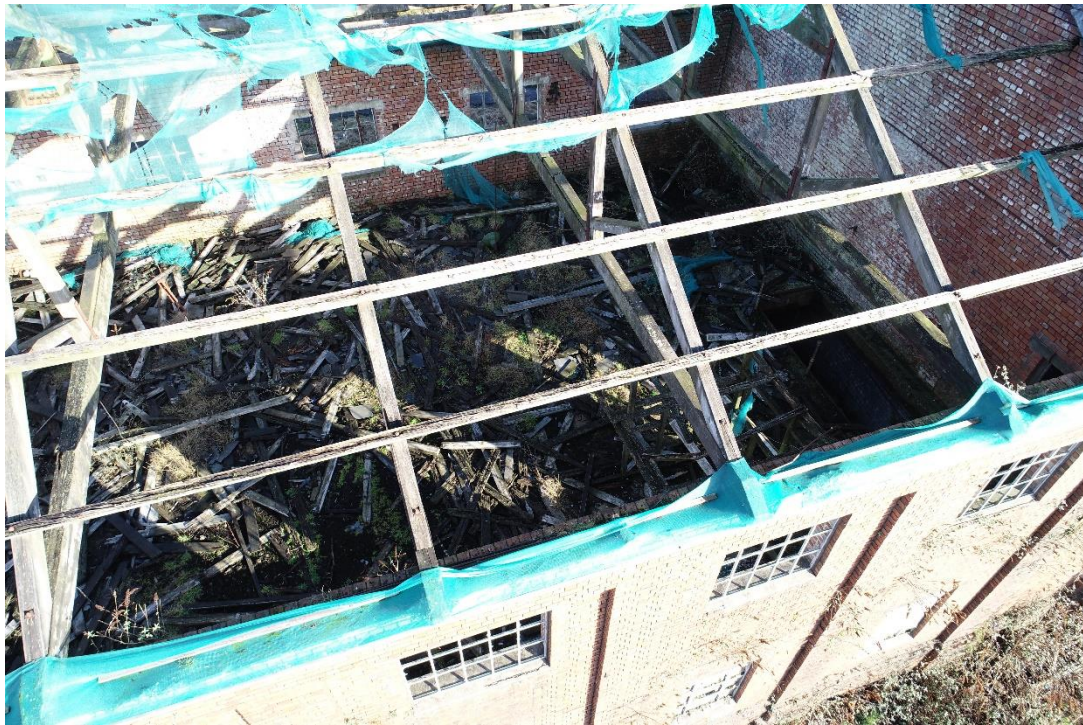
**Photograph 14 ~ Roof debris on first floor structure to west end**

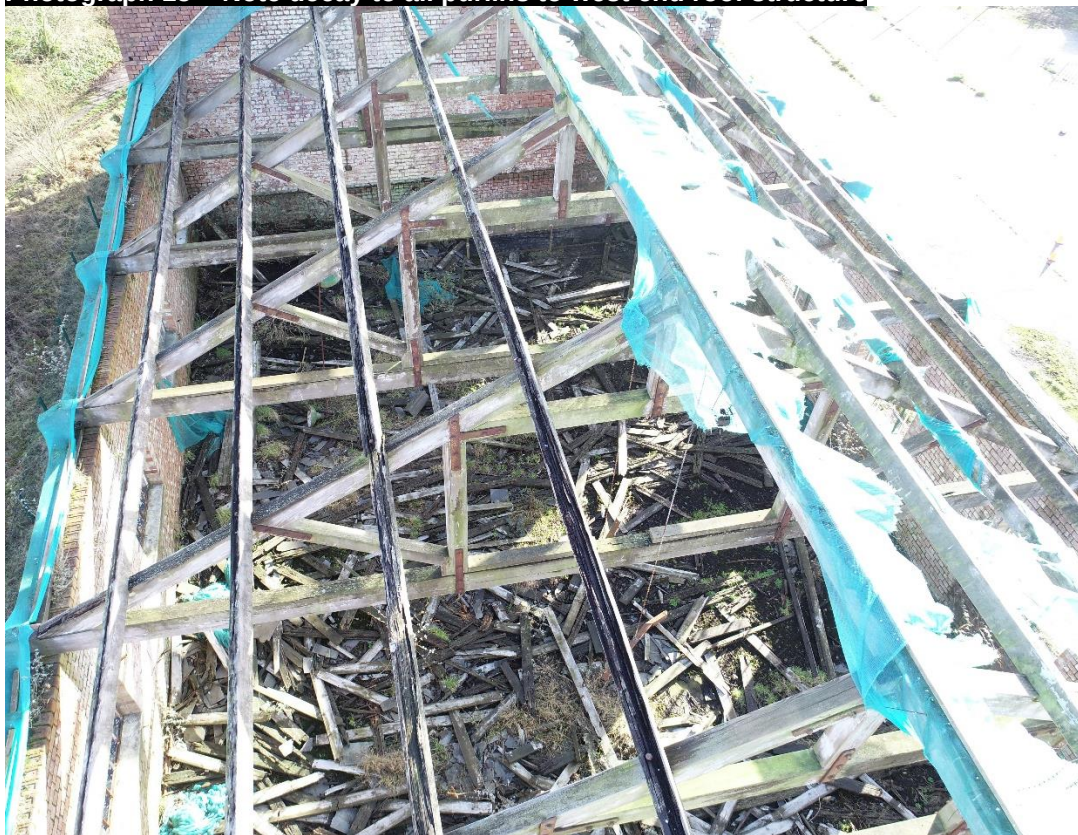
**Photograph 15 ~ Note decay to all purlins to west end roof structure**

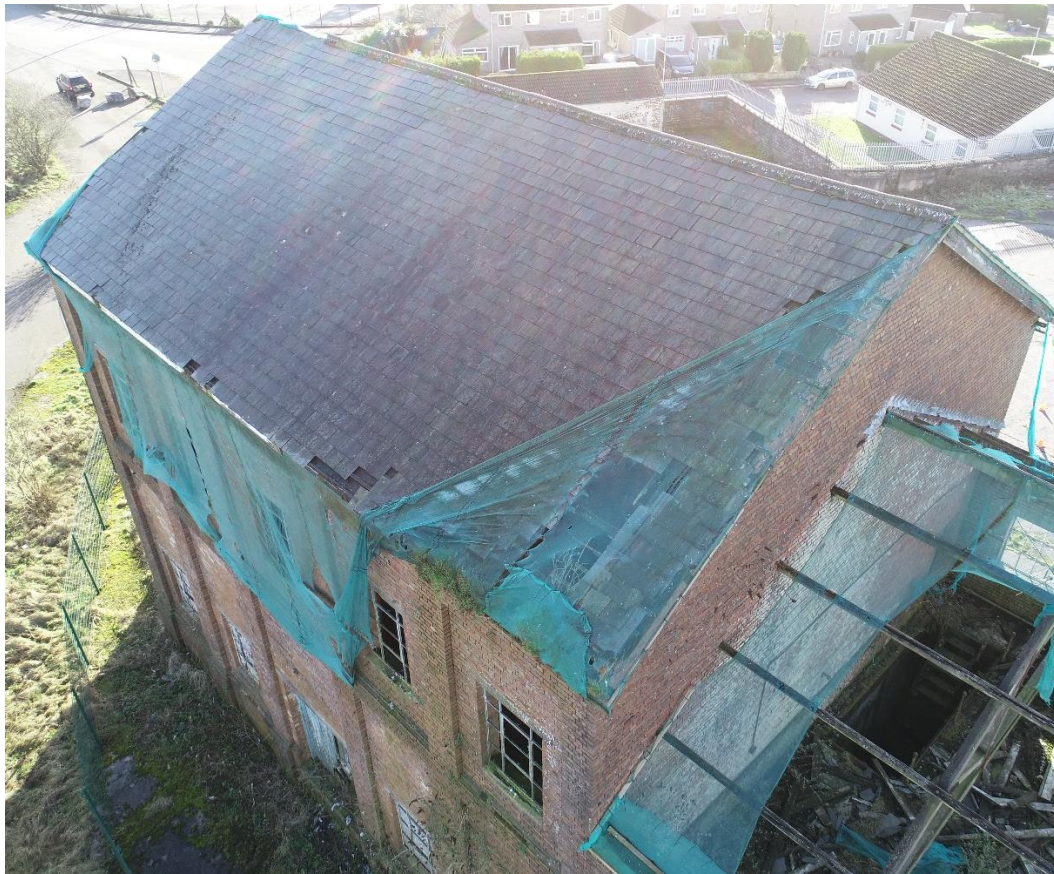
**Photograph 16 ~ Roof holed to rear elevation under netting**

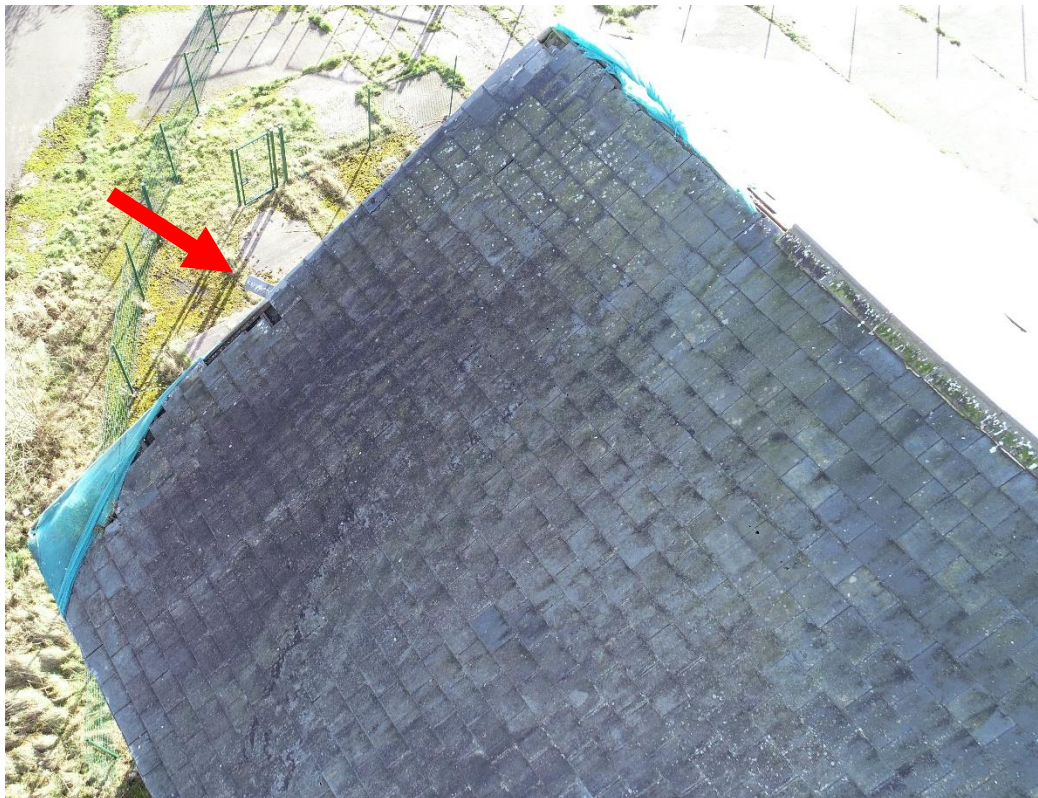
**Photograph 17 ~ slates coming off east gable verge overhang slate arrowed**

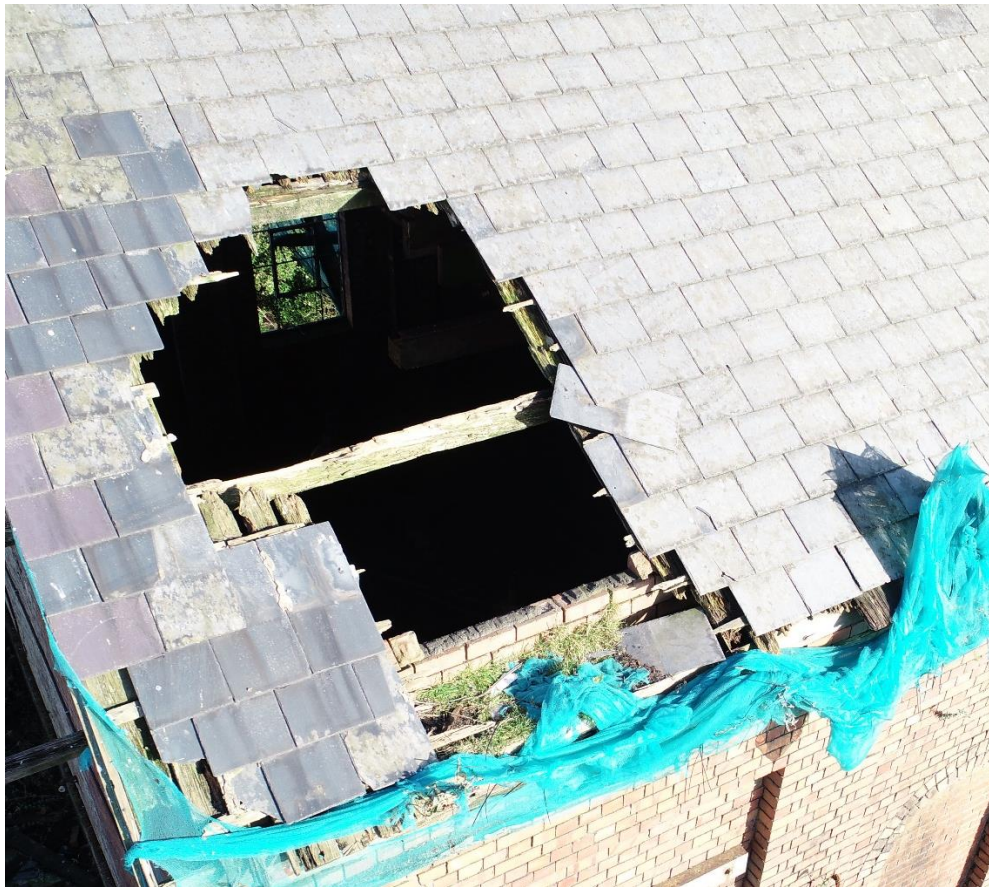
**Photograph 20 ~ Roof holed to front elevation**

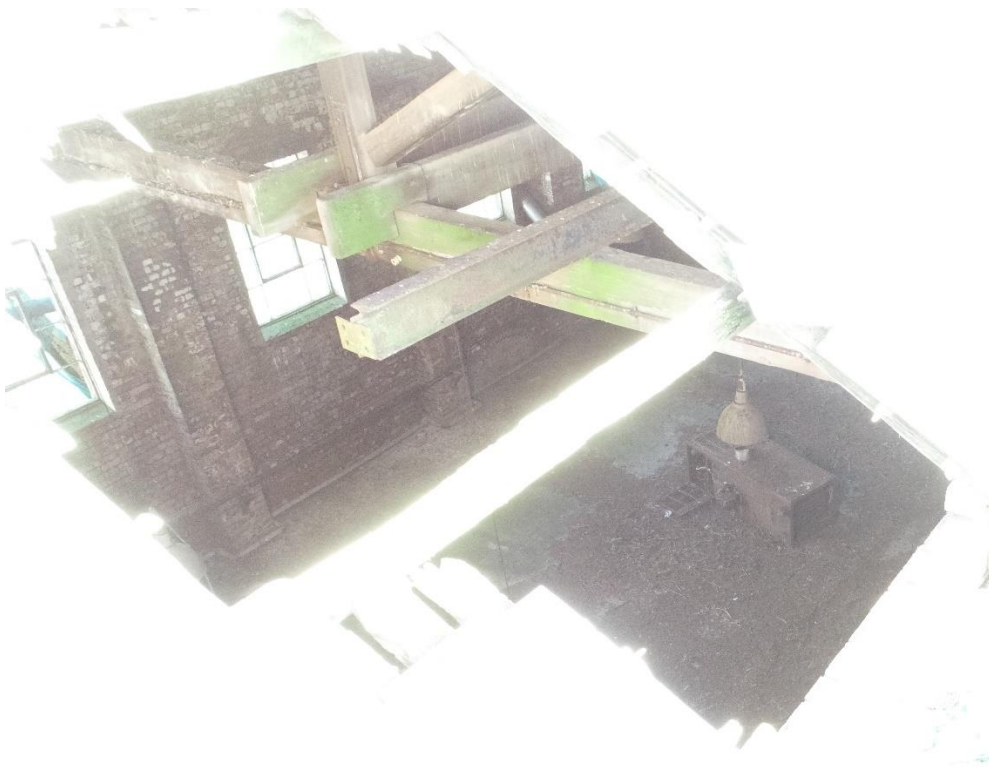
**Photograph 21 ~ View to first floor through hole in roof**

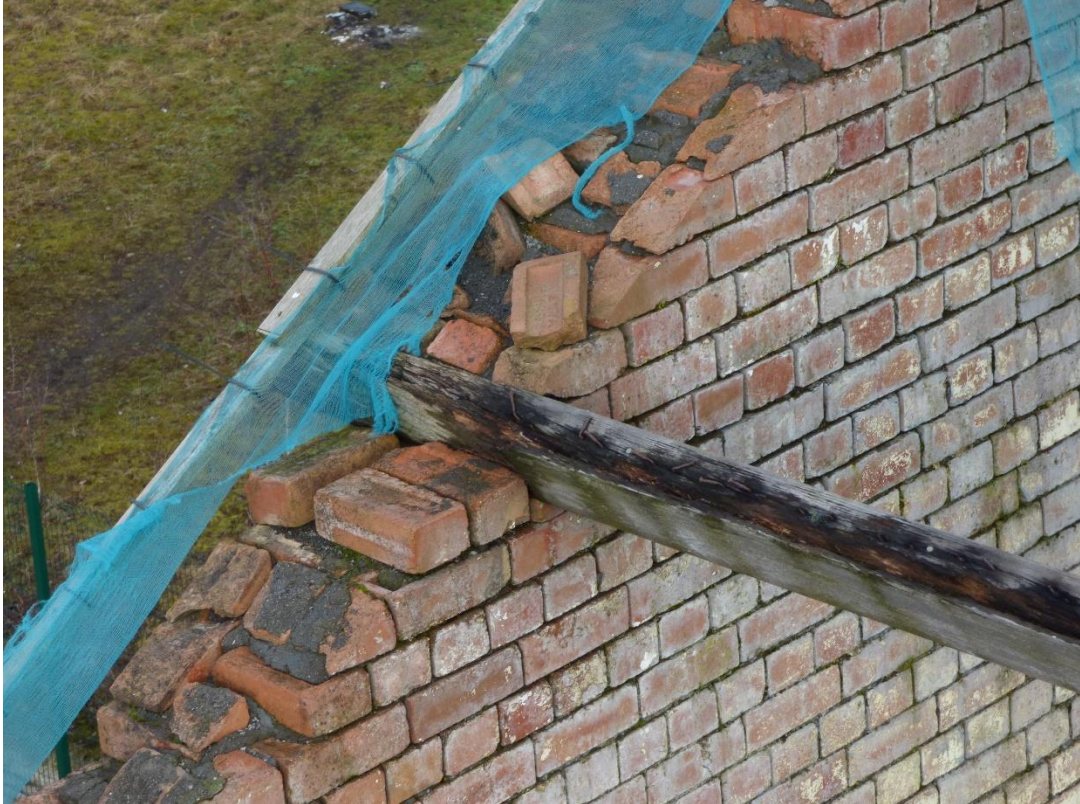
**Photograph 22 ~ Loose bricks to west end gable wall purlin loosely supported**

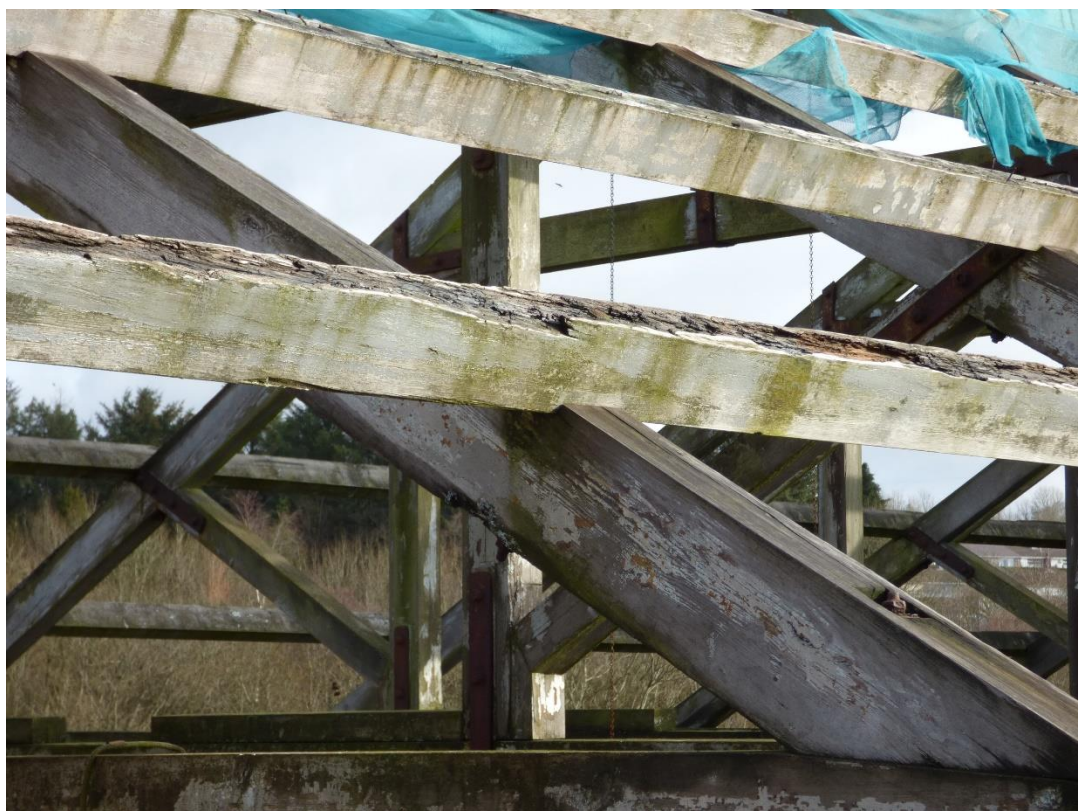
**Photograph 18 ~ Decay to purlins where bolted to truss**

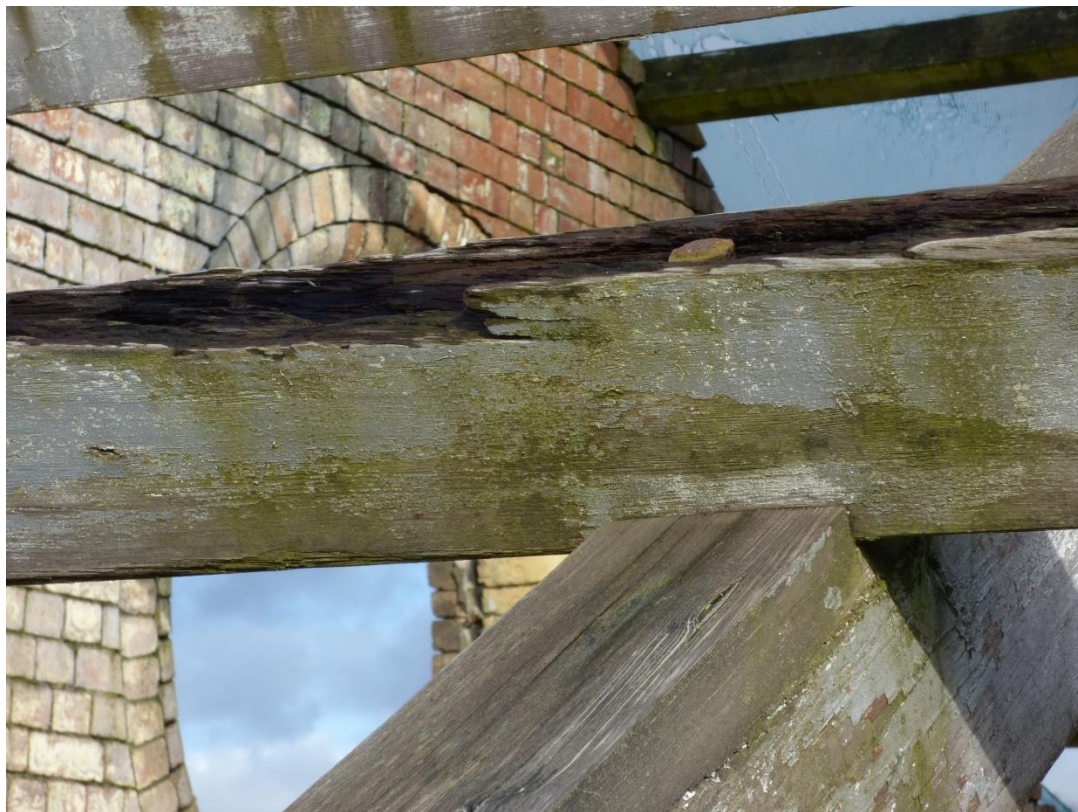
**Photograph 19 ~ Decay to purlin where bolted to truss**

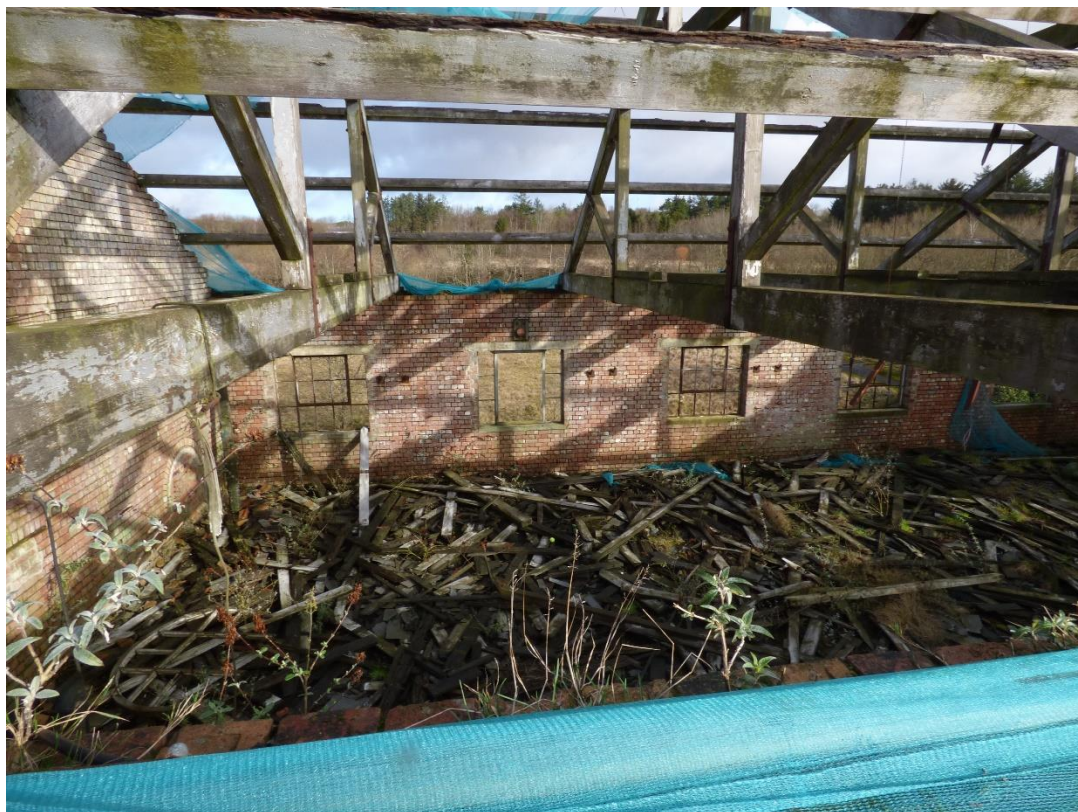
**Photograph 20 ~ Roof debris on first floor to west end**

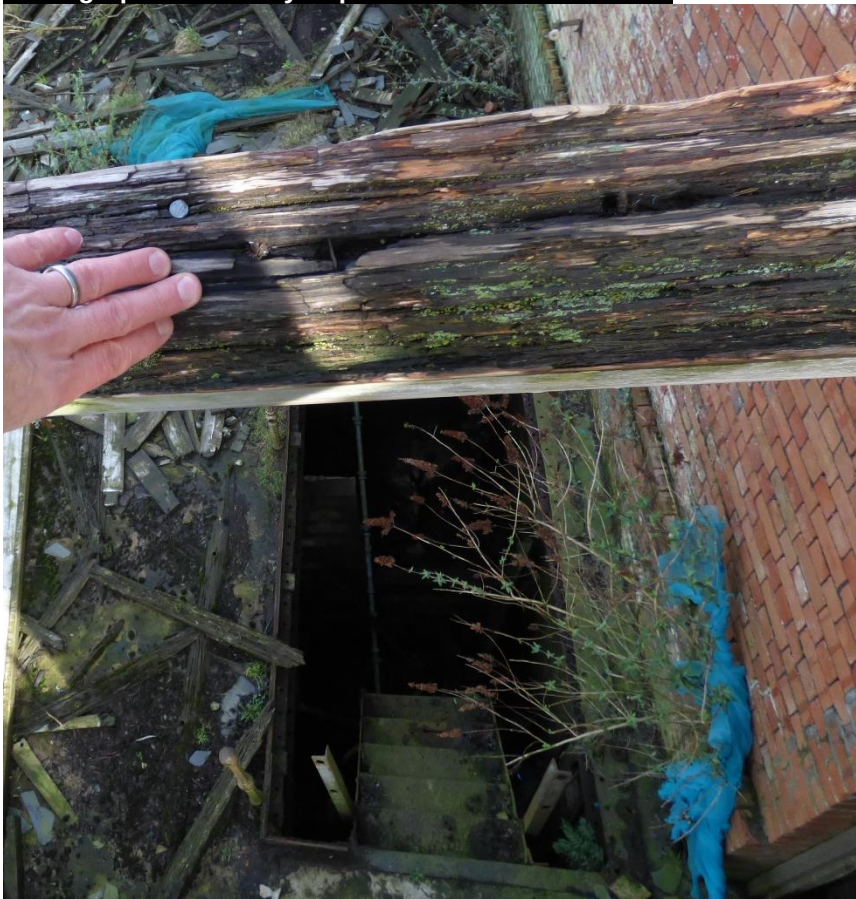
**Photograph 22 ~ Decay to purlin and stair well below**

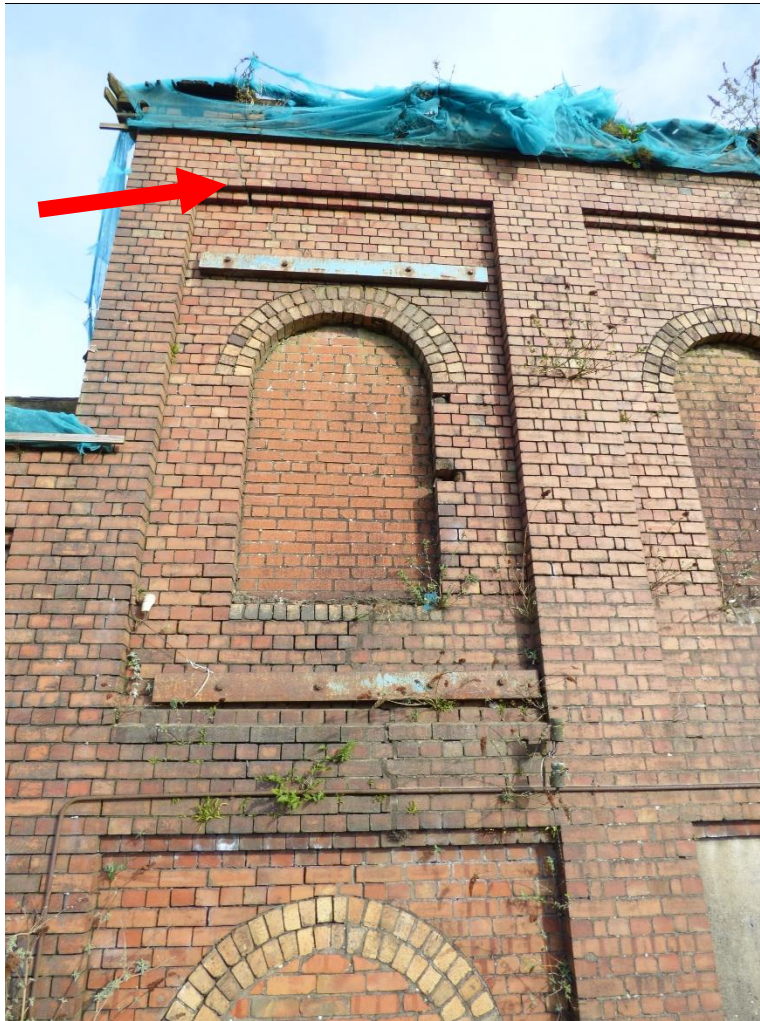
**Photograph 23 ~ Crack in top corner of front elevation wall and metal straps**

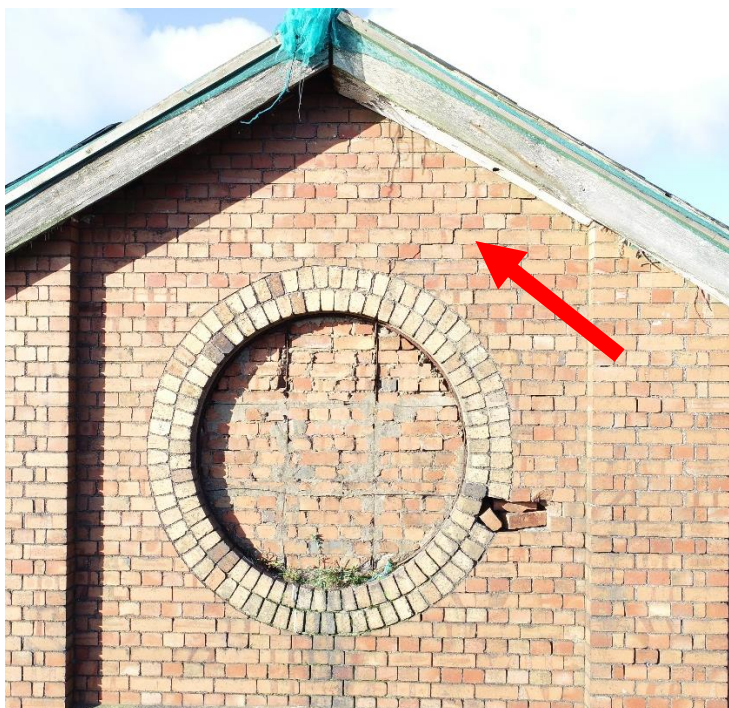
**Photograph 24 ~ Crack above blocked in circular window to east end gable**

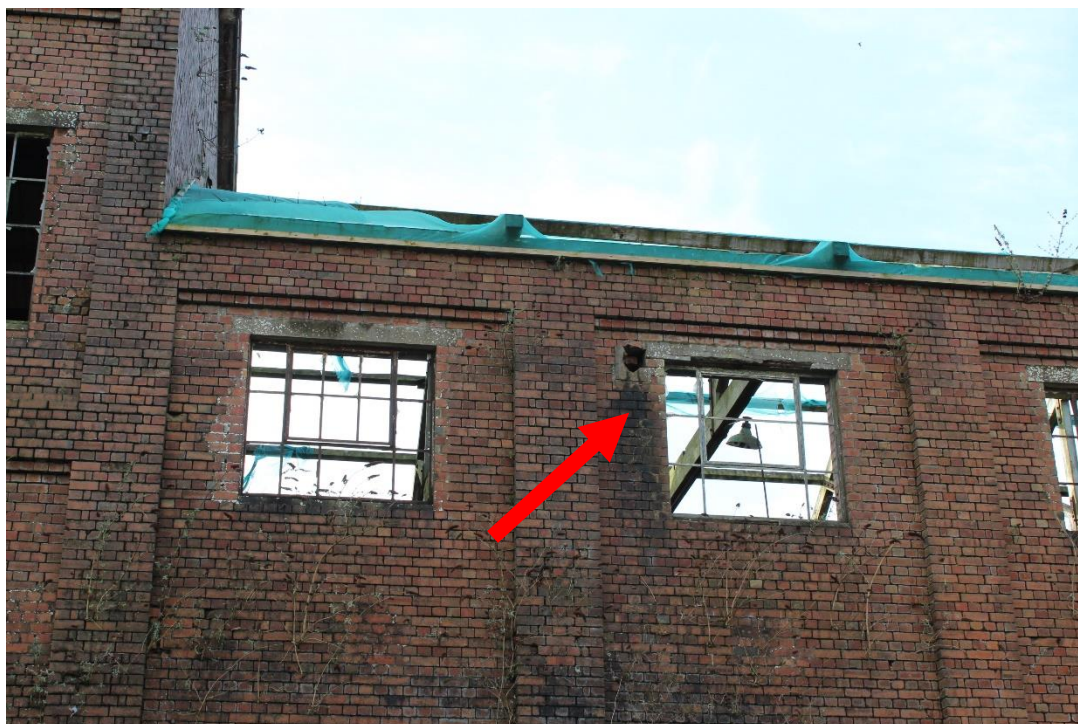
**Photograph 25 ~ Hole in wall and deterioration to rear elevation lintel**

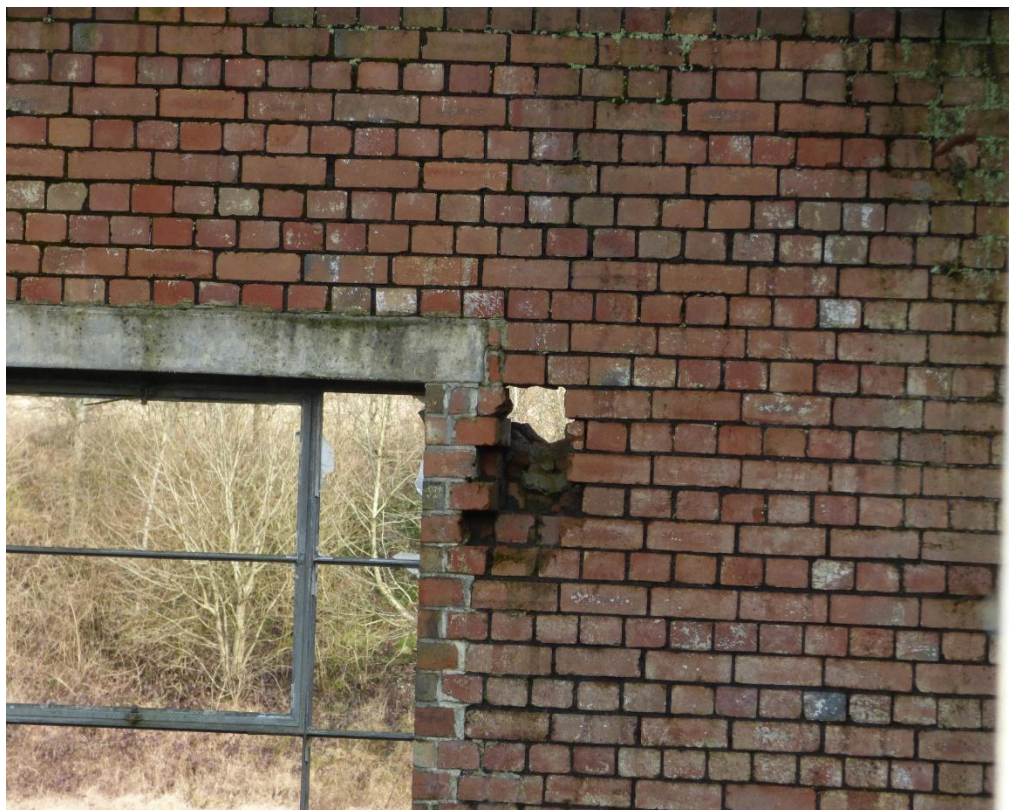
**Photograph 26 ~ Internal view of hole in wall as above**

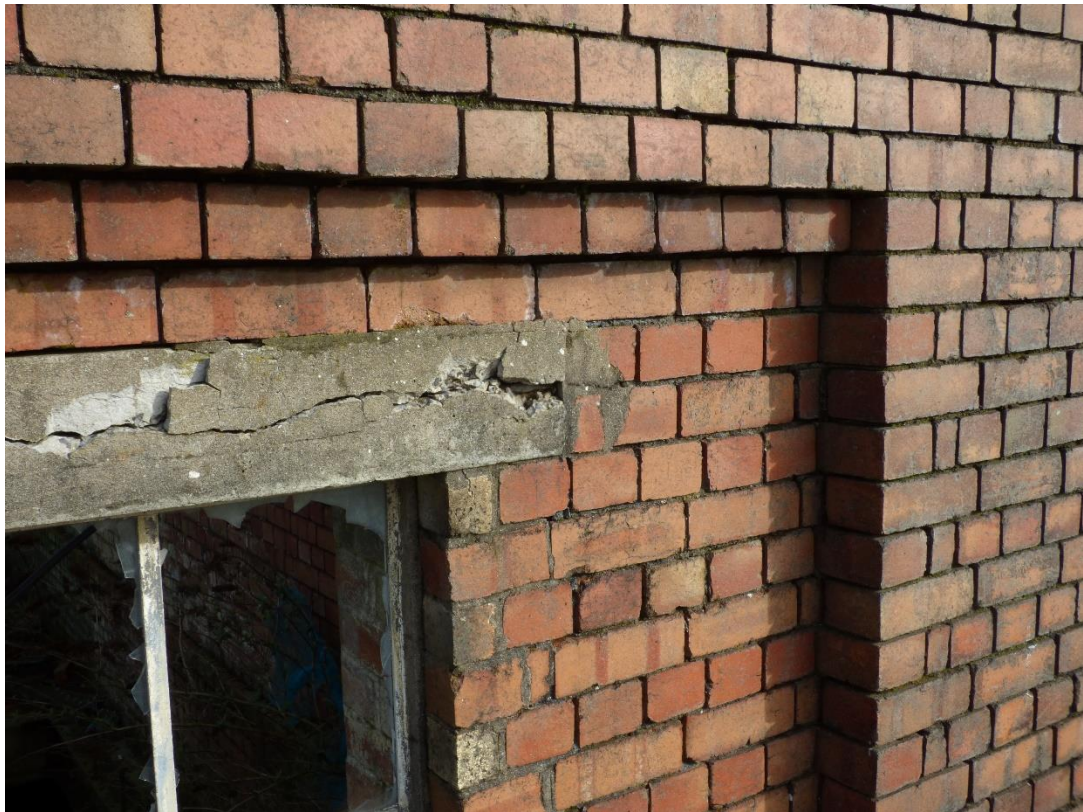
**Photograph 27 ~ Typical deterioration to precast concrete lintel**

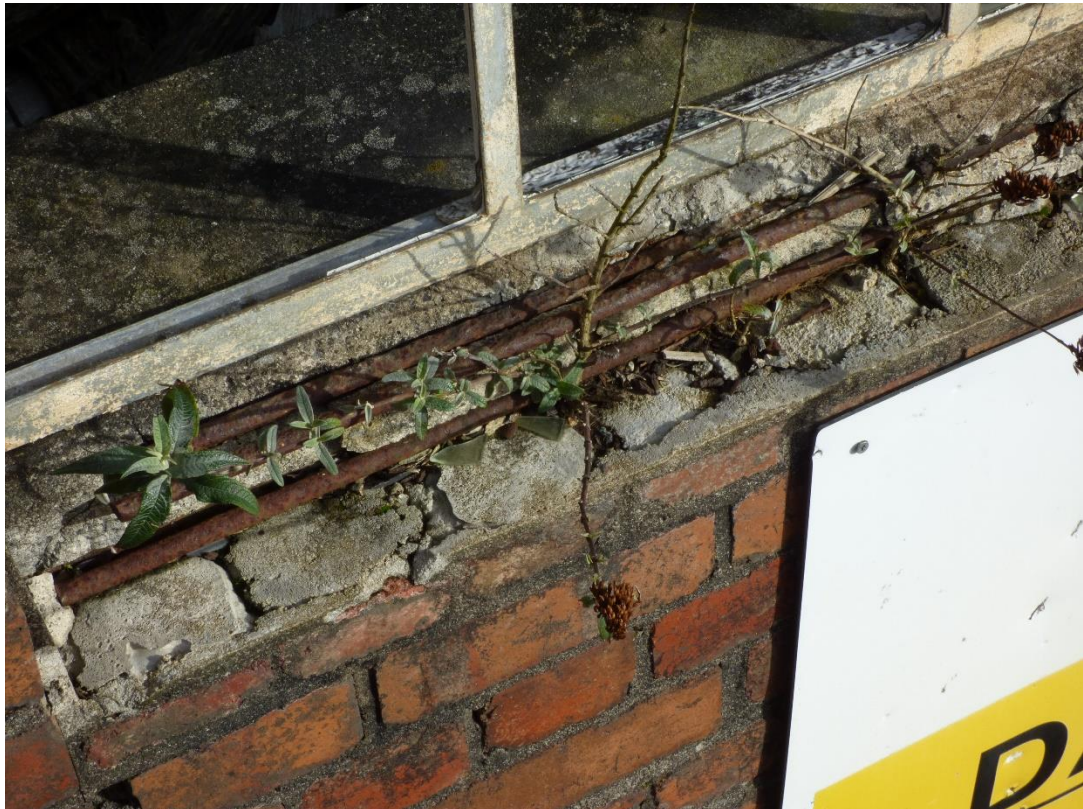
**Photograph 28 ~ Corrosion of metal reinforcement bars causing concrete lintel to disintegrate**
