**R 145 South East Elevation- Terracotta Supply**

| YMCA, Merthyr Tydfil | | |
| | | 3510_R_145 |

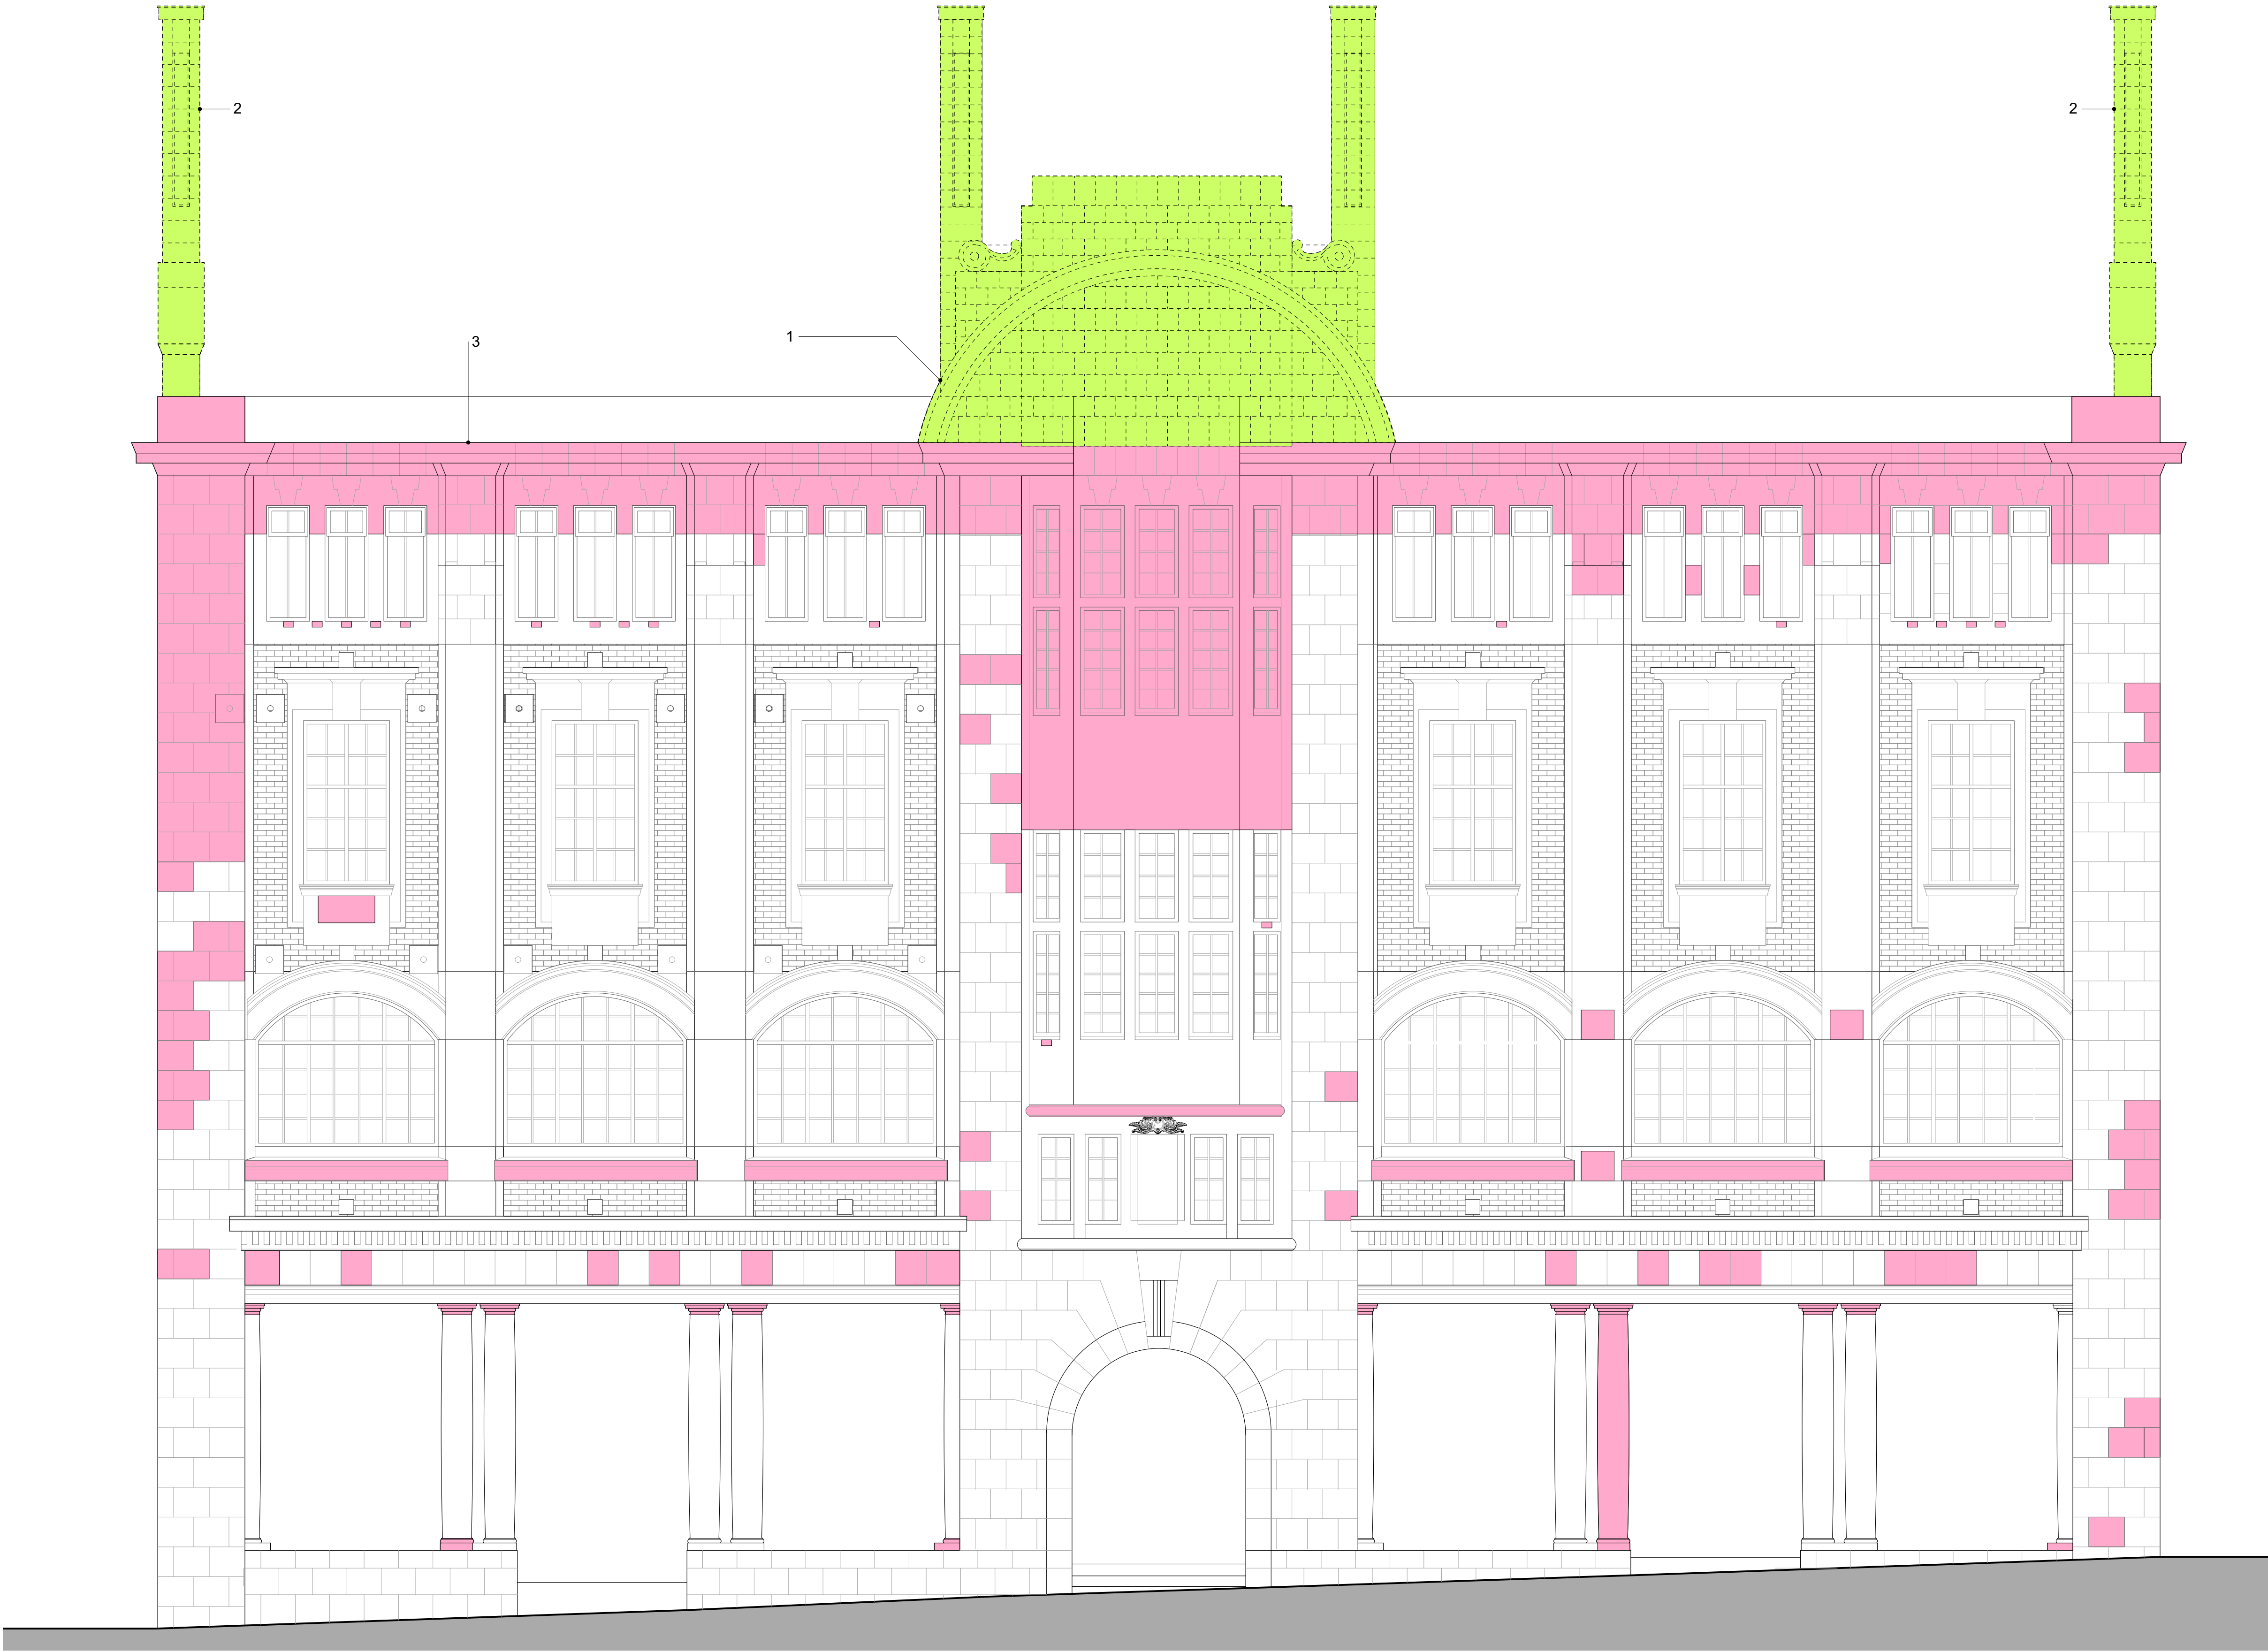
1. Remaining pediment terracotta units to be cleaned/ repaired and re-used. Missing terracotta to be manufactured to match original.
2. Entire gable end chimney is missing, new terracotta required to rebuild.
3. Replacement terracotta required.

**Defective terracotta unit** - Allow for careful removal/ of existing terracotta and replacement with new as specification section C41.

**Missing terracotta units** - Allow for careful removal of any remains of existing terracotta unit and replacement with new as specification section C41. (Units may be found on site).

**Partially Damaged terracotta unit** - To be repaired where possible. Allow for careful removal of damaged units, repair and reinstatement, supplemented with new as specification section C41.
