### R 147 North East Elevation - Terracotta Supply

| NO | DATE | REVISION |
|---|---|---|
| PROJECT<br><b>YMCA, Merthyr Tydfil</b> | | |
| DRAWING TITLE<br><b>Elevations - Terracotta Supply</b> | | |
| DO NOT SCALE FOR CONSTRUCTION PURPOSES - ALL DIMENSIONS TO BE CHECKED ON SITE - NOTIFY ARCHITECT OF ALL DISCREPANCIES - THIS DRAWING IS COPYRIGHT | | DRAWING NO.<br><b>3510_R_147</b> |

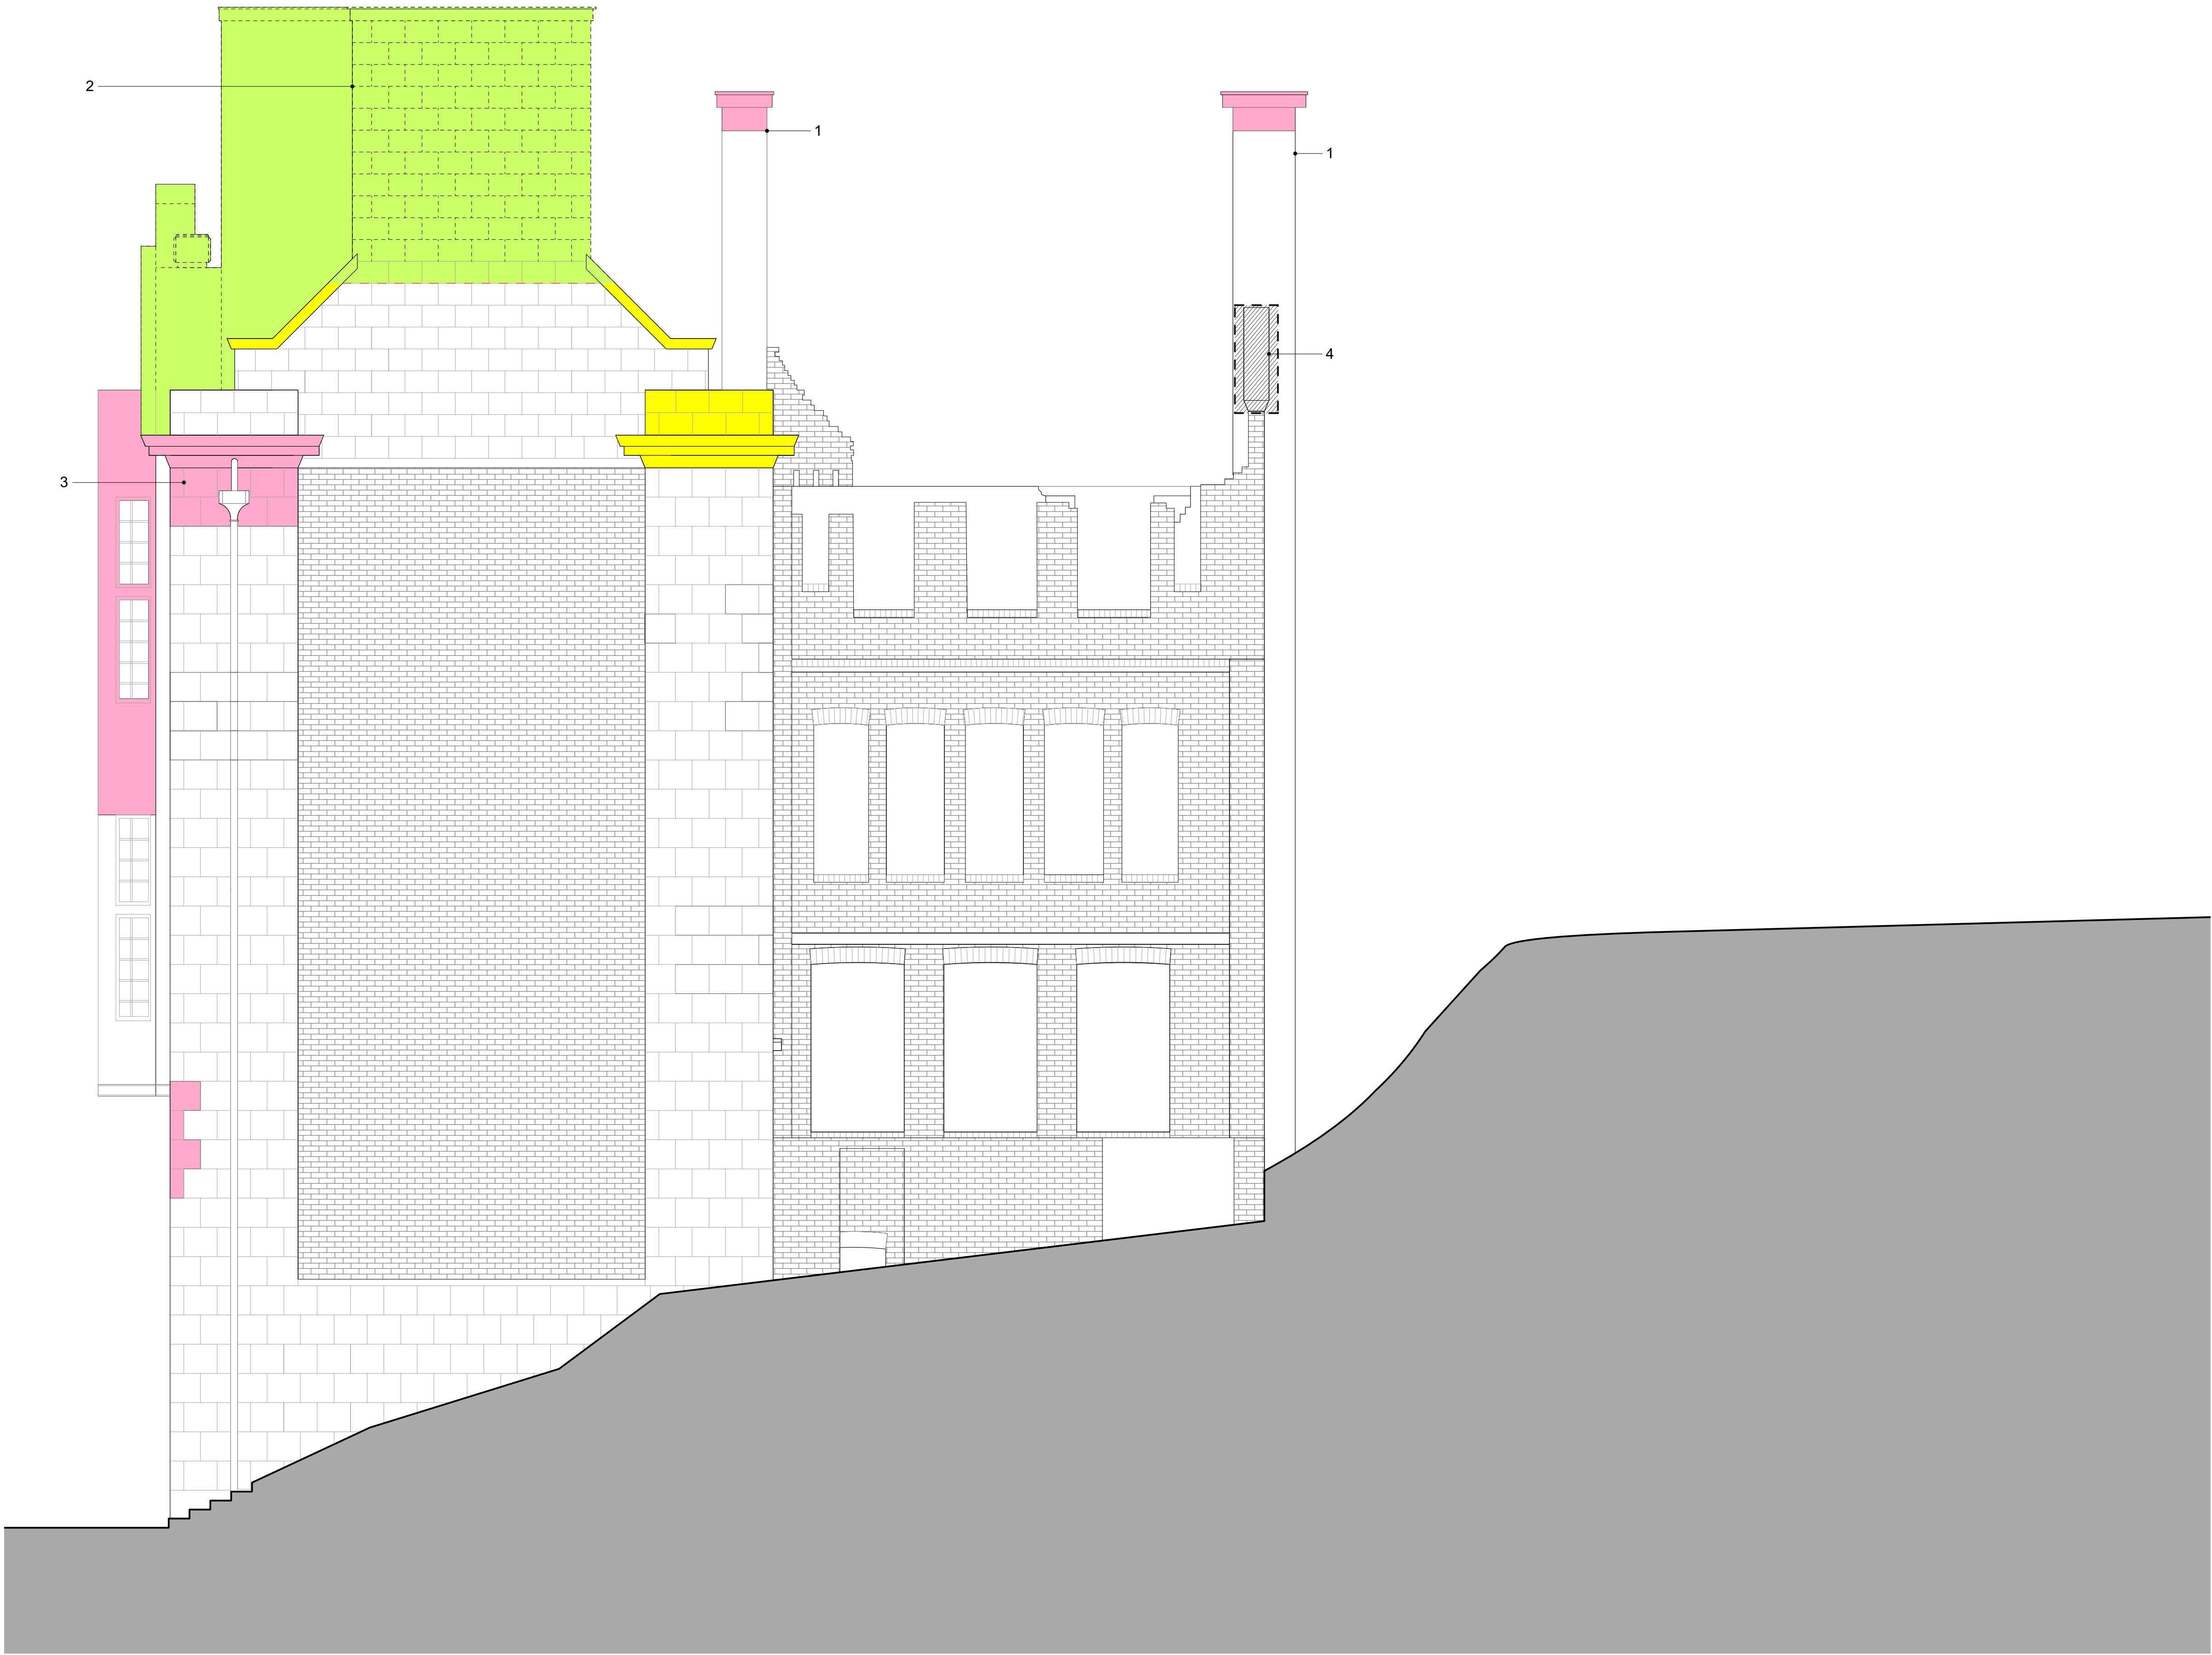
1. Chimney dimensions are according with proposed rather than existing.
2. Entire gable end chimney is missing, new terracotta required to rebuild.
3. Replacement terracotta required.
4. Existing coping is in poor condition, consider repair/ replacement.

**Defective terracotta unit** - Allow for careful removal/ of existing terracotta and replacement with new as specification section C41.

**Missing terracotta units** - Allow for careful removal of any remains of existing terracotta unit and replacement with new as specification section C41. (Units may be found on site).

**Partially Damaged terracotta unit** - To be repaired where possible. Allow for careful removal of damaged units, repair and reinstatement, supplemented with new as specification section C41.
