**Tree condition survey on land adjacent to 80 Westwood Drive,  
Treharris CF46 5BL**

**Date:**  
4<sup>th</sup> December 2019

**Document ref:**  
PC19-192

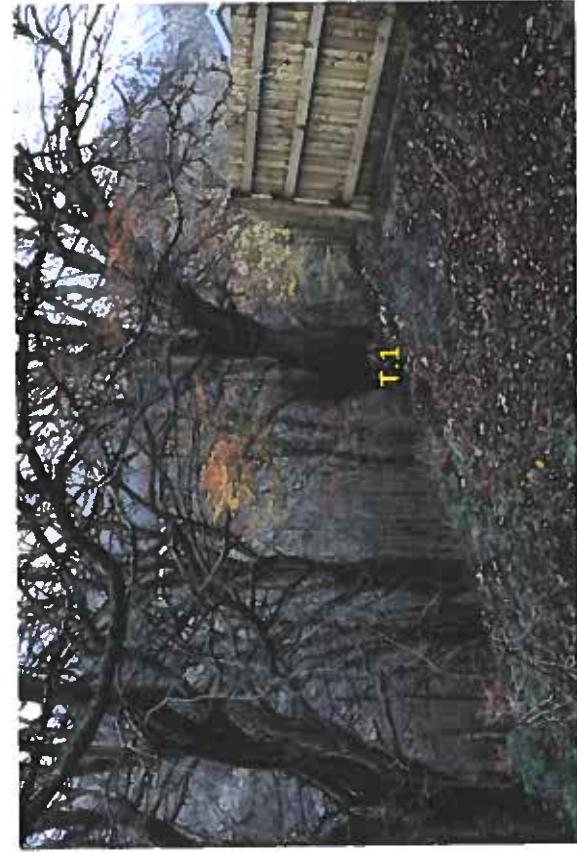
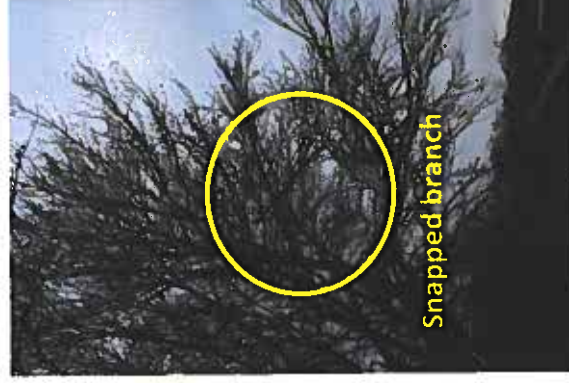
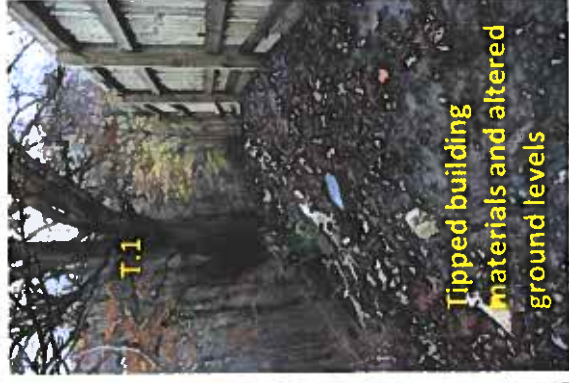
| Tree number | Species | Comments | Failure foreseeable? | Intervention required? | Within what timeframe? |
|---|---|---|---|---|---|
| T.1 | Beech | A high value mature tree growing on steeply sloping ground adjacent to property boundary. Single stem dividing into 4 significant stems at 1.5m. Building materials from property's driveway construction tipped around base and ground levels altered; top layer of ground easily displaced. East half of crown extends over property of 80 Westwood Drive. Deadwood in crown, 75mm diameter x 4.5m long, and snapped hung-up branch over driveway. Good bud density throughout crown with some foliage in autumn colour still attached. No critical defects observed, tree appears healthy with good vitality. | Yes – deadwood and snapped branch only<br><br><b>Risk of harm:</b><br><br>Low | Yes<br><br>Remove deadwood and snapped branch<br><br>Clear building materials away from trees | 12 months |

**Management:** although the tree does not pose a significant safety concern at present, it's height and branch spread relative to the adjacent single storey residential property causes the occupants to be intimidated and concerned.

| Tree number | Intervention required | Within what timeframe | Date work completed |
|---|---|---|---|
| T.1 | Remove deadwood and snapped branch<br>Clear building materials away from trees | 12 months | |

To ease the intimidation, reduce the concerns and help prevent future safety issues arising, we recommend the branches overhanging the bungalow and drive are reduced by approximately 4m (from 12.5m to 8.5m). Finished cuts to be made at viable growth points, with pruning wounds no larger than 50mm diameter to help prevent significant damage to the tree's health.
