Site: Flat 1 Rechabite Hall Crescent Street, Merthyr Vale, CF48 4RH

Flat 2 Rechabite Hall, Crescent Street, Merthyr Vale, CF48 4RH

**Contact:** Chris Jones  
**Customer:** Merthyr Council  
**Project No:** S19-01384

**Issue Number:** 1  
**Survey Start Date:** 16 July 2019  
**Report Issue Date:** 22 July 2019

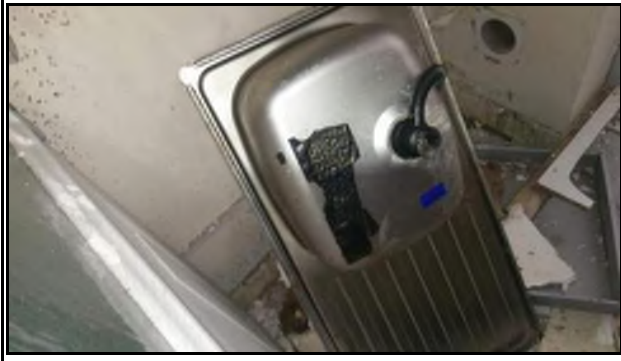
| <b>Room ID</b> | Kitchen |

| <b>Item Description</b> | Bituminous Products Sink Pad (s) |
| <b>Notes:</b><br>Sink pad to sink on ground unit broken | |

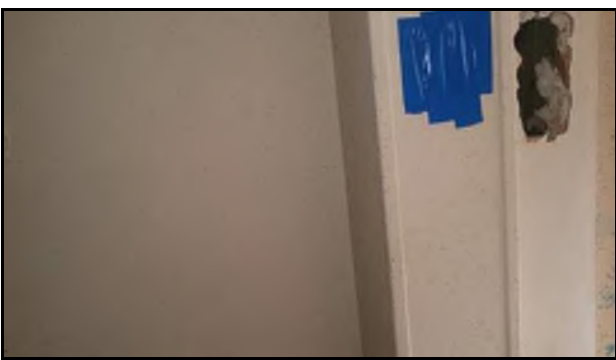
| <b>Room ID</b> | Hallway |

| <b>Item Description</b> | Cement Product Boxing |

| HSG 264 Material Assessment Scores | | | | Priority Assessment Scores | | | | Risk Priority Rating: |
|---|---|---|---|---|---|---|---|---|
| Product: | 1 | Condition: | 2 | Occupant Activity: | 0 | Likelihood of Disturbance: | 0 | 3 |

| <b>Recommendation:</b> | Remove |

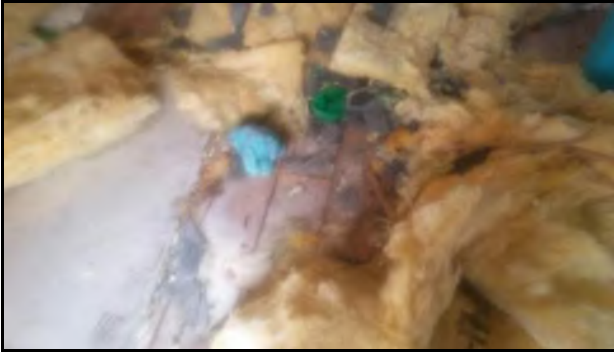
| <b>Room ID</b> | Lounge | <b>Notes:</b> | <p>Slate debris from vandalism of roof and ceiling collapse.</p> <p>Window reveals accessed no suspect material. external roof exposed internally from vandalism.</p> |

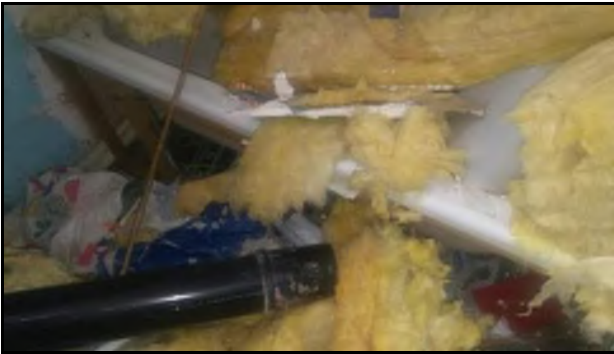
| <b>Room ID</b> | Bathroom | <b>Notes:</b> | <p>Textured coating debris from collapsed ceiling. Loft void accessed no suspect material.</p> <p>External roof exposed internally from vandalism.</p> |

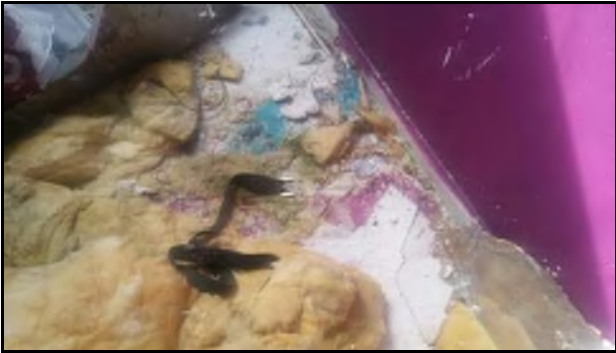
| <b>Room ID</b> | Bedroom | <b>Notes:</b><br>Textured coating debris from collapsed ceiling.<br><br>Window reveals accessed no suspect material. External roof exposed internally from vandalism.<br><br>Plasterboard boxing to corner of room. | |

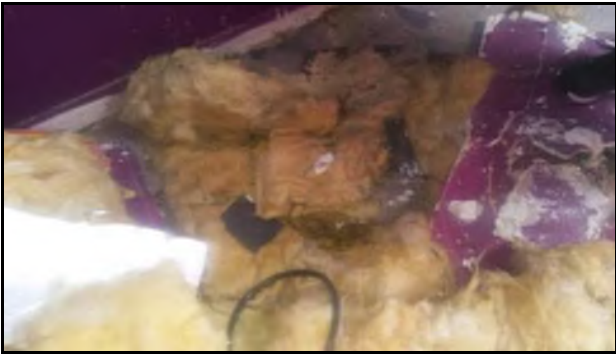
| <b>Room ID</b> | Bedroom | <b>Notes:</b><br>Cement slate debris from vandalism of roof and ceiling collapse.<br><br>Window reveals accessed no suspect material. External roof exposed internally from vandalism.<br><br>Plasterboard boxing to corner of room. | |

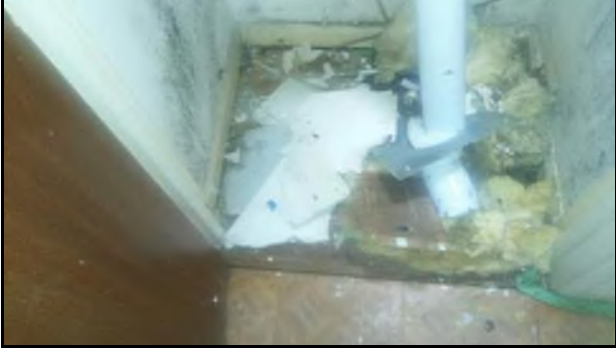
| <b>Room ID</b> | Hallway Cupboard | <b>Notes:</b><br>Insulation board debris from collapsed ceiling, tiny amount still connected to flue pipe on ceiling.<br><br>External roof exposed internally from vandalism. | |

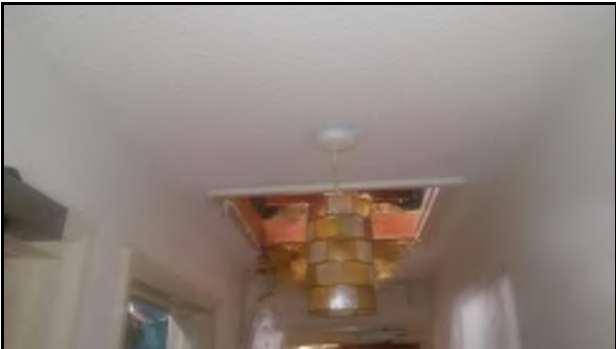
| <b>Room ID</b> | Hallway | <b>Notes:</b><br>Loft void above ceiling accessed no suspect material.<br><br>External roof exposed internally from vandalism. | |
