## 1.0 Executive Summary

The survey was carried out at Flat 11 Rechabite Hall, Crescent Street,, Merthyr Vale, CF48 4RH as agreed.

The scope of inspection in these areas included: Demolition Survey to the entire property.

**Contact:** Chris Jones  
**Customer:** Merthyr Council  
**Project No:** S19-01392

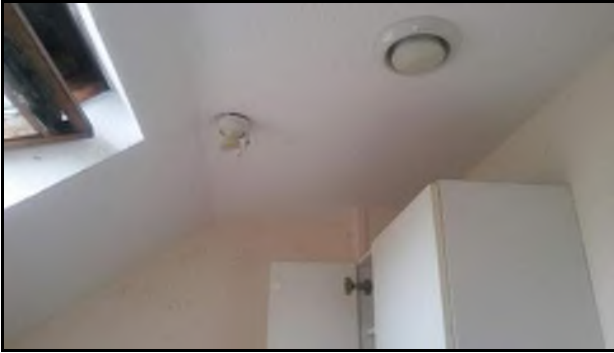
| <b>Room No.</b> | 001 |

| <b>Item Description</b> | Ceiling |
| <b>Material</b> | Textured Coating |

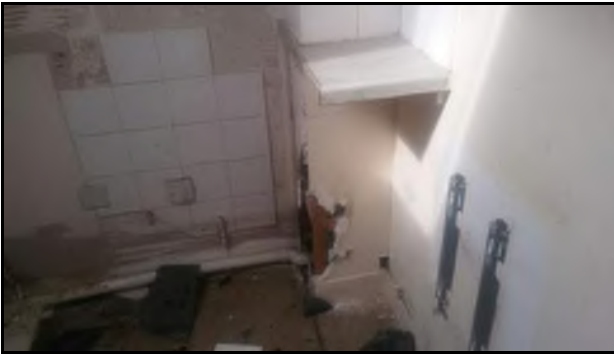
| <b>Room No.</b> | 001 |

| <b>Item Description</b> | Boxing |
| <b>Material</b> | Insulating Board |

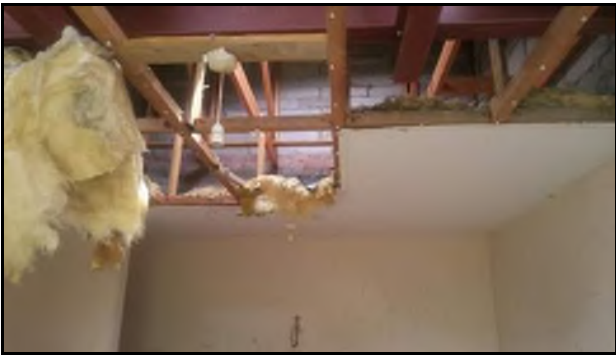
| <b>Room No.</b> | 002 |

| <b>Item Description</b> | Ceiling |
| <b>Material</b> | Textured Coating |

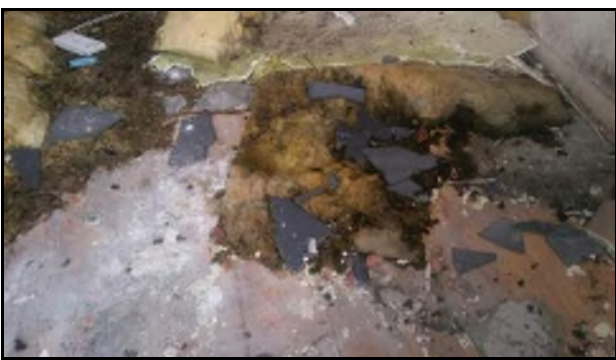
| <b>Room No.</b> | 002 |

| <b>Item Description</b> | Floor |
| <b>Material</b> | Debris |

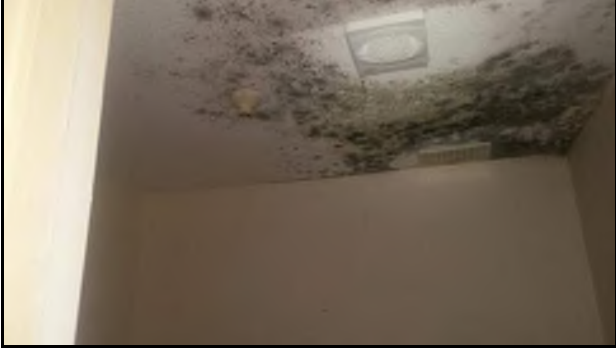
| <b>Room No.</b> | 003 |

| <b>Item Description</b> | Ceiling |
| <b>Material</b> | Textured Coating |

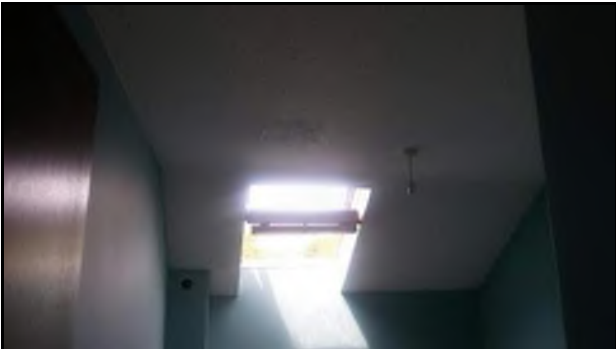
| <b>Room No.</b> | 004 |

| <b>Item Description</b> | Ceiling |
| <b>Material</b> | Textured Coating |

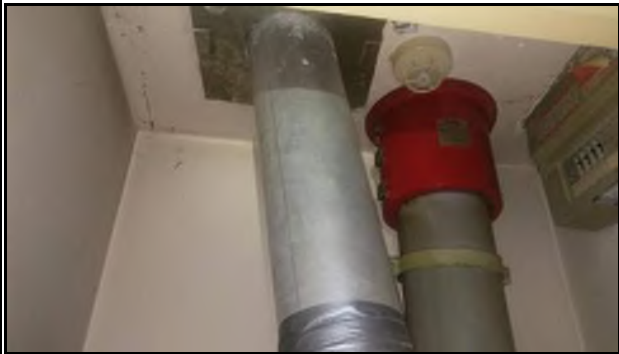
| <b>Room No.</b> | 005 |

| <b>Item Description</b> | Ceiling |
| <b>Material</b> | Insulating Board |

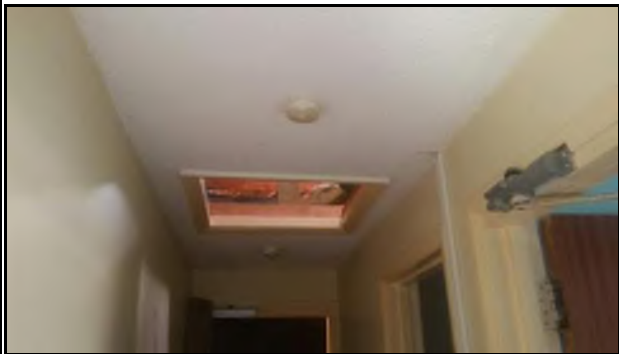
| <b>Room No.</b> | 006 |

| <b>Item Description</b> | Ceiling |
| <b>Material</b> | Textured Coating |

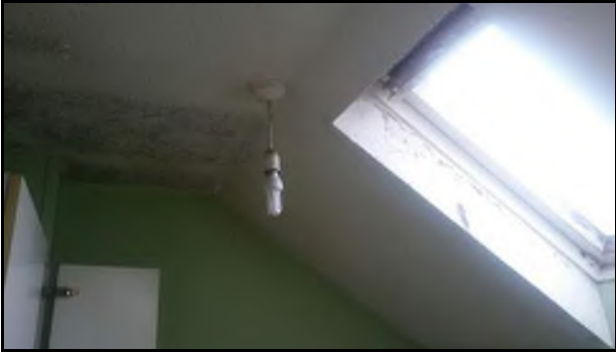
| <b>Room No.</b> | 001 |

| <b>Item Description</b> | Textured Coating Ceiling |
| <b>Material</b> | Textured Coating |

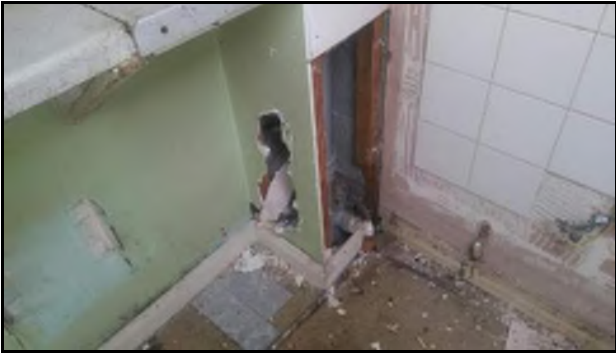
| <b>Room No.</b> | 001 |

| <b>Item Description</b> | Insulating Board Boxing |
| <b>Material</b> | Insulating Board |

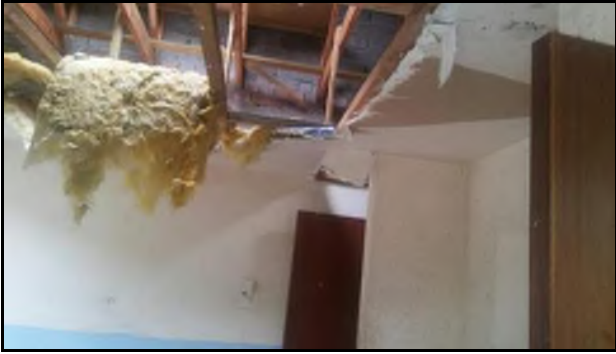
| <b>Room No.</b> | 002 |

| <b>Item Description</b> | Textured Coating Ceiling |
| <b>Material</b> | Textured Coating |

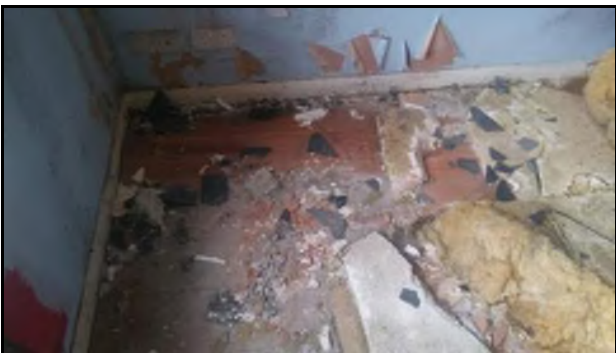
| <b>Room No.</b> | 002 |

| <b>Item Description</b> | Debris to the Floor |
| <b>Material</b> | Debris |

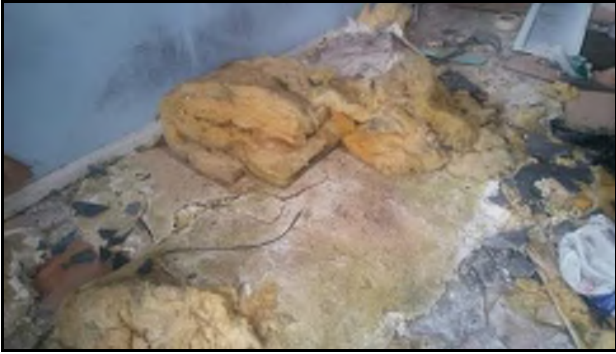
| <b>Room No.</b> | 002 |

| <b>Item Description</b> | Textured Coating to the Floor |
| <b>Material</b> | Textured Coating |

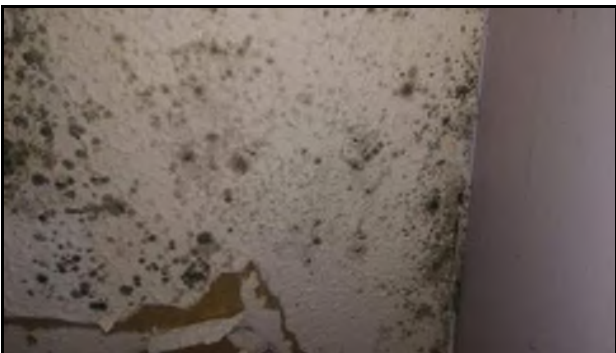
| <b>Room No.</b> | 003 |

| <b>Item Description</b> | Textured Coating Ceiling |
| <b>Material</b> | Textured Coating |

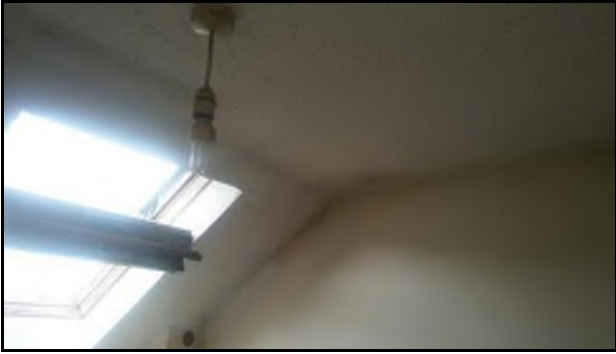
| <b>Room No.</b> | 004 |

| <b>Item Description</b> | Textured Coating Ceiling |
| <b>Material</b> | Textured Coating |

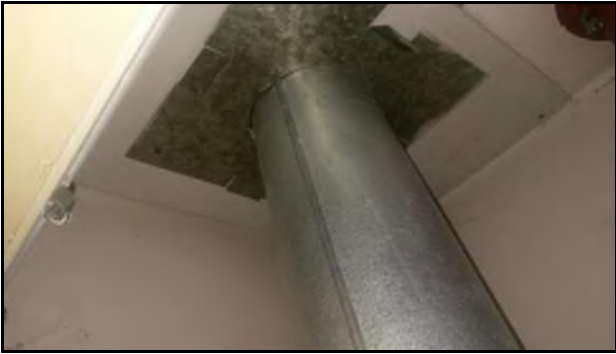
| <b>Room No.</b> | 005 |

| <b>Item Description</b> | Insulating Board Ceiling |
| <b>Material</b> | Insulating Board |

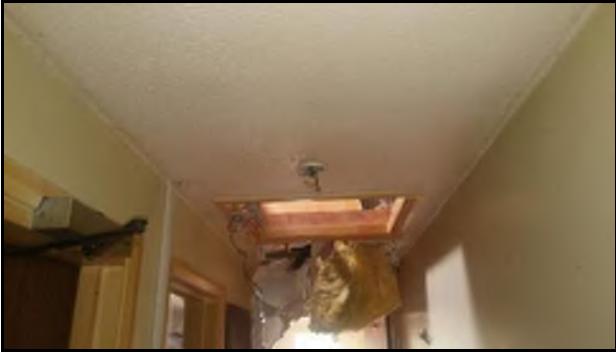
| <b>Room No.</b> | 006 |

| <b>Item Description</b> | Textured Coating Ceiling |
| <b>Material</b> | Textured Coating |

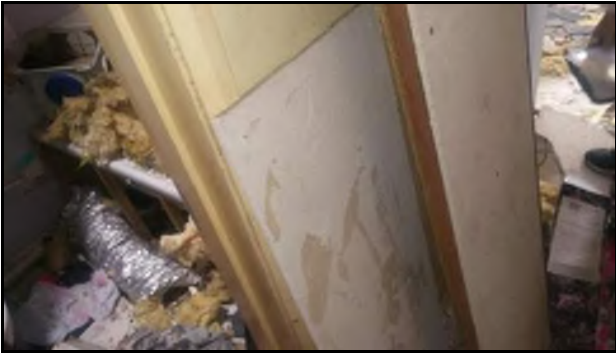
| <b>Room No.</b> | 006 |

| <b>Item Description</b> | Insulating Board Panel (s) |
| <b>Material</b> | Insulating Board |
| <b>Notes:</b><br>Loft void above ceiling accessed<br><br>Insulation board panels loose in hallway are from dry risers off main landing | |

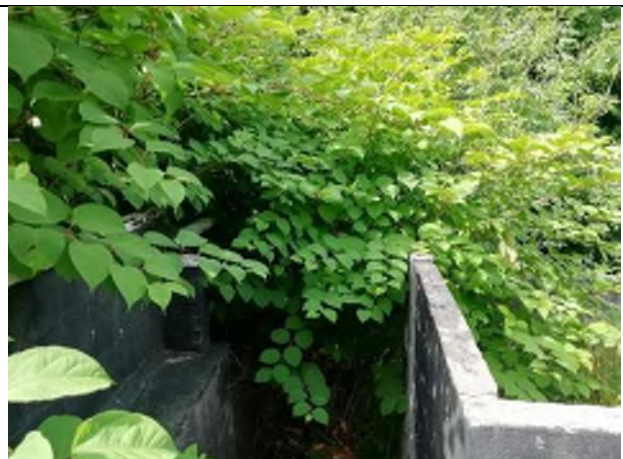
Figure 11 – Japanese knotweed in garden to rear of south-westernmost property (Taff Street)

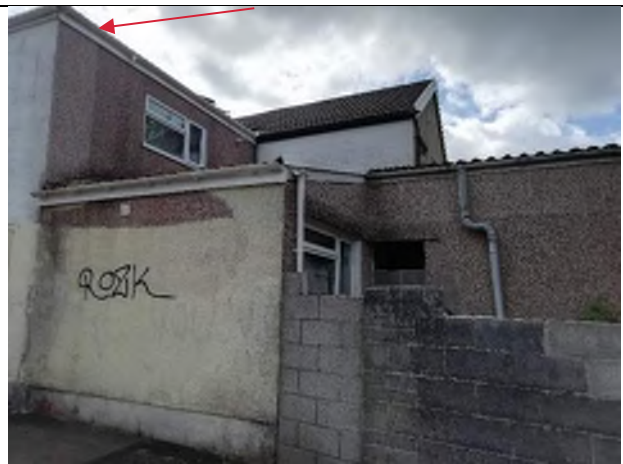
Figure 15 – North-westernmost property with common pipistrelle roost (at roof light)

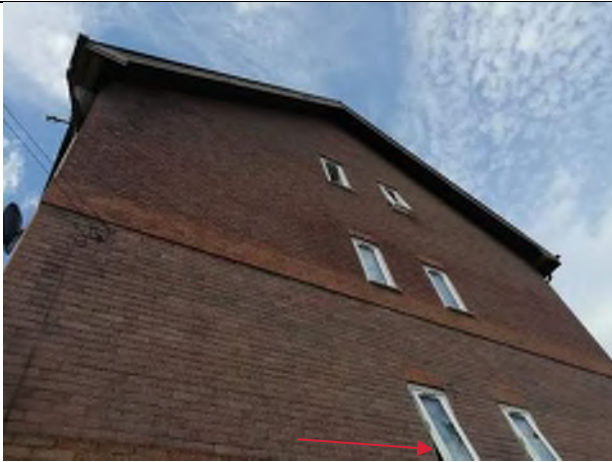
**Figure 18 – Northern gable of block of flats. Partially open window (arrow) indicated entry point for single pipistrelle**

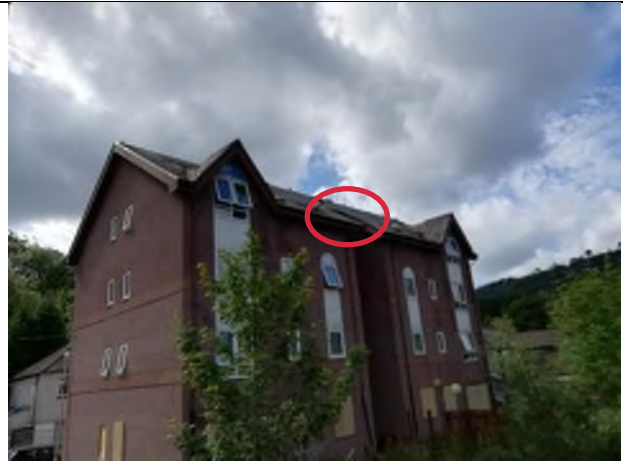
**Figure 19 – Block of flats, rear aspect with soprano maternity roost circled.**
