**Water connections at Crescent Street and Taff Street, Merthyr Vale, Merthyr Tydfil**

## **APPENDIX H - DRAINAGE CCTV PLAN AND REPORT**

Pre-Demolition Inspection Report

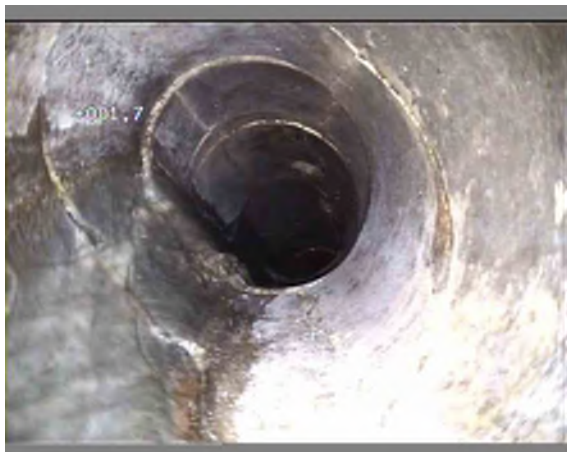
| Scale: | 1:50 | Position [m] | Code | Observation | Photo | Grade |
|---|---|---|---|---|---|---|
| | | 1.70 | FC | Fracture, circumferential, from 5 to 5 o'clock | 1 | 3 / 2 |

1, 00:01:22, 1.70 m  
Fracture, circumferential, from 5 to 5 o'clock

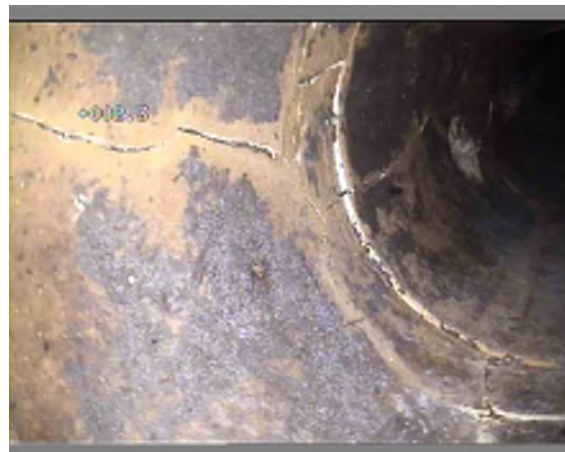
| Scale: | 1:50 | Position [m] | Code | Observation | Photo | Grade |
|---|---|---|---|---|---|---|
| | | 2.30 | FLJ | Fracture, longitudinal at joint, at 11 o'clock | 2 | 3 / 2 |

2, 00:01:59, 2.30 m  
Fracture, longitudinal at joint, at 11 o'clock

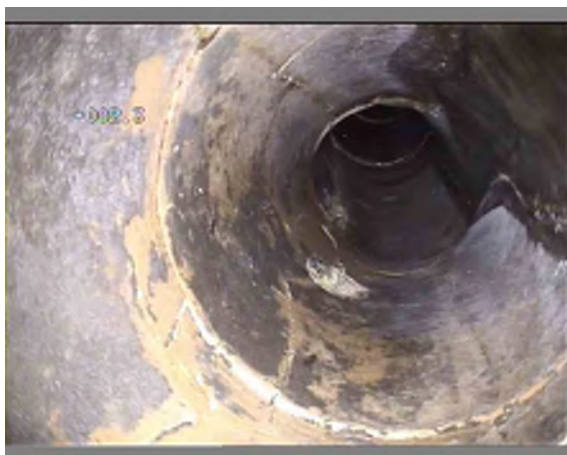
| Scale: | 1:50 | Position [m] | Code | Observation | Photo | Grade |
|---|---|---|---|---|---|---|
| | | 2.30 | FMJ | Fracture, multiple at joint, from 7 to 5 o'clock | 3 | 4 / 2 |

3, 00:02:19, 2.30 m  
Fracture, multiple at joint, from 7 to 5 o'clock

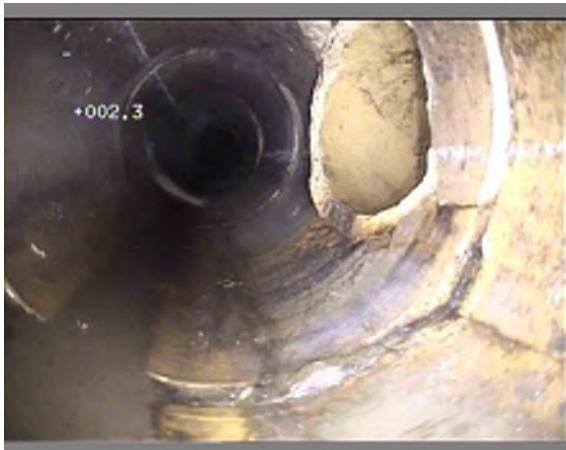
1, 00:00:33, 2.30 m  
Connection intruding, at 2 o'clock, diameter 150mm, intrusion  
5%

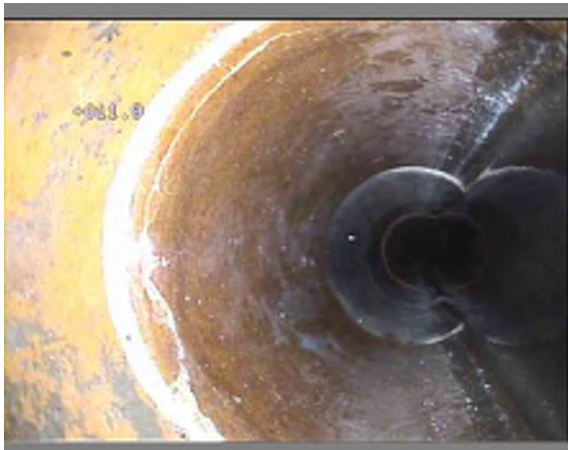
| Scale: 1:138 | Position [m] | Code | Observation | Photo | Grade |
|---|---|---|---|---|---|
| | 11.90 | FCJ | Fracture, circumferential at joint, from 10 to 2 o'clock | 1 | 3 / 2 |

1, 00:03:05, 11.90 m  
Fracture, circumferential at joint, from 10 to 2 o'clock

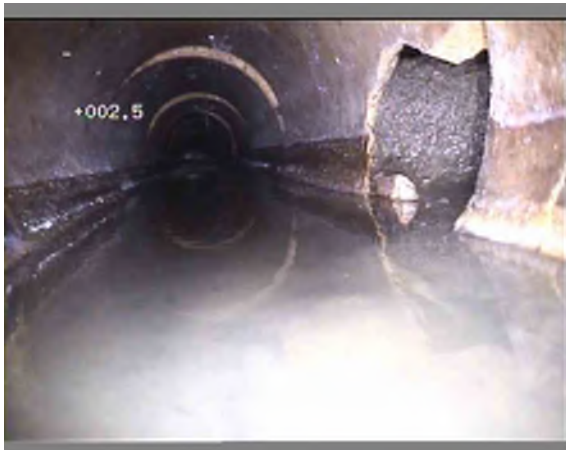
1, 00:00:40, 2.50 m  
Hole in drain/sewer at joint, from 3 to 4 o'clock

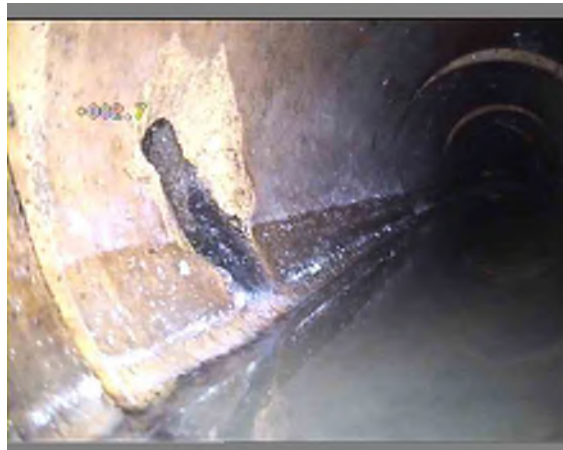
2, 00:00:54, 2.70 m  
Hole in drain/sewer at joint, from 8 to 9 o'clock

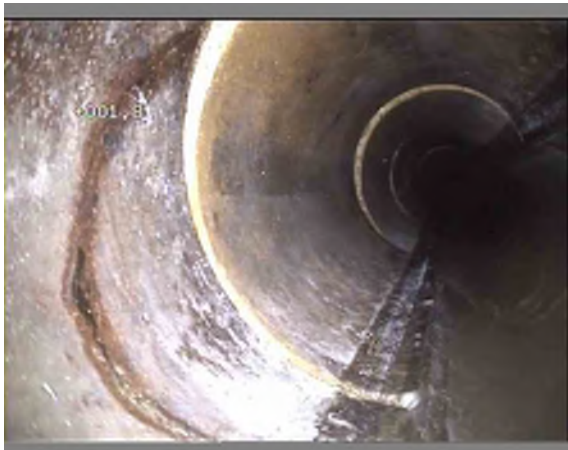
| Scale: 1:243 | Position [m] | Code | Observation | Photo | Grade |
|---|---|---|---|---|---|
| | 1.80 | FCJ | Fracture, circumferential at joint, from 8 to 11 o'clock | 1 | 3 / 2 |

1, 00:00:27, 1.80 m  
Fracture, circumferential at joint, from 8 to 11 o'clock

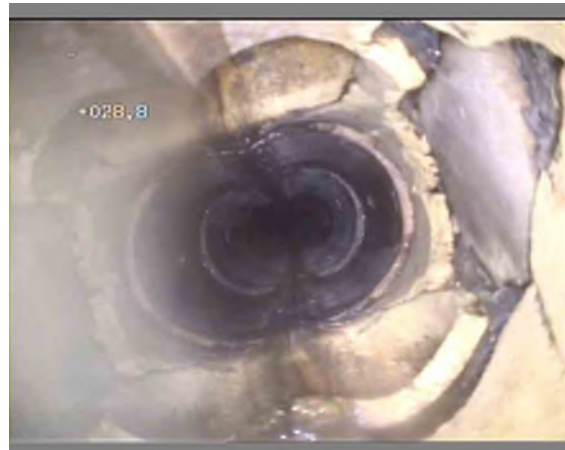
2, 00:05:05, 28.80 m  
Hole in drain/sewer, from 10 to 2 o'clock

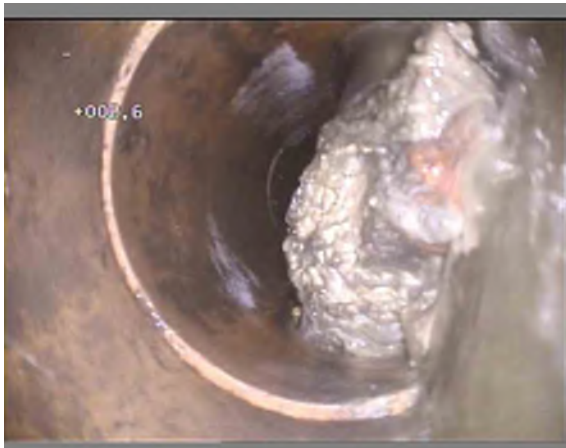
1, 00:00:34, 2.60 m

Settled deposits, fine, 50% cross-sectional area loss

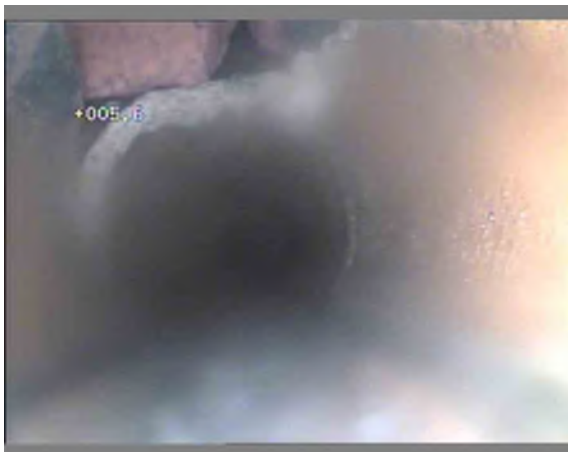
1, 00:01:17, 5.60 m  
Hole in drain/sewer, from 10 to 2 o'clock

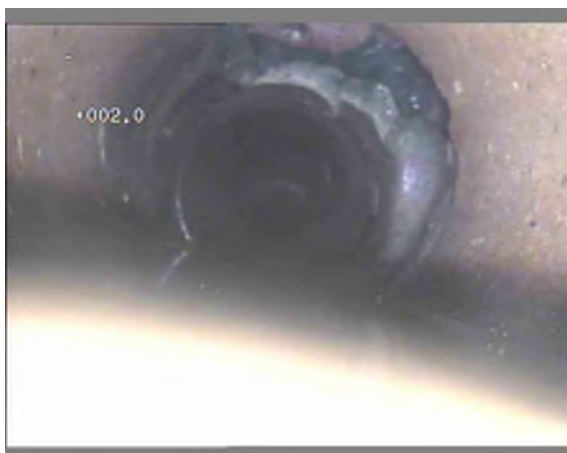
1, 00:00:49, 2.00 m  
Hole in drain/sewer at joint, from 10 to 3 o'clock
