# MERTHYR VALLEY HOMES

## DEMOLITION OF 6 GARAGES AT PINE CLOSE, GURNOS ,MERTHYR TYDFIL

### BUILDING INSPECTION REPORT (PROTECTED SPECIES)

Document Ref: E23118501/Doc 01. NOVEMBER 2023

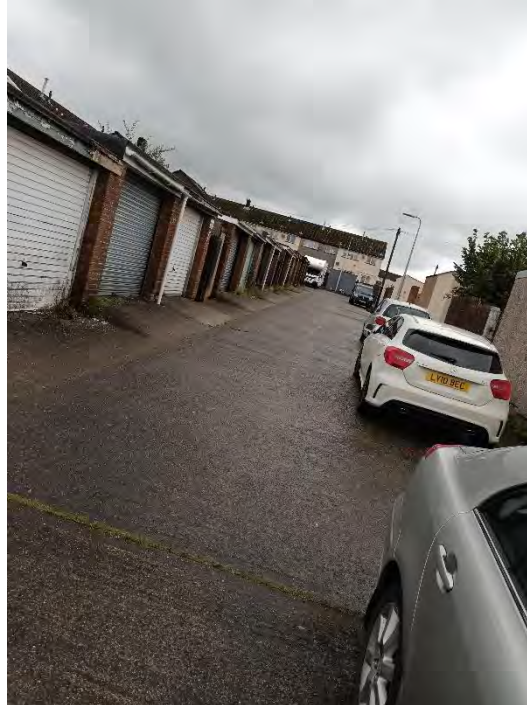
**Plate 1-Lighting columns on the front elevation of the garages.**

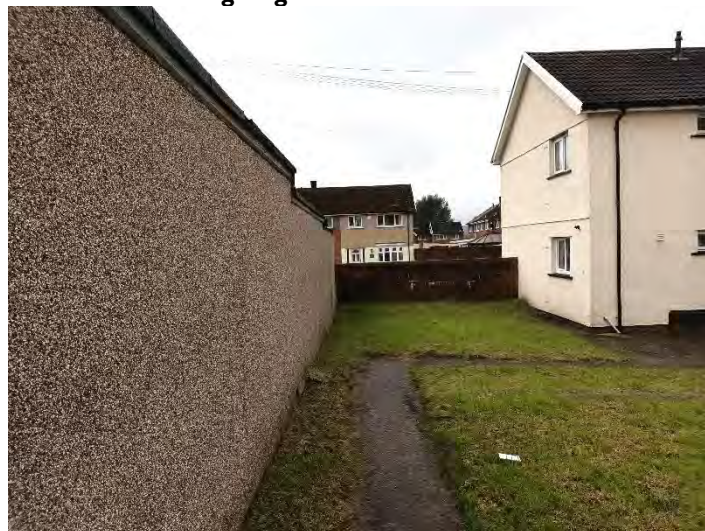
**Plate 2-Communal garden to the rear of the garages.**

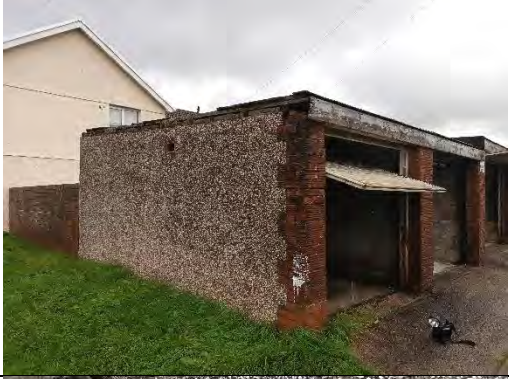
| Description | Photograph |
|---|---|
| <b>Garage 1</b> | |

| Description | Photograph |
|---|---|
| Missing fascia covering on southern elevation exposing wooden beams/plyboard.<br>Large gap in SE corner. | |

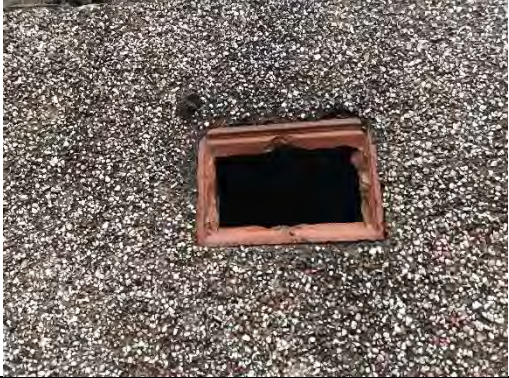
| Description | Photograph |
|---|---|
| Uncovered vent leading into the garage-these vents connect all 6 garage's. | |

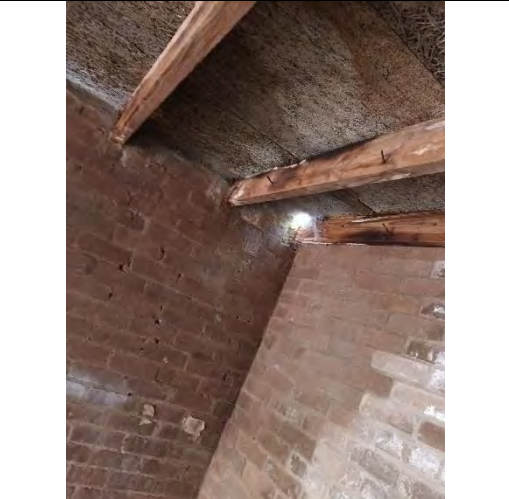
| Description | Photograph |
|---|---|
| Gap south western corner of the garage-light ingress noted internally. | |

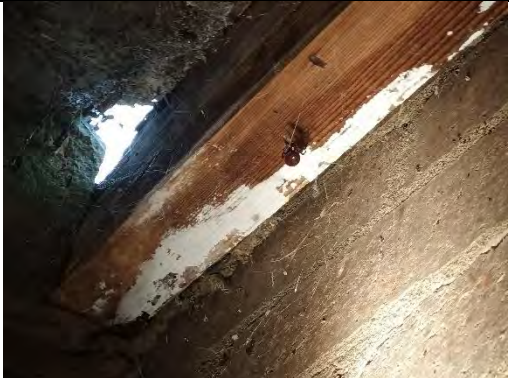
| <p>False widow spider <i>Steatoda nobilis</i> noted.</p> | |

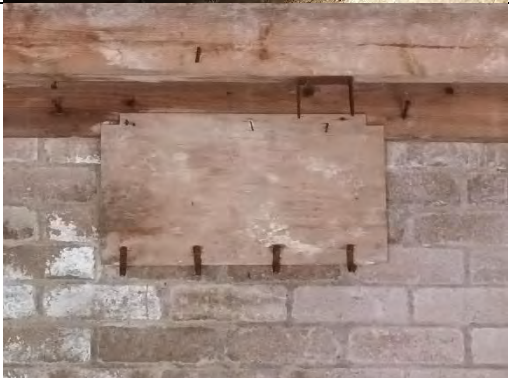
| <p>Wooden board attached to the internal wall. This was checked using a high powered torch and endoscope.</p> | |

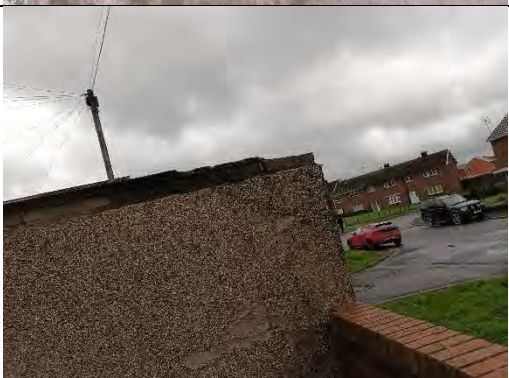
| <p>No fascia covering to the rear of the property exposing brickwork. Location of damaged roof consistent with area of light ingress observed internally..</p> | |

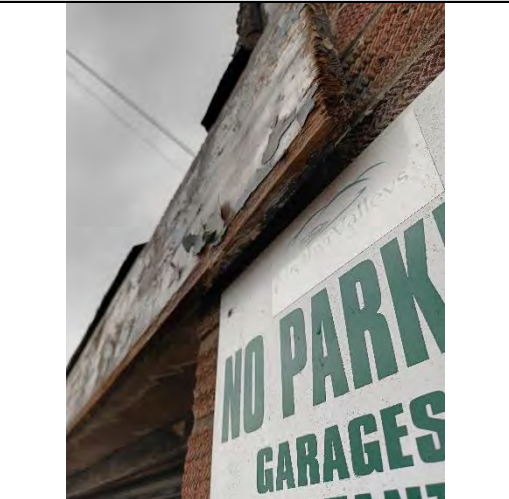
| <p><b>Garage 2</b></p> | |

| <p>Gap &gt;5cm between wooden facias covering and wall.</p> | |

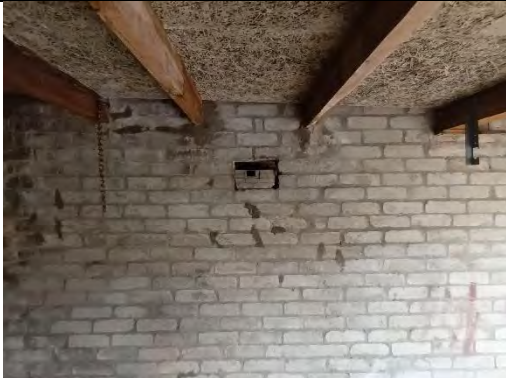
| <p>Open/uncovered internal vent between the adjacent garages.</p> | |

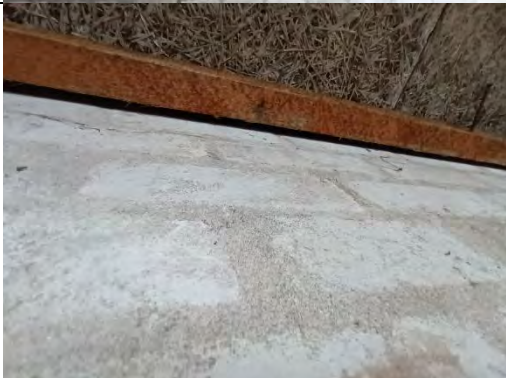
| <p>Small gap &lt;5cm between 1oodend beam and rear internal wall of the garage. This was checked using a high powered torch and endoscope.</p> | |

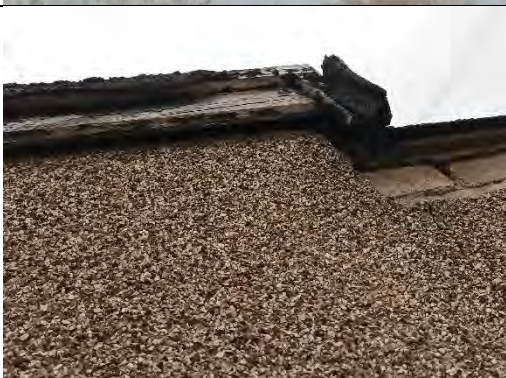
| <p>Gap between wooden fascia to the rear of the garage (western elevation) and the wall.</p> | |

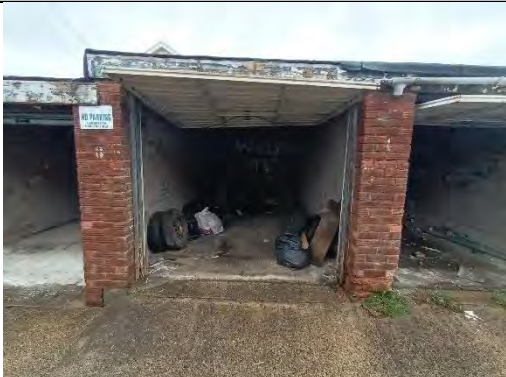
| <p>Debris present in this garage. No signs of droppings on any of the surfaces noted.</p> <p>Gap between wooded fascia covering and wall above garage doors.</p> <p>Area of raised felt adjoining the next garage.</p> | |

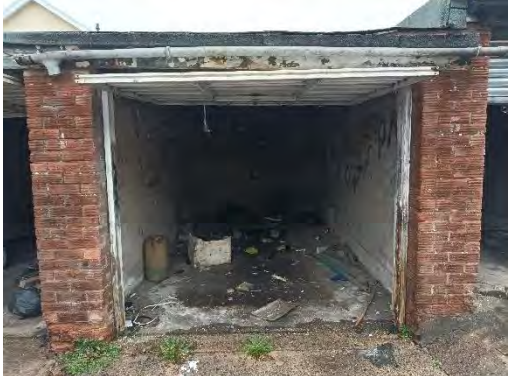
| <p>Debris present in this garage. No signs of droppings on any of the surfaces noted. Gap between wooded fascia covering and wall above garage doors.</p> | |

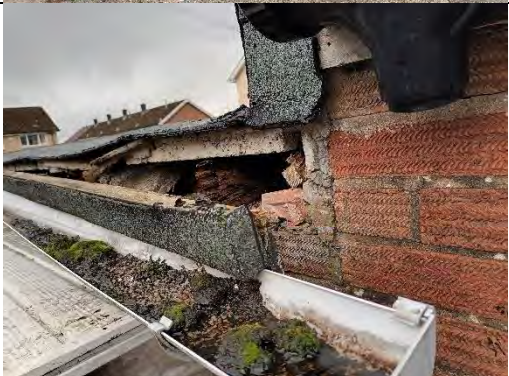
| <p>Felt and wooden batten has come away from the brickwork leaving a large gap.</p> <p>Gaps in roofing felt present along the length of the front of the garage.</p> | |

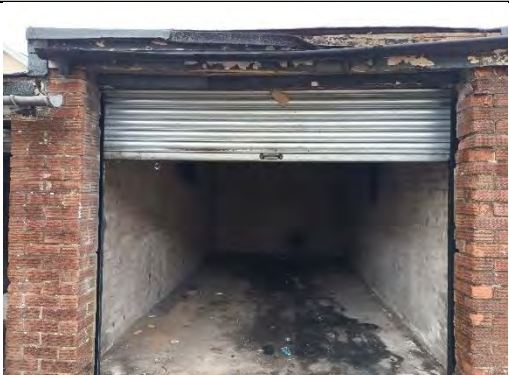
| <p><b>Garage 5</b></p> | |

| <p>Clean garage. Guttering and felt has dropped on the from of the garage exposing the plyboard ceiling.</p> | |

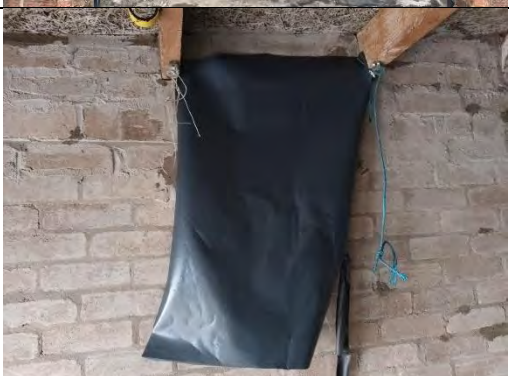
| <p>Internal vents have been covered with plastic sheet.</p> | |

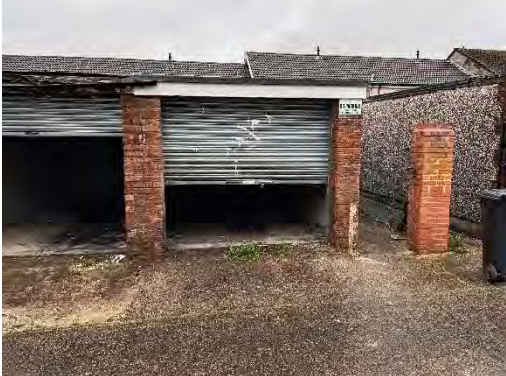
| <p><b>Garage 6</b></p> | |

| <p>Plastic fascia covering intact on the front/side and rear of the garage.</p> | |

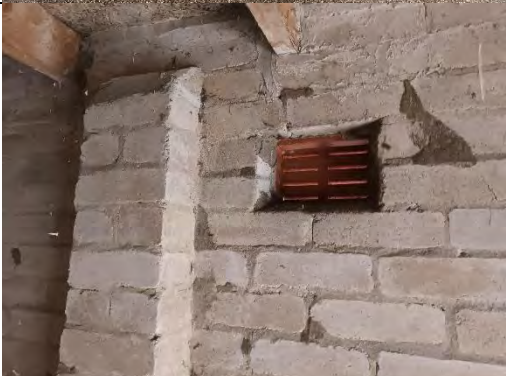
| <p>Vent covering present,</p> | |

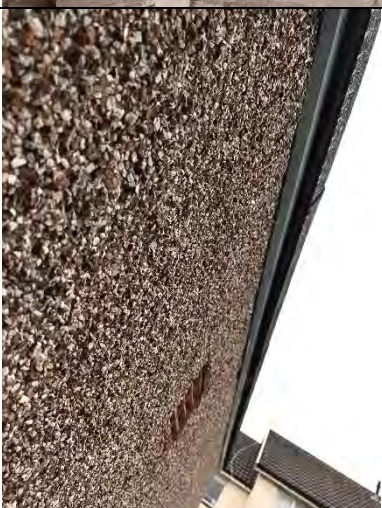
| <p>Very few gaps present between plastic fasci and wall.</p> | |
