Our Ref: 13951/MNJ

17<sup>th</sup> November 2021

**Structural survey of stone barn attached to Tyla Glas Farm Barn, Bedlinog. CF46 6SN**

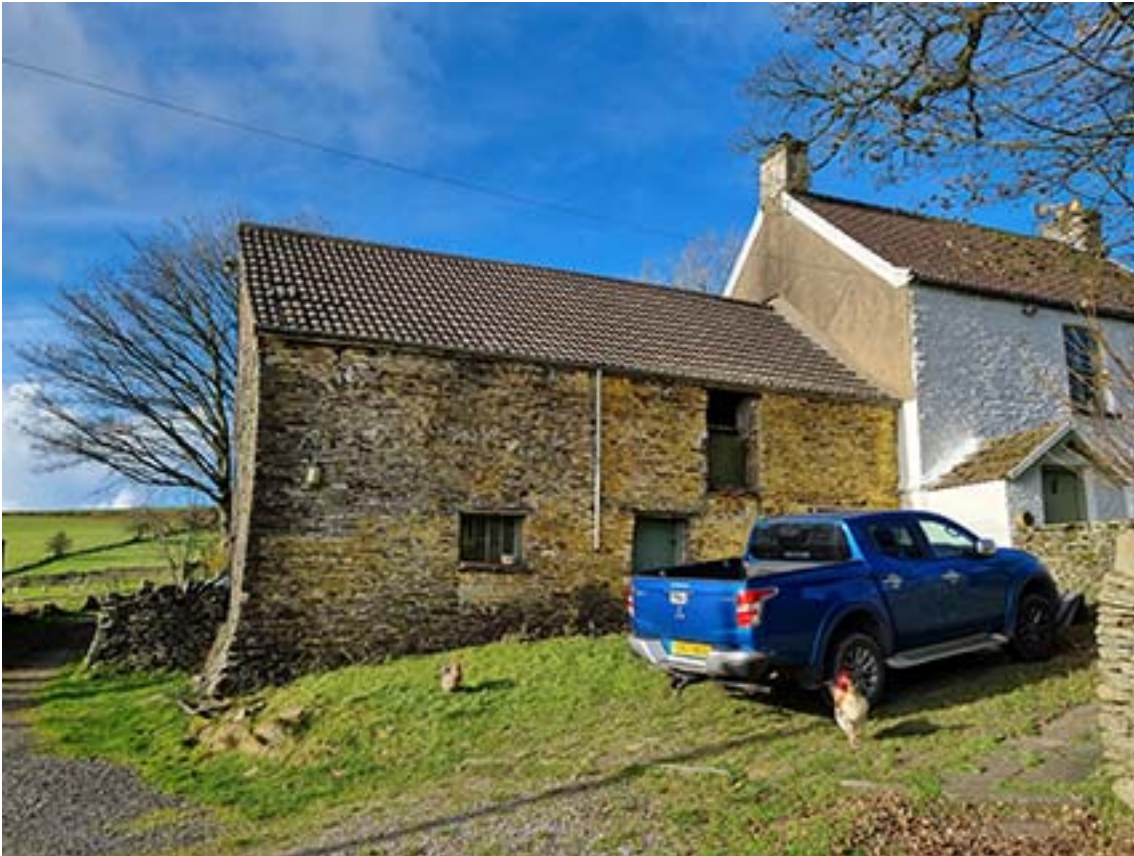
Photo of front elevation of barn showing it attached to main farm house

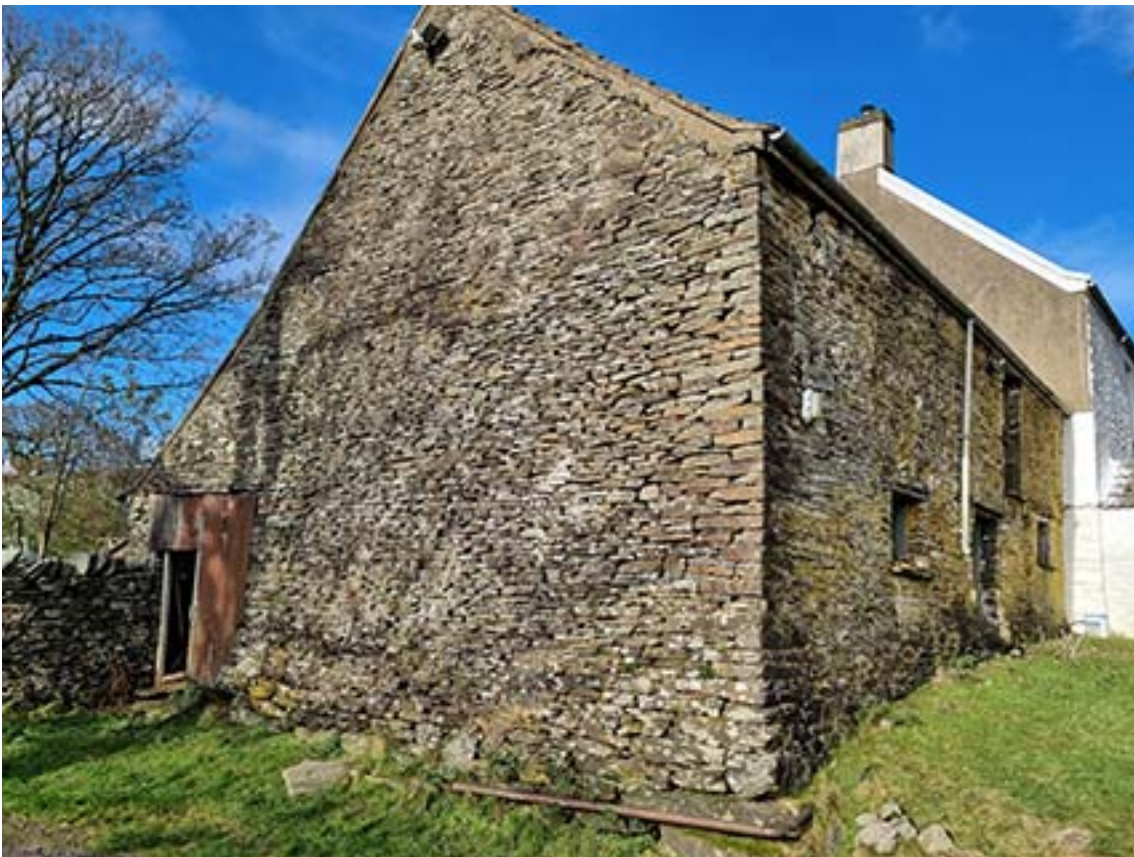
Inspection of the barn's main four elevations (from internally and externally) revealed that much of the 500mm thick walls were in need of general re-pointing throughout. From inside the barn, closer inspection of the gable elevation (furthest away from the main farm building) revealed that it was leaning over, probably as a result of the movement in the roof.

Inspection of the same gable elevation from the outside revealed an obvious outward lean in the wall. There were no other structural movement cracks in the main walls of the barn that were of a serious structural concern. However there was a vertical crack in the rear wall through to the lean-to building

Photo of gable elevation showing lower external ground levels

In order to remedy the movement in the far side gable elevation we would recommend that the top section of the gable elevation is re-built vertically and then tied to the new first floor and roof structure to give it lateral restraint. All other cracks in the masonry walls (as noted above) will need to be stitched using 'Helibar Helifix' (see attached document ref, CS10) stainless steel tie bars.

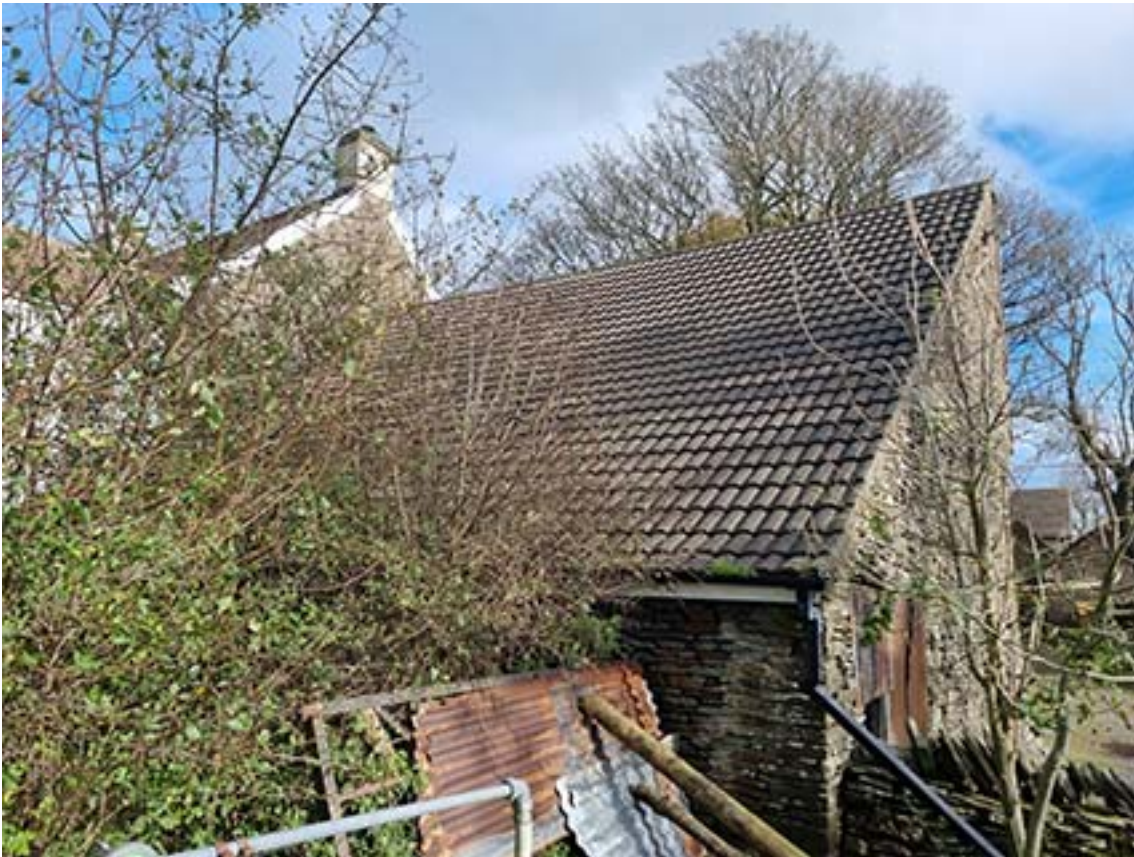
Photo of rear roof of barn extending over rear out-buildings

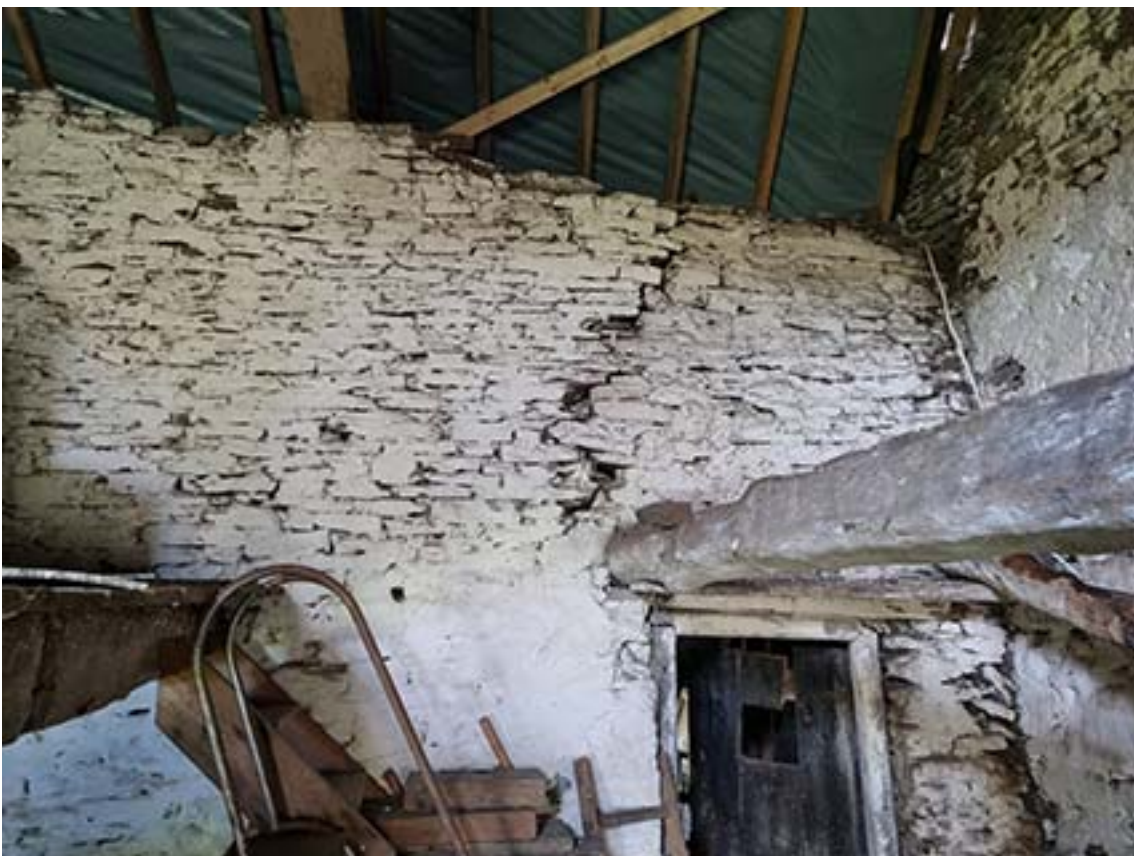
Photo of crack in internal wall and uneven wall plate level

In addition, I would advise that the top of the walls would need to be re-built with a level concrete wall plate in order to receive the replacement timber trusses. All timber lintels to door and window openings should be replaced with precast concrete lintels.

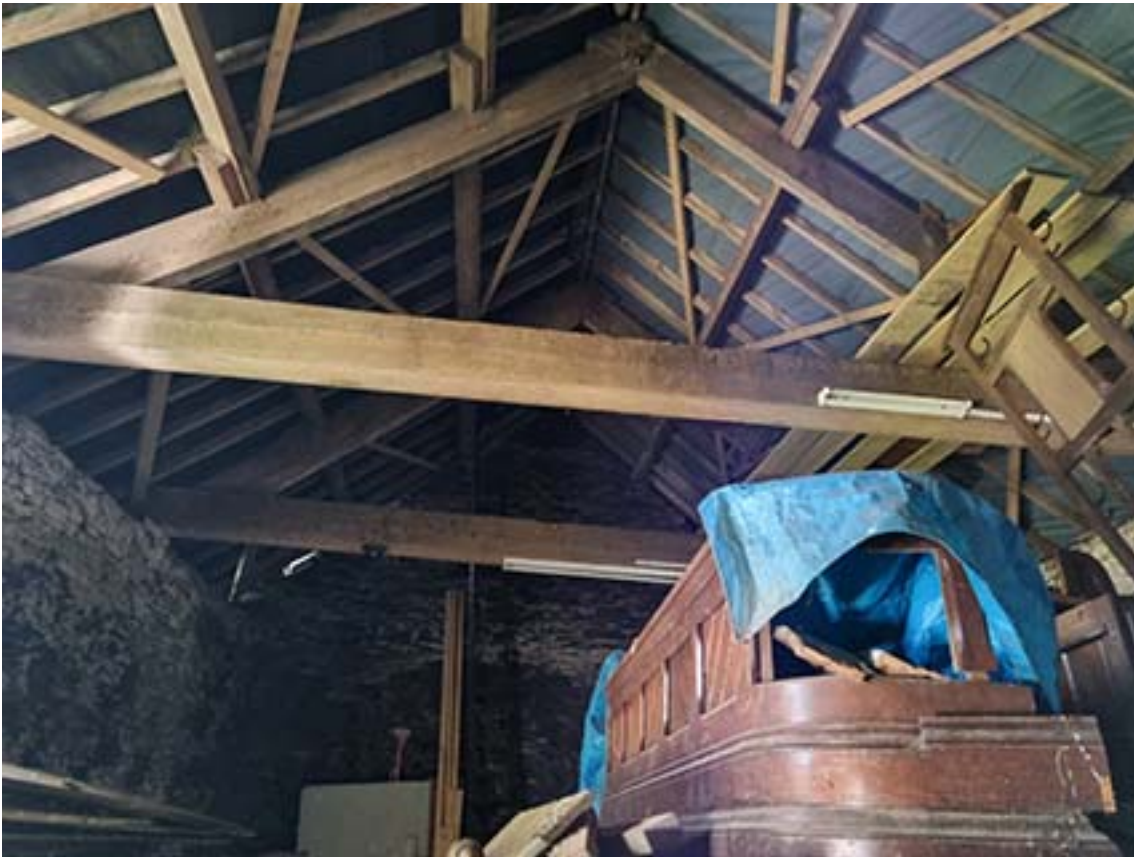
It is clear from my inspection that the barn roof structure has moved as a whole, laterally, and diagonal timber bracing members have been installed to prevent this from getting worse. It is likely that the original roof timbers were not designed for the relatively heavy concrete tile finish and they have significantly distorted since as a result.

Photo of showing cut roof trusses, purlins and rafters with more recent diagonal bracing

The cut timber roof comprises of A-frame timber trusses, which supports timber purlins and cut timber rafters. As expected with most old agricultural buildings, the timber roofs tend to be misshapen and generally in poor condition (as in this instance) and would need to be replaced for the barn to be brought back in to beneficial use and in order to support the additional weight of a built-up roof to Building Regulation standards.

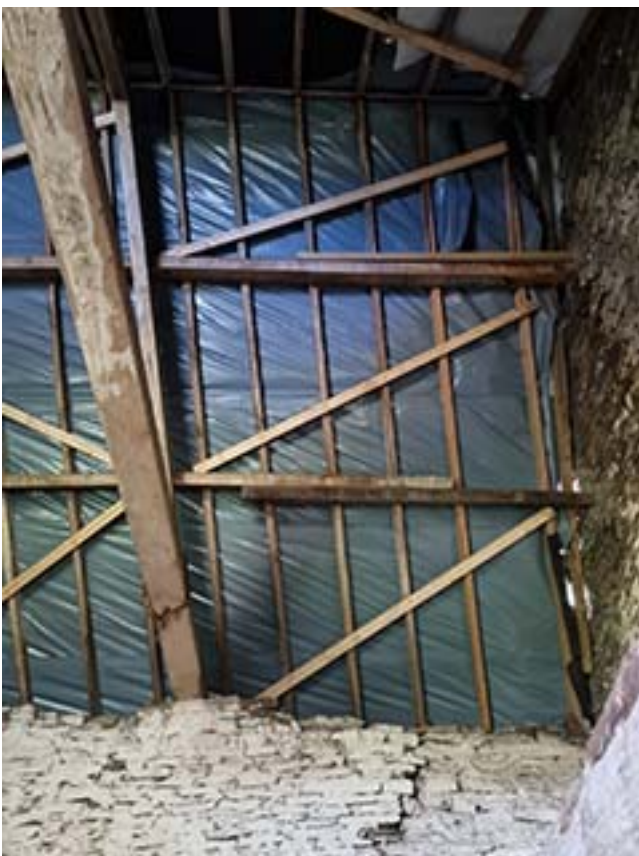
Photo showing misshapen roof structure
