**Heritage Impact Assessment:  
Treharris Library, Merthyr Tydfil**

Report No. 2143

Prepared for Merthyr Tydfil County Borough Council

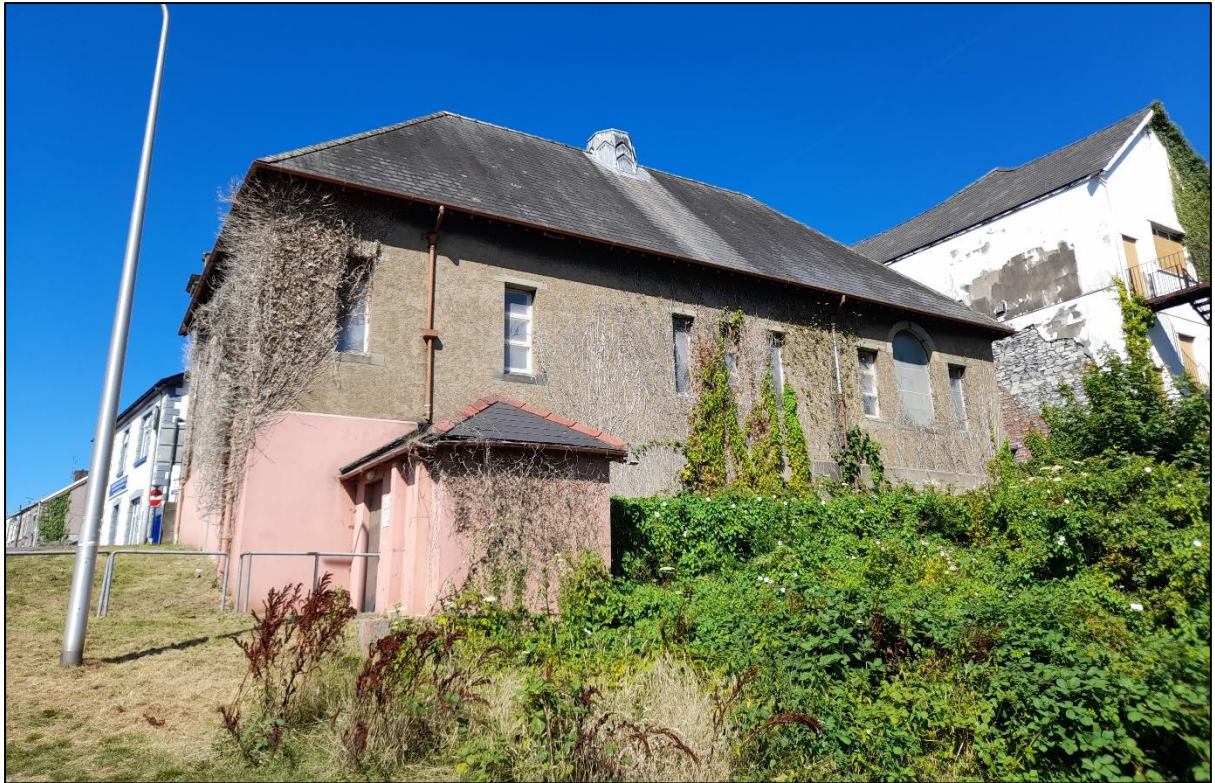
- 4.3.5. The rear of the building is two-storey, with the basement storey being above ground level due to the sloping ground (Plate 3). The ground floor has eight windows. The second from the right is round arched and the others are rectangular. They all have simple stone sills and lintels. Five of the windows, including the round arched one, retain their original leaded stained glass and the other three are three light wooden framed casement windows that appear to be of mid 20<sup>th</sup> century date. The basement has three windows to the centre of the elevation, all with single light, uPVC windows covered by a protective metal grill. Immediately to the right of the modern extension is a blocked window opening with a boiler flue to the upper part of the boarding. The small modern extension projects from the left side of the rear elevation. It is smooth rendered. Currently, the area to the rear of the building, including the existing metal railing fence, is overgrown.

*Plate 3. East-facing elevation of Treharris Public Library with single storey rear extension. Looking north-west.*

- 5.2.3. The extension to the rear was built in 2014 and is therefore of no historic value. It detracts from the appearance of the rear of the building. Part of the extension has been deemed unsafe and at risk of collapse. The extension abuts the original rear wall of the library and there is a low potential for damage to the original fabric of the exterior wall during the removal of the extension. Removal work should be carried out with care to minimise any damage to the original building fabric. The removal of the extension is beneficial to the building's appearance and evidential value.

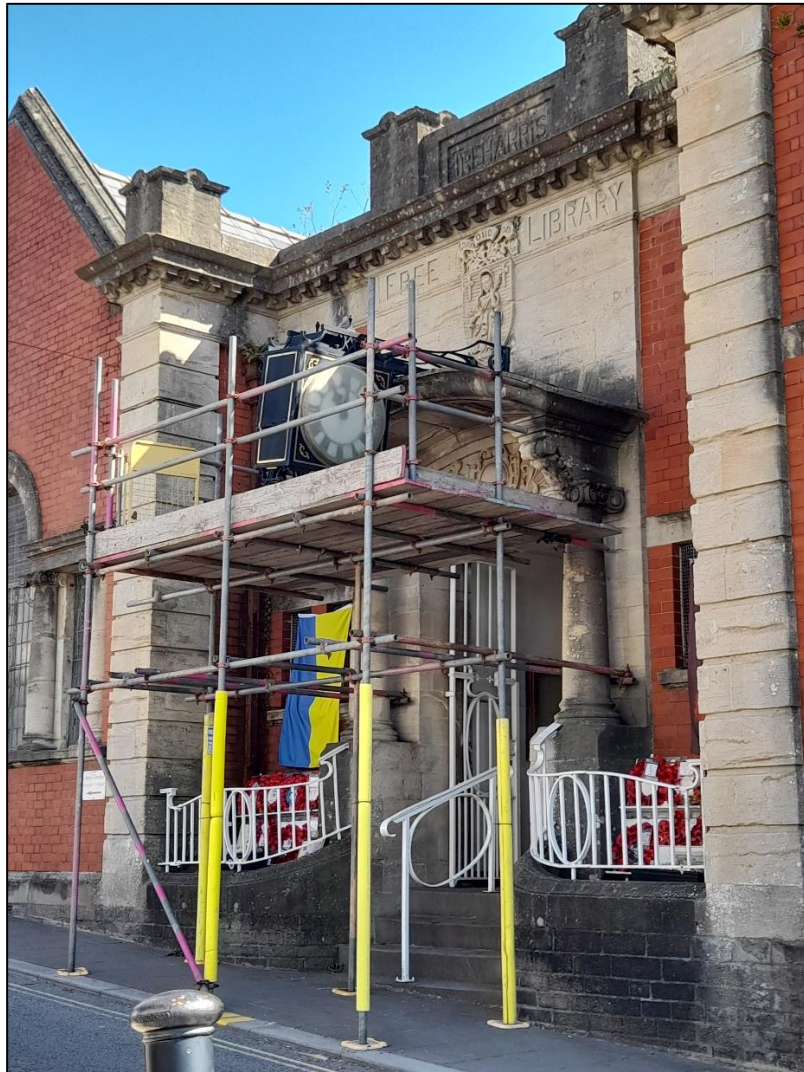
*Plate 5. Main entrance including memorial clock, looking north-east.*

| Proposed Work | Objective | Significance of affected aspect | Assessing beneficial impact | Assessing harmful Impact | Proposed Solution |
|---|---|---|---|---|---|
| Memorial clock to be removed, cleaned, and repaired. | To maintain the clock in good working condition. | Although not part of the original building design, the Memorial Clock is an important part of the building, with a high communal value. | It will maintain the Clock in good working order and improve its appearance. | None | None |

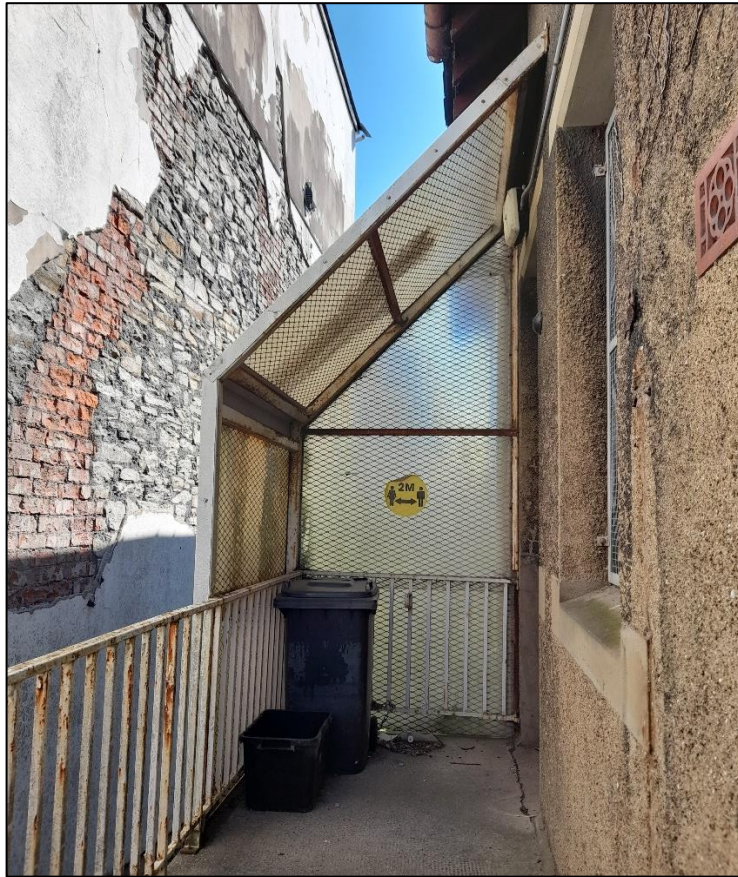
- 4.3.4. The north-facing elevation has a wooden door with four glazed panels, and a transom light above. There is a lean-to style entrance canopy over the door, which is wooden framed with opaque glazing and protective metal grill (Plate 7). The approach to the door is concrete, and there are concrete steps down to the side of the building to access the rear space. The three windows are all decorative stained glass with a crest design. They are slightly recess and have simple bevelled stone sills and lintels (Plate 8).

*Plate 7. Canopy over door on north-facing elevation, looking east.*

- 5.2.4. The existing canopy over the entrance walkway on the north-facing elevation is an incongruous modern addition that impacts views of the front of the building from higher up Perrott Street to the north. Its replacement will be more in keeping with the main building and make use of the same materials, including a natural slate roof, through colour rendered walls, cast iron Victorian ogee gutter and cast iron downpipe. An opening to the east wall will have stone sill and lintel to match existing windows. The removal of the old canopy and installation of the new has a low likelihood of damaging the original fabric of the north wall, which can be mitigated by appropriate care being taken during the process.

| Proposed Work | Objective | Significance of affected aspect | Assessing beneficial impact | Assessing harmful Impact | Proposed Solution |
|---|---|---|---|---|---|
| Construction of a new side entrance walkway canopy. | To replace the existing canopy with one more sympathetic to the appearance of the building. | Existing canopy was built in the 1980s and is considered of no historic value. | Removes an incongruous modern addition to the Library, visible from the front of the building. | The replacement canopy is not an original aspect of the building and may detract from its appearance. Works to remove and install the new canopy could damage the fabric of the north wall. | The new canopy will be in materials to match the main building. It will have a natural slate roof, the walls (north and east) will be through colour rendered, the gutter will be traditional cast iron Victorian ogee and the downpipe will be cast iron. The opening to the east wall will have stone sill and lintel to match existing windows. Care will be taken when removing and installing the new canopy not to cause any damage. The works will not require significant disturbance of the wall. |

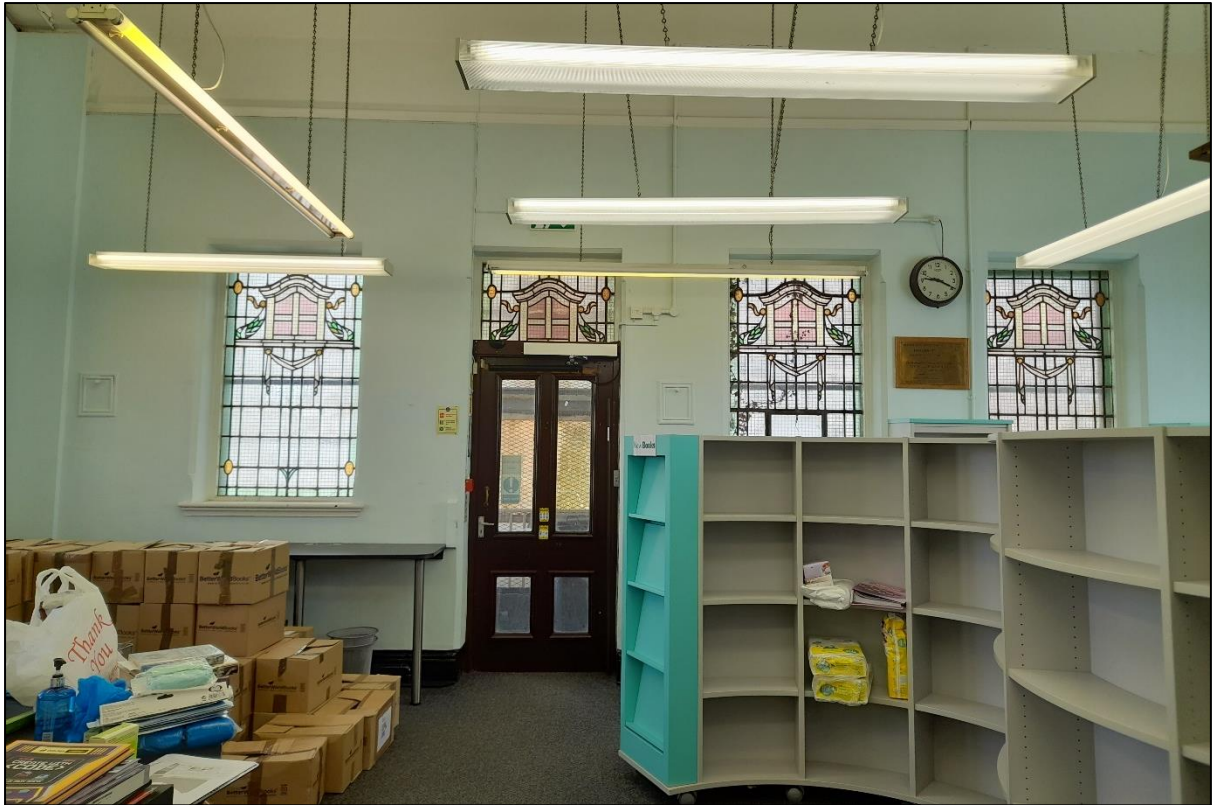
added into a window opening, with the upper part of the window being retained as the transom above (Plate 15). The removed lower section has been used to repair one of the windows on the east wall (Plate 11).

*Plate 15. North-wall of library with side door.*

| Proposed Work | Objective | Significance of affected aspect | Assessing beneficial impact | Assessing harmful Impact | Proposed Solution |
|---|---|---|---|---|---|
| New external door to side entrance to match existing. | To replace existing door. | The existing door is a later addition to the building, probably dating to the 1980s when the canopy was added. It has been fitted into an original window opening, and the upper part | None | Potential to damage aspects of the original window during the installation. | The stained glass will be removed from the existing frame and re-fitted into the new frames. |

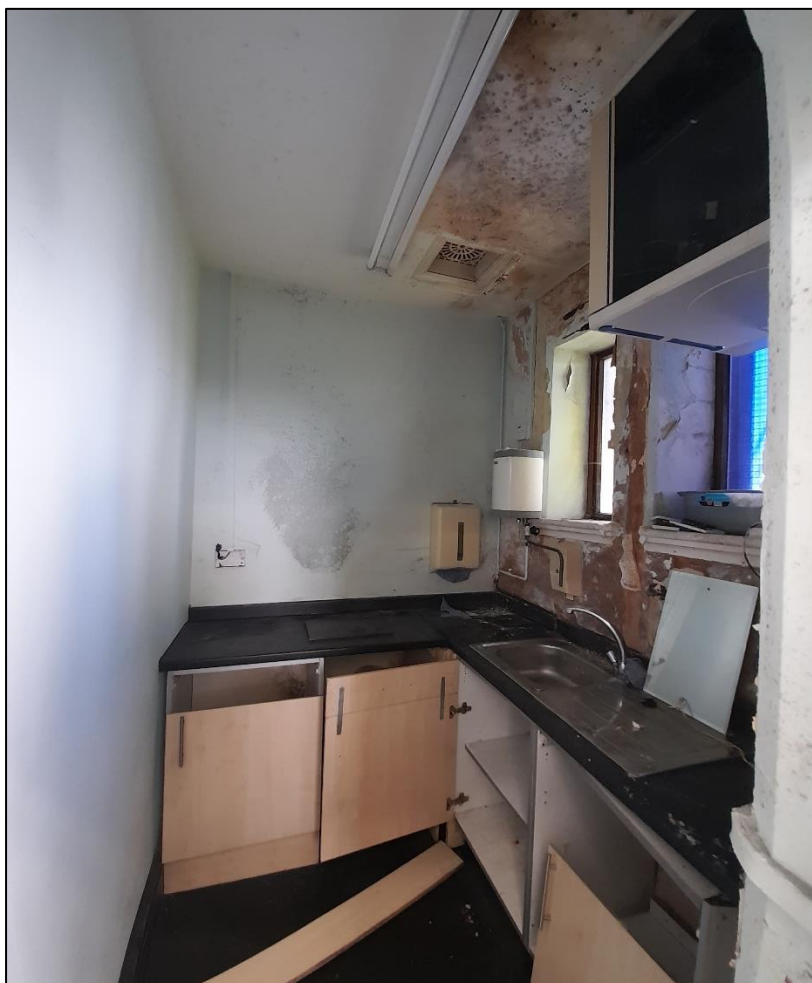
- 4.3.10. The existing reception area is in the north-west of the library (Plate 16). It has a modern curved desk with shelving behind. There is a door on the south wall that leads into a small kitchen area with modern fittings and fixtures. The door is not original, but it appears to have been fitted an original opening. The kitchen is in very poor condition with signs of damp.

*Plate 17. Kitchen in north-west of library, looking south.*

| <b>Proposed Work</b> | <b>Objective</b> | <b>Significance of affected aspect</b> | <b>Assessing beneficial impact</b> | <b>Assessing harmful Impact</b> | <b>Proposed Solution</b> |
|---|---|---|---|---|---|
| Installation of new kitchen in existing kitchen to north of entrance, including new units and appliances. | To replace the existing kitchen, which is currently in a very poor state of repair. | The kitchen units and other fixtures are modern and are not considered of historic value. | None | None | None |

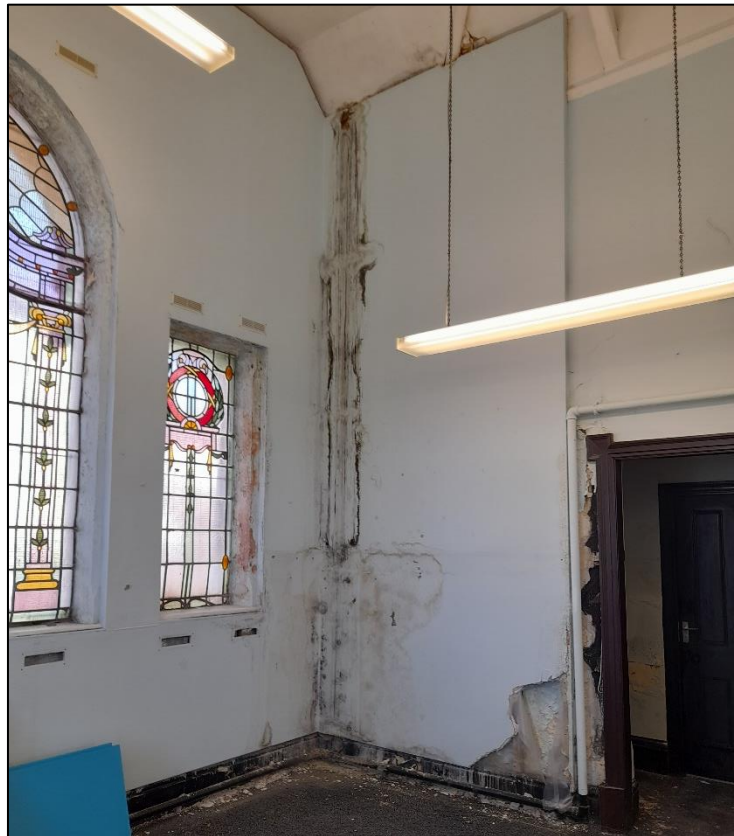
- 4.3.12. The children's library, in the south-west corner, has clear signs of water damage (Plate 20). On its north wall is a doorway through to a cloakroom and toilet, also in poor condition (Plate 21). The dividing wall appears to be a later stud addition.

*Plate 20. North-west corner of children's library, showing water damage.*

- 5.2.11. There will be some areas of the ground floor where modern fixtures and fittings are used. These are the kitchen area, reception, and the children's library. In both cases, the elements to be replaced are also modern, including the existing kitchen units, reception desk, and carpet in the children's room. They are of no historic value and their replacement will have a neutral impact on the historic significance of the building. The changes are necessary to bring these areas up to modern standards and to repair damage caused by water ingress.

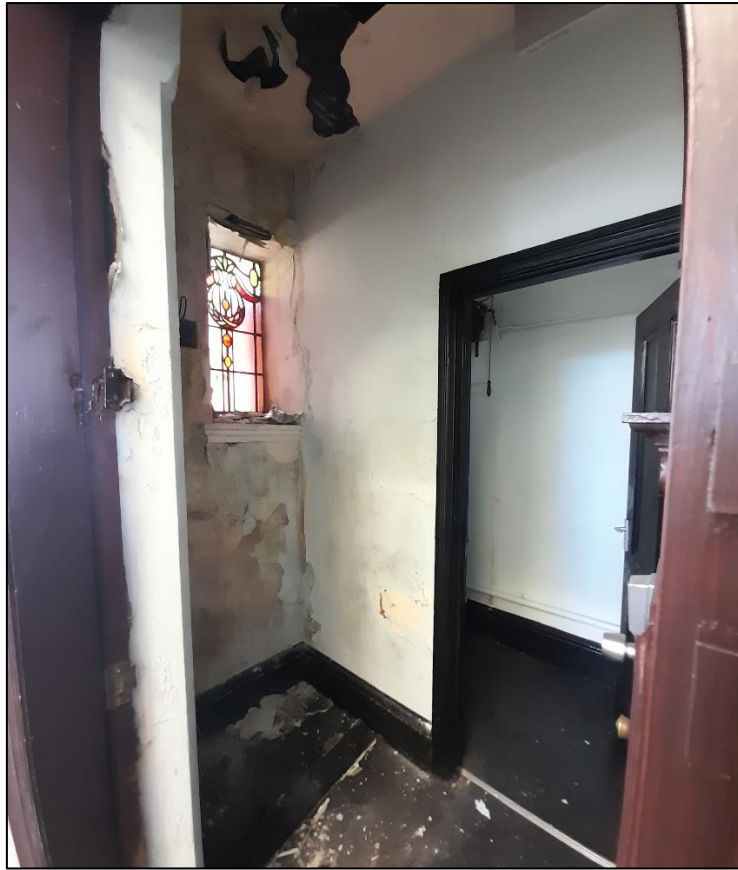
*Plate 21. Cloakroom and toilet in south-west of library, looking north-west.*

- 5.2.9. A DDA compliant WC will be installed in the existing cloakroom/WC to the north of the children's library. This work is necessary to replace the existing DDA compliant WC in the rear extension. The existing original door between the cloakroom and the children's library will to be made good and changed to outward opening. The work also involves the removal of a stud wall and door between the existing cloakroom and WC. These are later additions, and their removal is not considered to have any impact on the building's significance.
