### R 146 South West Elevation - Terracotta Supply

| NO. | DATE | REVISION |
|---|---|---|
| PROJECT<br><b>YMCA, Merthyr Tydfil</b> | | |
| DRAWING TITLE<br><b>South West Elevations - Terracotta Supply</b> | | |
| DRAWING NO.<br><b>3510_R_146</b> | | REV. |

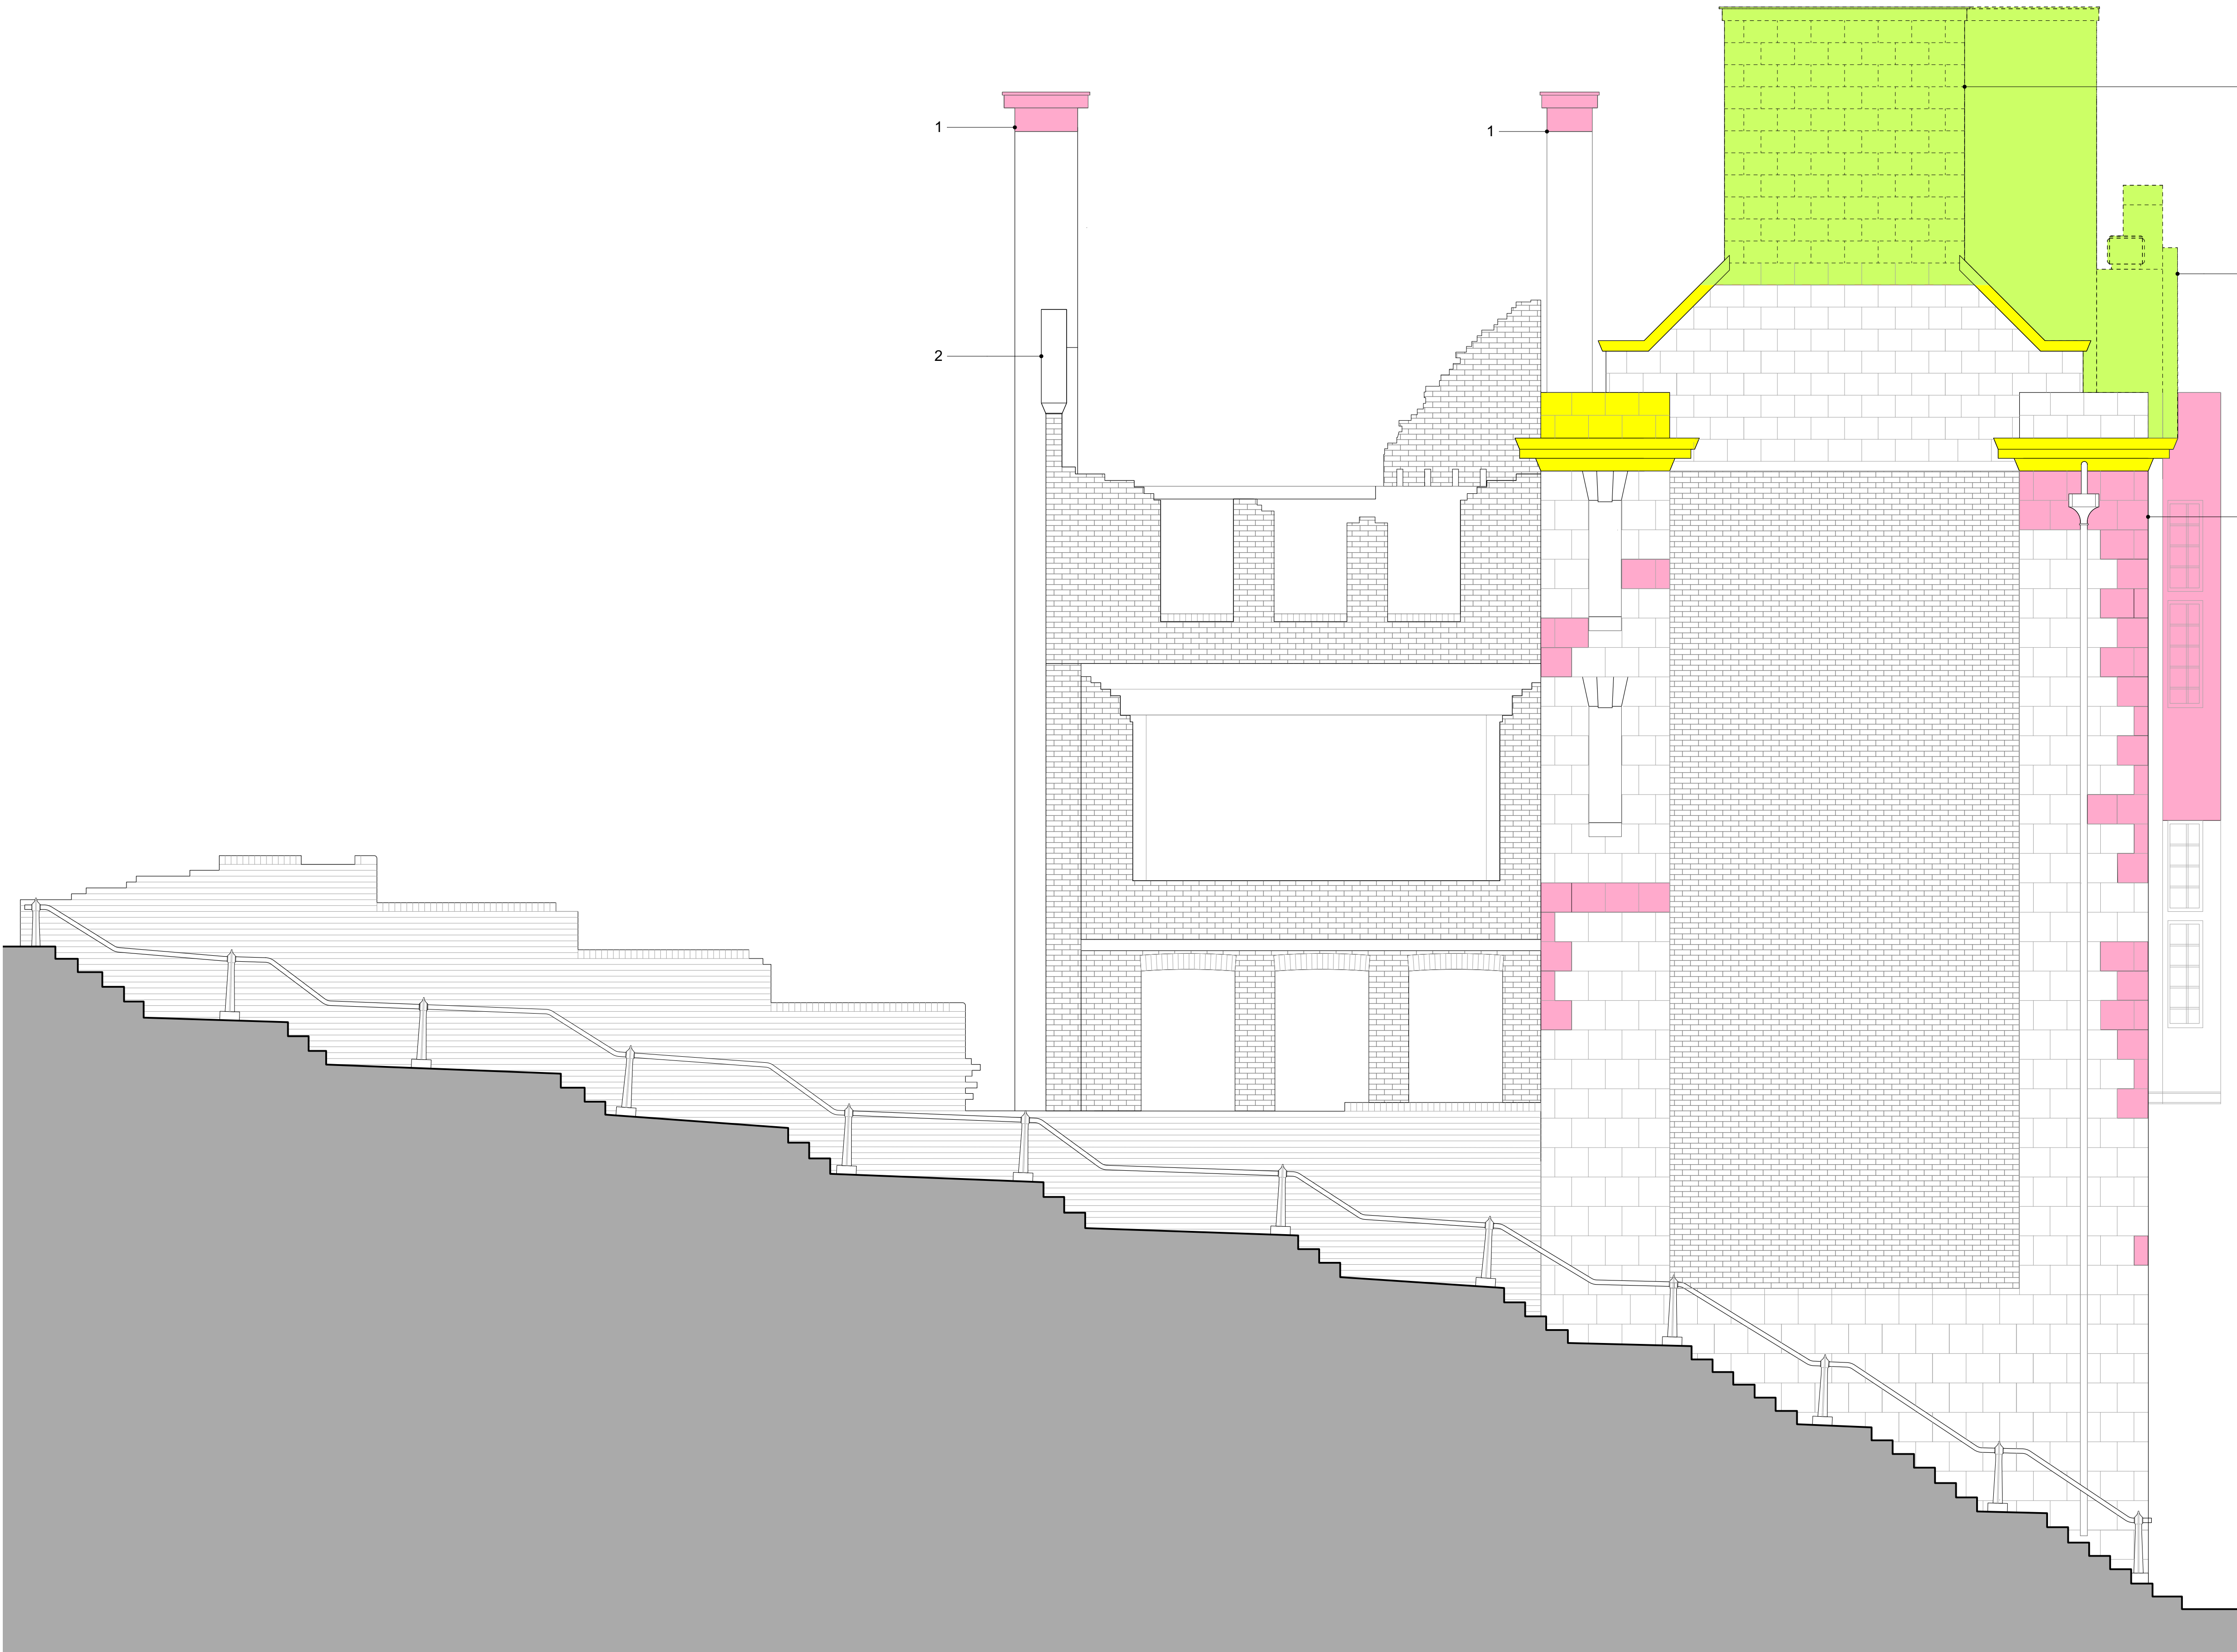
1. Chimney dimensions are according with proposed rather than existing.
2. Existing coping is in poor condition, consider repair/ replacement.
3. Entire gable end chimney is missing, new terracotta required to rebuild.
4. Remaining pediment terracotta units to be cleaned/ repaired and re-used. Missing terracotta to be manufactured to match original.
5. Replacement terracotta required.

- Defective terracotta unit** - Allow for careful removal/ of existing terracotta and replacement with new as specification section C41.
- Missing terracotta units** - Allow for careful removal of any remains of existing terracotta unit and replacement with new as specification section C41. (Units may be found on site).
- Partially Damaged terracotta unit** - To be repaired where possible. Allow for careful removal of damaged units, repair and reinstatement, supplemented with new as specification section C41.
- Proposed terracotta unit** - as specification section C41.
