RHONDDA  
GEOTECHNICAL  
SERVICES

GROUND STABILITY STATEMENT  
M.T.C.B.C. PLANNING APP. P/22/0088

PROPOSED RESIDENTIAL DEVELOPMENT  
WINCHFAWR ROAD  
WINCHFAWR  
MERTHYR TYDFIL  
CF48 1RD

18/11/2025

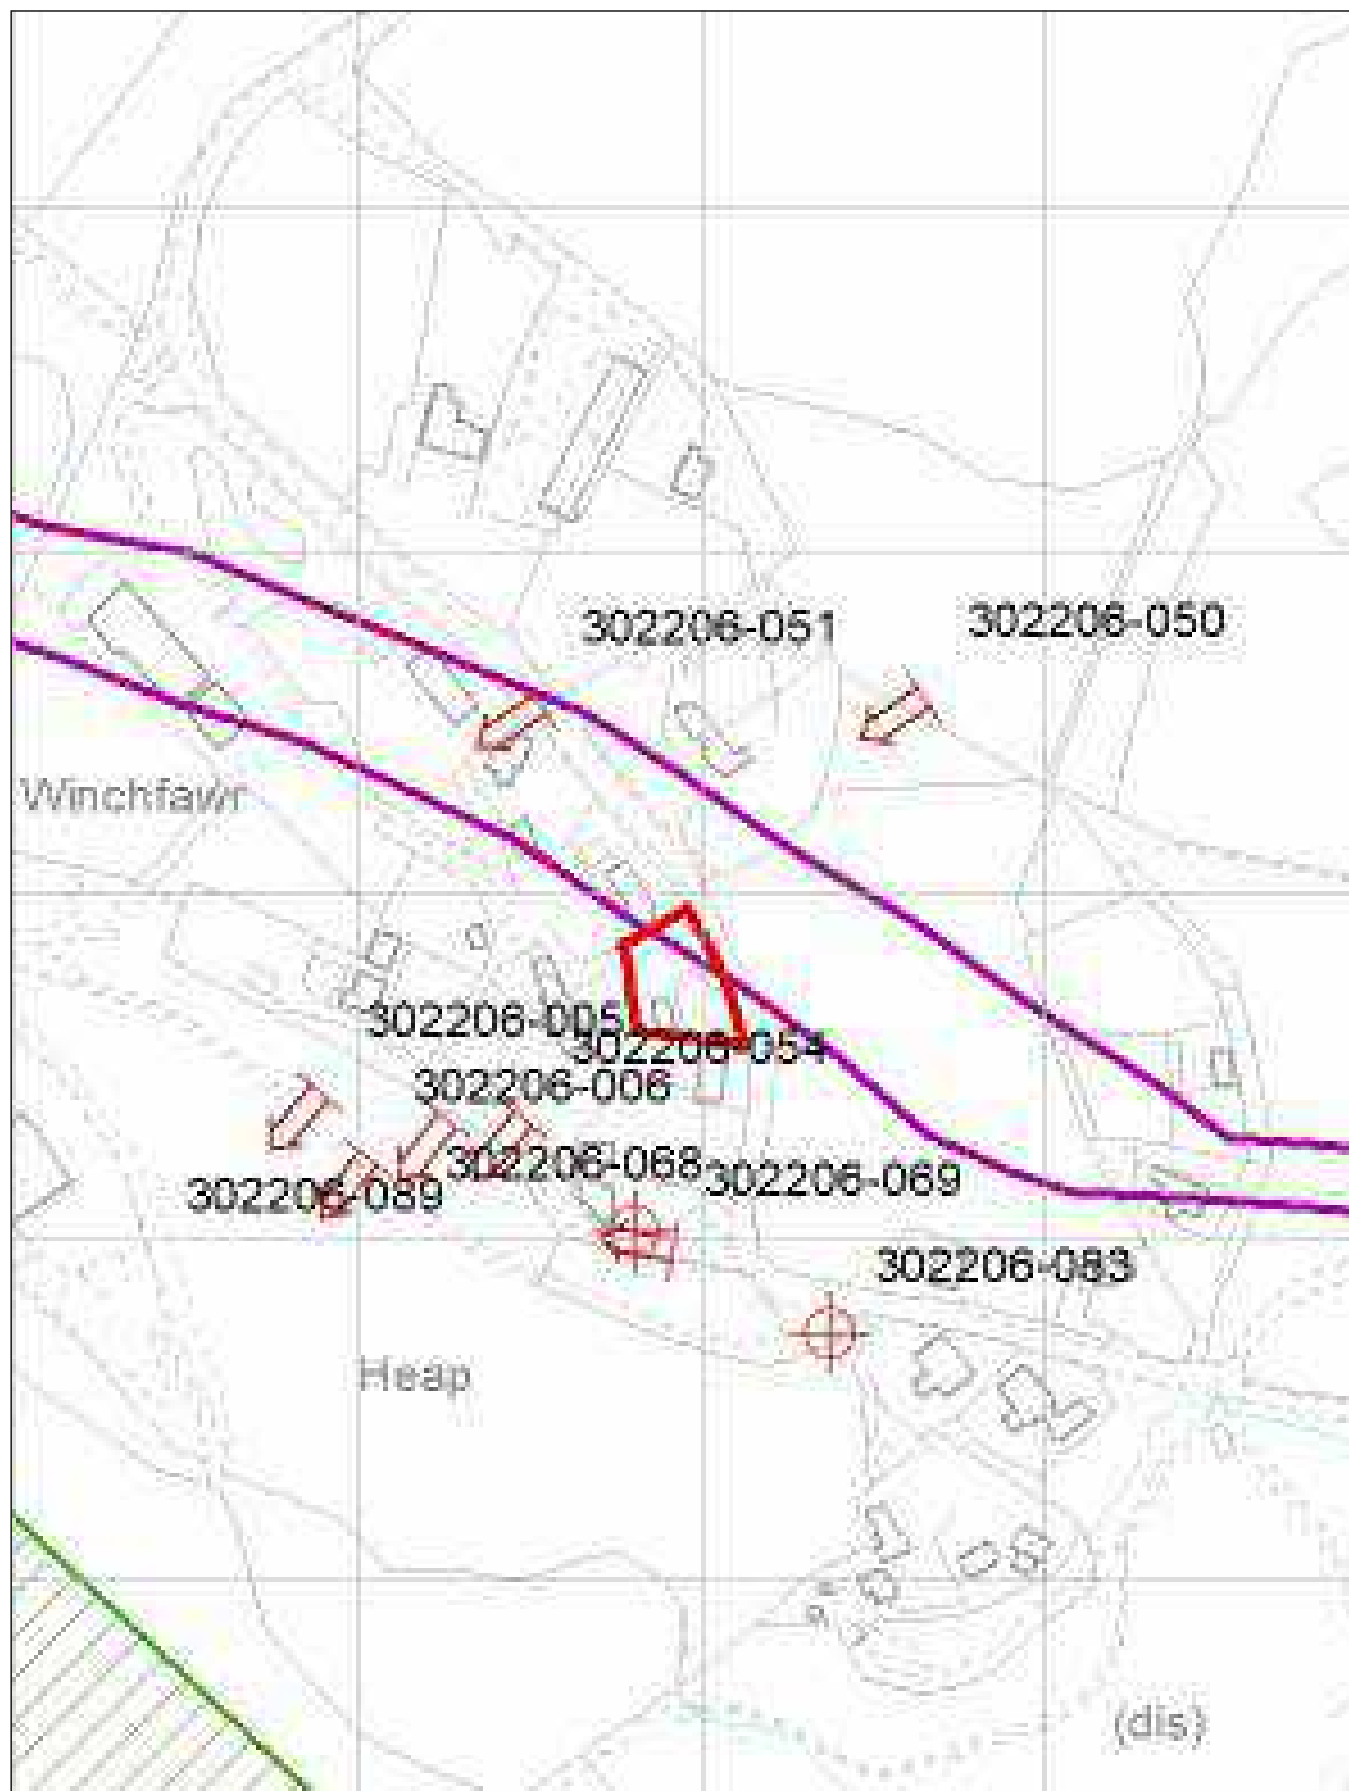
FIGURE 3  
EXTRACT OF THE SUMMARY OF FINDINGS  
MAP FROM THE C.A. CONSULTANTS REPORT

Four mine entries north of the site have been highlighted. They are all adits with additional information in the database. Two are shown in Figure 3. 302206-051 is the No.8 Level (Level is the South Wales Term for a sub-horizontal mine entrance and will be used from this point as the term adit is usually reserved for metalliferous mines). It has an orientation of 236°. 302206-050 is the D. Lewis Level and also has an orientation of 236°. Two other mine entrances have been highlighted. They are 302206-009 and 302206-042. These are the No.1 Bute Level and No.2 Bute Level with orientations of 208° and 210° respectively. All four levels are associated with the Bute outcrop and are orientated toward the site. This would indicate they could be associated with the recorded workings in the Bute Seam.

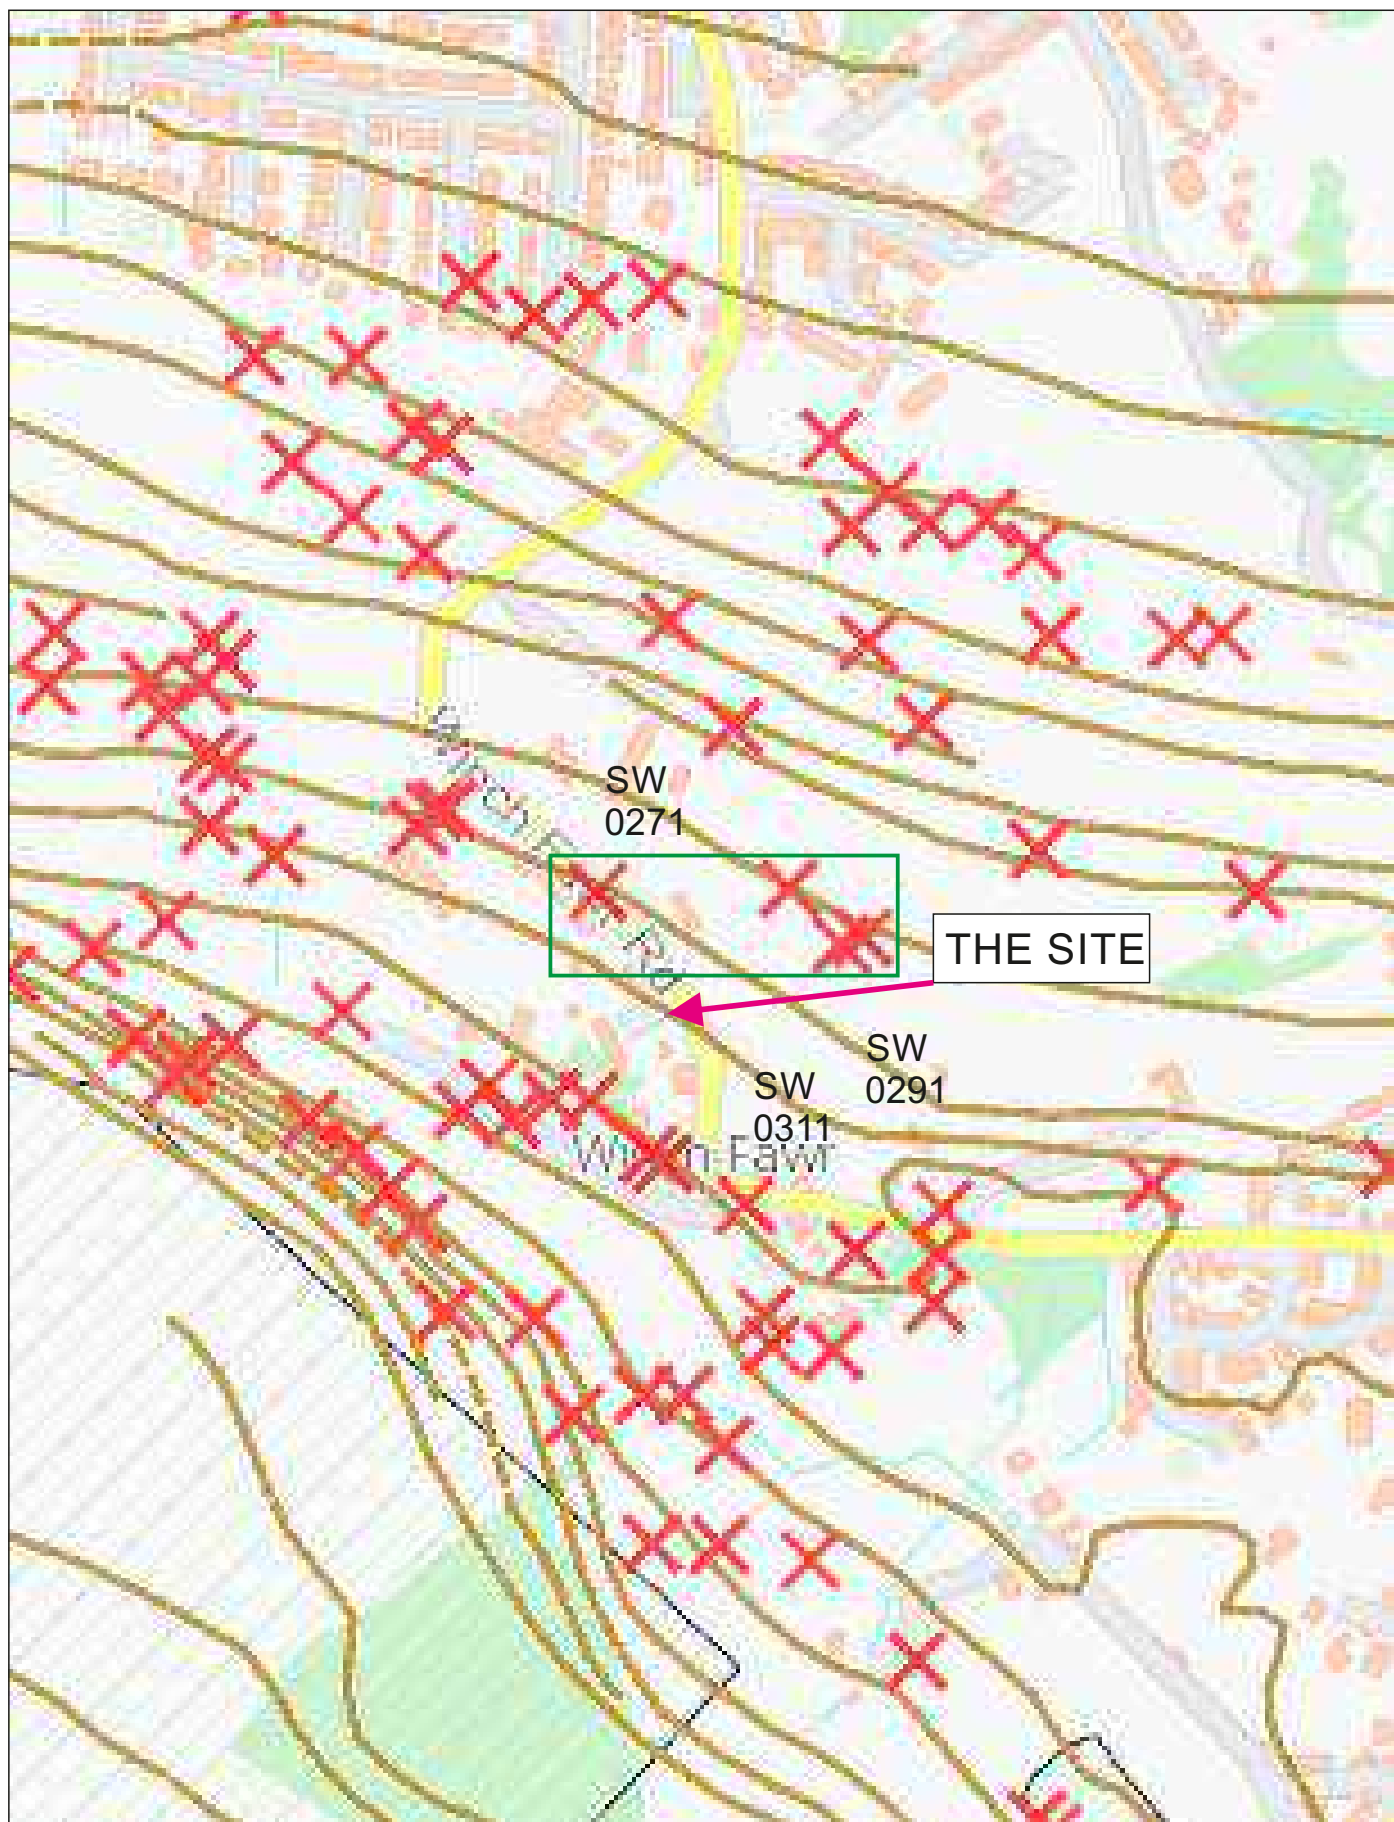
FIGURE 5  
C.A. VIEWER, MINING DATA WINDOW. RED CROSSES ARE  
MINE ENTRIES. BROWN LINES ARE SEAM OUTCROPS.

In order to fully understand why sites have a high risk status it is informative to study the Coal Mining Data window. This window is far superior to the planning window as it is at a larger scale. There are multiple datasets which can be turned on and off. An extract from the Mining Data Window is reproduced as Figure 5 overleaf. For clarity only three sets of data are turned on in Figure 5- seam outcrops, mine entries and opencast mining (green hatched area). The outcrop pattern north and south of the site is regular and tightly spaced. The interactive viewer shows no topography or geological faulting, which can make interpretation difficult without other sources of information. The closest three outcrops to the site have been labelled with their seam codes. The seam codes are ascending to the southwest. This could mean the strata is dipping to the southwest, the topography is rising to the southwest or a combination of both. A seam outcrop crosses the site as in Figure 3. This has the seam code SW0311. The closest outcrop north of the site is SW0291. Both codes in the C.A. Seam Code Directory correspond to the curious seam names in the Consultants Report. A third outcrop has had the seam code SW0271 added in Figure 5. This is the Bute Seam.

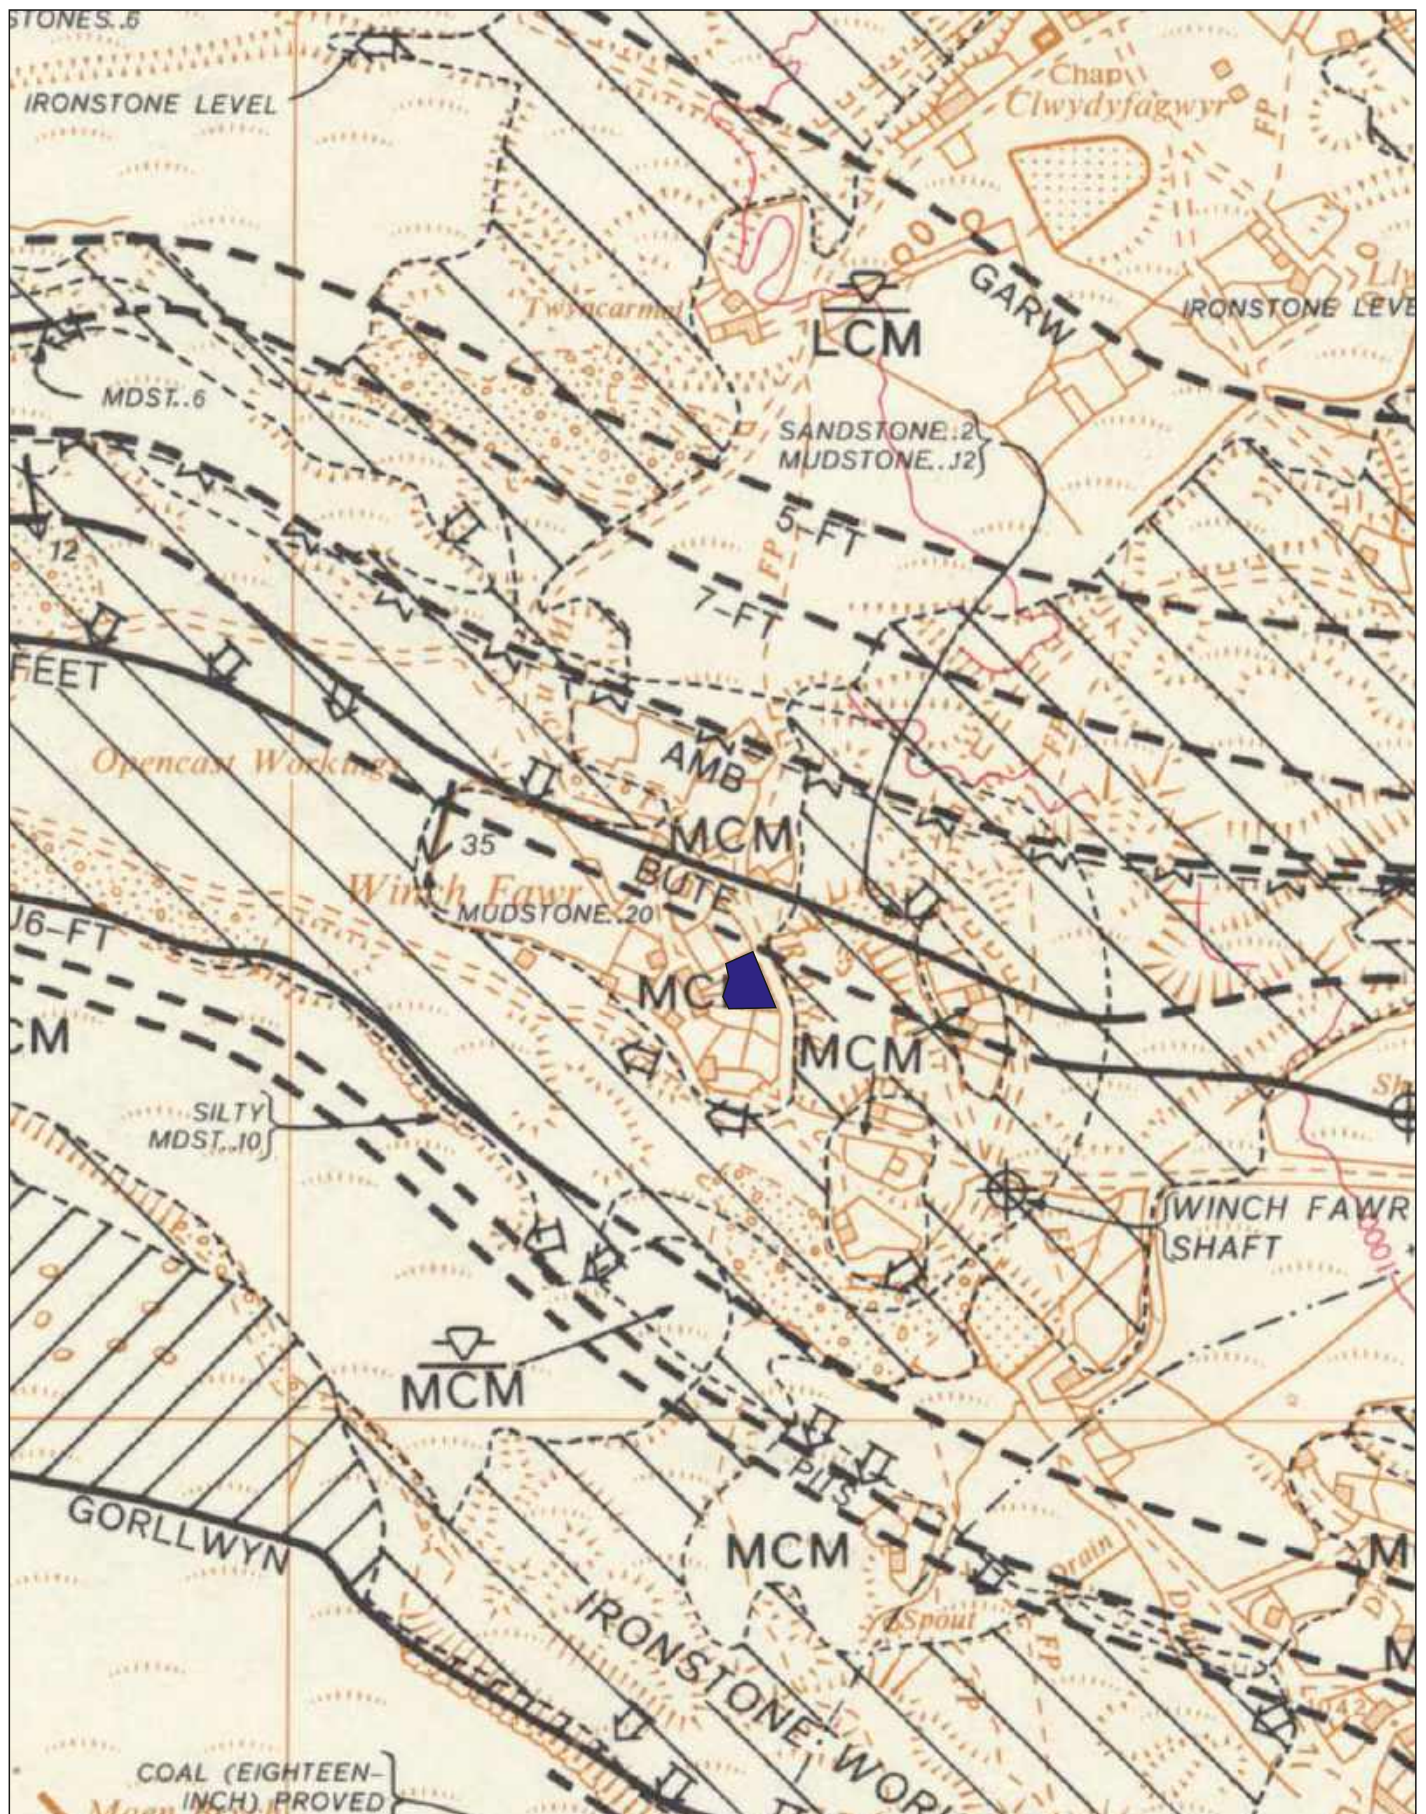
FIGURE 6A  
EXTRACT OF GEOLOGICAL SURVEY SHEET SO 00NW.  
THE SITE IS HIGHLIGHTED IN BLUE.

In Figure 6A the large areas of NW-SE cross hatching represent Made Ground from very extensive surface mining of Ironstone and Coal. The debris from this can be seen on the underlying base map. This is better seen in Figure 6B which has an older base map. Southwest of the site in Figure 6A is an area of SW-NE hatching. This represents opencast mining. The broad outcrop pattern is similar to Figure 5 but with fewer outcrops. This is because the Survey usually only shows the most important seams to avoid overcomplicating the map. In contrast, many of the outcrops on the C.A. Viewer are thin and unworkable. North of the site the entire Lower Coal Measures are exposed from the basal Garw Seam to the Amman Marine Band which marks the junction with the Middle Coal Measures. Only four coal seam outcrops are shown in the entire Lower Coal Measures. The Memoirs make it clear that there are other closely spaced coal seams underground with splits and recombination giving quite a complicated picture. There is a measured dip  $35^{\circ}$  along strike from the site. Further northwest is a second measured dip of  $12^{\circ}$ . This is a considerable difference over a relatively short distance. Strata dip is going to have a very important bearing on depth of seams below the site.

The site is shown underlain by the Middle Coal Measures. The Bute Seam is shown as a solid line. The Nine Foot is also shown as a solid line west and east of the site but in the vicinity of the site it is dashed. This means the outcrop is conjectural, not proven. Both seams occupy positions similar to those shown in Figure 5. It is evident the Bute and Nine Foot (if present) will underlie the site at shallow depth. The arrow symbols are levels corresponding to some of those shown in Figure 5.

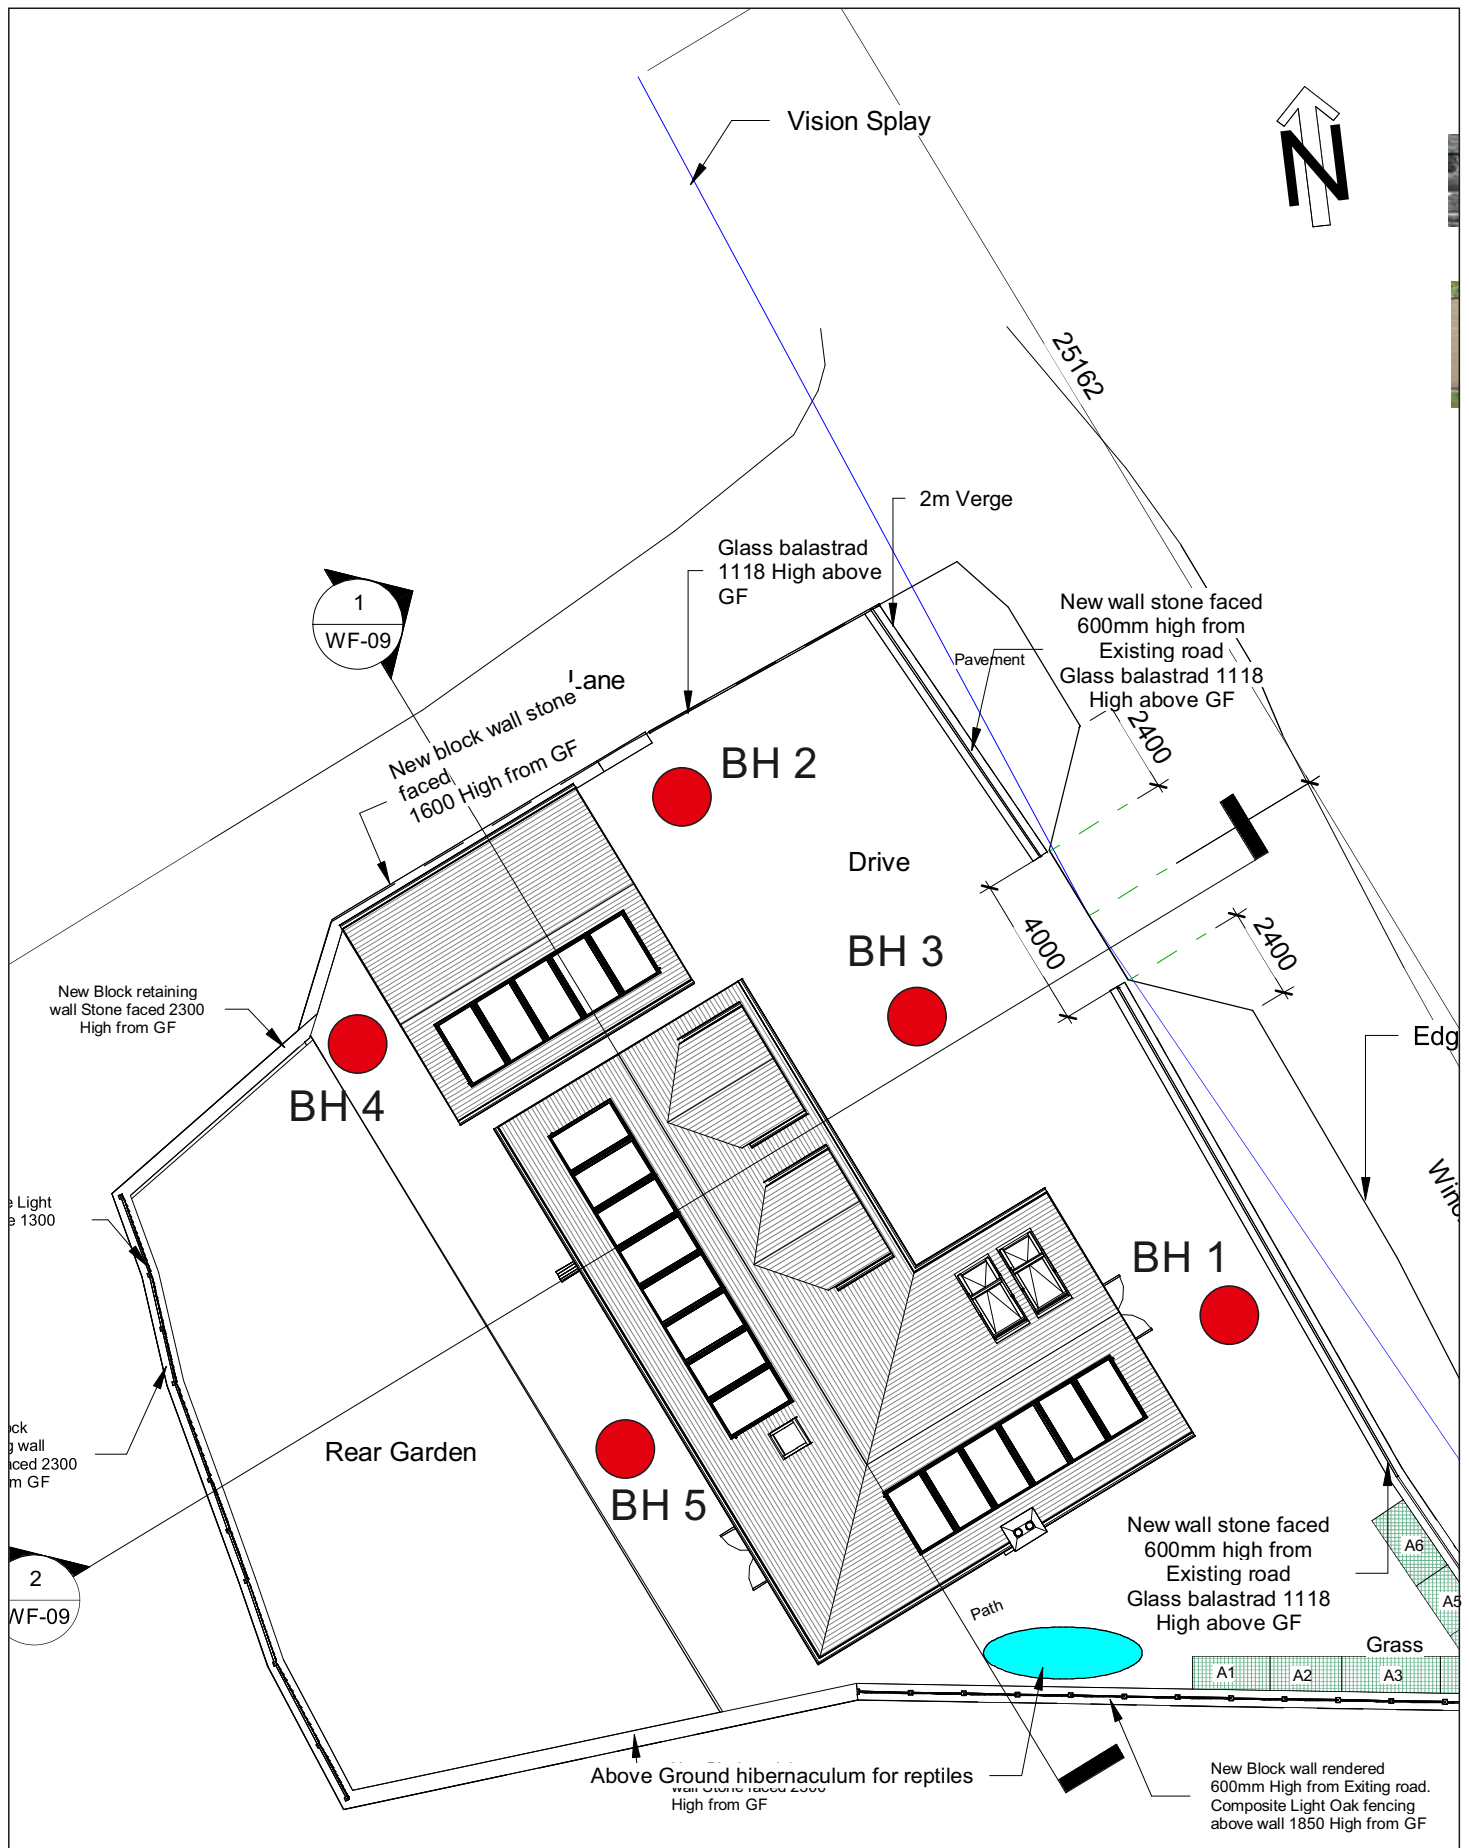
**FIGURE 6**  
BOREHOLE POSITIONS SHOWN WITH THE  
FOOTPRINT OF THE PROPOSED DEVELOPMENT.

The drilling was carried out on 4<sup>th</sup>-5<sup>th</sup> of September 2023 under the full-time supervision of the author. Apex Drilling used a small Fraste P.L.G. rotary rig to drill the boreholes using water flush. All permit conditions were adhered to. Continuous monitoring at the rig, and regular monitoring in the surrounding area detected no mine gases. Full borehole logs are in Appendix 1, but to summarise, in the first borehole (BH1) there was only 2.7m of colliery spoil and Glacial Till above rockhead. BH1 was being drilled when it encountered broken ground with sporadic voids at 18.2m. All flush was lost, and the base of the broken ground came in at 20.6m. From there the drilling was “normal” with no returns. The hole was stopped at 22.0m because of the risk of the drill string jamming in the hole. This pattern was repeated in BHs 3, 4 and 5 with 1.9m-2.8m of broken ground at approximately the same depth. BH2 was drilled to 33m. No obvious broken ground was encountered, and neither was any intact coal seen. Coal dust was seen in the water flush returns from 18.2m-22.0m, but flush was not lost all the way to 33m. It is the authors opinion that the borehole had gone through a pillar, but very close to the edge/face.

The thickness of the broken ground together with the depth below ground level confirms that the broken ground represents workings in the Bute Seam. The desk study material strongly suggested that the seam would be worked. The outcrop position and dip mean seam projection would place the seam at approximately the depth of the broken ground. The development clearly can't go ahead without remediation. In this case, this would be drilling and grouting. The broken ground is too deep for any alternative, and too shallow to be mitigated by specialist foundations.

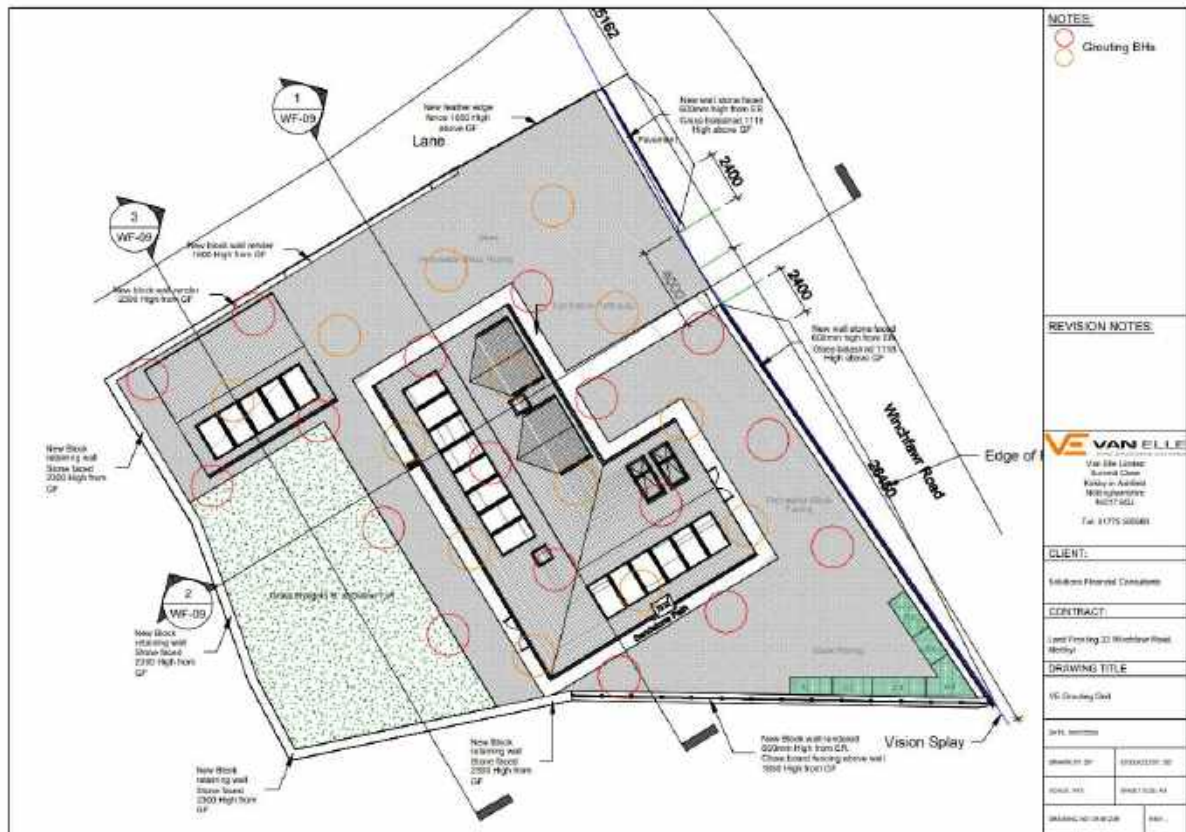
Figure 2: Treatment plan

Of all the boreholes, drilled 69% showed evidence of former shallow mine workings with soft / broken ground being encountered with partial or total loss of flush. Each borehole was grouted and back filled with a 12:1 PFA/OPC grout, and on removal of the casing, boreholes were topped up to surface. 2 no. Validation boreholes were drilled across the site and held their pressure of 2 bar for 2 minutes showing treatment had been successful.

As with all formerly mined sites, there is always a possibility of unknown mineshafts/bell pits/adits and previously formed crown holes being present on site. We would suggest that there is a watching brief whilst undertaking any excavation/earthworks on site and any changes in fill material or colour are noted and investigated.

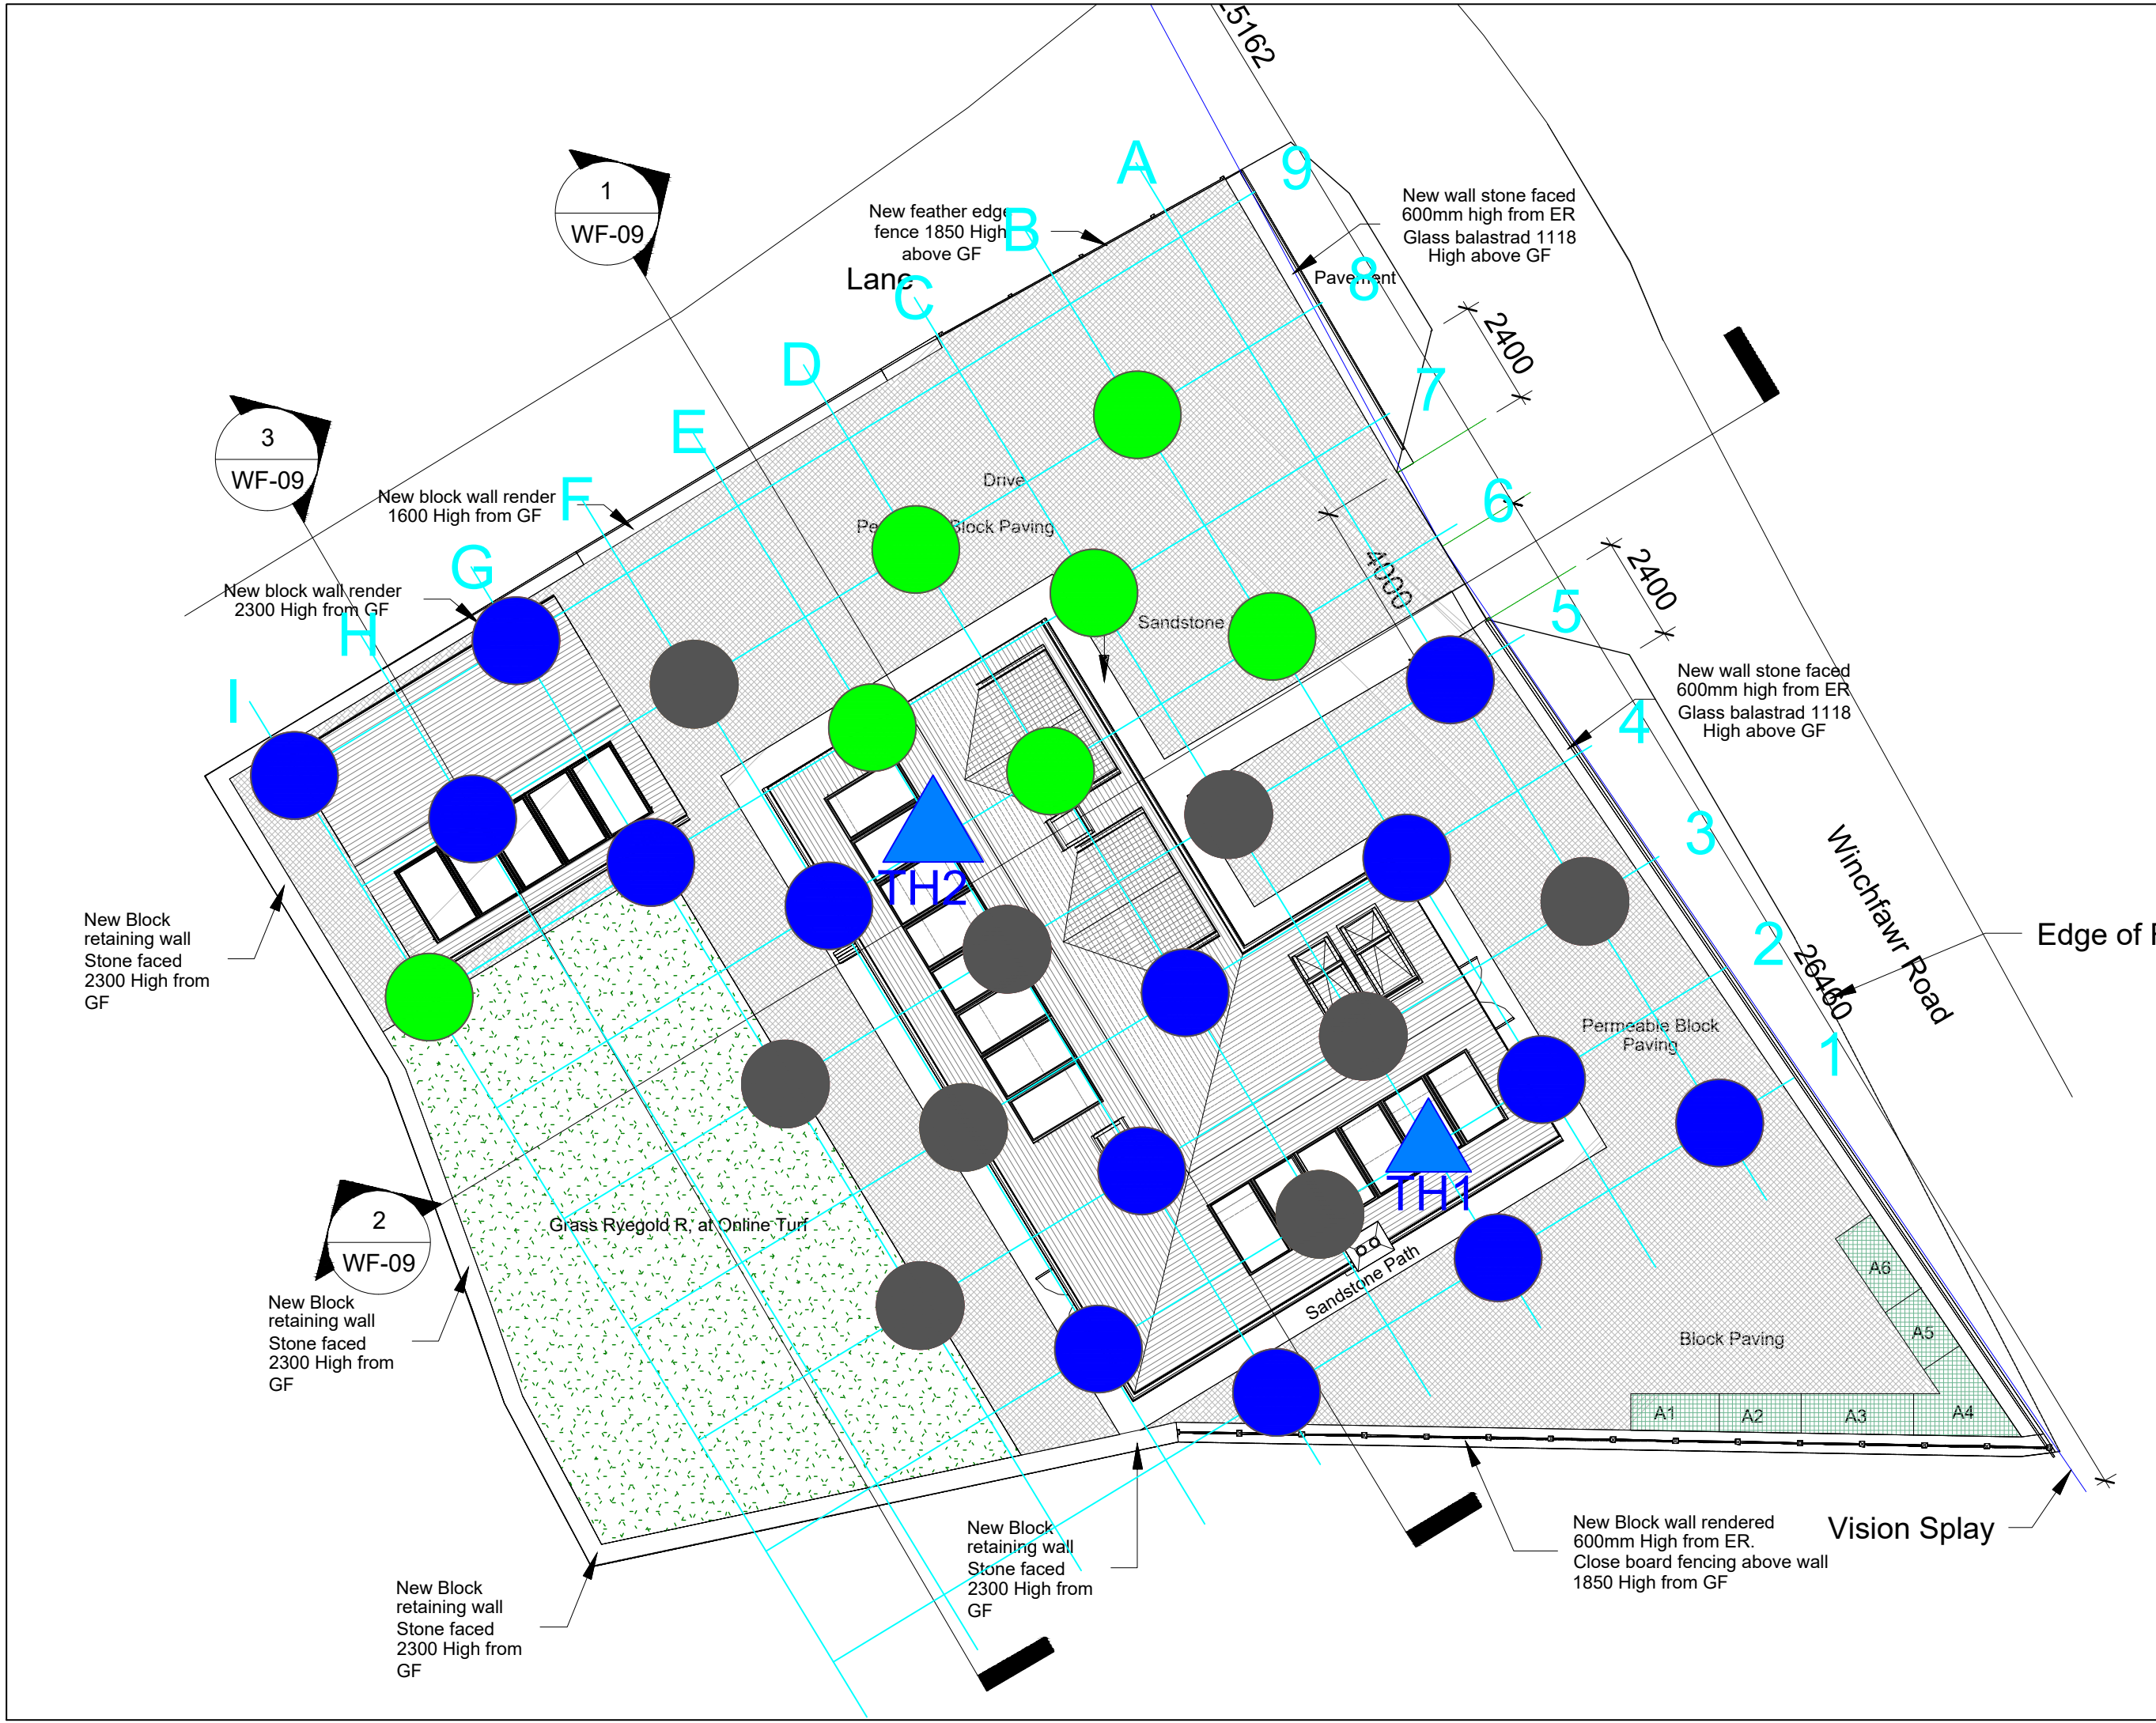
# Appendix 4: Drilling Summary

There was evidence of former workings in the form of soft drilling / broken ground with losses of flush.
