*Report No. BC/MB/11.20.04.*

# **Preliminary Site Investigation: Land at Colliers Row, Merthyr Tydfil.**

**Maxiom Developments Ltd.**

# **Preliminary Site Investigation Report: Land at Colliers Row, Merthyr Tydfil.**

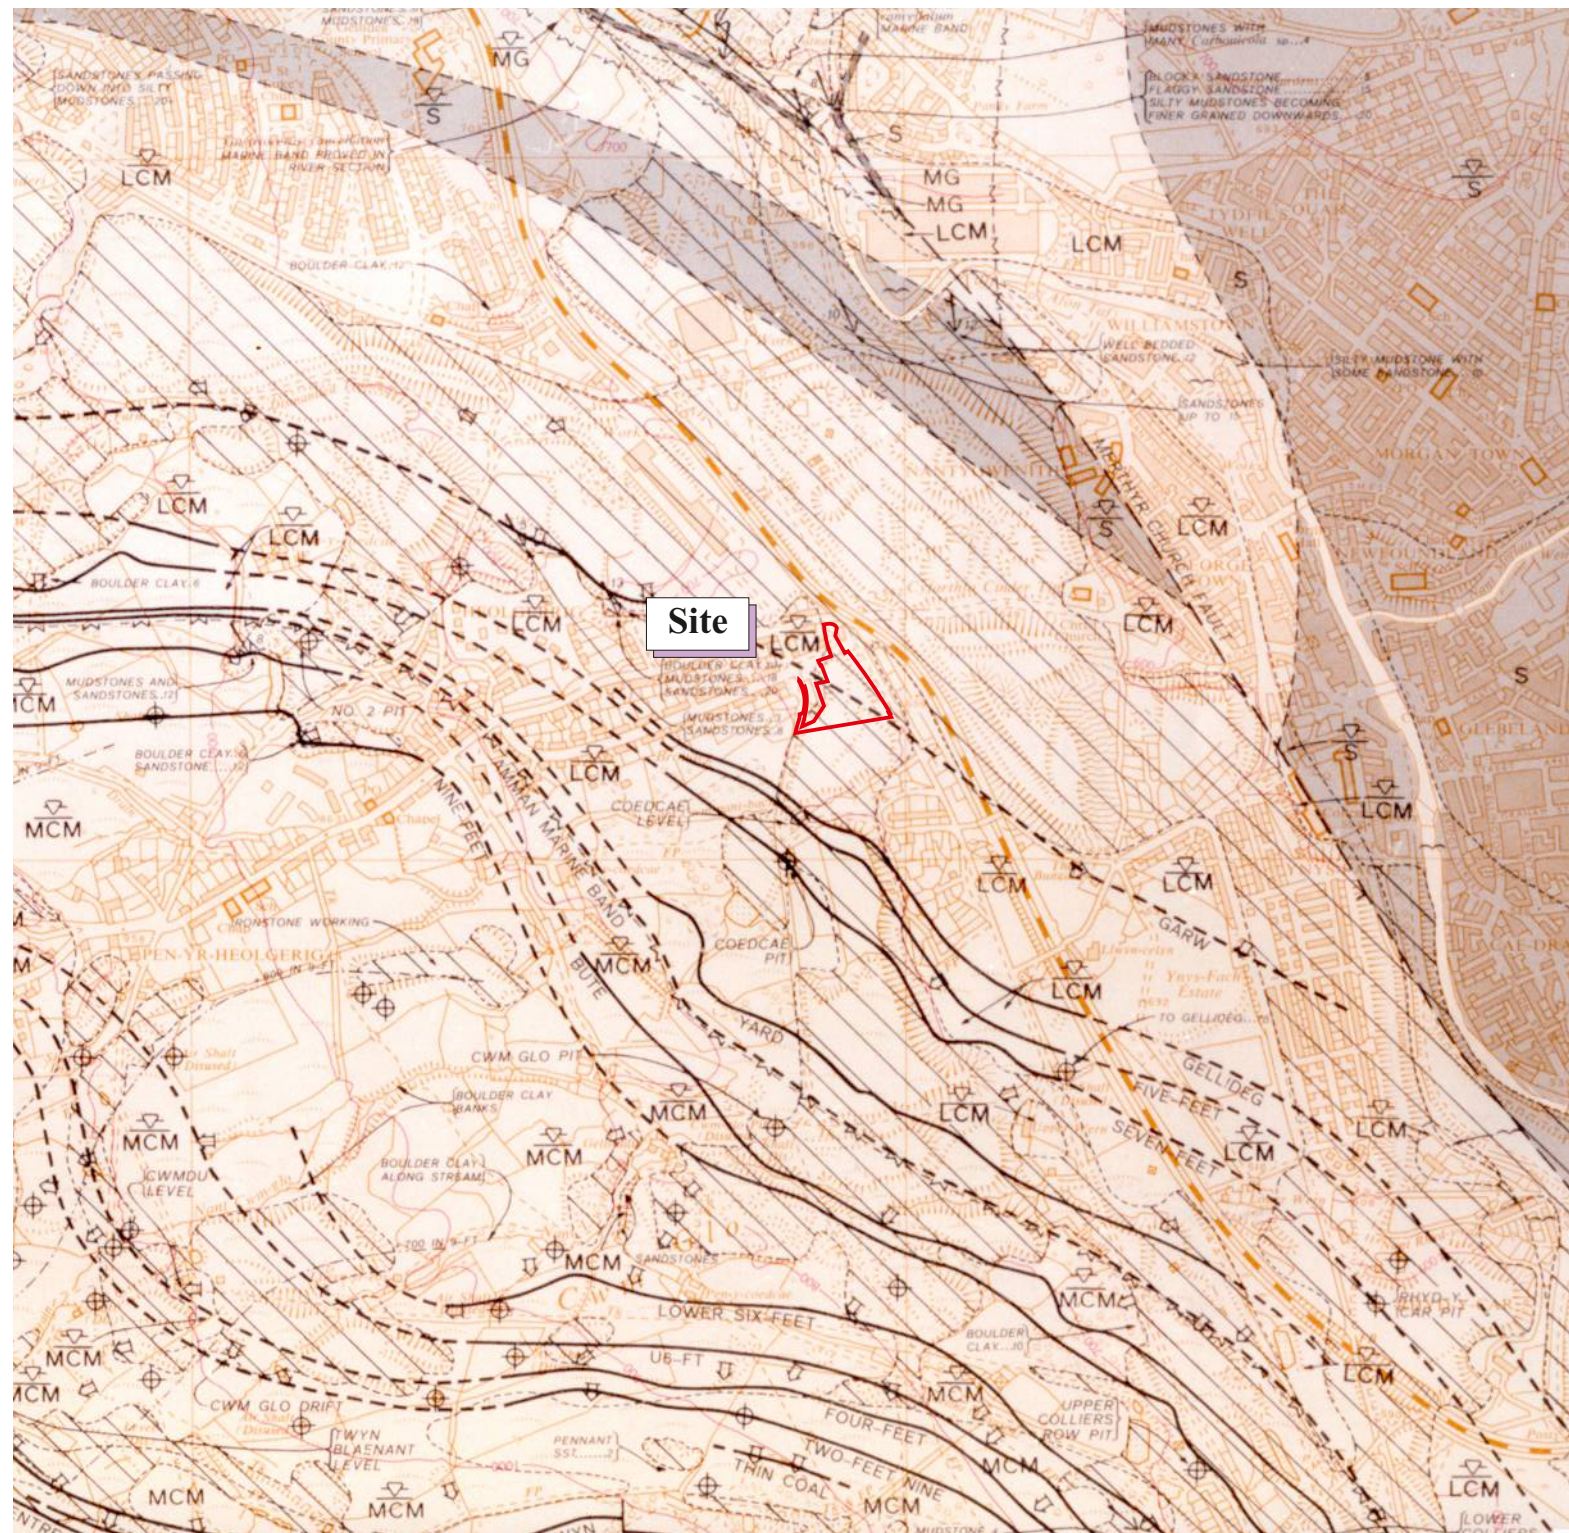
**Drawing No: BC/MB/11.20.04.02.**

(SO 00 NW) shows the inferred positions of the outcrop of the Garw Seam to pass through the Site (see *Geology Plan*, drawing no. BC/MB/11.20.04.02). However, mining records indicate that the outcrops are south-east of the positions shown on the published geological sheet such that the outcrop of the Five Feet/Gellideg Seam passes through the south-west corner of the Site (see *Plan of Old Workings in the Five Feet/Gellideg Seam*, drawing no. BC/MB/11.20.04.04). A number of ironstone bands are present within the coal measures, occurring above and below the Garw Seam (see Figure 2, Part of the Stratigraphic Column).

The coal measures of the South Wales Coalfield have been affected by large faults. In the Brondeg area these large faults have a slightly sinuous trace at the surface and an average trend towards the north-west. The published geological sheet indicates that the Site is not affected by large scale faulting.

The published geological sheet indicates that locally the coal measures are overlain with deposits of glacial till, Boulder Clay; we have no detailed information regarding the thickness and engineering properties of the Boulder Clay in the vicinity of the Site. Published geological records indicate that the Site is not affected by landslip.

There are no features associated with the solid geology of the Site that would require any particular measures to be included in the design and construction of the foundations for the proposed development. It is recommended that no further action is required in this respect.

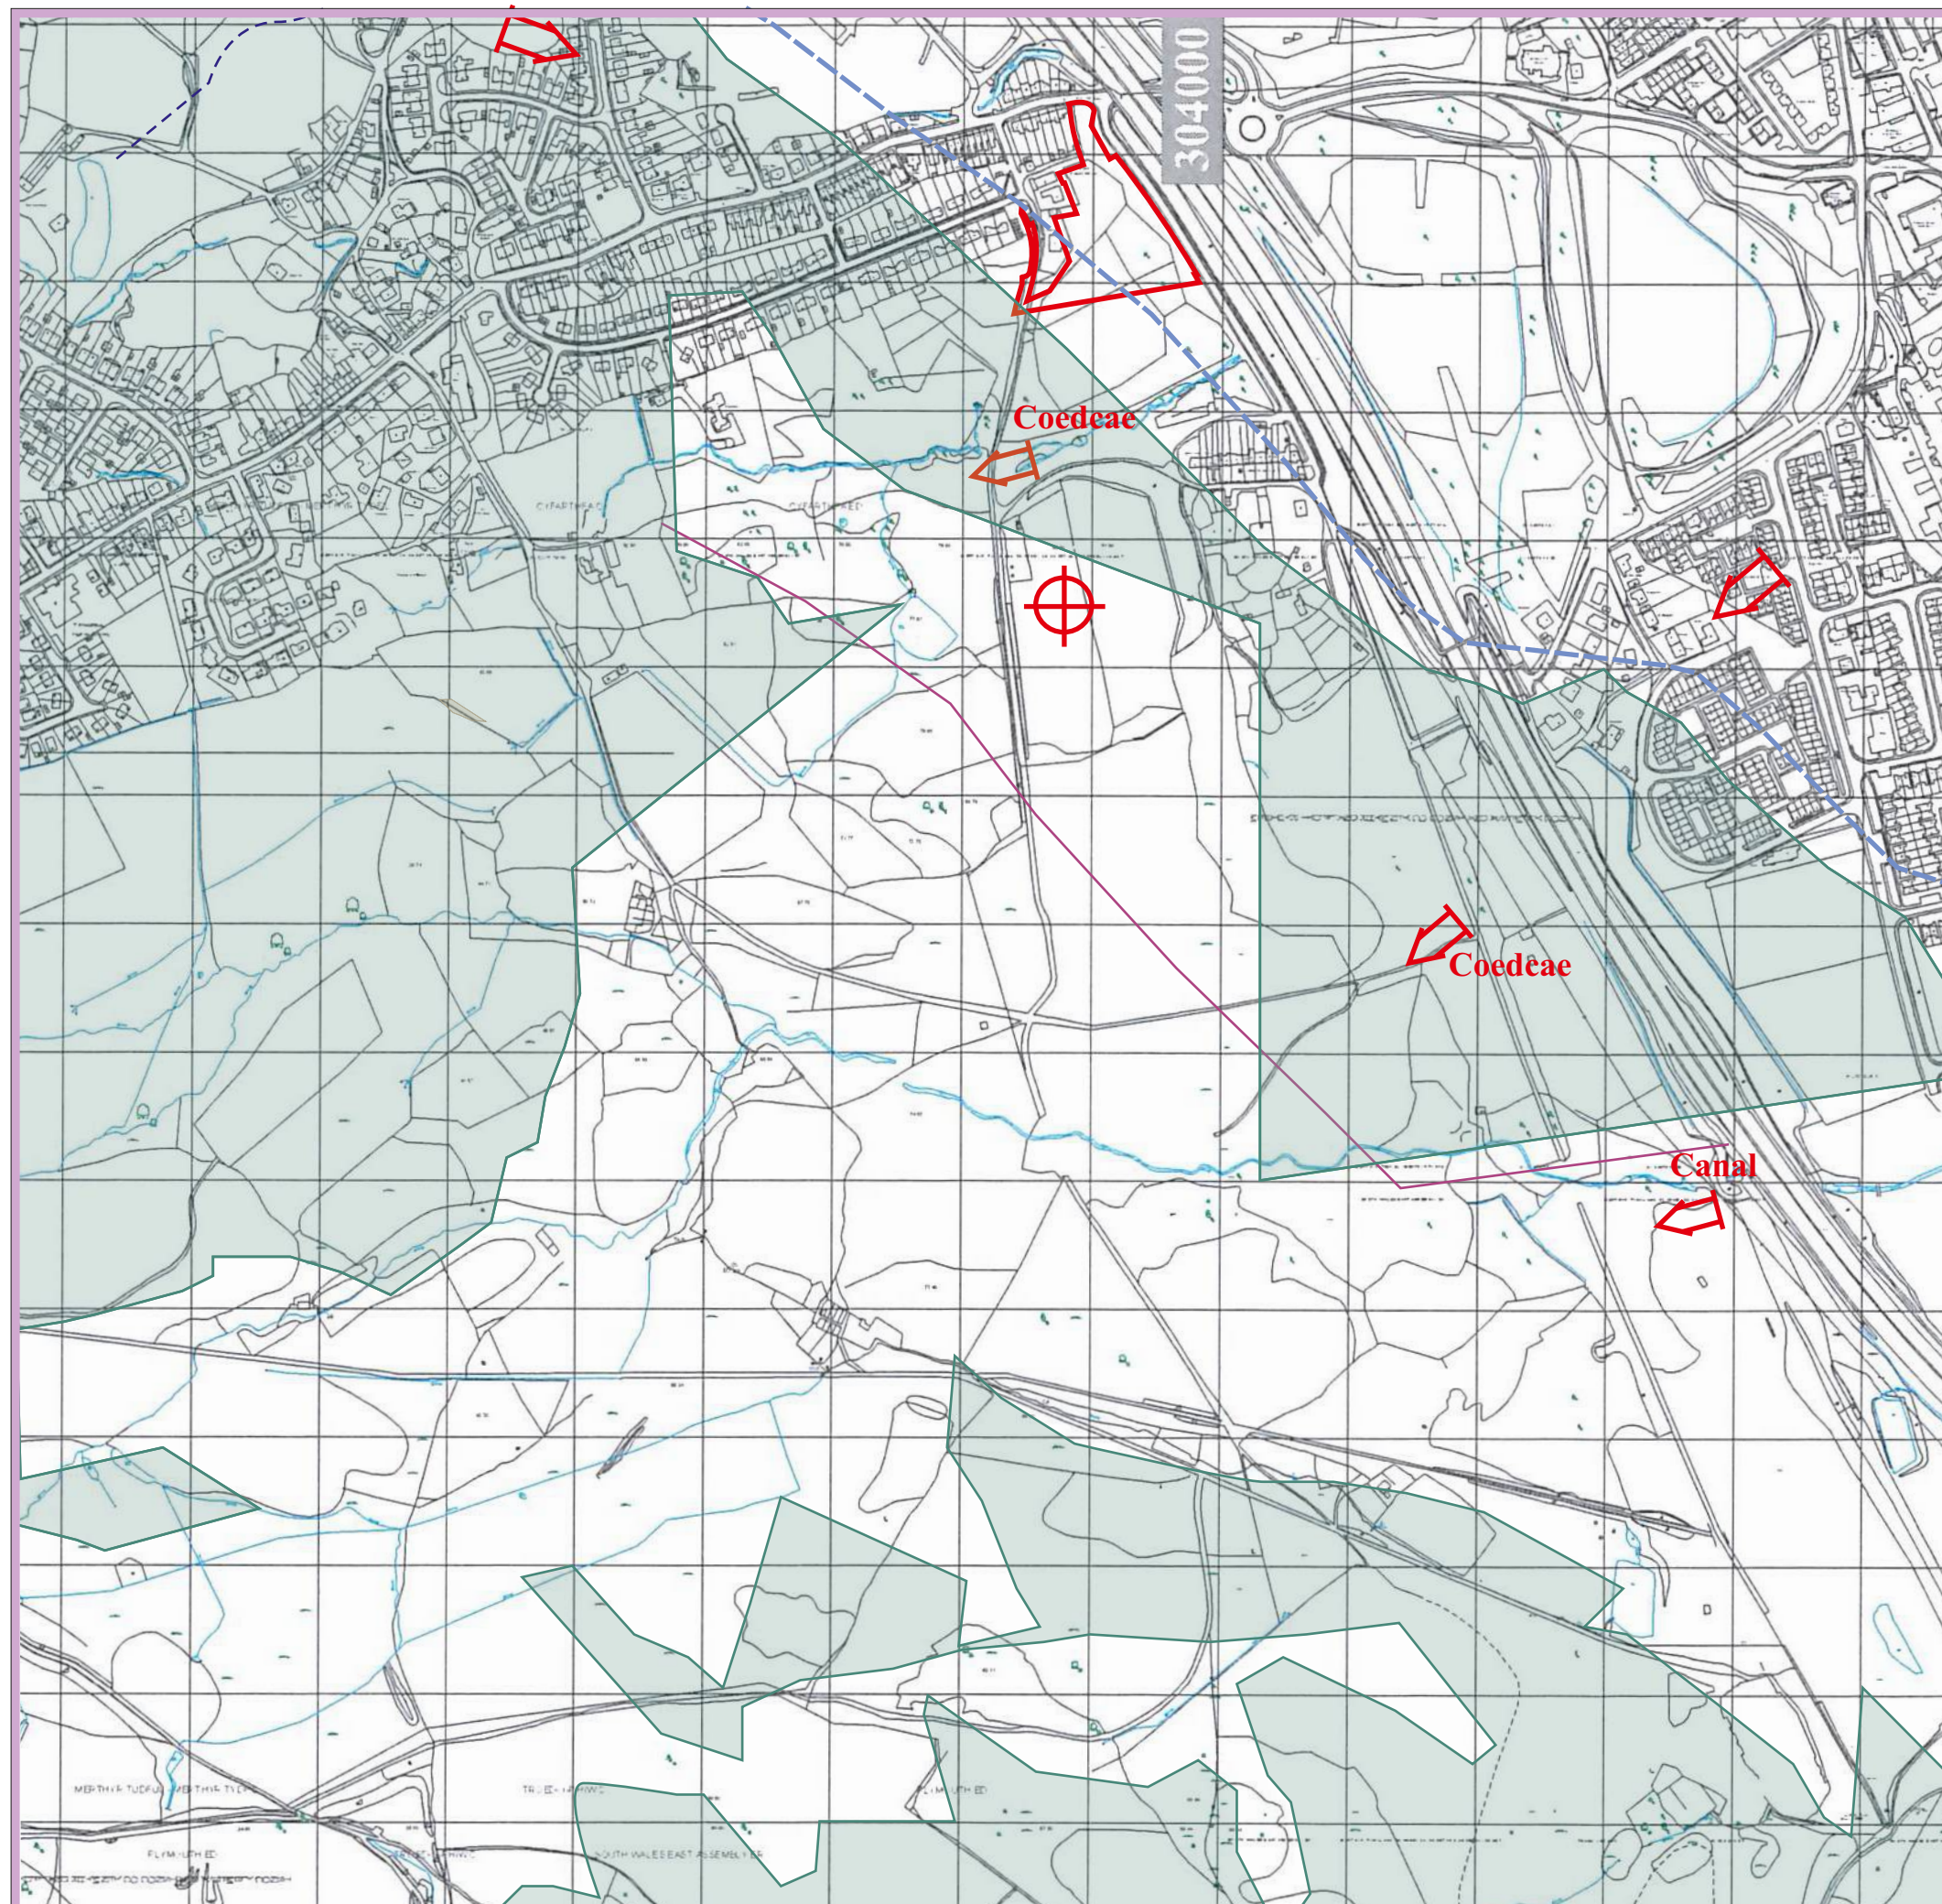
**Drawing No: BC/MB/11.20.04.04.**

The extensive coal mining operations that have taken place in the vicinity of the Site all lie to the west and south-west of the Site. The Five Feet Gellideg Seam is the lowest coal seam in the geological sequence that has been widely mined and the old workings in the Seam do not underlie the Site. The Coal Authority's mining report covers a larger area than the Site but does not include the finger of land along the lane at the western side of the Site. However, the report is broadly applicable to the Site and identifies that there are no shallow coal workings that may affect the Site and there is no disused mine entry within the confines of the Site or within 20m of its boundary. Further, the Site has not been part of an opencast coal site. An inspection of The

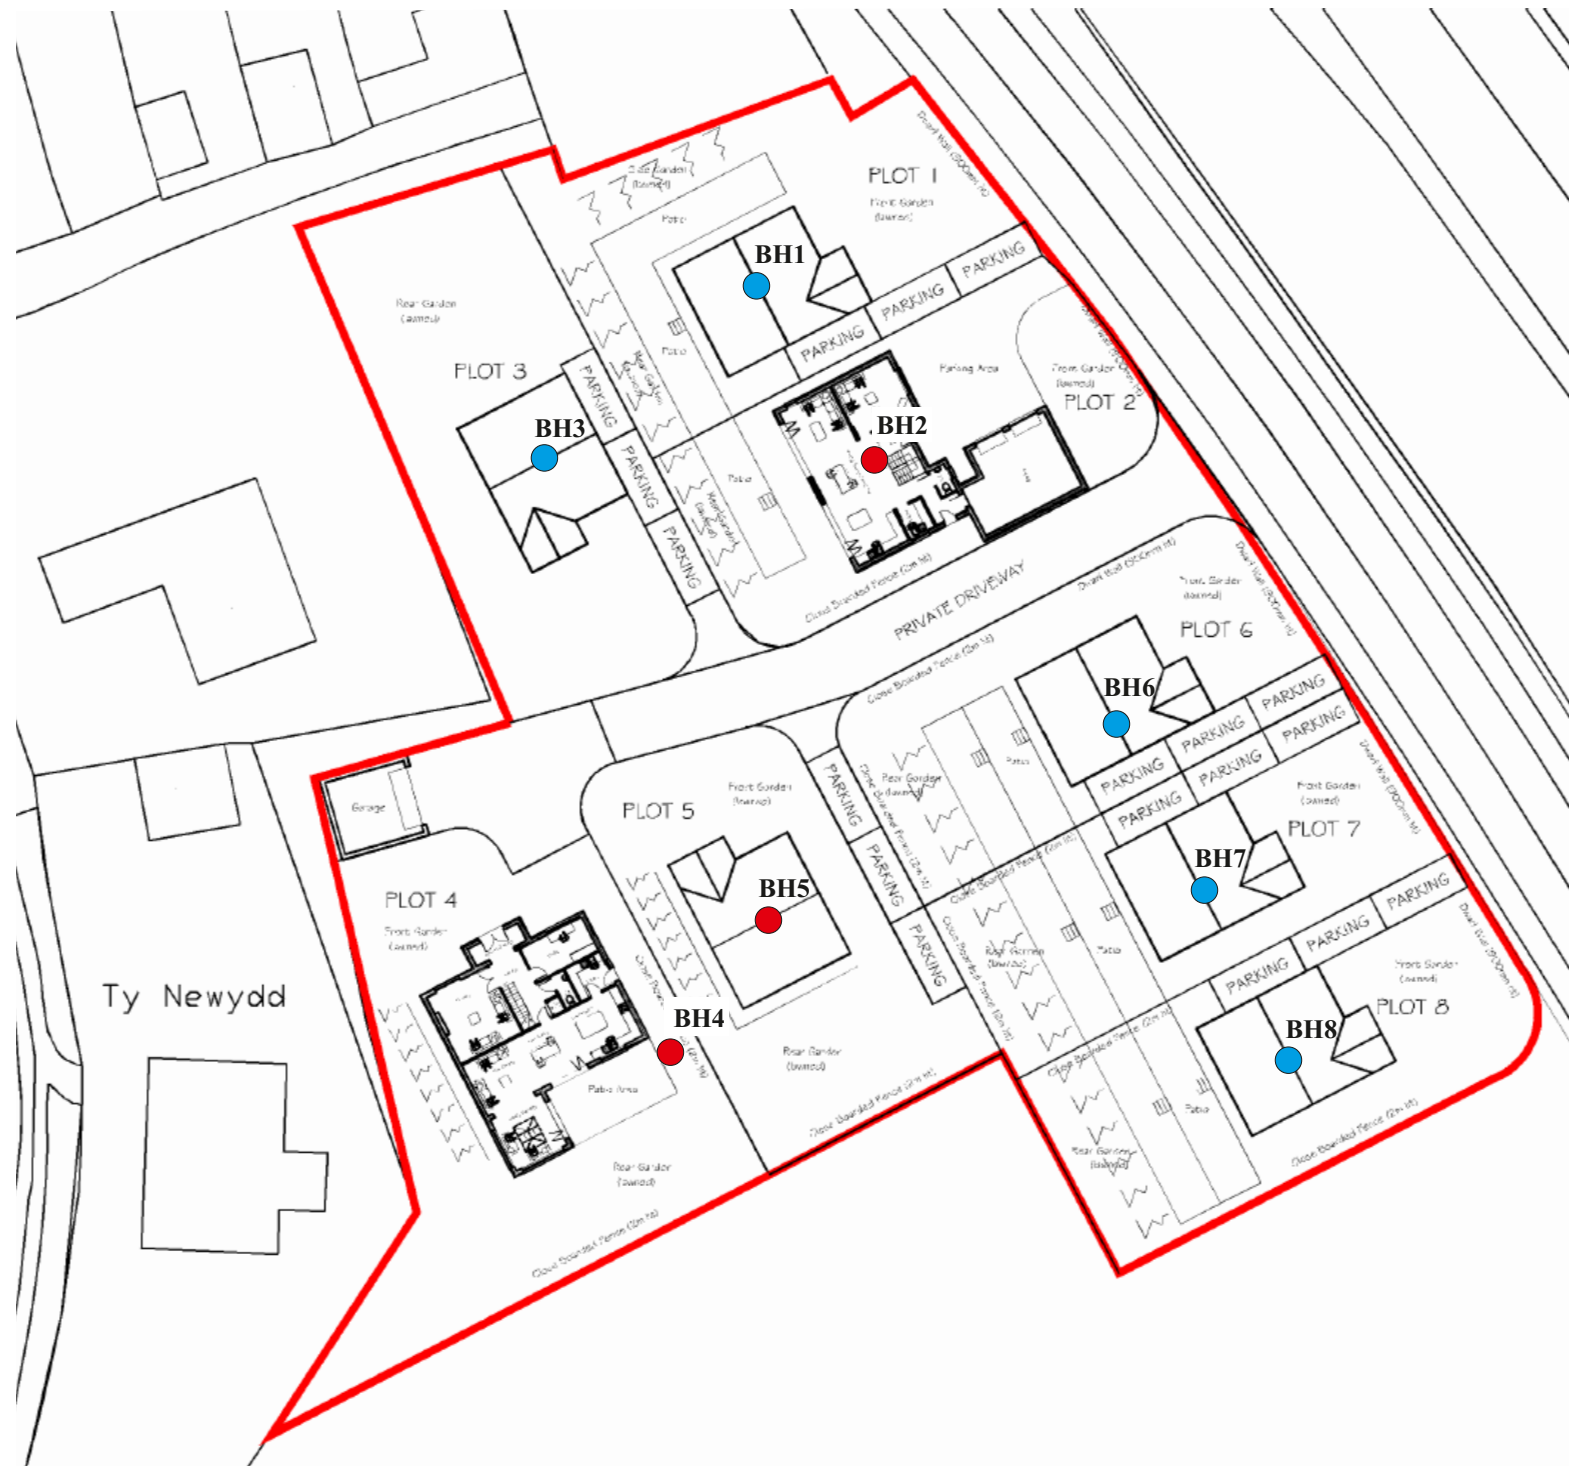
Drawing No: BC/MB/11.20.04.05.

The borehole positions are shown on the *Borehole Location Plan*, drawing no. BC/MB/11.20.04.05 and the graphic logs of the boreholes are contained at Appendix III.

The Garw Seam was encountered at depths to the top of the coal of between 28.0m and 28.5m, the thickness of the coal seam was found to vary between 0.2m and 0.8m. Old workings were encountered in the Seam in Borehole 4, they were found to be 1.0m thickness of soft drill taken to be backfilled old workings.

The old workings encountered in the two ironstone veins were variously found to be broken ground or soft drill (backfilled old workings). The range of thicknesses encountered, when compared to the thickness of overlying bedrock, generally resulted in a strata:void ratio that is less than 10:1. A 10:1 strata void ratio is generally accepted as the limiting ratio whereby old workings are unlikely to reach rockhead. The strata:void ratio for the old workings encountered in the Garw Seam is 13.8:1; the workings are considered to pose no risk to the development.

The boreholes encountered old workings in two ironstone veins and in the Garw Coal Seam. The old workings in the ironstone veins are generally at depths where they pose a risk of collapsing up to rockhead. Where old workings are present in both ironstone veins there is a risk of them interacting to increase the risk of a collapse to rockhead. The old workings in the Garw Seam are considered to pose a negligible risk of collapsing to rockhead.

It is recommended that as a minimum, where no old workings have been encountered on a given plot that a pattern of five boreholes is completed to confirm that no old workings are present beneath the footprint of the building. For buildings longer than 10m the number of boreholes should be increased to eight. If a borehole encounters old workings at the depths that pose a risk of them collapsing to the surface, then the borehole pattern should be modified to provide a grid suitable for the injection of grout to stabilise the old workings. For plots where the preliminary drilling has encountered old workings, the old workings underlying the plot should be stabilised by means of a drilling and grouting programme.

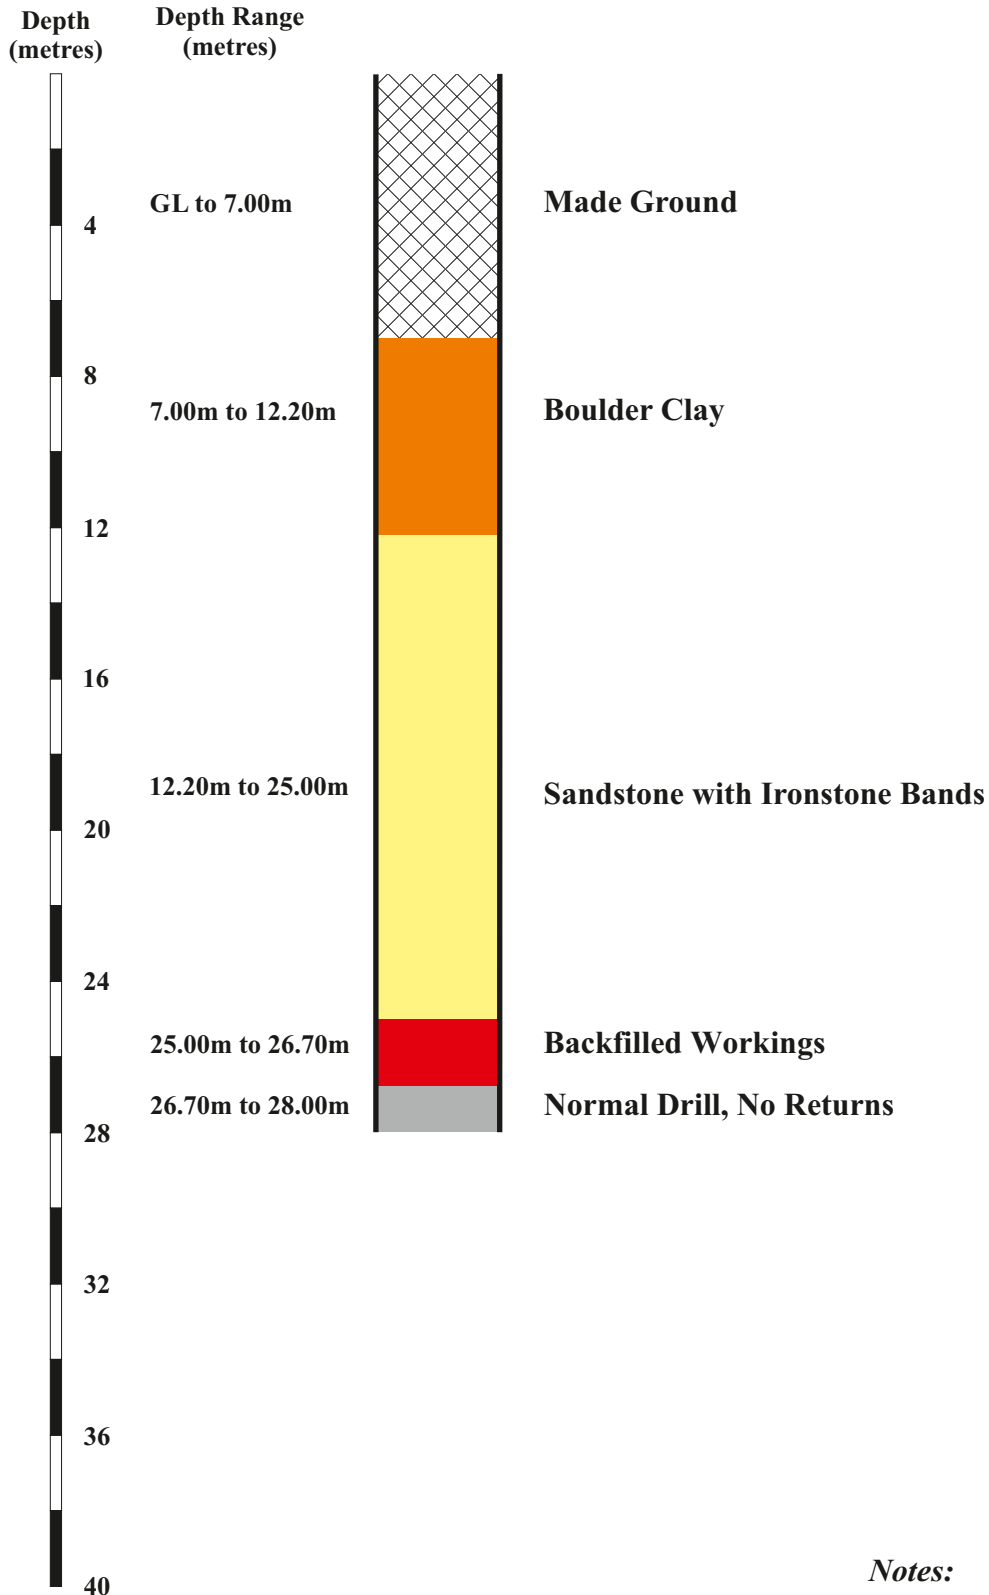
### *Borehole No. 2*

| Borehole Number | Made Ground Thickness | Glacial Till Thickness | Blue Ironstone | | | Big Blue Ironstone | | | Garw Seam |
|---|---|---|---|---|---|---|---|---|---|
| BH2 | 7.0 | 5.2 | - | - | - | 25.0 | 1.7 | 12.8 | - |

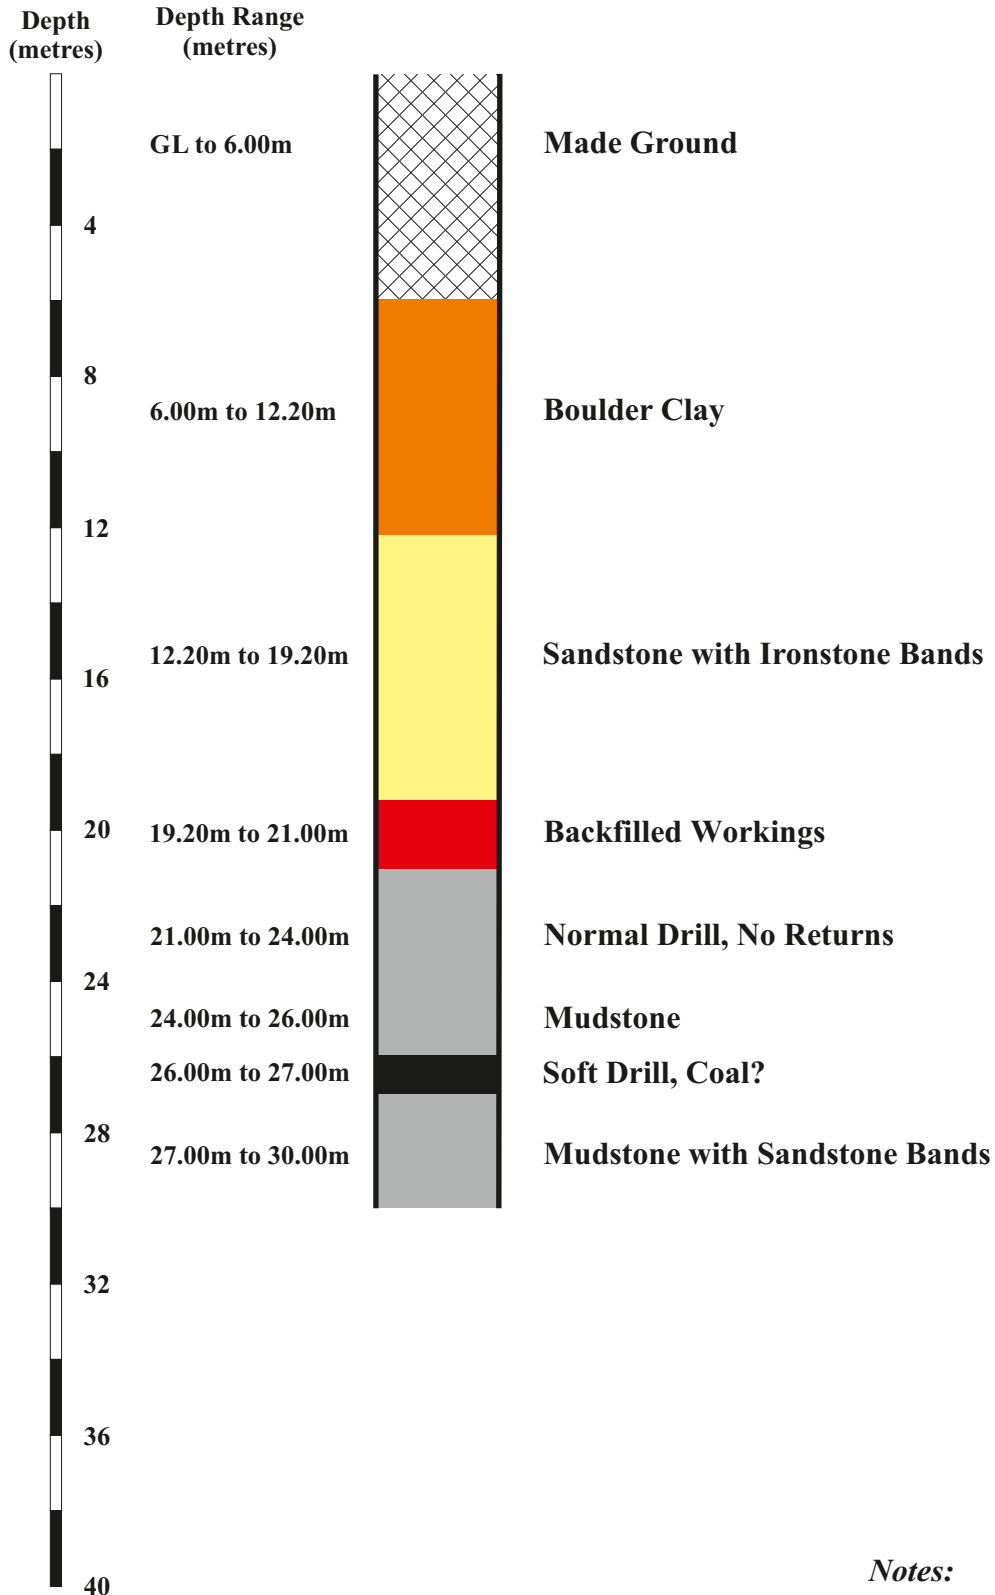
### *Borehole No. 4*

| Borehole Number | Made Ground Thickness | Glacial Till Thickness | Blue Ironstone | | | Big Blue Ironstone | | | Garw Seam |
|---|---|---|---|---|---|---|---|---|---|
| BH4 | 6.0 | 6.2 | 19.2 | 1.8 | 7.0 | - | - | - | 1.00 |

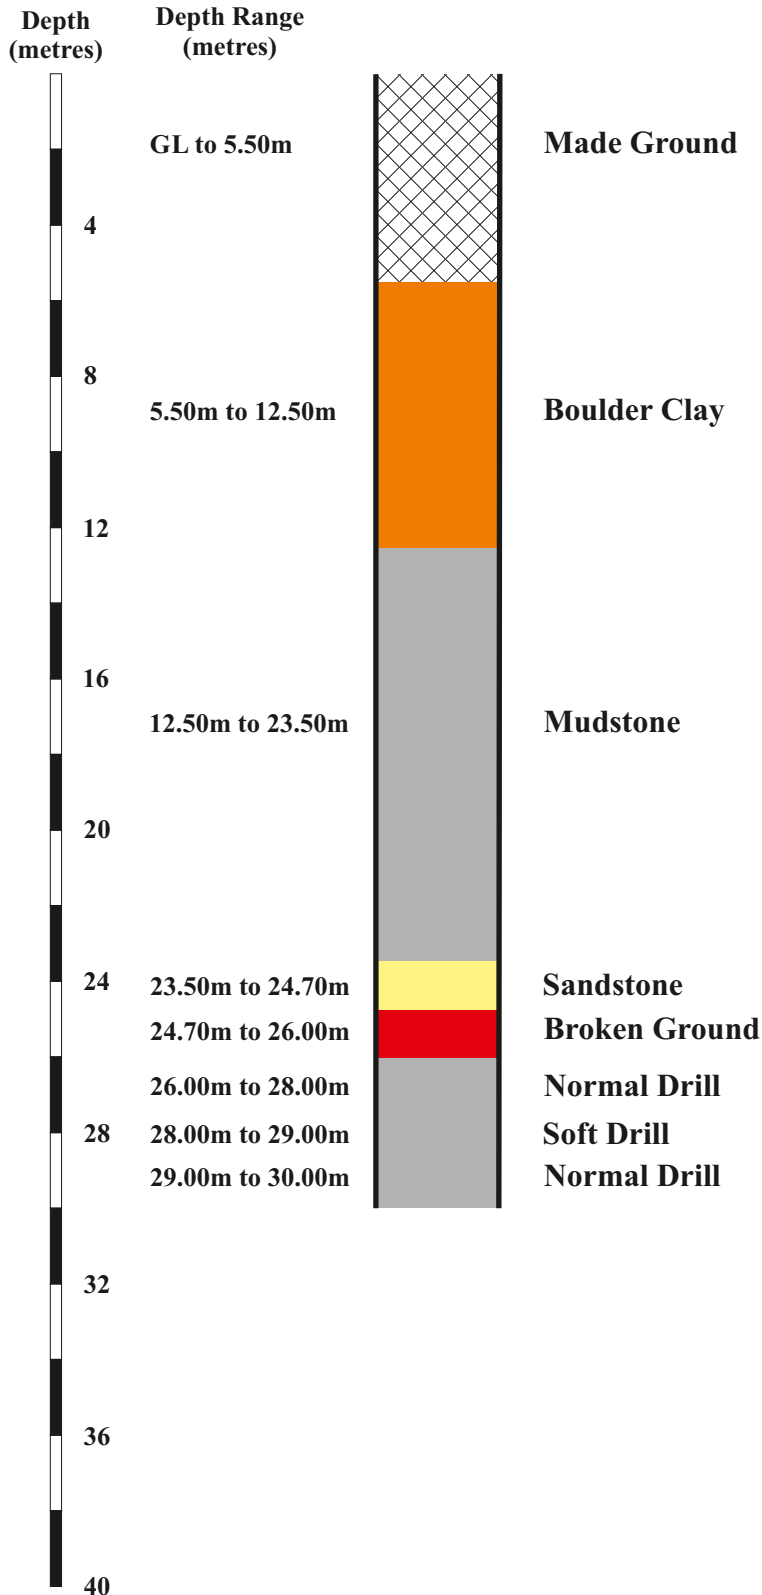
### *Borehole No. 5*

| Borehole Number | Made Ground Thickness | Glacial Till Thickness | Blue Ironstone | | | Big Blue Ironstone | | | Garw Seam |
|---|---|---|---|---|---|---|---|---|---|
| BH5 | 5.5 | 7.0 | - | - | - | 24.7 | 1.3 | 12.2 | 1.00 |
