**Goitre Coed Fach Farm, Goitre Coed Road, TREHARRIS, CF46 5BB**

**Agricultural Barn**

**Structural Inspection Report**

## **Steve Morgan Associates**

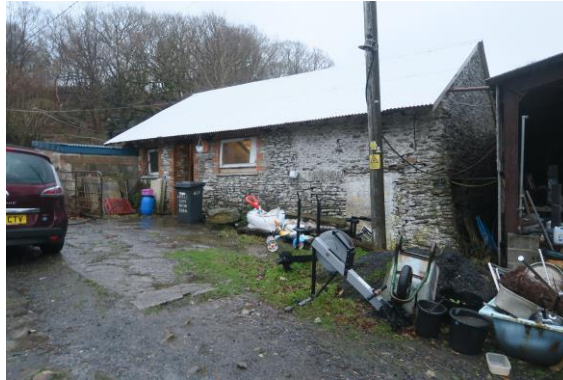
EAST ELEVATION: NOTE BRICK SURROUND TO OPENINGS AND  
INFILLED OPENINGS AT SOUTH END:

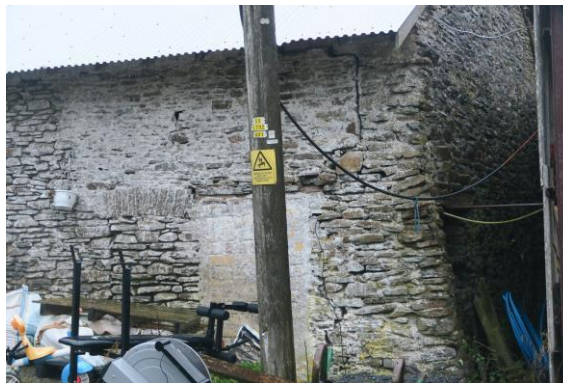
EAST ELEVATION / SOUTH END: NOTE INFILLED OPENINGS AND CRACK IN UPPER  
SECTION – SIDES OF OPENING TO BE BONDED TO INFILL AND CRACK TO BE  
REPAIRED BY INTRODUCING STONES BETWEEN WALL EACH SIDE:

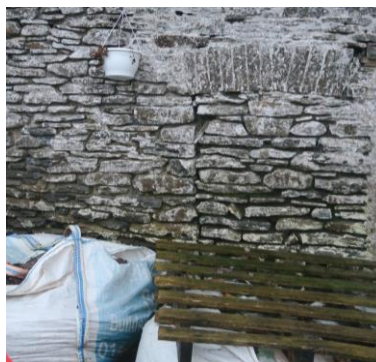
EAST ELEVATION / SOUTH END: NOTE INFILLED OPENINGS WITH STRAIGHT JOINT  
– SIDES OF OPENING TO BE BONDED TO INFILL:

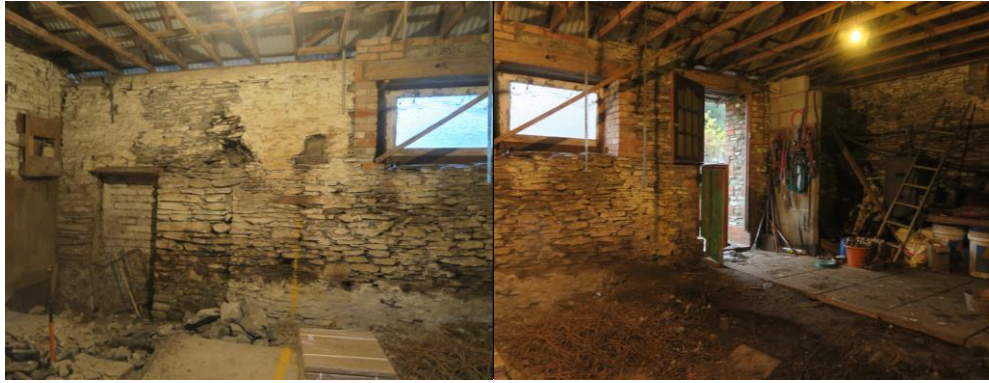
**EAST ELEVATION INTERNAL: NOTE INFILLED OPENINGS WITH STRAIGHT JOINT AND STRAIGHT JOINT AT CORNER – SIDES OF OPENING TO BE BONDED TO INFILL AND CORNER MECHANICALLY TIED USING RESIN / SOCK ANCHORS:**

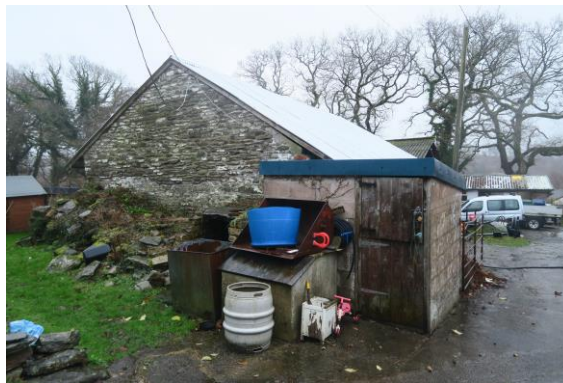
**NORTH ELEVATION: NOTE RUBBLE AGAINST WALL AND PALER BAND OF STONE – STRUCTURE AT CORNER TO BE REMOVED:**

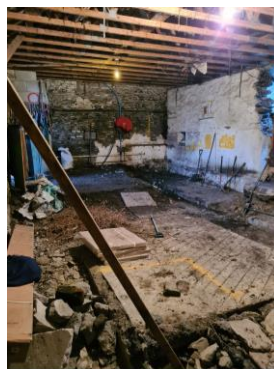
**NORTH ELEVATION INTERNAL: NOTE POSSIBLE FIREPLACE WITH STRAIGHT JOINT AT CORNER - CORNER MECHANICALLY TIED USING RESIN / SOCK ANCHORS:**

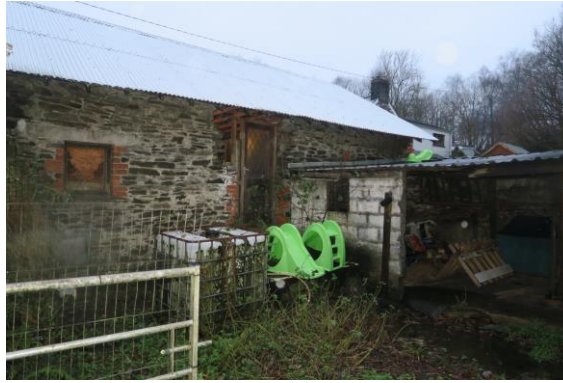
**PART OF EAST ELEVATION WITH LOWER (CATTLE) BARN:**

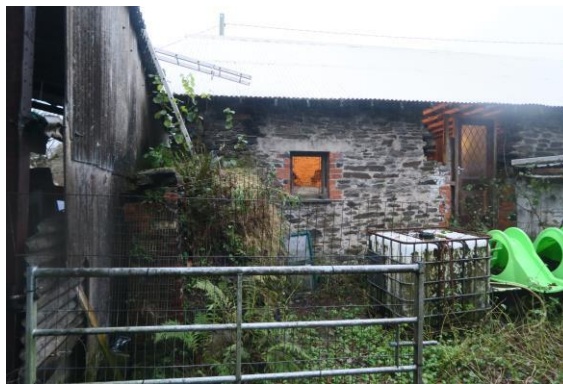
**PART OF EAST ELEVATION: NOTE WALL TO SIDES OF DOOR – DOOR JAMBS TO BE REBUILT AND BONDED INTO EXISTING:**

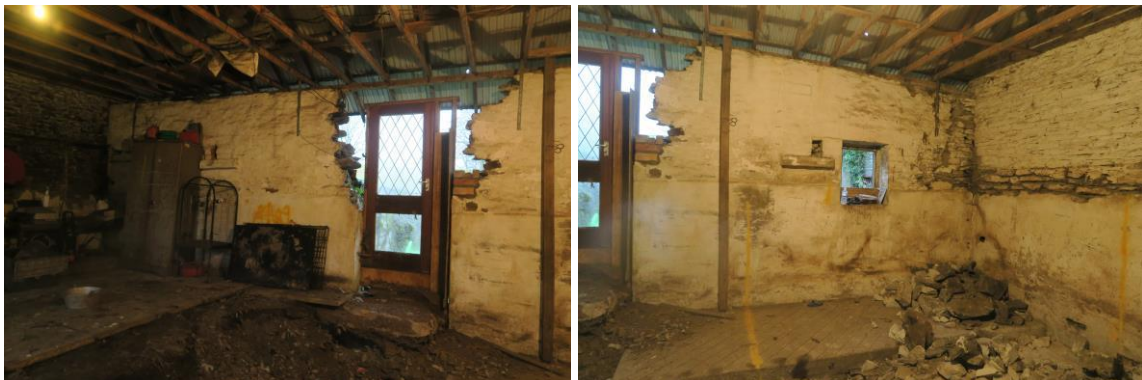
**EAST ELEVATION - INTERNAL: NOTE WALL TO SIDES OF DOOR AND LEVEL DIFFERENCES – DOOR JAMBS TO BE REBUILT AND BONDED INTO EXISTING:**

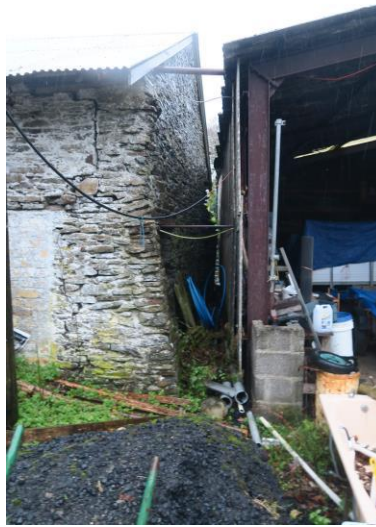
**VIEW ALONG SOUTH ELEVATION: NOTE POSSIBLE  
FORMER WALL EXTENSION AT CORNER:**

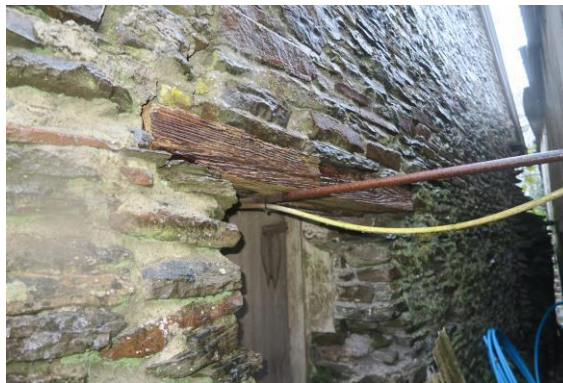
**VIEW ALONG SOUTH ELEVATION: NOTE OPENING AT WEST SIDE – SECTION BOARDED  
OFF INSIDE – OPENING TO BE MADE NARROWER AND NEW WINDOW INSERTED,  
REBUILD JAMB TO ONE SIDE BONDED NEW TO EXISTING:**

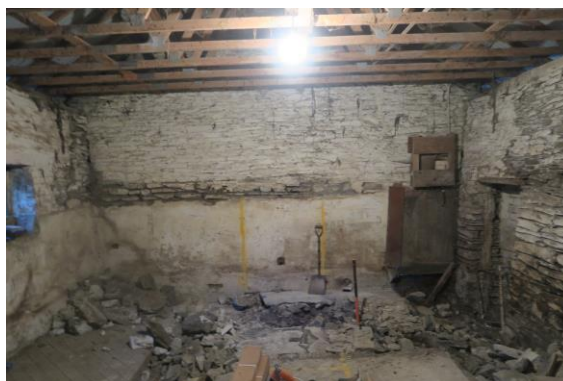
**SOUTH ELEVATION INTERNAL: NOTE BOARDED OVER OPENING AND WITH STRAIGHT  
JOINTS AT CORNERS– OPENING TO BE MADE NARROWER AND NEW WINDOW**

**INSERTED, REBUILD JAMB TO ONE SIDE BONDED NEW TO EXISTING – STRAIGHT  
JOINTED TO BE MECHANICALLY TIED:**

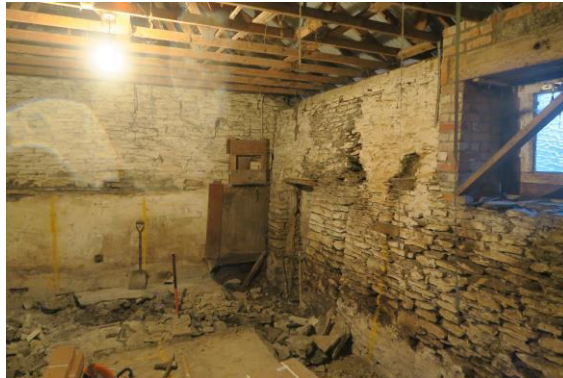
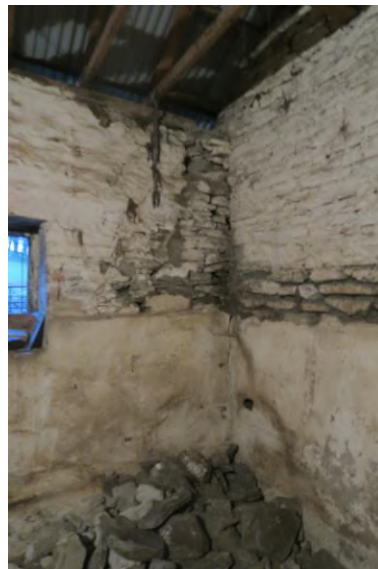
**SOUTH ELEVATION INTERNAL - DETAILS: NOTE BOARDED OVER OPENING AND WITH  
STRAIGHT JOINTS AT CORNERS – REFER TO NOTES ABOVE RE WINDOW AND JOINTS:**

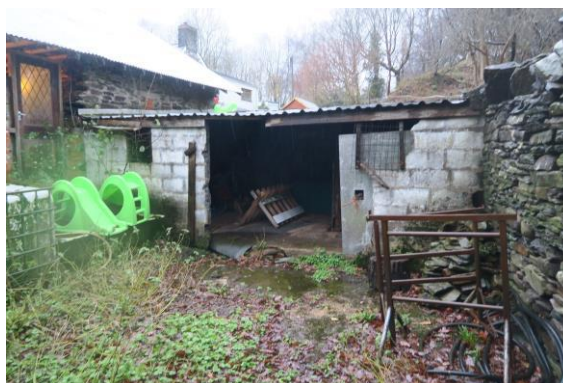
**LOW LEVEL (CATTLE) BARN – BLOCK WALL TO BE REPLACED GLAZING FOR THE MOST  
PART AND WHERE RETAINED OVERCLAD WITH INSULATED CLADDING:**
