RHONDDA  
GEOTECHNICAL  
SERVICES

# VALIDATION REPORT

LAND ADJACENT TO

SIX BELLS ESTATE

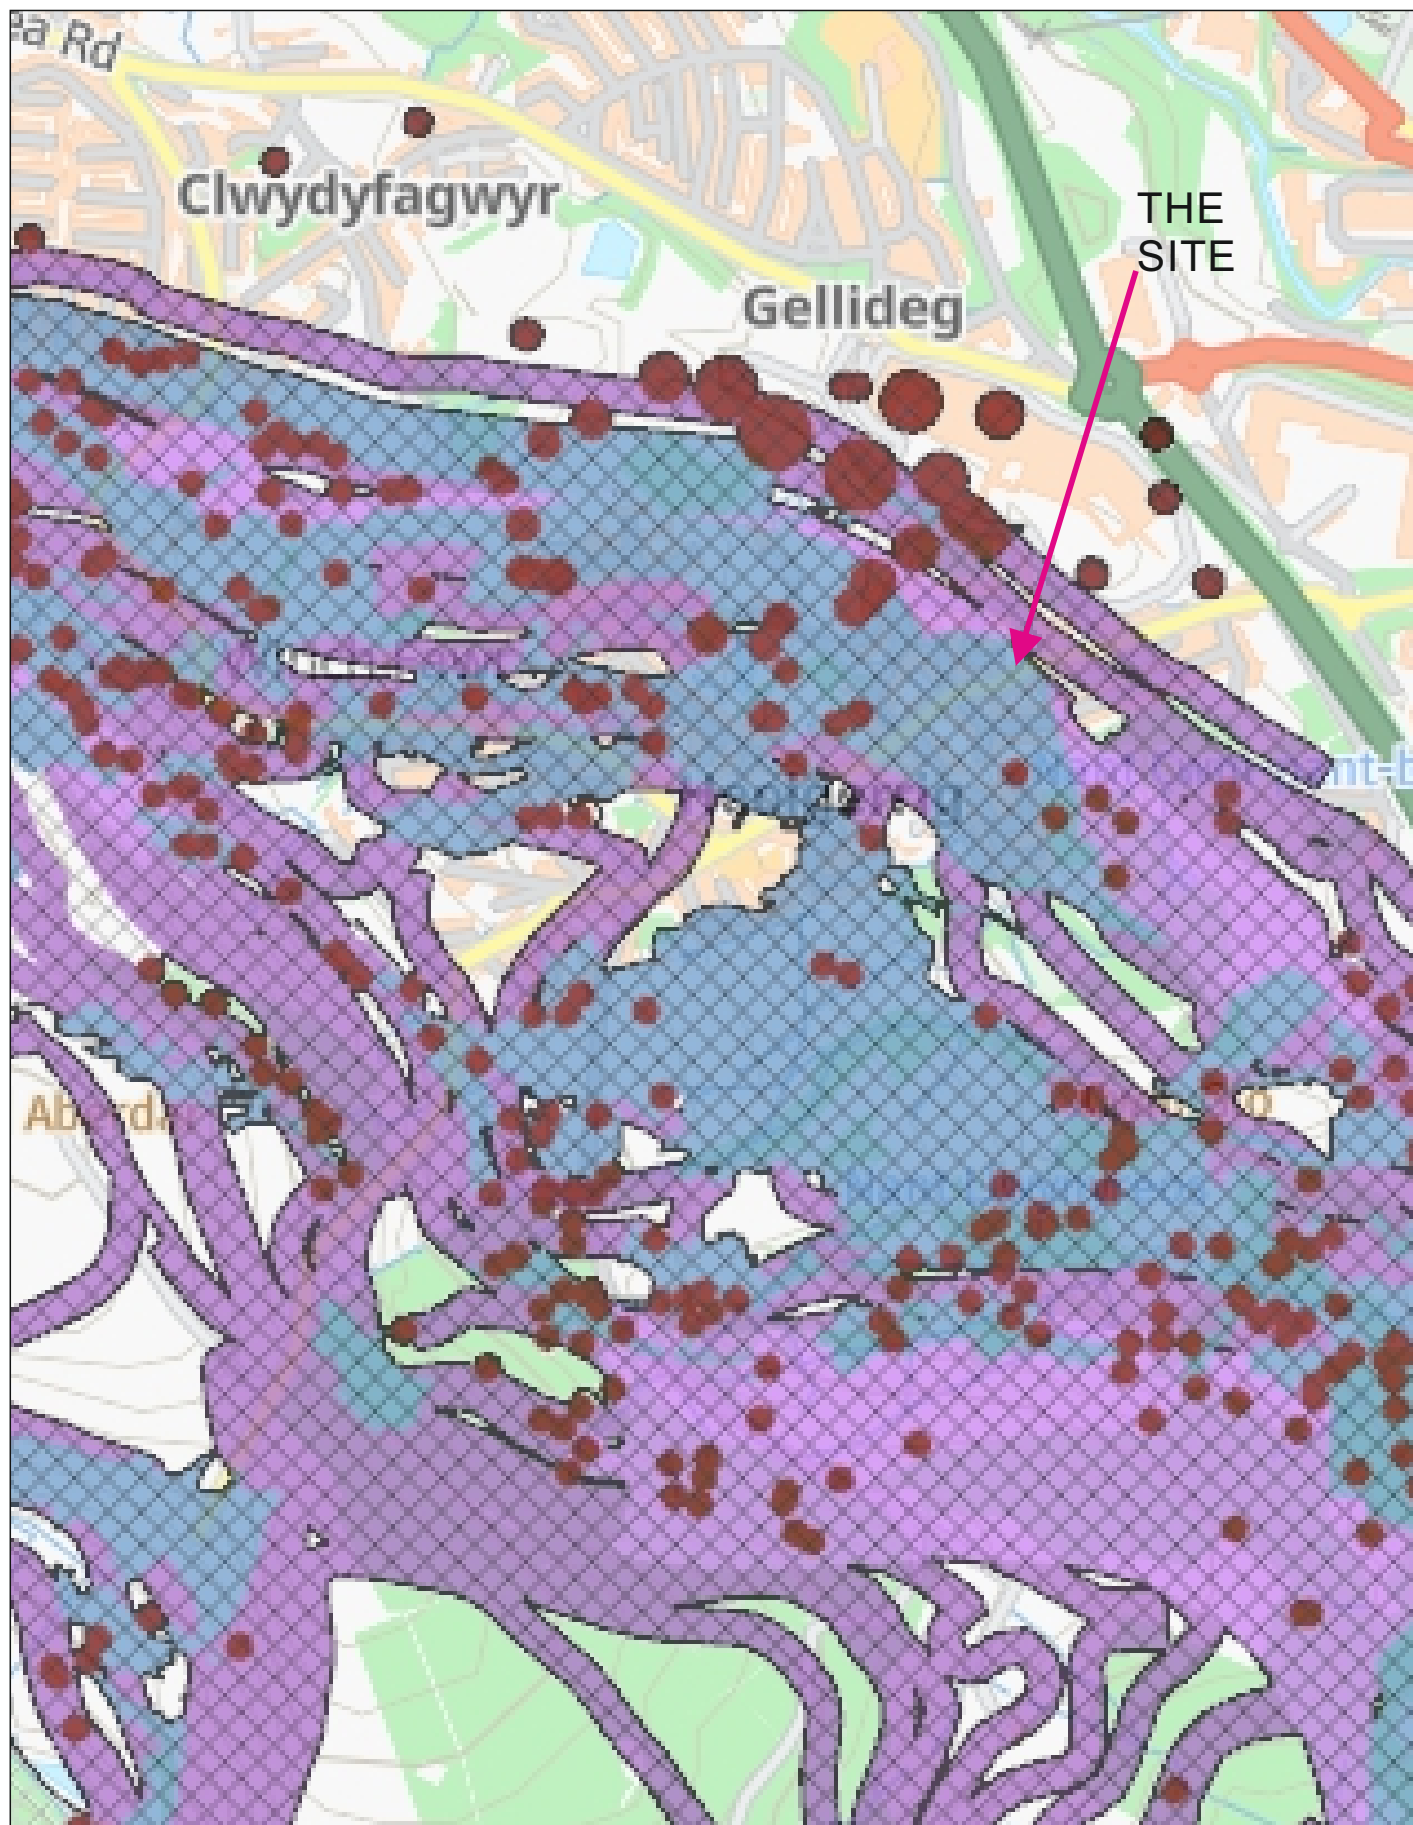
FIGURE 3  
THE EXTENT OF DEVELOPMENT HIGH RISK IN WEST MERTHYR.

Figure 3 is a section of the Coal Authority Interactive Viewer. The hatched areas are classed as Development High Risk by the C.A. The site position is shown. The different colours represent different reasons for the High-Risk classification. The purple areas are buffer zones above seam outcrops. Although hard to distinguish, there are lighter, violet areas. These cover areas of suspected unrecorded shallow mining. Much of the mining under Heolgerrig had ceased by the time the keeping of mine plans became a legal requirement. Nevertheless, commercial rivalry and mineral rights boundaries means there are extensive mine plans from the early nineteenth century still extant. The blue represents areas of recorded shallow mining. The site appears to lie within one of these. The Terra Firma C.M.R.A. used a CON29 as the starting point whereas a Consultants Report would have highlighted available mine plans beneath the site. A single mine plan was used to inform the report. This is purported to show workings in the vicinity of the site in 1827. These are in the Seven Foot Seam and the author considers this irrelevant (see below).

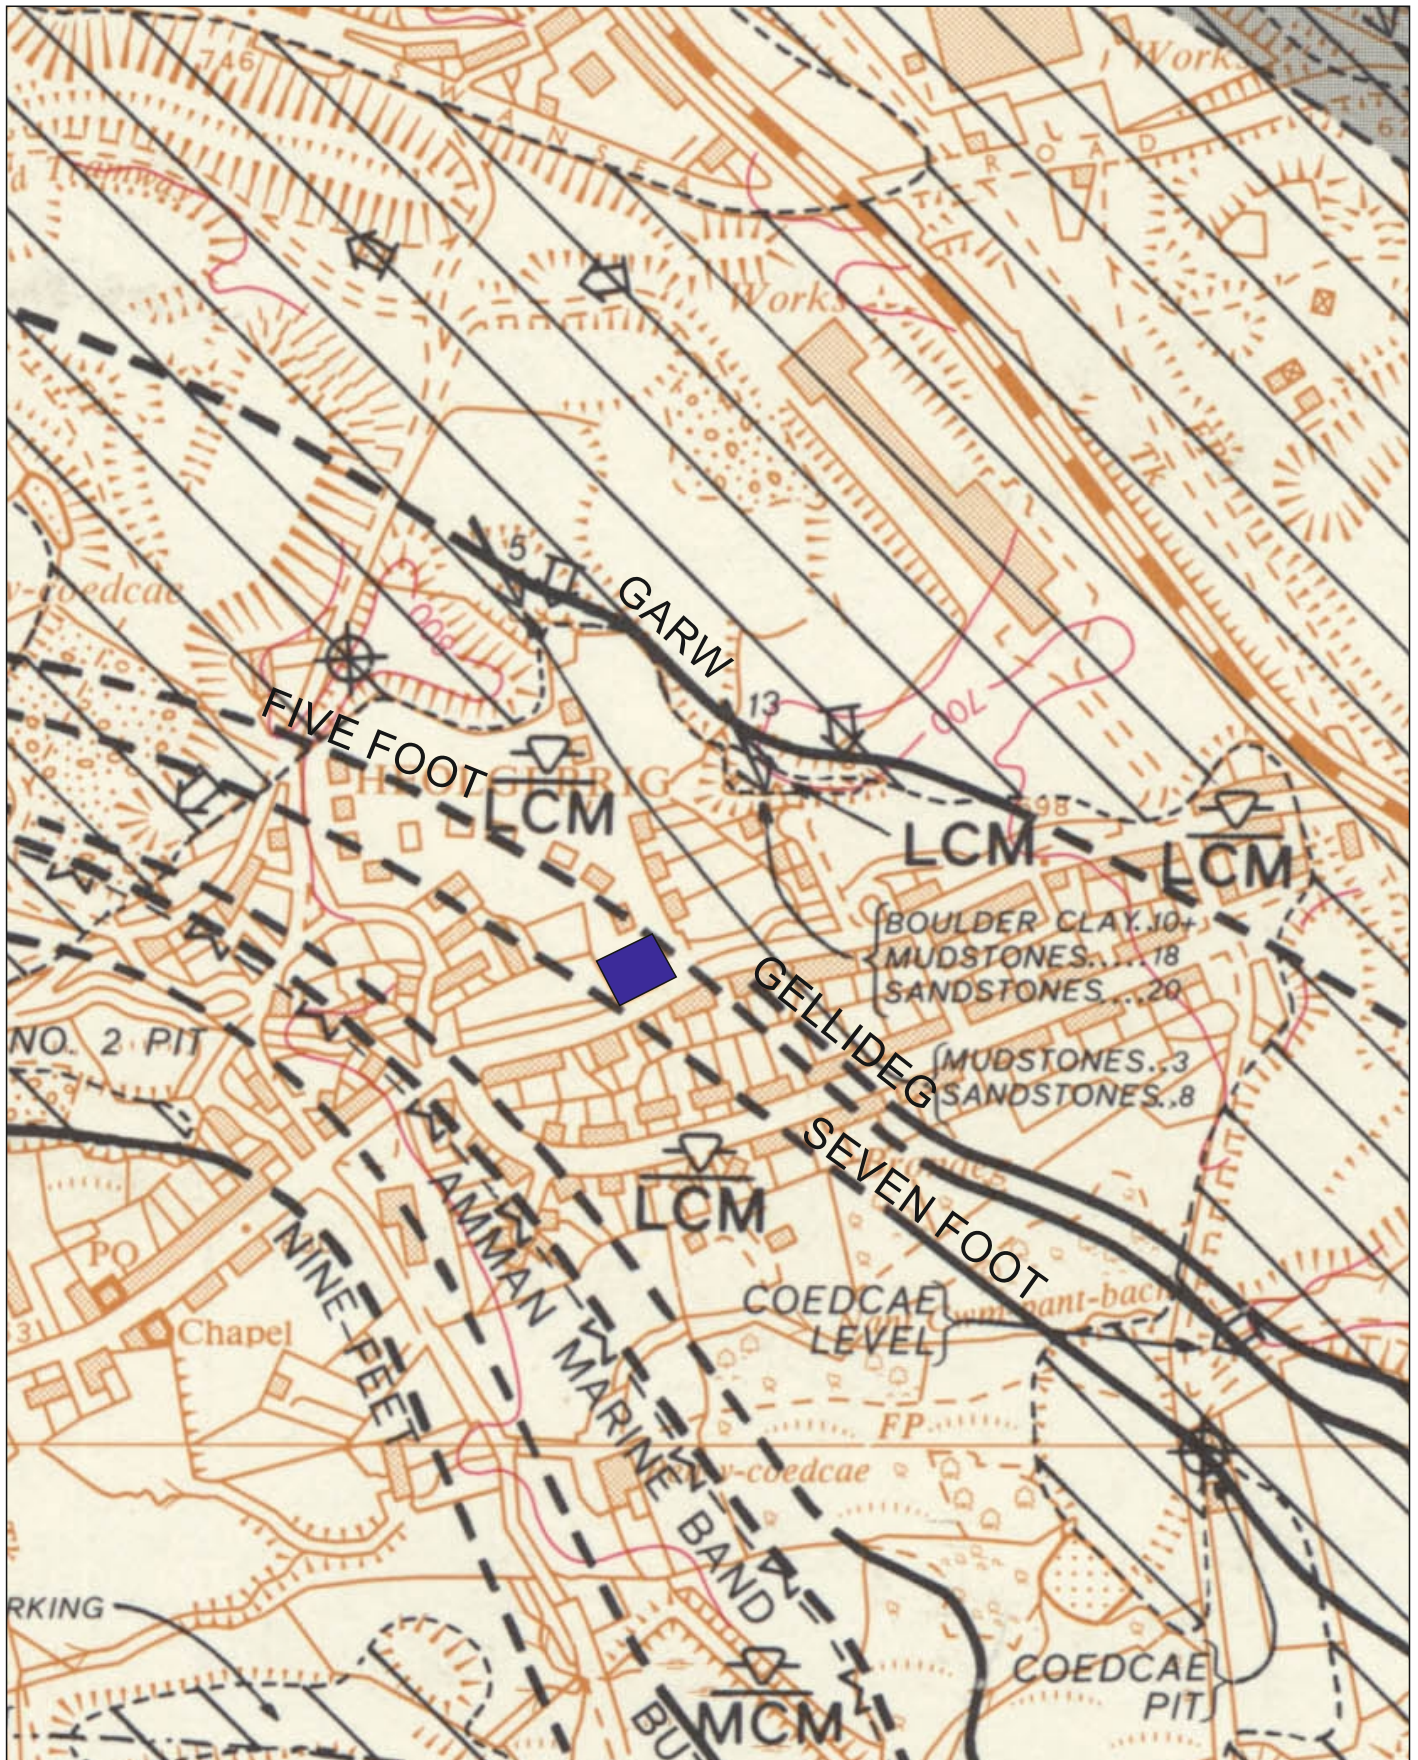
FIGURE 4  
SECTION OF GEOLOGICAL SURVEY SHEET SO 00NW.  
THE SITE IS HIGHLIGHTED IN BLUE.

Figure 4 is a section of Geological Survey Sheet SO 00NW. The site has been highlighted in blue. L.C.M. stands for Lower Coal Measures. The seam outcrops have been annotated by the author. The outcrop of the Garw Seam is shown north of the site. This is the lowest workable coal seam in the South Wales Coalfield although in the Merthyr area there is intensive mining of the Rosser Veins beneath the Garw. These are a group of 3-5 Ironstone Veins. The broad arrow symbols are levels (sub-horizontal mine entrances) driven on the outcrop. The thin arrow symbols are measured dips of  $5^{\circ}$  and  $13^{\circ}$  both to the southeast, i.e. toward the site. The contour lines are complicated by the extensive spoil heaps and made ground. As a generalisation the hillside is rising to the southwest. The combination of dip and topography means that any workings in the Garw would probably be at a “safe” depth of 30m+ although this would need to be confirmed. The C.M.R.A. concluded that the site was underlain by the Five Foot and Gellideg Seams at shallow depth with the Seven Foot outcropping across the site. It is difficult to disagree with the conclusion regarding the Five Foot and Gellideg. The outcrop of the Gellideg is truncated just before the site. The Survey Memoirs record the Gellideg as the lowest of three closely spaced coals, with the upper two forming the Five Foot. All three are often combined as one seam formerly known in Merthyr as the Lower Four Foot. The truncation of the Gellideg outcrop merely means the Survey were unclear how close together the seams were beneath the site, probably due to lack of mining records. Southeast of the site the Coedcae Level is shown driven on the Five Foot outcrop. The Seven Foot outcrop appears not to cross the site, but to be slightly above it stratigraphically and topographically. There is a level shown driven on

the Seven Foot outcrop northwest of the site. The methods used by the Survey to mark outcrops are varied. One of them is projecting seams to the surface from underground records. This method takes no account of superficial deposits or Made Ground. Both are believed to be present at the site. The subcrop of the seam is likely to be slightly further south than shown because of glacial erosion/deposits and is considered unlikely by the author to be encountered below the site as stated in the C.M.R.A.

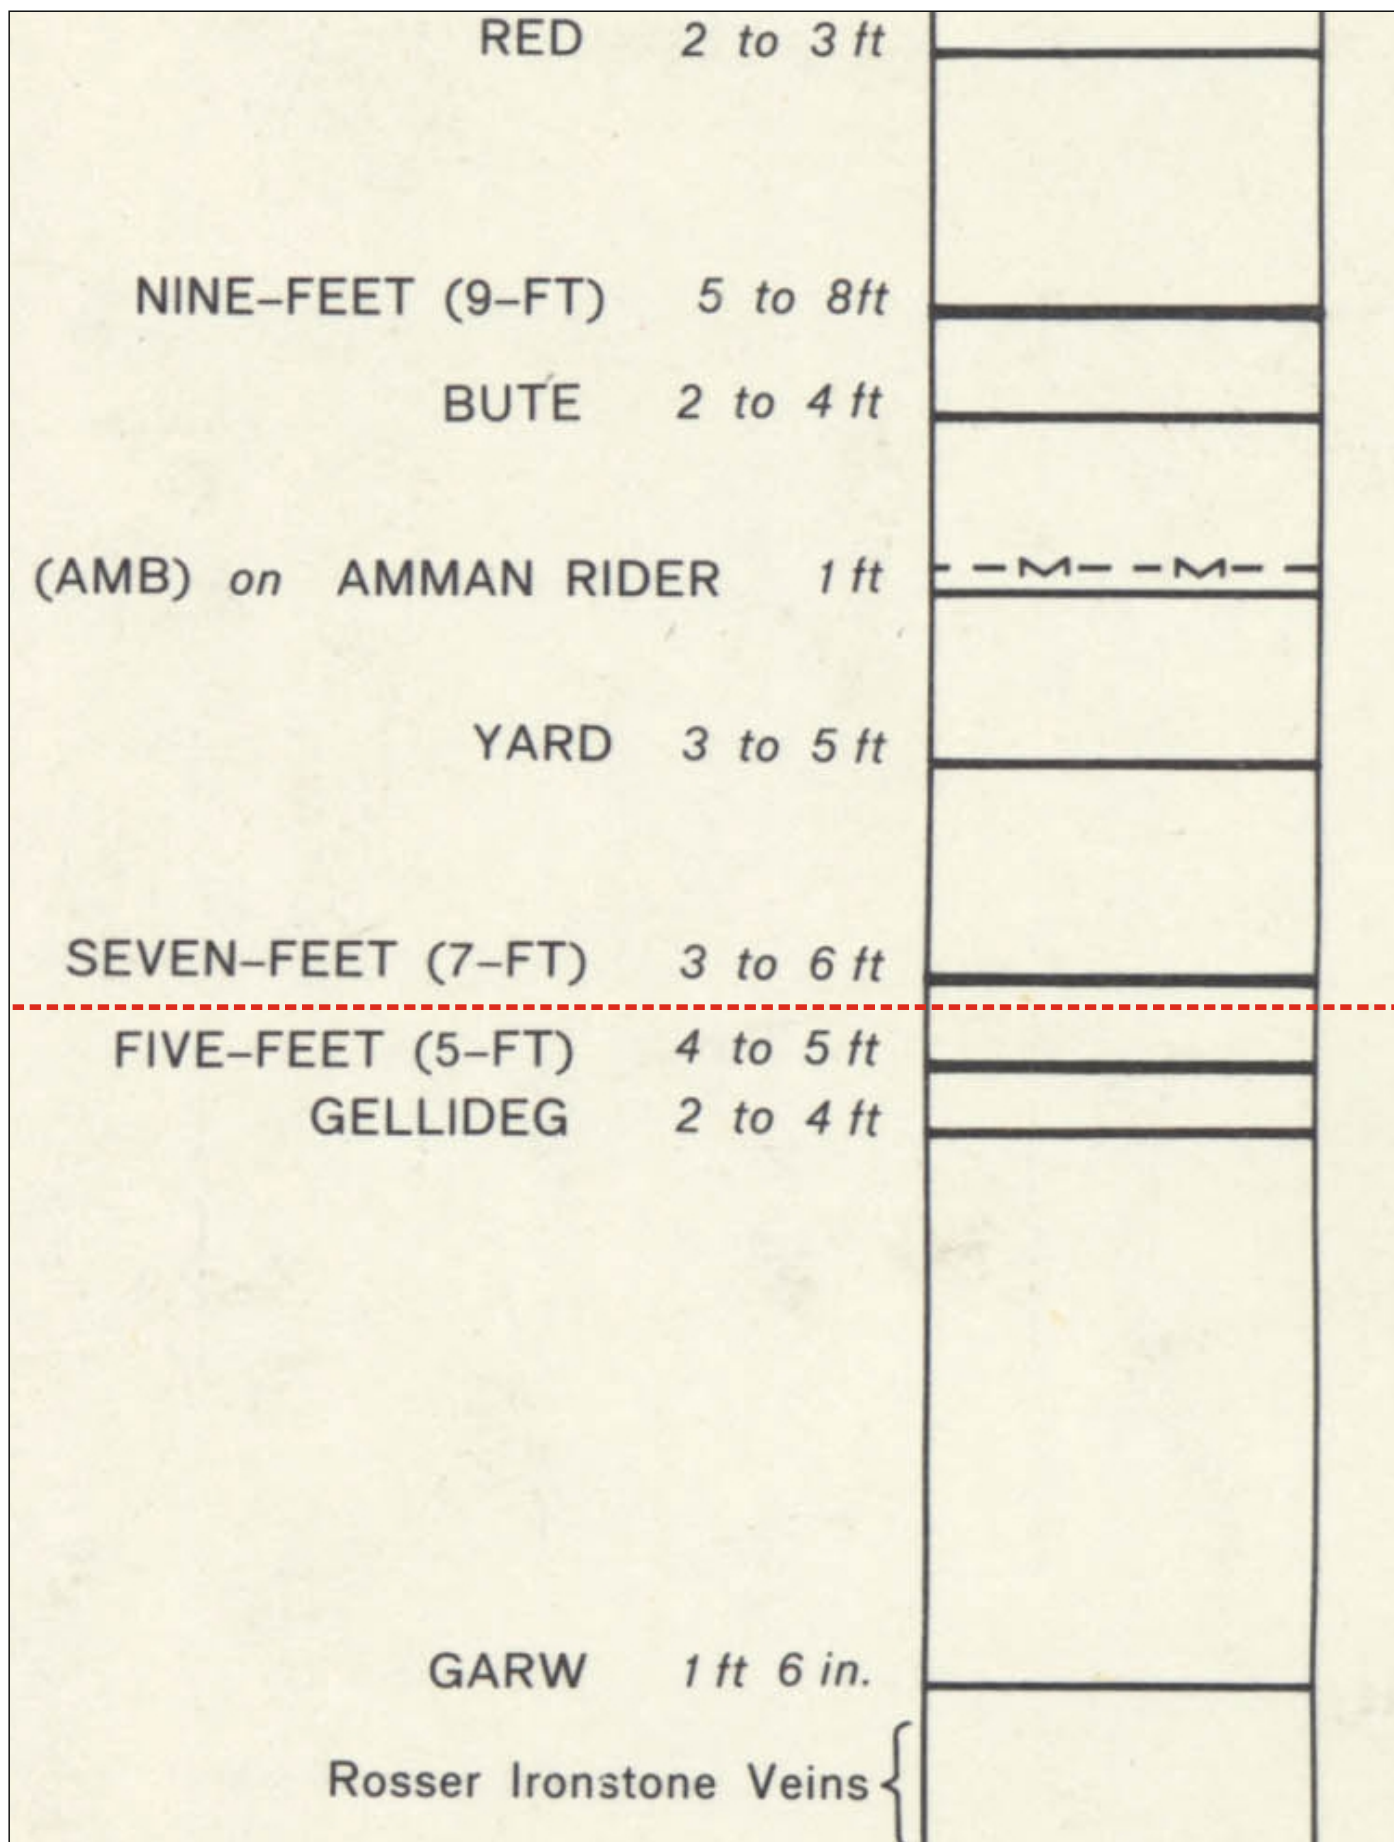
FIGURE 5  
SECTION OF THE STRATIGRAPHIC COLUMN FROM SO 00NW.  
THE APPROXIMATE SITE LEVEL IS MARKED IN RED.

A section of the stratigraphic column from the map is shown in Figure 5 with the approximate site level marked. The site is underlain by the Five Foot and Gellideg (or a combined seam) at shallow depth. These are not known to be worked beneath the site. The Garw seam is known to be possibly worked beneath the site but is thought to be at a safe depth. This would mean workings in the Rosser Veins would also be at a safe depth. Not marked in Figure 5 are multiple Ironstone Veins above the Garw Seam. These include (in ascending order) the Lumpy, Blue, Red Yellow and Spotted Veins. Any of these veins could possibly be worked beneath the site. For the purposes of the intrusive investigation, unrecorded workings in all the above-mentioned horizons could possibly pose a threat to ground stability at the site. This means that although the risk from recorded workings in the Seven Foot are not considered a threat by the author, it is agreed that an intrusive investigation as recommended by the C.M.R.A. is entirely merited due to the wealth of mineable minerals beneath the site.

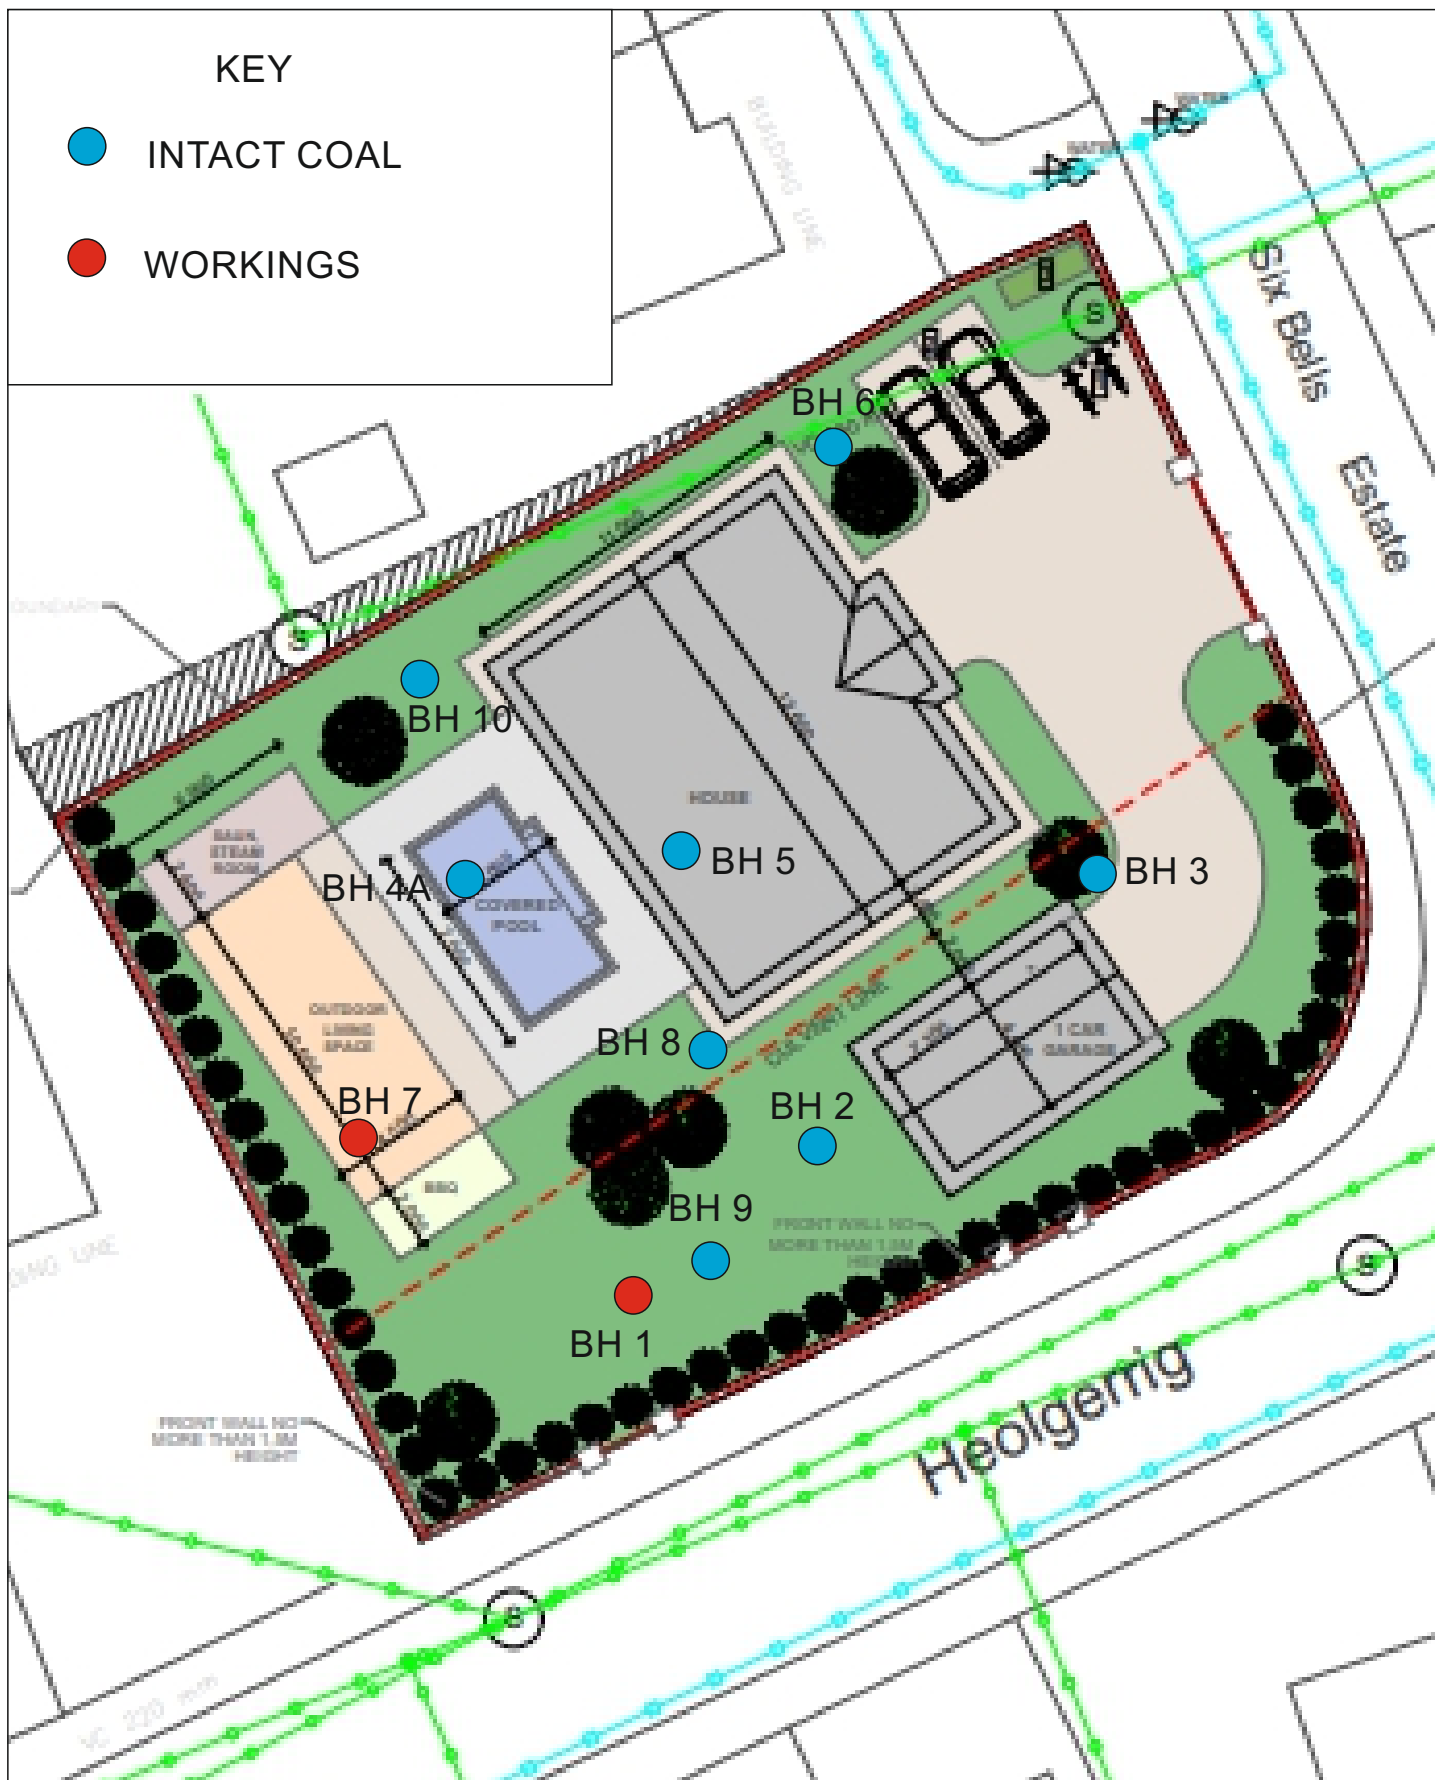
**FIGURE 7**  
BOREHOLE POSITIONS AS DRILLED AT SIX BELLS  
SUPERIMPOSED ON THE PROPOSED DEVELOPMENT..

Between the time the author was engaged to start the permit application process and the actual site investigation, the nature and design of the proposed development was drastically changed. This was nothing to do with potential shallow mining but was a combination of M.T.C.B.C. comments on building lines and highway access. Figure 6 shows the borehole location plan that accompanied the permit application. The original development footprint is shown. A combination of the new footprint, the culvert position and geological conditions encountered meant that Figure 7 is the borehole plan as drilled, superimposed on the new design.

were in the southwest corner of the site, away from the proposed building footprint. It was now important to delineate the extent of any workings. BHs 3 and 6 had not proved the Garw Seam in positions where it would have been at its shallowest. Therefore, the decision was taken to cut borehole lengths down to 20m on the basis that the Five Foot and Gellideg could be checked for workings, with anything below being too deep to affect ground stability at the site. BHs 8-10 all proved both seams to be intact. BH9 was only 2.5m from BH1.

There is no risk to ground stability at the site due to mining legacy issues. No remediation is required, neither are specialist foundations. Foundation design will be entirely dependent on shallow ground conditions. Standard strip footings can be used if the soils at the site have sufficient bearing capacity. This will need to be checked on site and is outside the remit of this report.
