**R 148 Roof Plan- Terracotta Supply**

| NO | DATE | REVISION |
|---|---|---|
| YMCA, Merthyr Tydfil | | |
| Roof Plan - Terracotta Supply | | |
| 3510_R_148 | | |

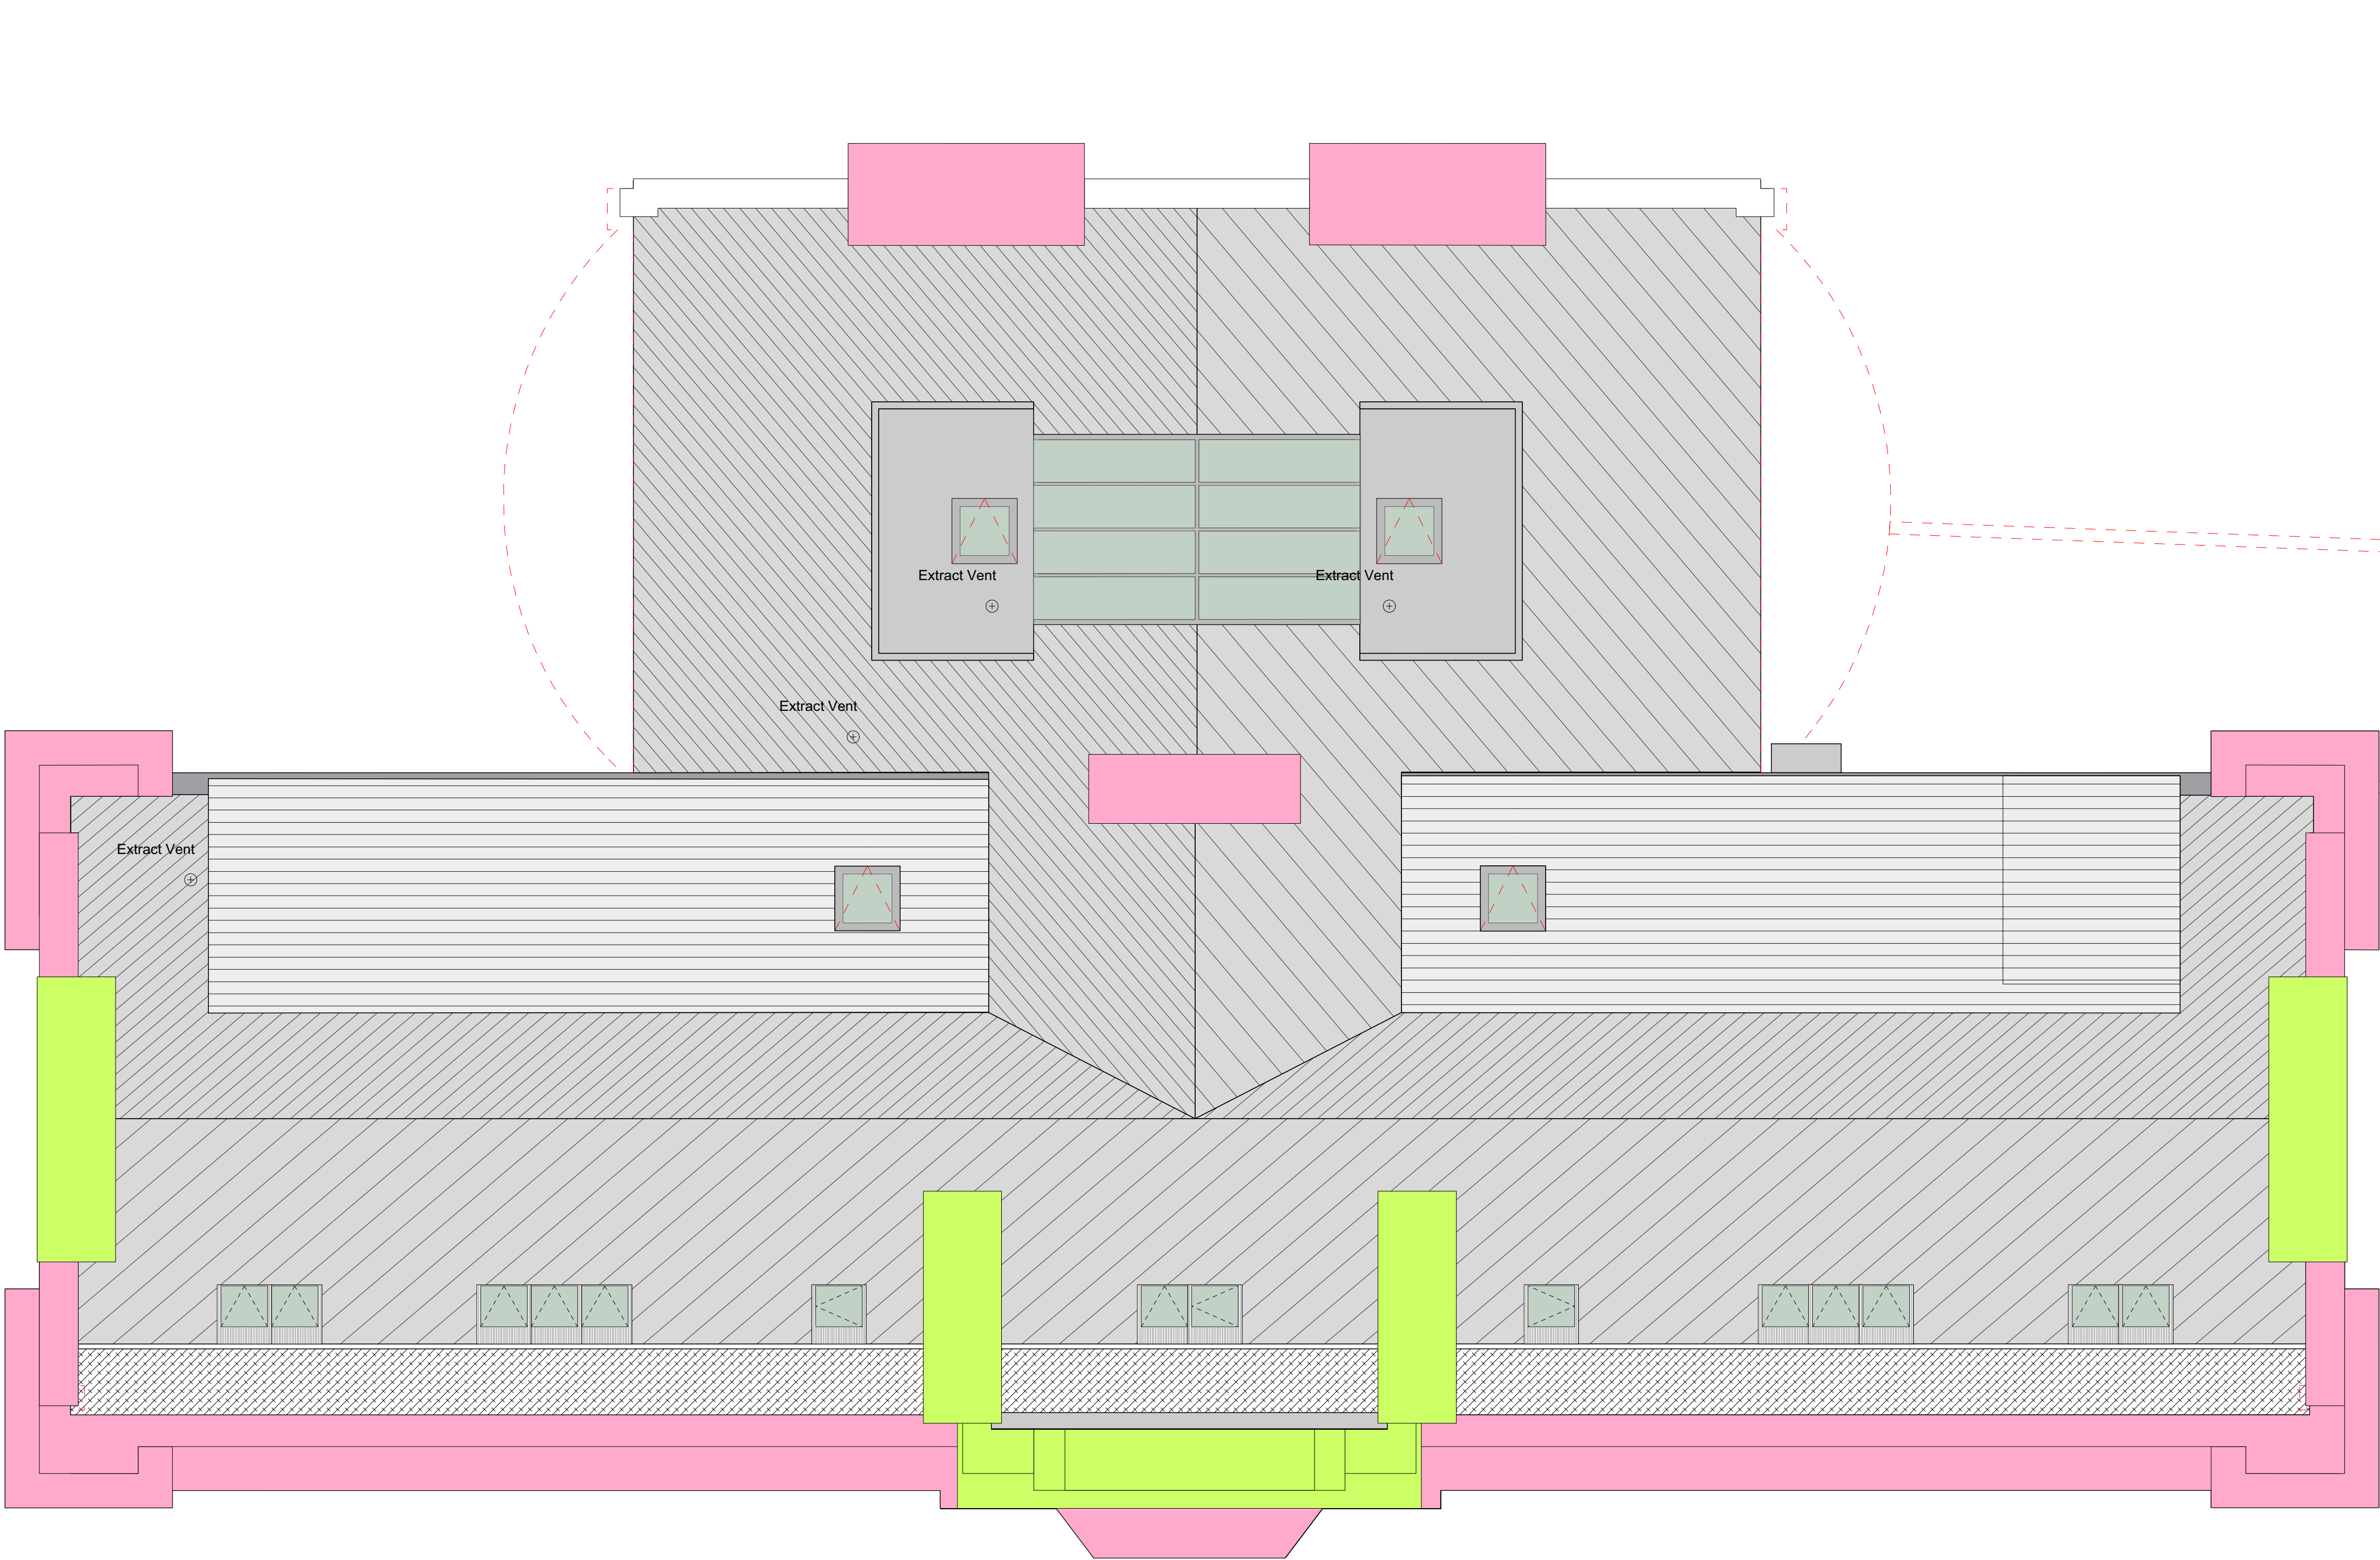
- Defective terracotta unit** - Allow for careful removal/ of existing terracotta and replacement with new as specification section C41.
- Missing terracotta units** - Allow for careful removal of any remains of existing terracotta unit and replacement with new as specification section C41. (Units may be found on site).
- Partially Damaged terracotta unit** - To be repaired where possible. Allow for careful removal of damaged units, repair and reinstatement, supplemented with new as specification section C41.
- Proposed terracotta unit** - as specification section C41.
