*Report No. BC/MB/12.18.04.*

# **Mining Risk Assessment: Land at Blaendowlais, Dowlais Top, Merthyr Tydfil.**

***Land Adjacent to, 1a  
Blaen Dowlais,  
Dowlais, Merthyr  
Tydfil, CF48 3RB.***

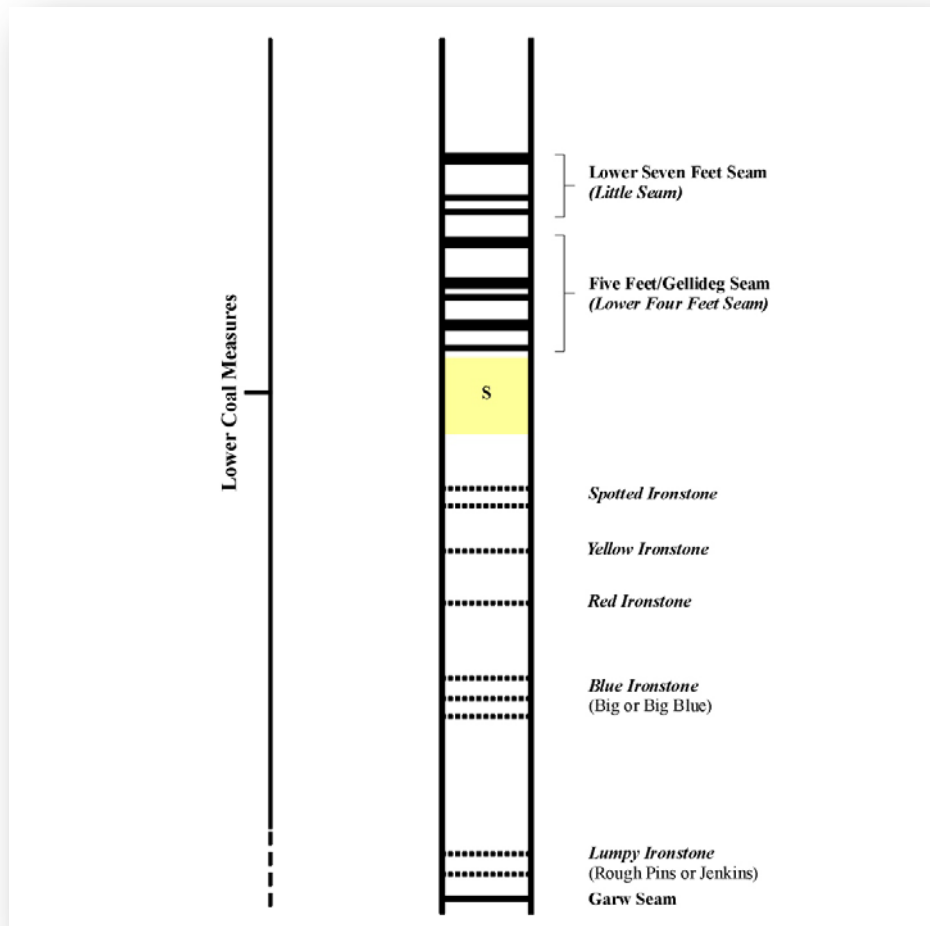
**Figure 1**  
**Part of the Stratigraphic Column.**  
 Scale: Not to Scale.

Beneath the Gellideg Seam in the geological sequence are a series of five ironstone veins, the Garw Coal Seam and then the Rosser Ironstones (see Figure 2, Part of the Stratigraphic Column); this group of measures underlie the Site at shallow depths.

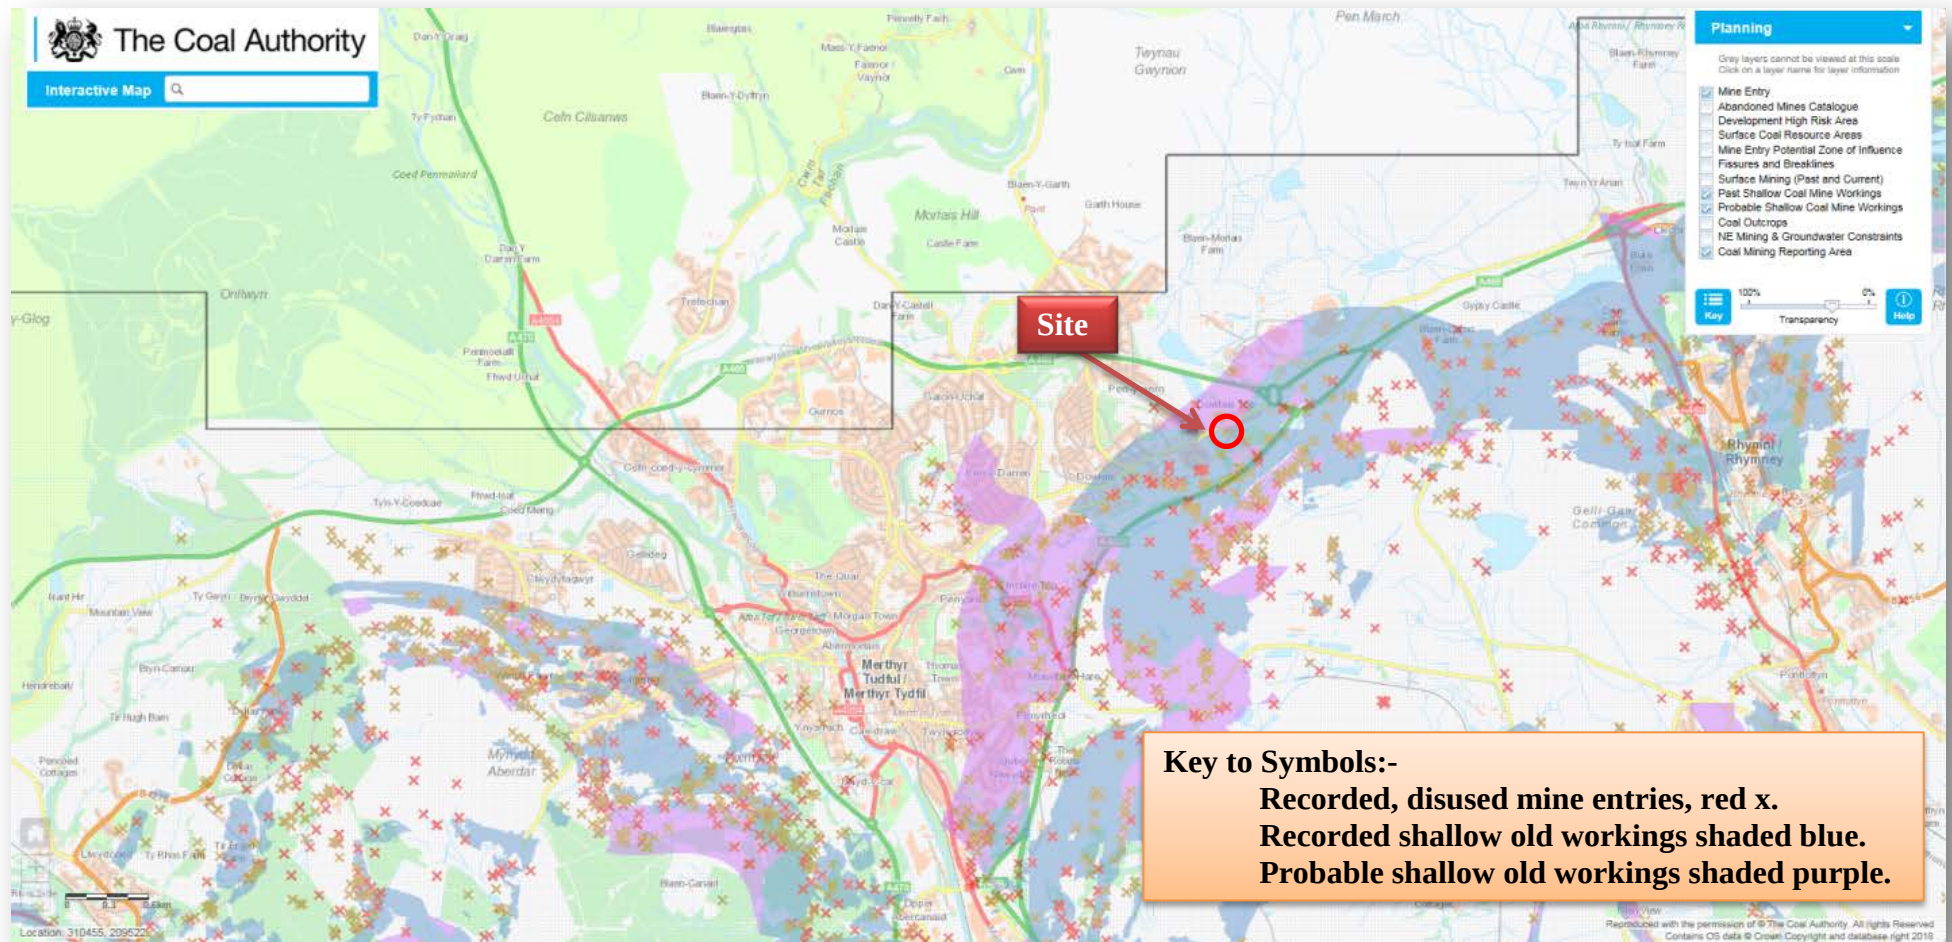
**Figure 3**  
**Print-out of The Coal Authority's Interactive Map**  
(Accessed 12<sup>th</sup> December 2018)

Our searches found no record of a disused shaft or adit within the confines of the Site, a situation confirmed by The Coal Authority *report no. 51001986507001*. The risk of unrecorded air shafts being present cannot be entirely discounted. The Site has not been part of an opencast coal site, and there have been no opencast mining operations close enough to the Site to affect the structural integrity of the proposed development. There are no operating collieries within influencing distance of the Site.

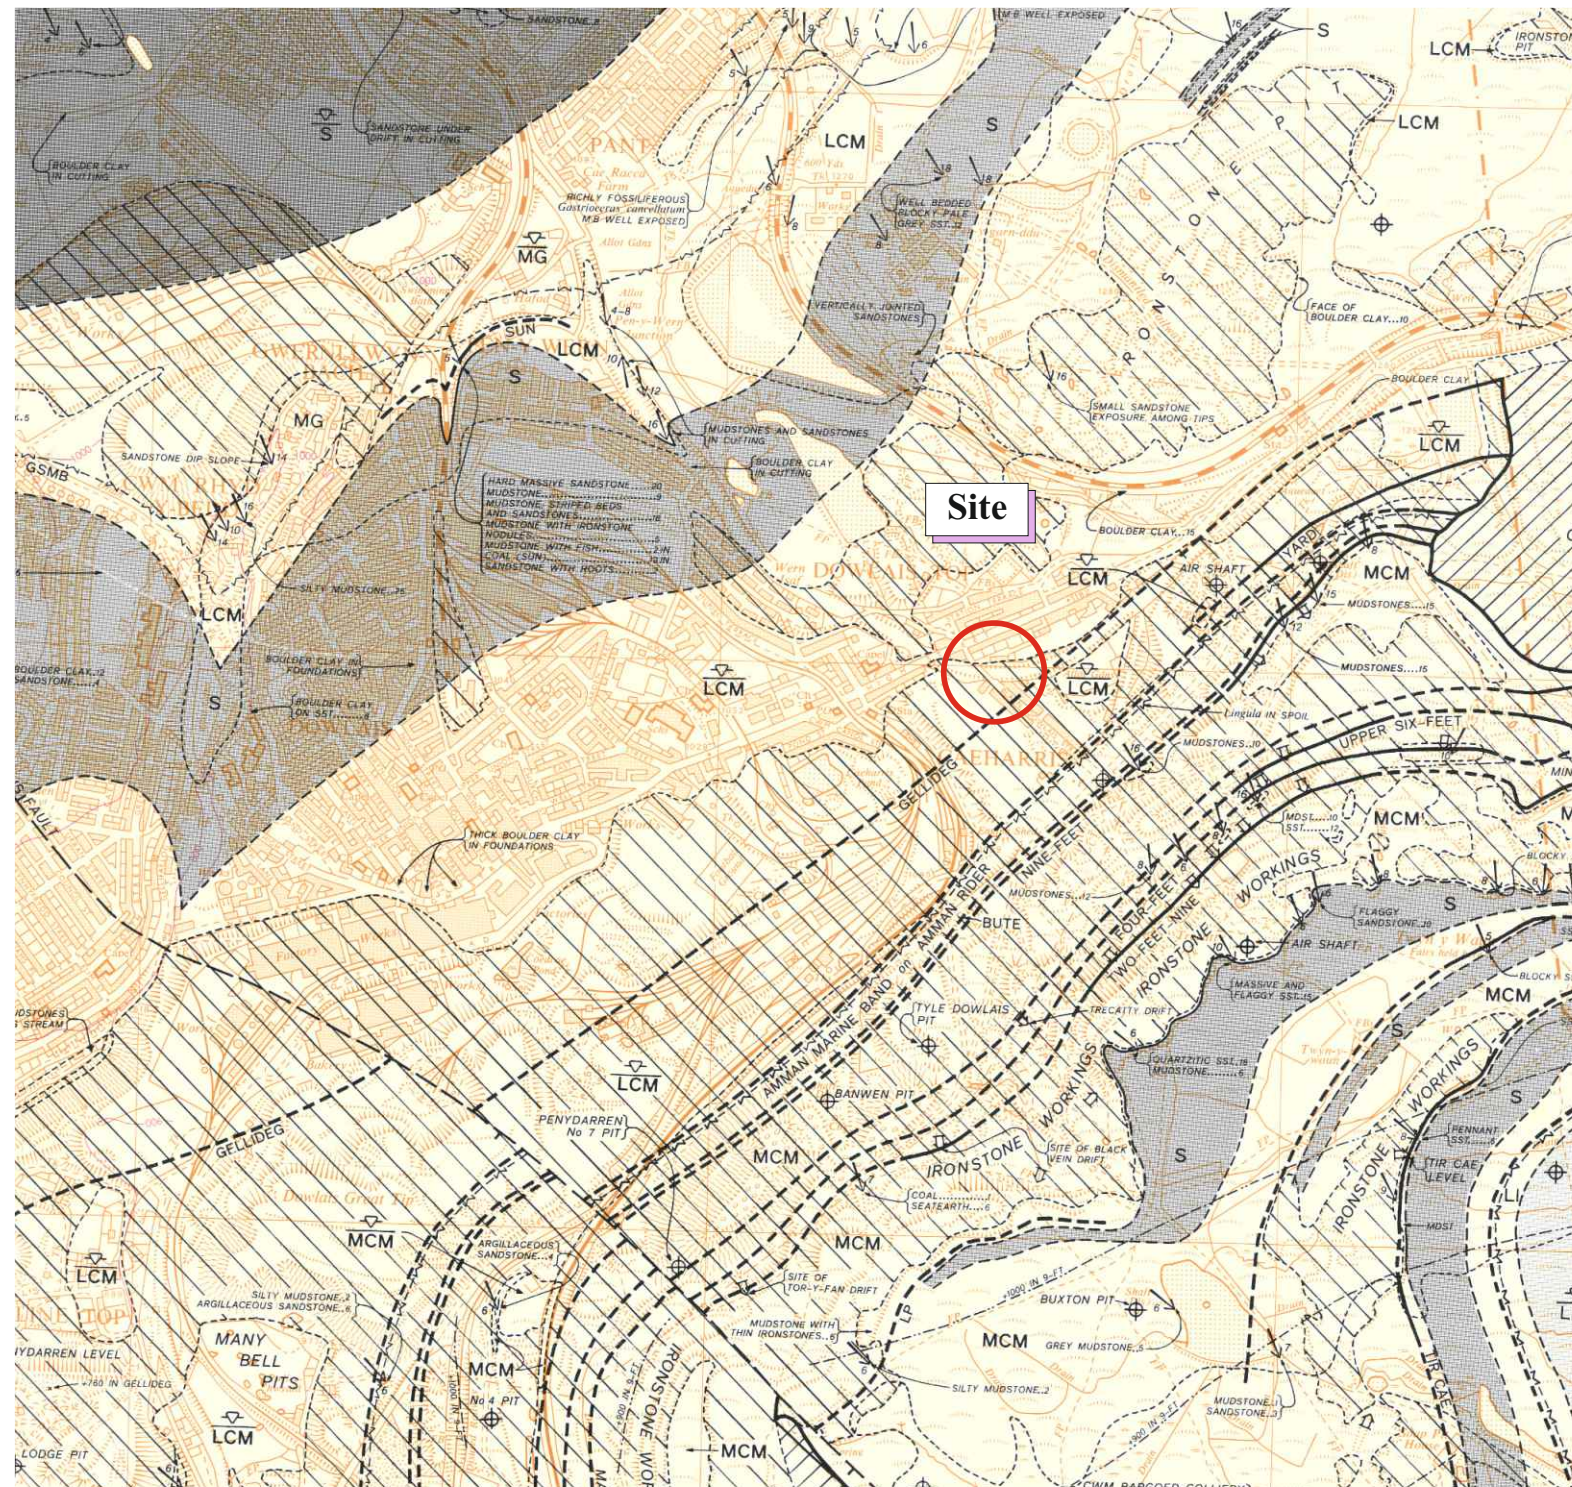
**Drawing No: BC/MB/12.18.04.02.**

Carboniferous Period. The published geological sheet for the area at a 1:10,560 scale, SO 00 NE, shows the inferred position of the outcrop of the Five Feet/Gellideg Seam (identified on the geology plan as the Gellideg and known locally as the Lower Four Feet Seam) to be present approximately 50m south-east of the Site (see *Geology Plan, drawing no. BC/MB/12.18.04.02*). The inferred outcrops of this and other coal seams follow a north-easterly trend along the slopes of the upper valley side. The regional dip of the coal measures in this area is 1 in 12 towards the south-west such that the Gellideg Seam does not underlie the Site.

The published geological sheet shows the Site to be covered with Made Ground which might be the product of the extensive coal mining activities that took place across the area or alternatively may be associated with the former railway line. The published geological sheet also shows that the Site is not affected by landslip conditions.
