*Report No. BC/MB/10.15.04.*

## **Stability Report on Land at Glyndyrus Close, Abercanaid, Merthyr Tydfil.**

**Miss Monica Marshall**

**BLANDFORD CONSULTING**

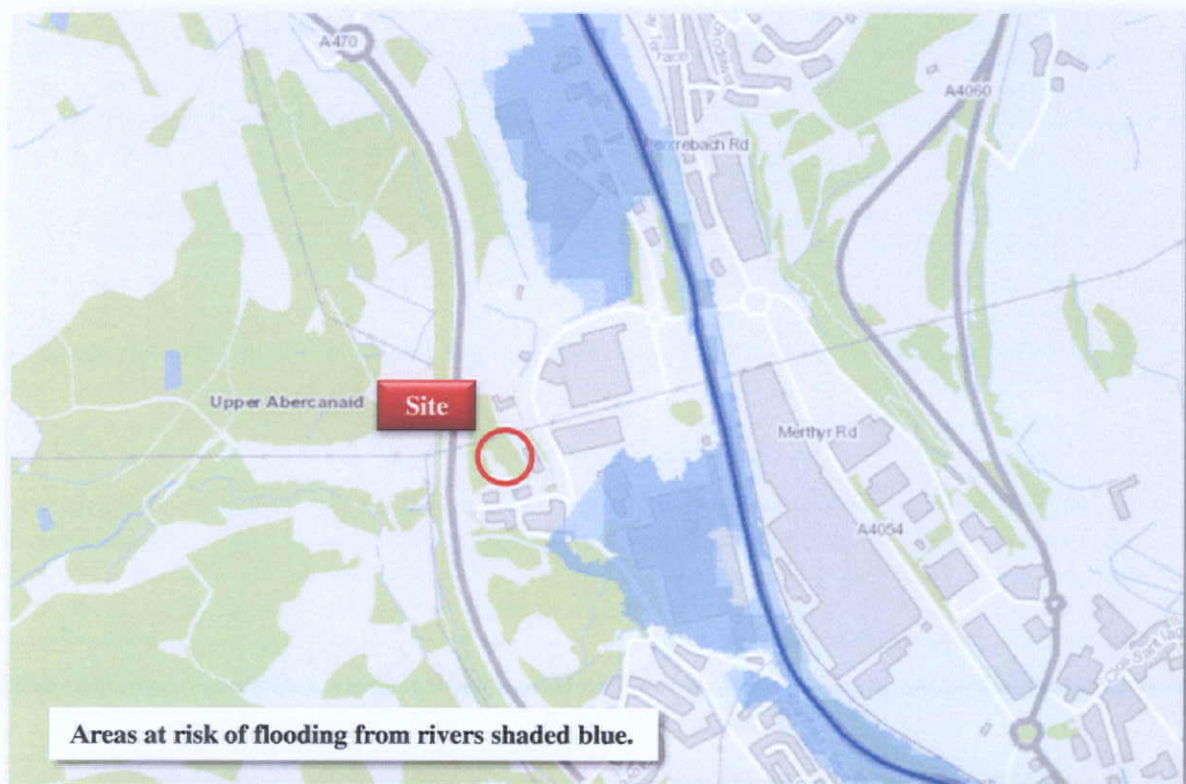
**Figure 4**  
**Areas at Risk of Flooding from Rivers**

There are no bodies of standing water on the Site and it is not in an area at risk of flooding from rivers. The River Taff, flowing in a north-south direction, lies approximately 400m to the east of the Site.

The Site and the spoil heap are not in an area at risk of flooding from rivers whereby a flood event could reduce the stability of the spoil heap. The Site is not on a major aquifer or spring line whereby groundwater flows might affect the stability of the spoil heap.

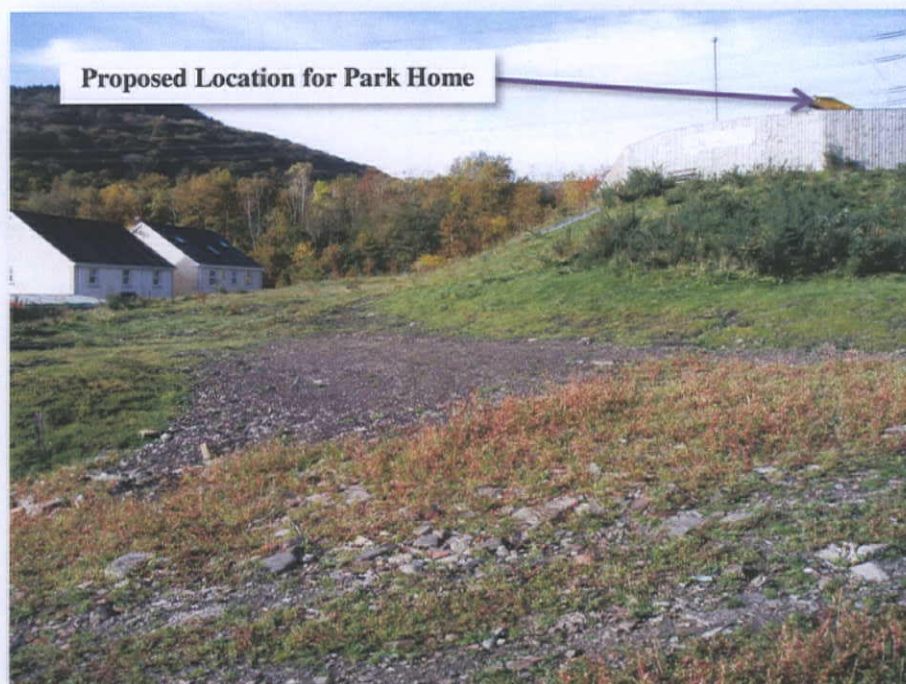
**Figure 4**  
**Southern Front Face of Spoil Heap**

The Site occupies a level area on the top of a disused colliery spoil heap together with a narrow, sloping access road down the eastern side of the spoil heap, leading to the public highway at Quay Row. A walkover survey of the Site found the front face of the spoil heap to be at an average slope angle of  $22^\circ$ , less than the typical angle of repose for loose tipped colliery spoil material of the above described nature. There was no obvious sign of bulging or heave in the southern, main face of the spoil heap that would indicate that the slope was unstable and no evidence of tension gashes along the top of the slope.

Spoil heaps can become less stable if the pore water pressure within the heap increases. No evidence was seen of running water entering the top of the spoil heap and no evidence was seen of seepages through the slopes of the spoil heap or at the toe of the main slopes. There is no body of standing water on the spoil heap.

The Park Home will surcharge the top of the southern face of the spoil heap. To avoid inducing a localised, shallow slip in the southern face it would be prudent to locate the Park Home a short distance back from the top of the slope. A detailed slope analysis is out of keeping with the very small scale of the proposed development and the low loadings that will result from the Park Home. The Park Home should be located no closer than 10m from the top of the slope.

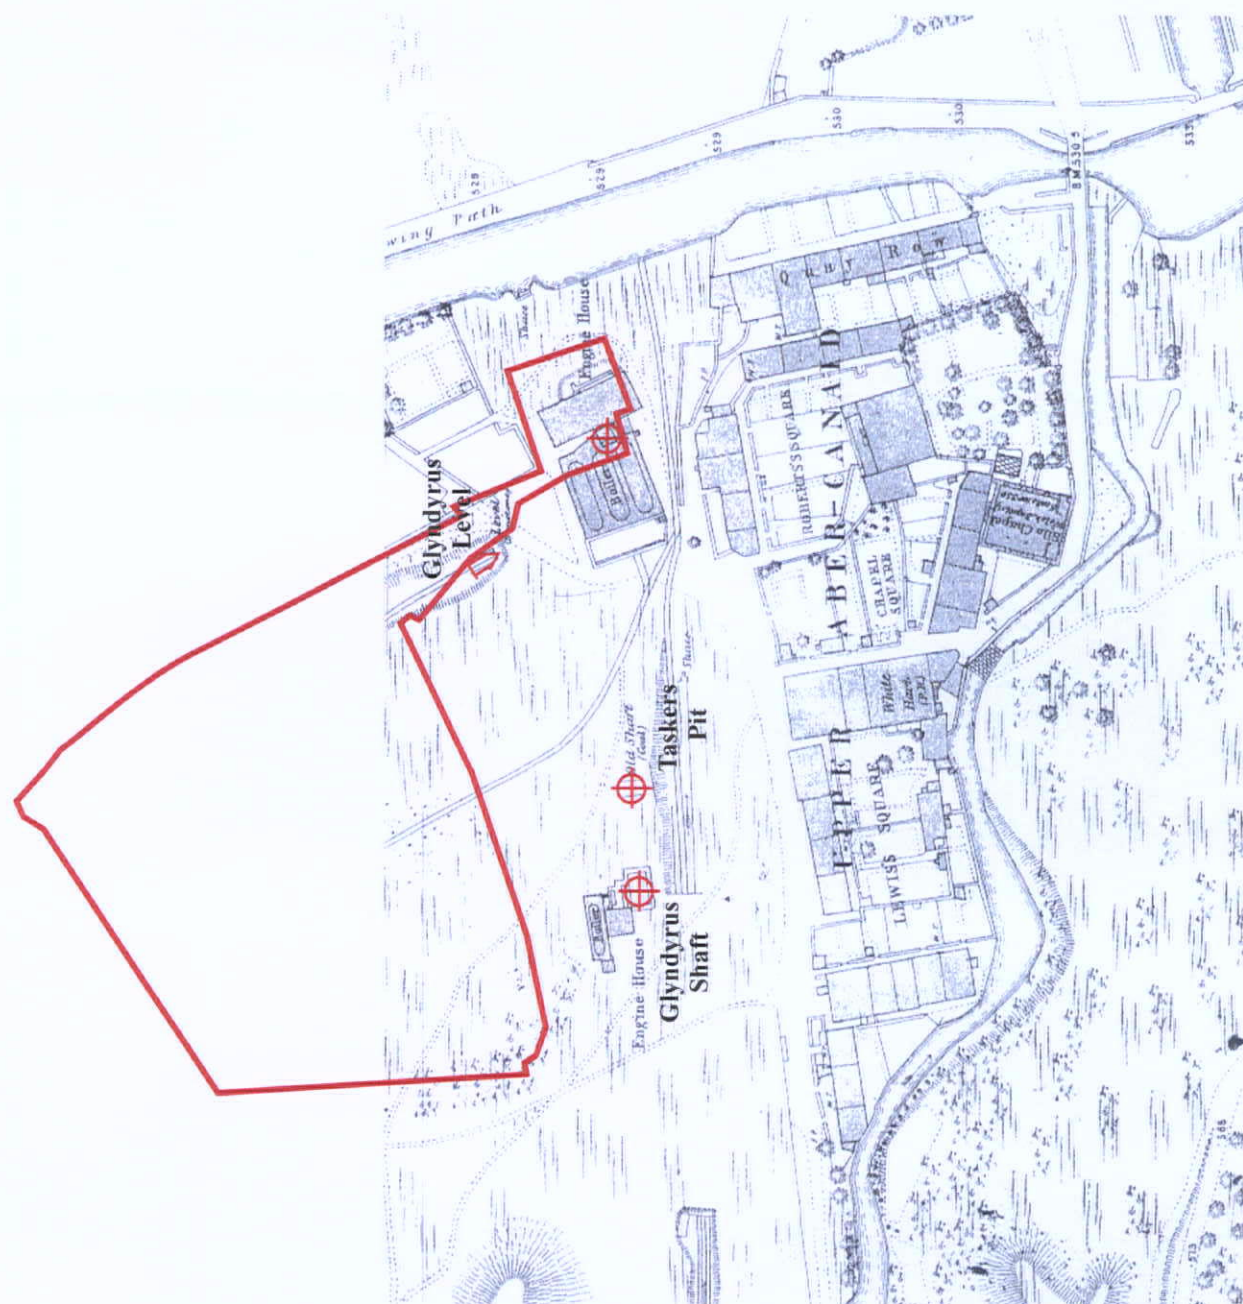
Drawing No: BC/MB/10.15.04.05.

Disused mine entries beneath or in the immediate vicinity of a spoil heap can reduce its stability either as a result of the mine entry collapsing or otherwise by introducing mine water into the spoil heap. Three disused shafts and one disused adit are present close to the south boundary of the Site, Taskers Pit, Glyndyrus Shaft, an un-named shaft and the Glyndyrus Level (ironstone) (see *Extract from Ordnance Survey (1874 Edition), drawing no. BC/MB/10.15.04.05*). The three shafts are too remote from the base of the spoil heap for a collapse of any of the shafts to affect the stability of the spoil heap. The Glyndyrus Shaft is the outflow point for the drainage system that serves the extensive mining operations northwards towards the town of Merthyr Tydfil. The outflow is continuous and is at a significant rate but is in an engineered channel and poses no risk to the stability of the spoil heap. The Glyndyrus ironstone level is situated at the toe of the south slope of the Site and was driven southwards so that any collapse of the adit where it is at shallow depths would be beyond the toe of the south slope of the spoil heap. The Glyndyrus Drift is too distant from the Site to affect its stability.
