Primrose Hill, Merthyr Tydfil

RECORD OF BUILDING AND CONDITION ASSESSMENT REPORT, WITH REPAIR PROPOSALS

.....
(449)2503-GVWP-A-HIS-P01

Date: 05.03.25

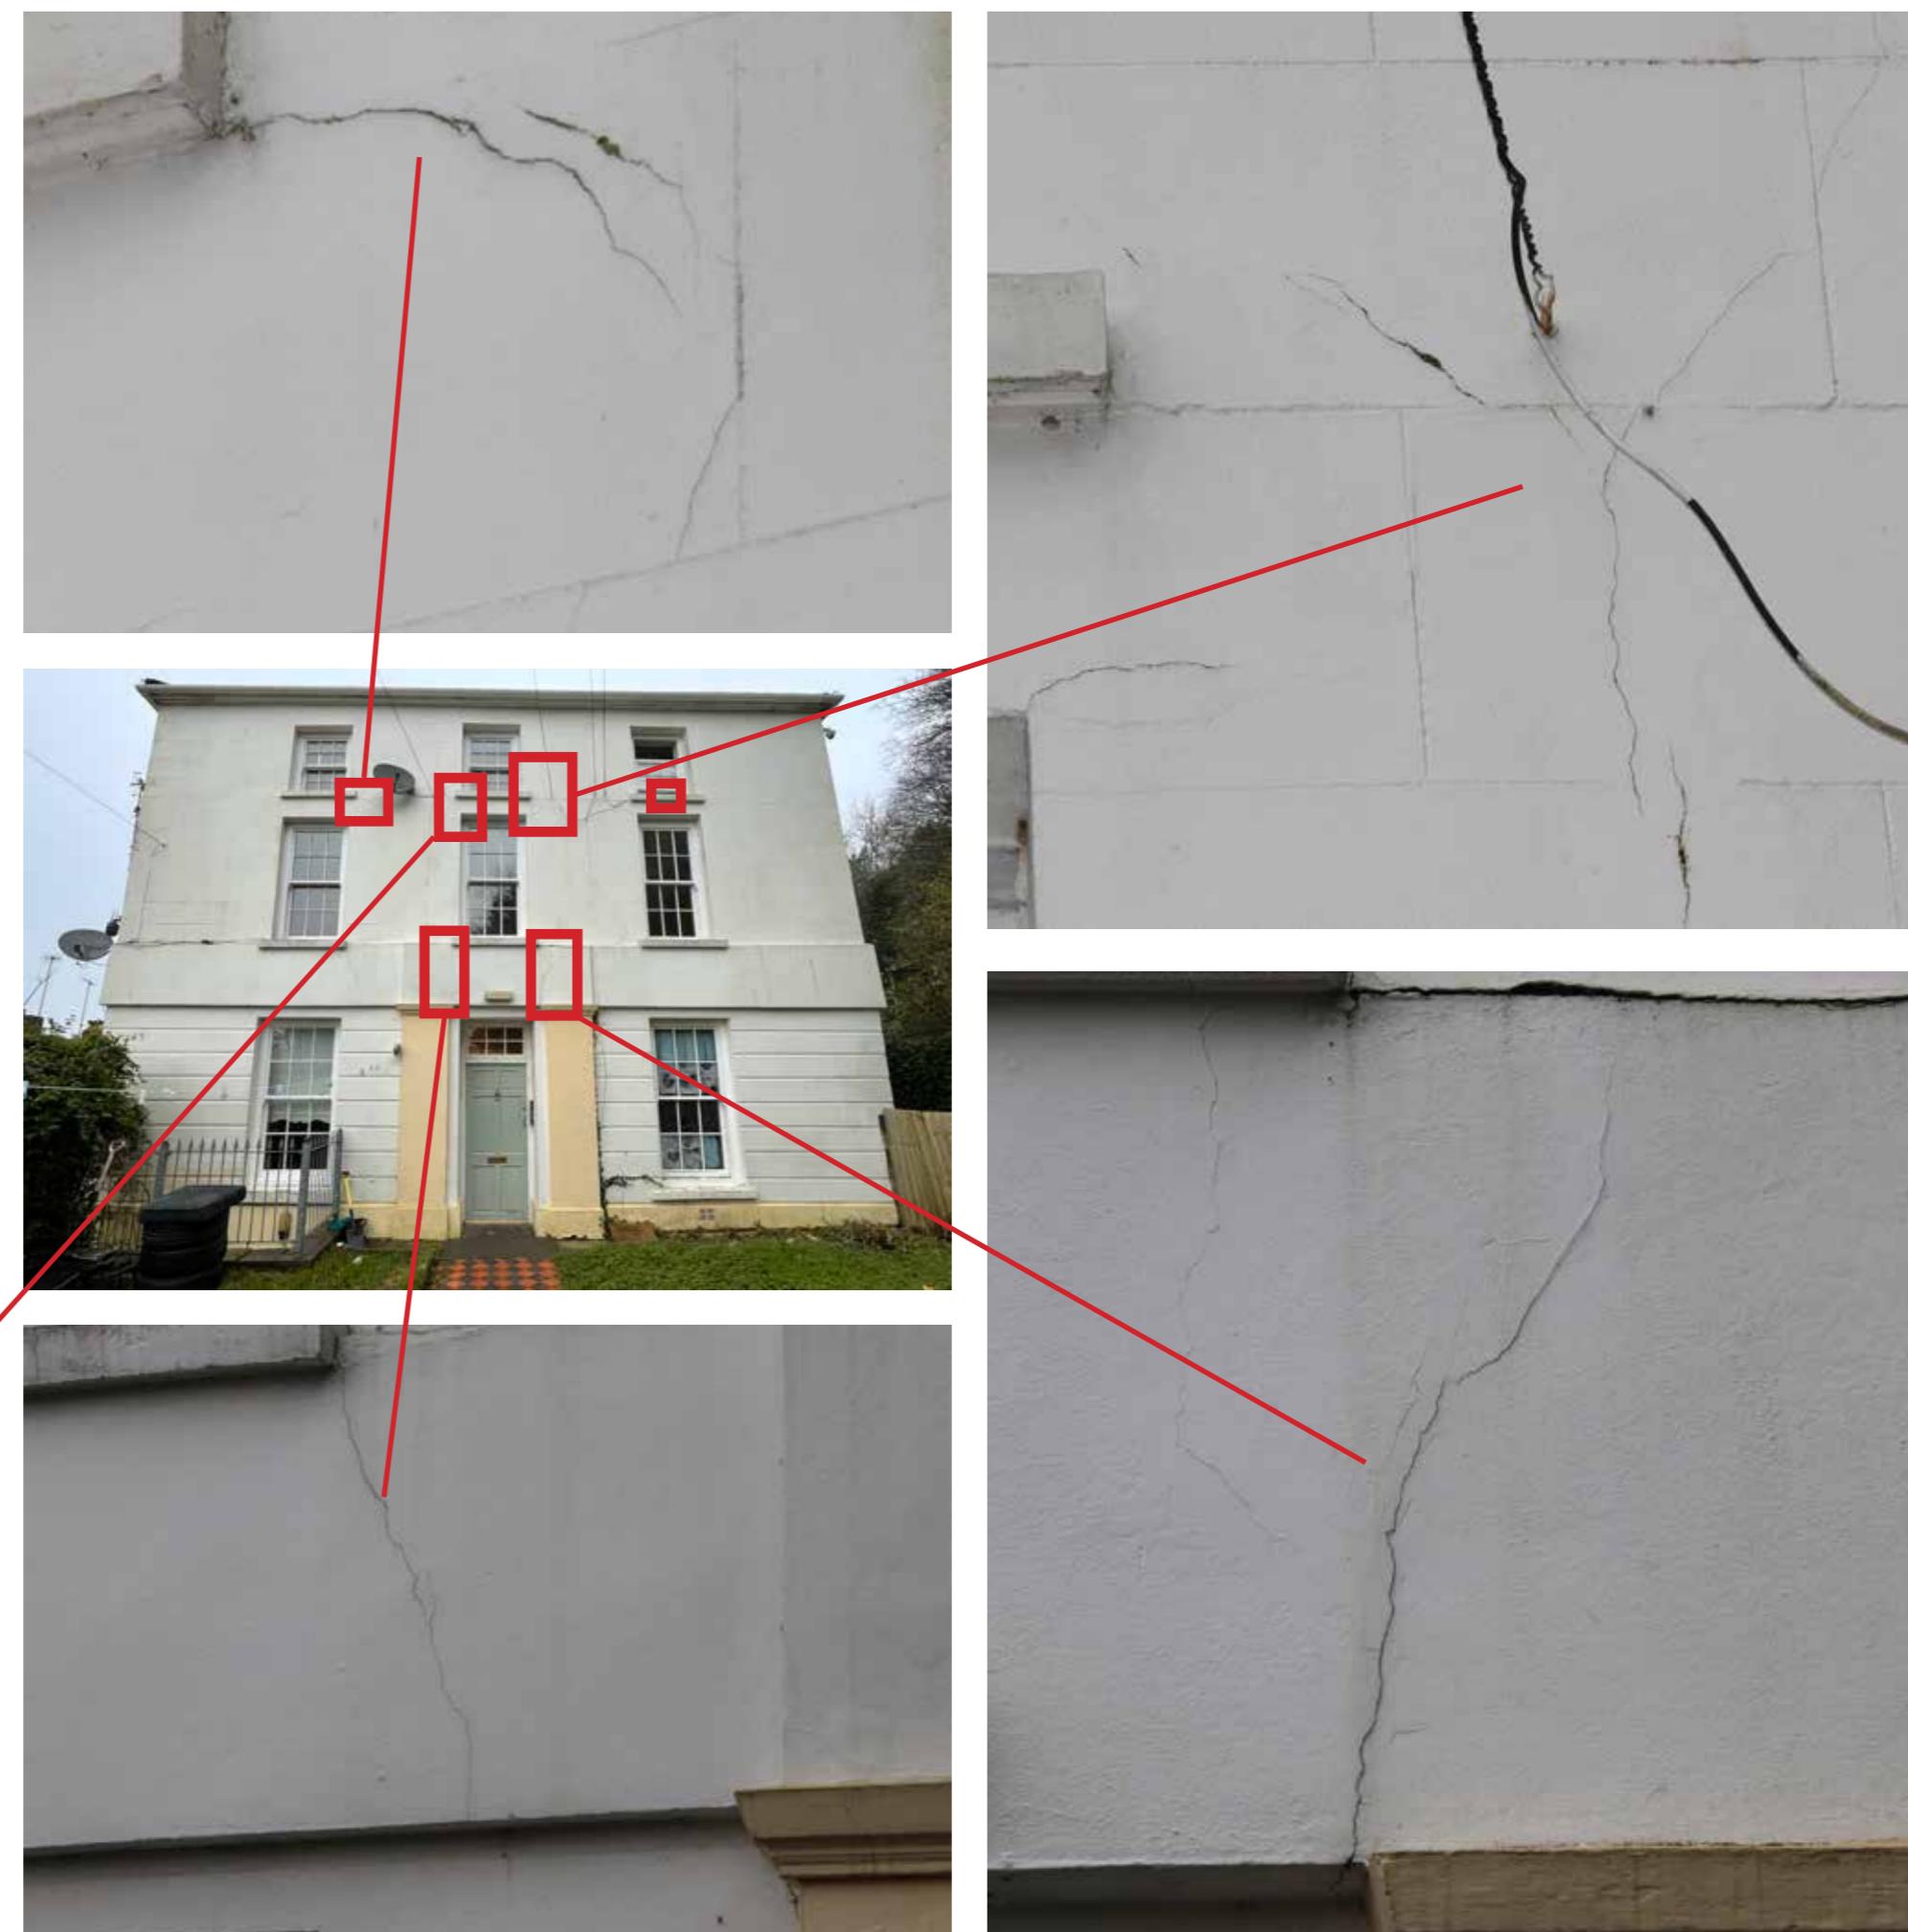
2.1 Front Elevation - Cementitious Render

The front elevation has been applied with a cementitious render, sometimes known as 'stucco'. To the upper two floors, the render has been incised to emulate coursed finished stone. Below the flat deep band underneath the first floor window cills, the render has been rusticated. The substrate behind the render (i.e. the masonry with which the walls were built) appears to be red brick (as suggested by the one view in the bottom right photo on the next page); however, there could also be stone. Given the age of the building, this render would initially have been a lime and sand render, not cementitious.

Clearly apparent across the elevation are cracks in the render - see photos on this page and the next page. This is a problematic issue. Traditional buildings made of solid masonry walls are designed to be slightly flexible. Lime mortar and render provides that flexibility, which allows the walls to expand and contract nominally without cracking. Cement render is not flexible, and so any expansion or contraction in the walls cannot be absorbed by the coating. The result is often the appearance of cracks within the cement render. Once cracks occur, water enters the wall through the cracks, and is held between the render and the masonry. Lime render is vapour-permeable, whilst cement render is impermeable. So, if the render was lime, not only would there be many fewer, if any, cracks; but also the moisture absorbed into the wall fabric would be drawn out of the wall (hygroscopically) through the joints and render, would sit on the surface of the wall, and be evaporated by the sun and wind. With cement render, it is not possible for the moisture to escape through the coating, and hence to evaporate on the surface. As such, a cement rendered wall, once cracks occur, holds onto the moisture. This can result in various defects – the breaking down of the masonry itself; the widening of cracks (as moisture held, freezes and expands); saturation of the masonry, which could cause damp or mould internally (especially if the internal plaster is gypsum, not lime, as it is here); saturation of timber in contact with the masonry, which could cause mould, rot or infestation; and a generally unhealthy building.

A quick response would be to repair the cracks; but this would not address the problems. More cracks will appear in time, and more water will get behind the render. In addition to this, we are aware of significant issues with water ingress to the fabric causing problematic mould growth to the internal face of the walls. The walls are, of course, not insulated (which they cannot be, being solid masonry); however, damp walls perform very badly as insulators, whilst dry walls are good insulators. The most important thing for the building is to dry out the walls and ensure they do not, again, become saturated. The only way to do this is to remove the water ingress causes (i.e. cracks in render, poor rainwater goods, lack in internal ventilation and heating) and then to ensure that the walls are vapour-permeable from both the outside face and the inside face.

To that end, we recommend very carefully hacking off the cementitious render to the external face (as well as the cementitious / gypsum plaster to the internal face), allowing as long a time as possible for the external walls to dry out, by exposing both external and internal faces of the masonry to evaporation), and then re-applying a 3-coat lime render to the outside face of the walls (and a 3-coat lime plaster to the inside faces). The external render will need to be smooth-finished with the top coat, rusticated at ground floor and incised at upper floors, to emulate coursed finished stone, to match the design of the existing stucco.

Trying to remove cementitious render, which usually bonds extremely well to masonry, can cause damage to the stone. However, sometimes it can be removed fairly easily with little damage; with the work in the right hands. This is a risk; however, given the damp condition internally, this may be a risk which needs to be taken.

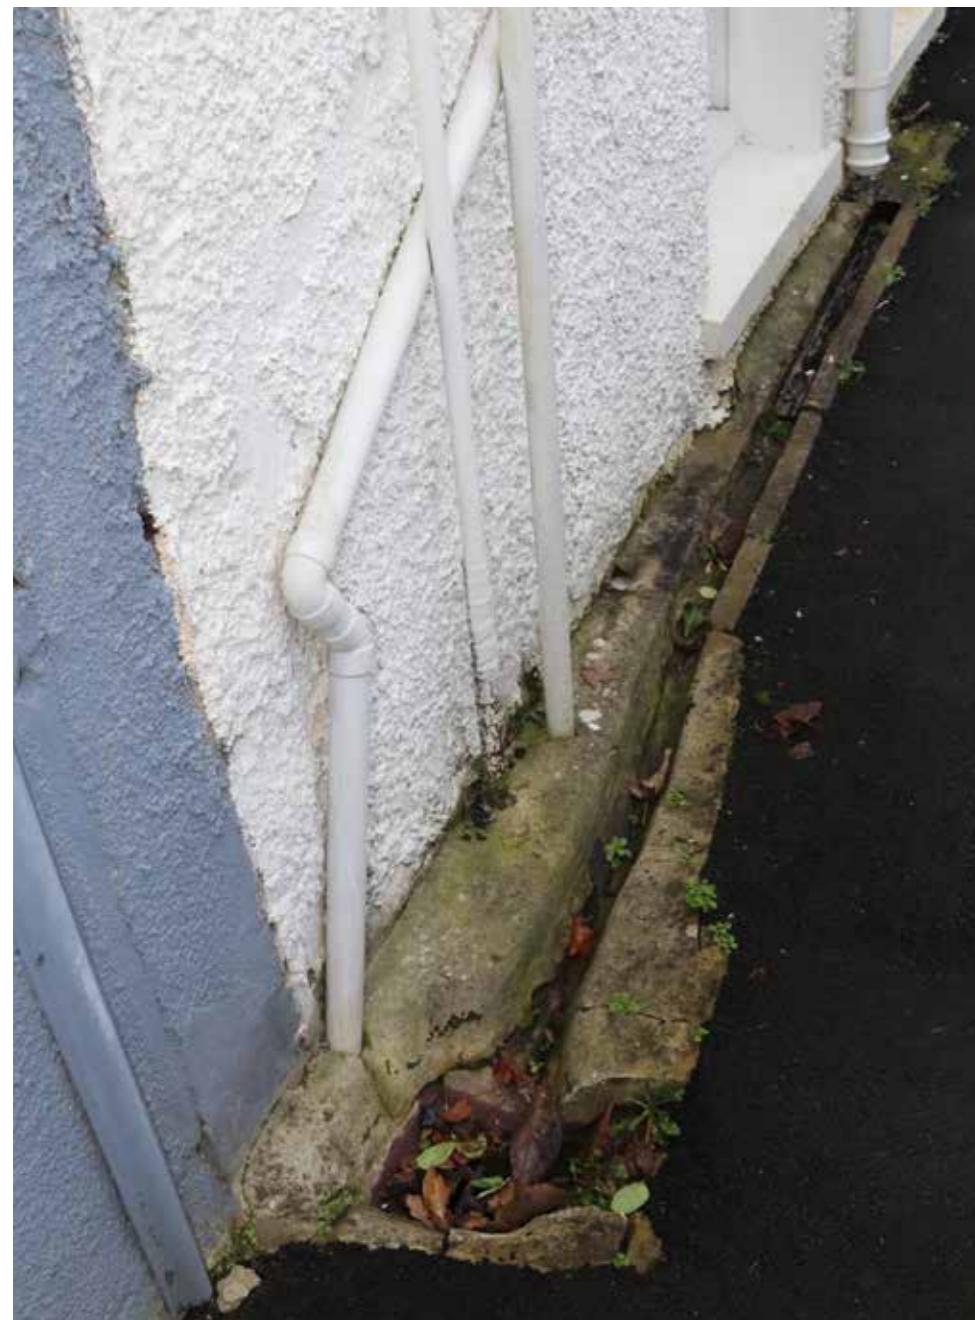
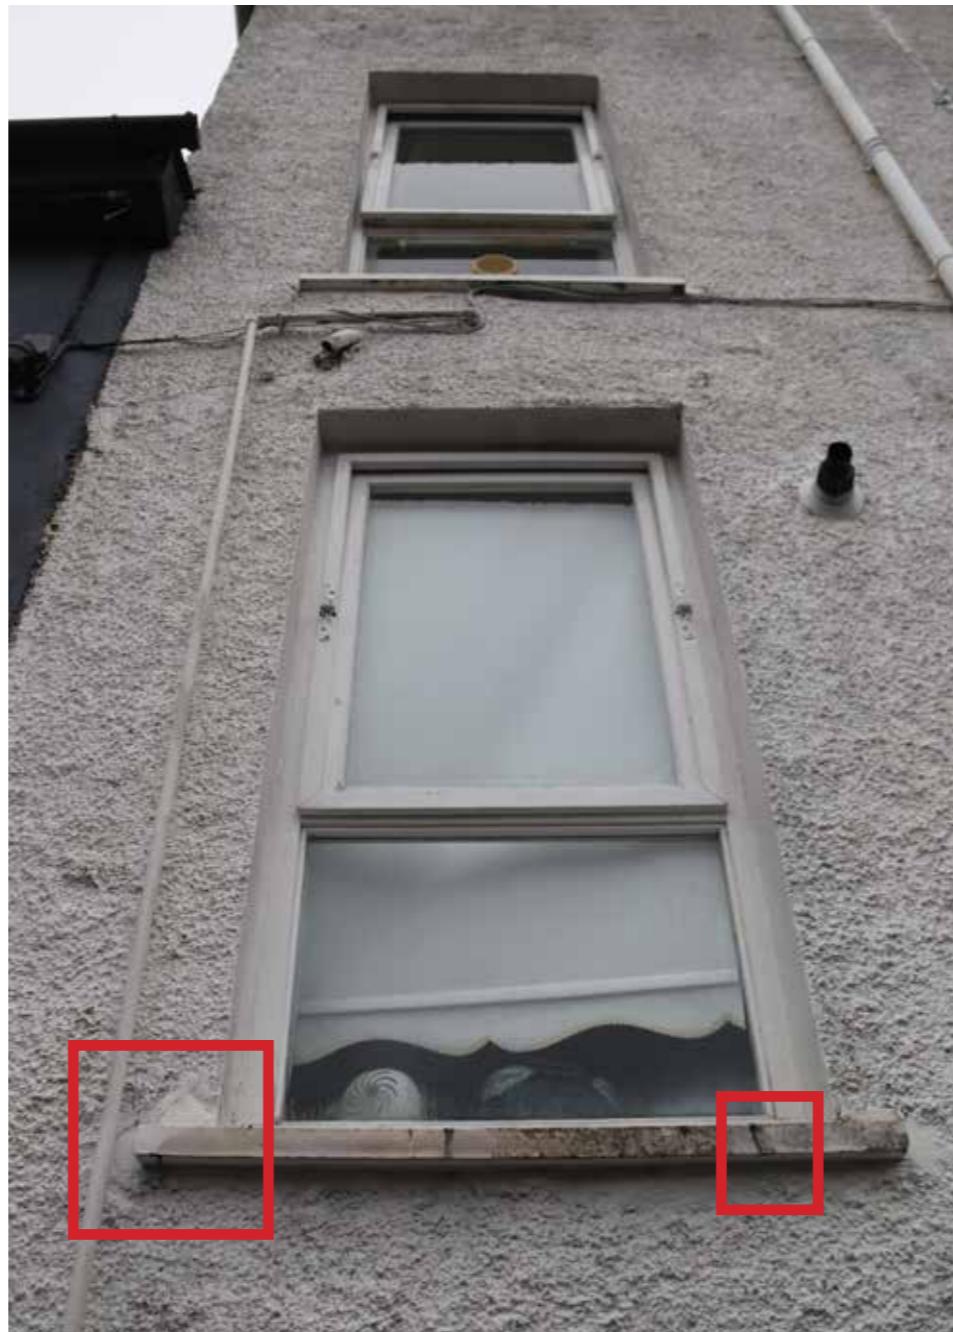
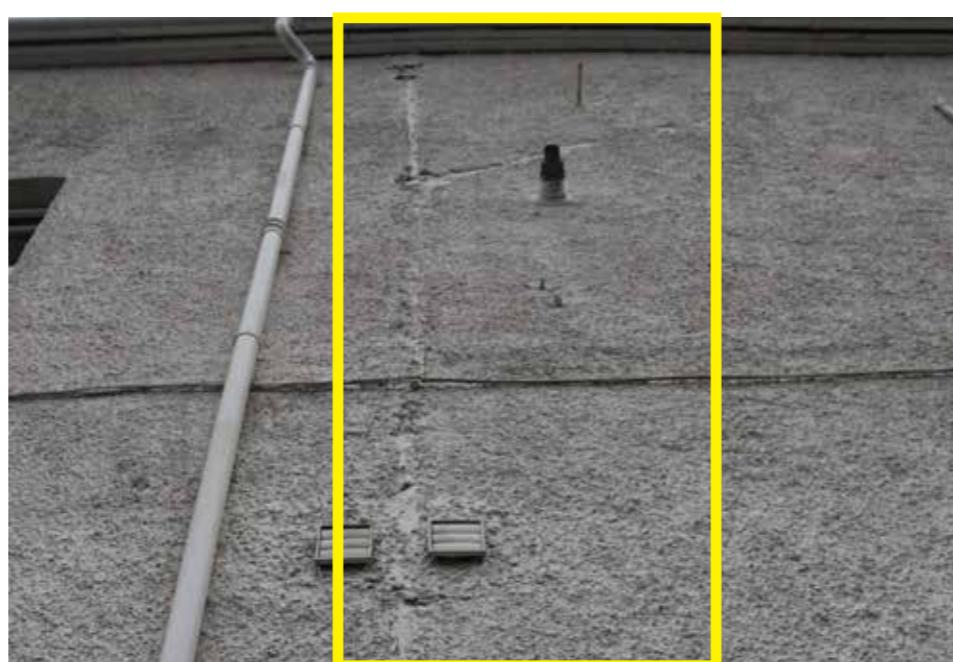
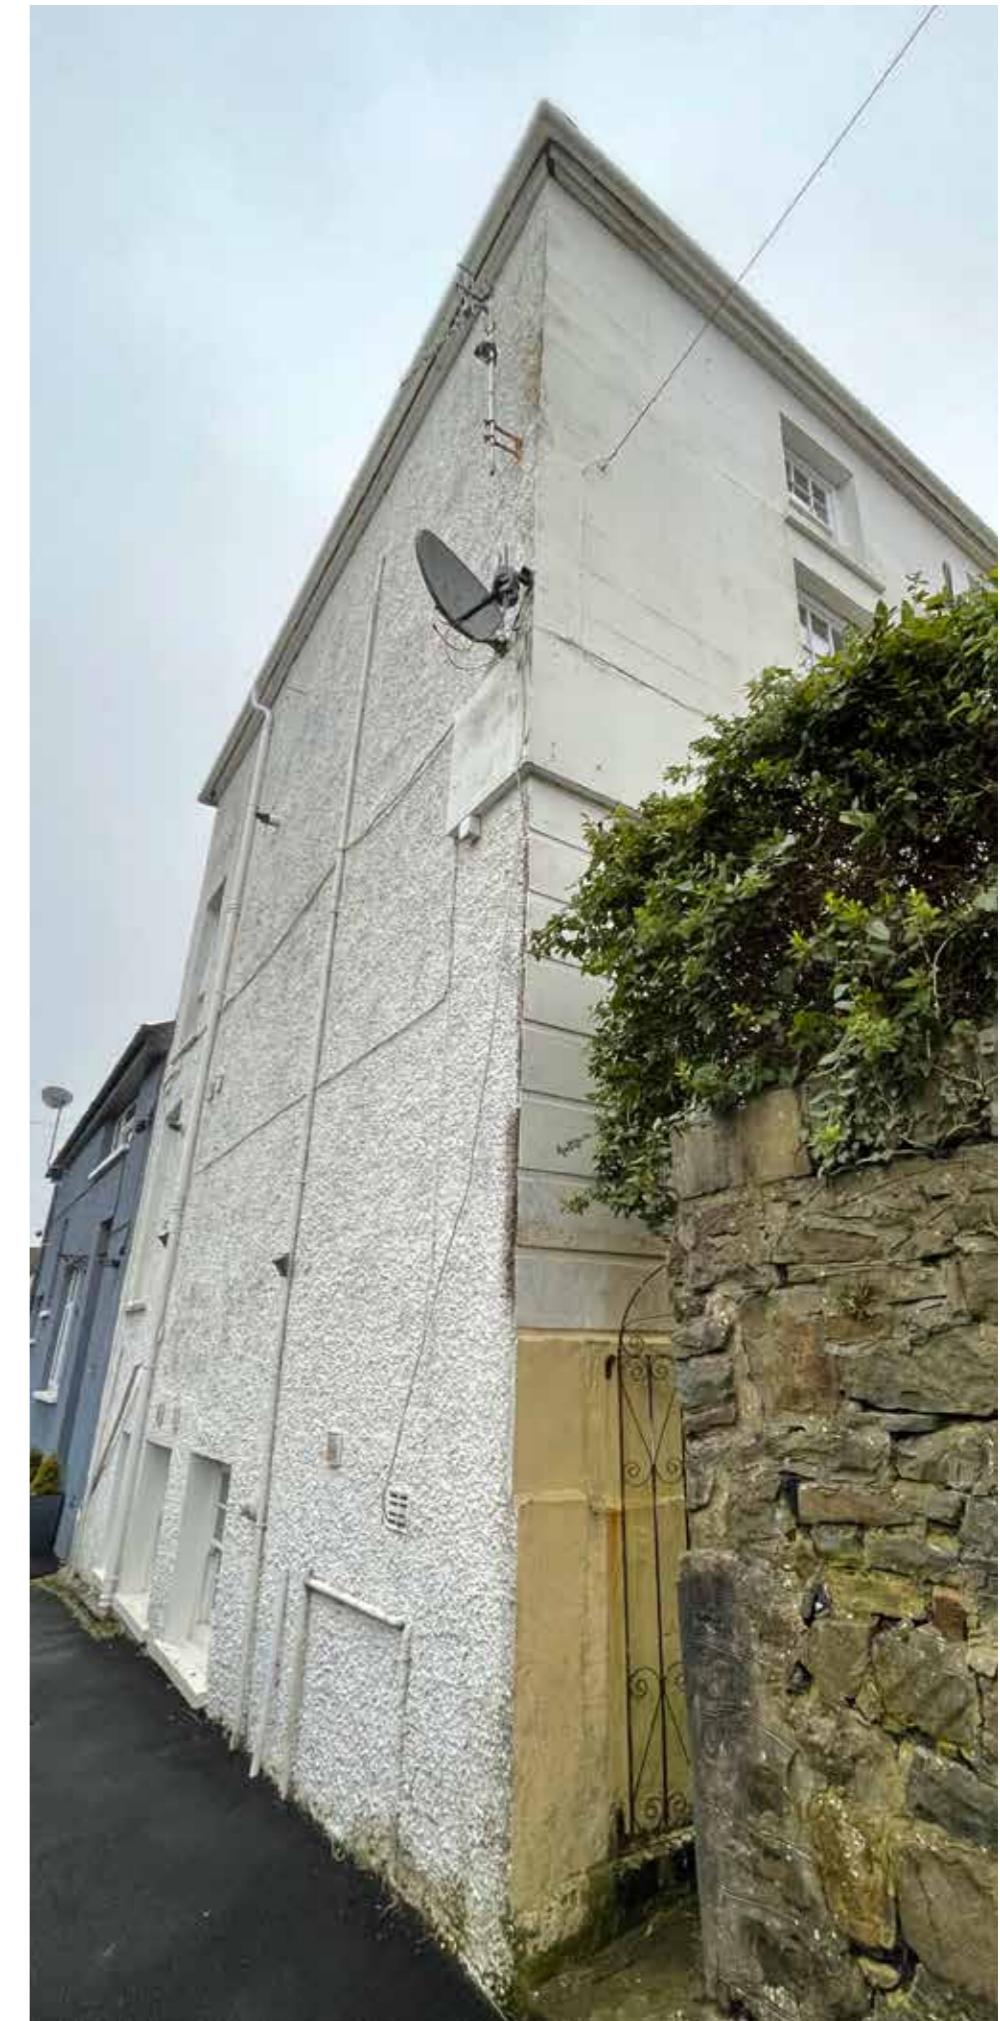
3.0 Side (West) Elevation

The 3no. 6-over-6 timber sash windows at the base of this elevation, and the 2no. central-pivoted windows down the side, at ground and first floor, are all timber windows, painted off-white. The panes to all 5no. windows are single-glazed. In the main, they appear to be in a reasonable condition, some having recently been re-painted; however, the timber cill to the middle low window has suffered from water ingress and is showing signs of loss of body. This should be rubbed back and, if any of the wood is soft, or 'gives' to the penetration of a sharp object, then the soft central should be cut out and a new section of timber spliced in, and the cill painted.

Indeed, it is proposed that all windows and cills are lightly rubbed back and re-painted a matching off-white.

It is also proposed that the glazing to all 5no. of these windows are replaced with 'Slimline' double-glazed units with white spacers.

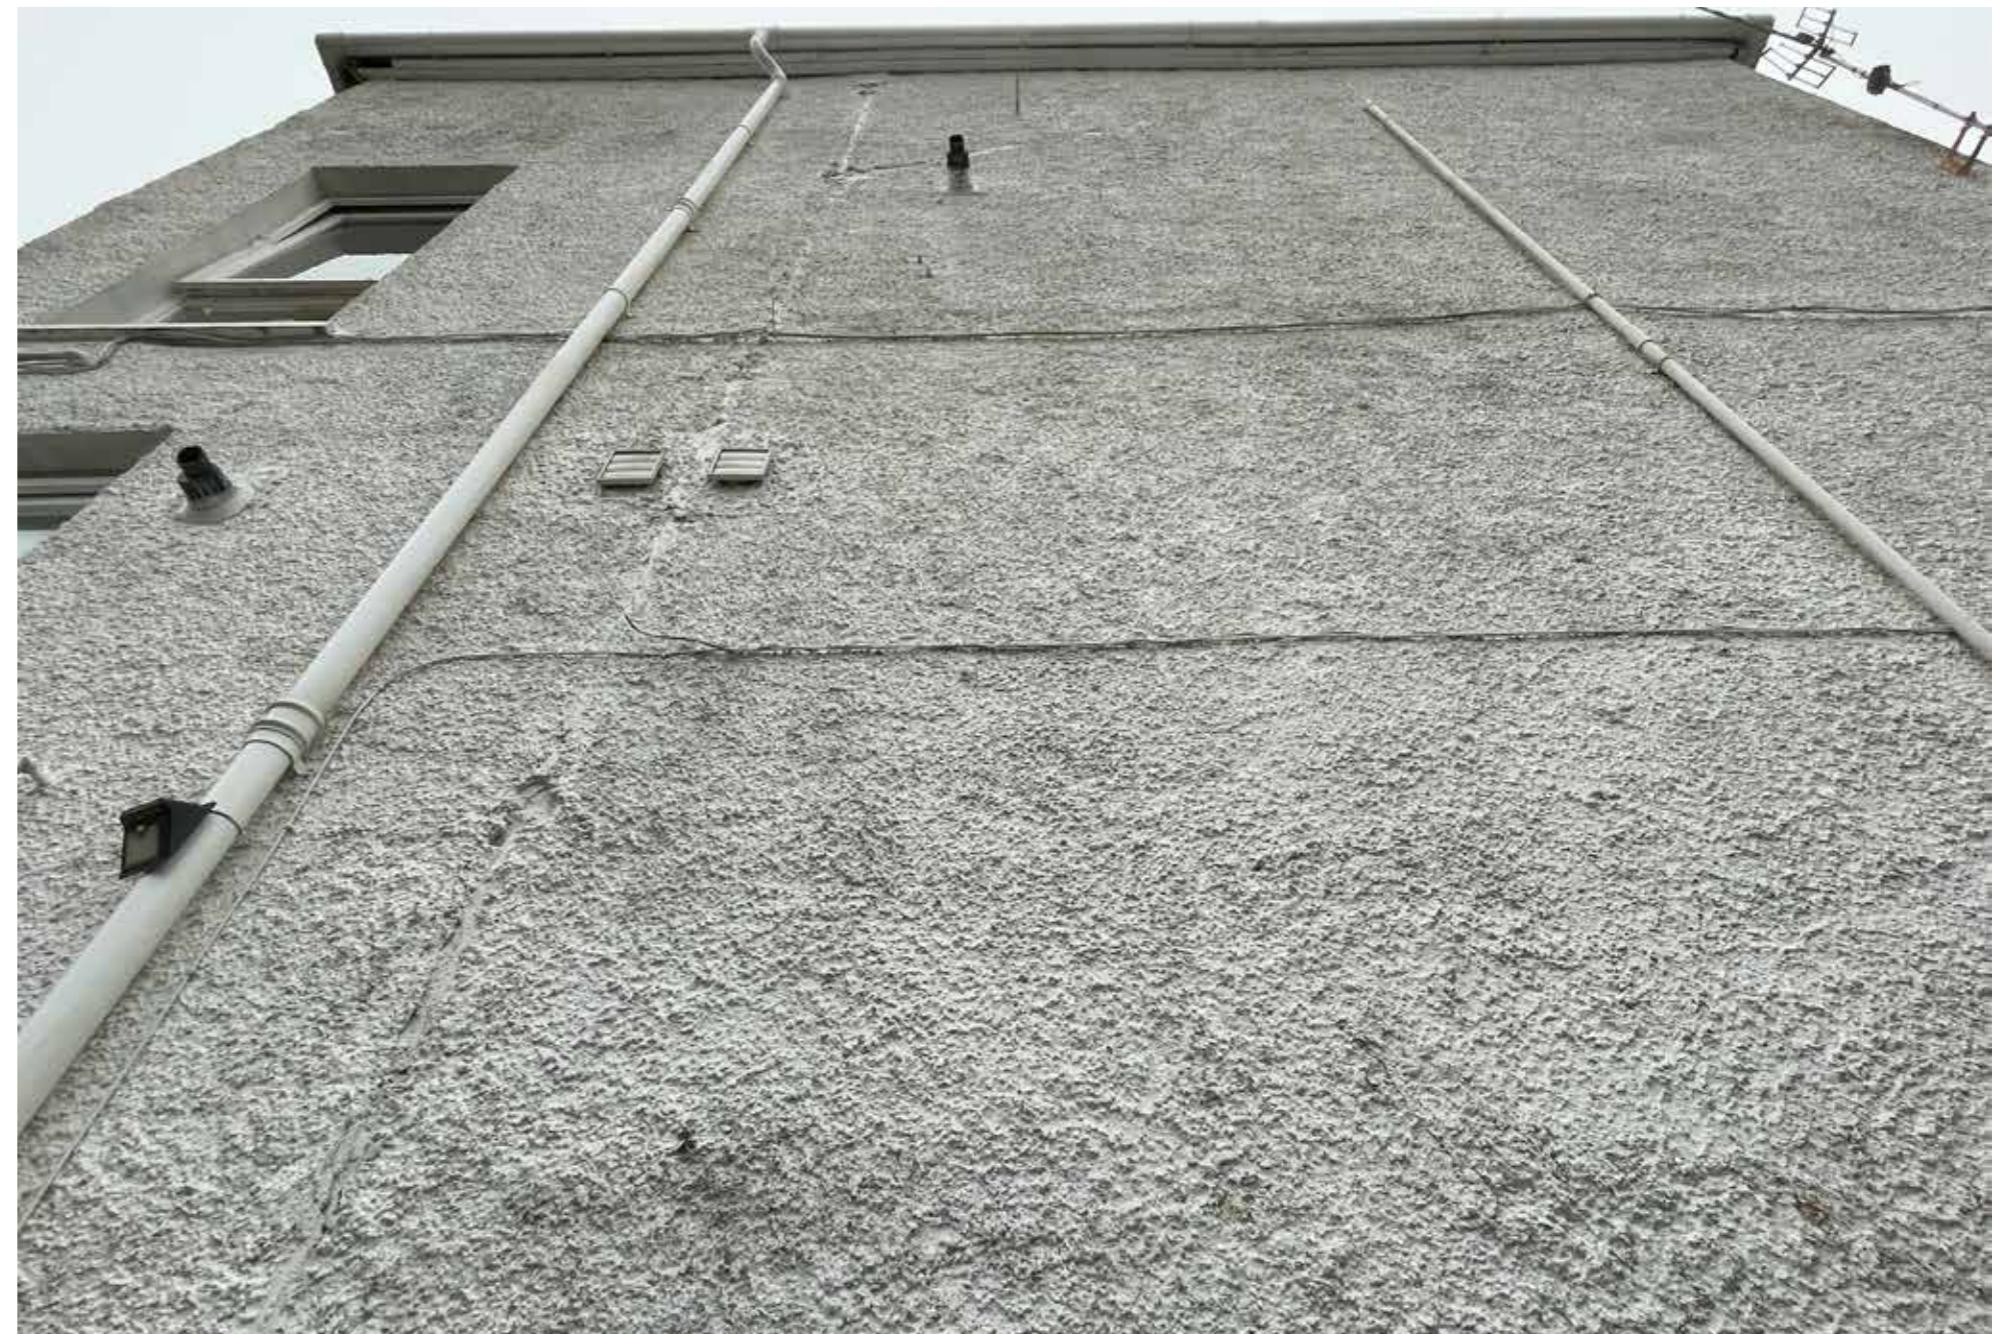
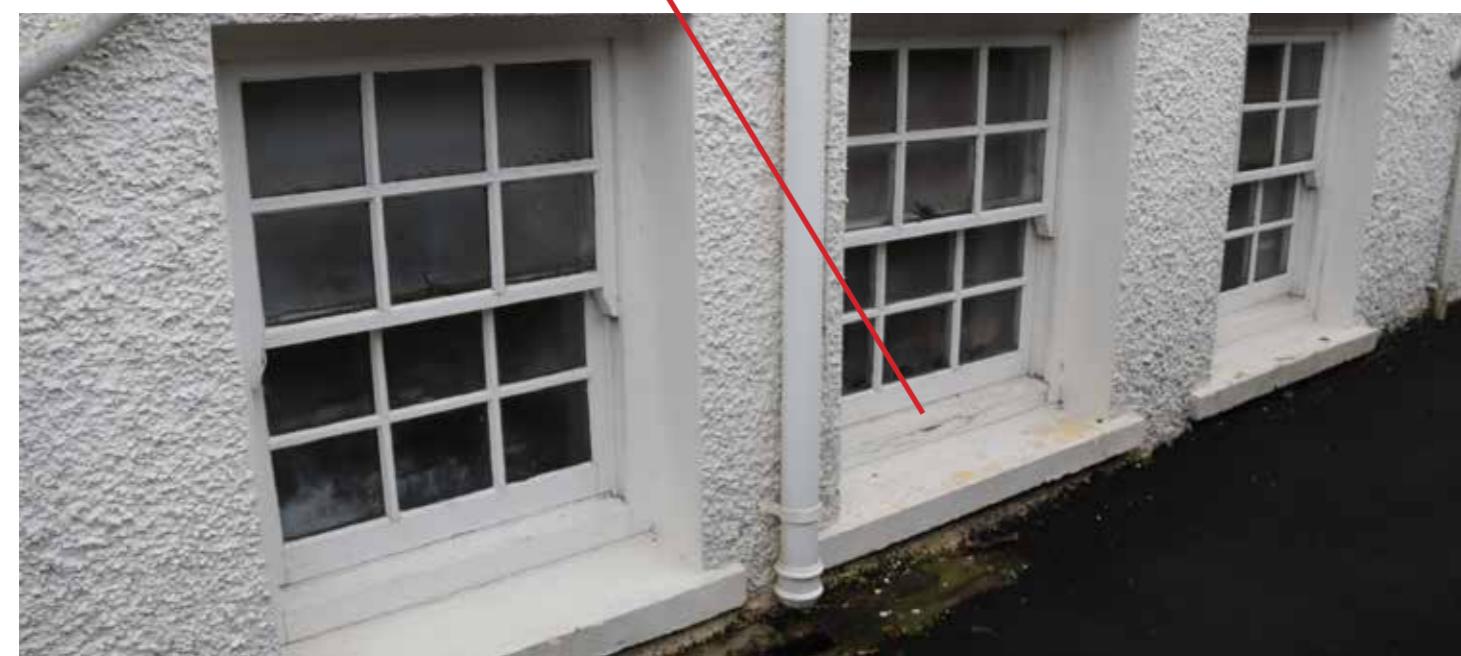
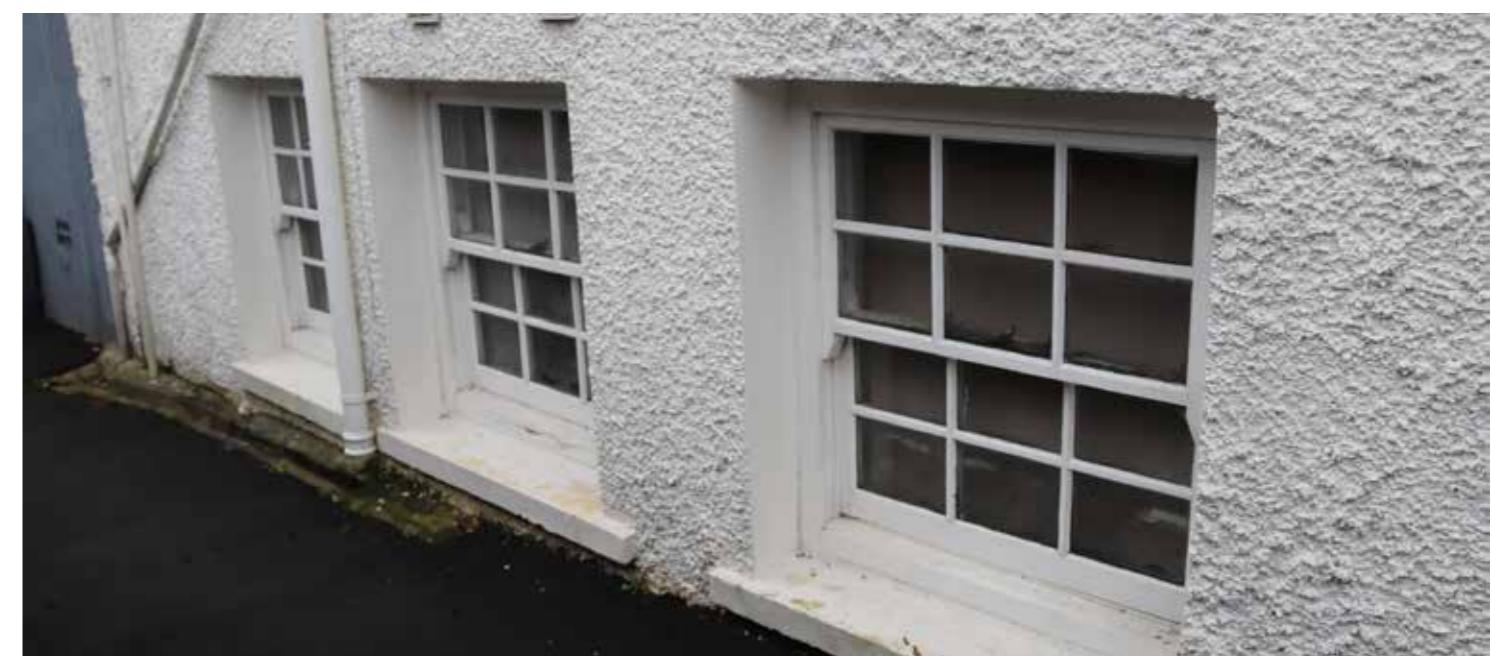
4.0 Side (East) Elevation

To this side elevation, the render is also roughcast; however, here it is a mixture of off-white and light grey with dark grey and green environmental and organic staining. It is not known whether this is a cementitious; however, it is assumed to be. This elevation comprises a number of soil drainage pipes, surface water drainage pipes and condensate pipes. It is assumed that, over time, leaks from one of more of these pipes has stained the render. It is also of concern that the rainwater pipe spills out onto concrete, which then runs into a gully. This means that the water splashes off the concrete and probably splashed back onto the wall.

The worst of the mould growth inside is on this elevation, at ground floor. It is not possible to determine if there are any defects in the masonry of the wall which would have caused this issue; or whether there are problematic cold bridges; or that it is simply a case of internal condensation; however, the worst issues are within a recess in this wall.

We recommend that the internal plaster is removed and the masonry investigated from inside. This may remove the need to expose the masonry from the outside; however, it may not. So, for now, we also recommend that the render is also removed from the outside face and, once the wall has dried out, and any defects in the masonry addressed, then the walls should be re-rendered with a roughcast lime render. We also propose that the drain is provided with a shoe which dresses into the gully cover to stop the chance of splashback.

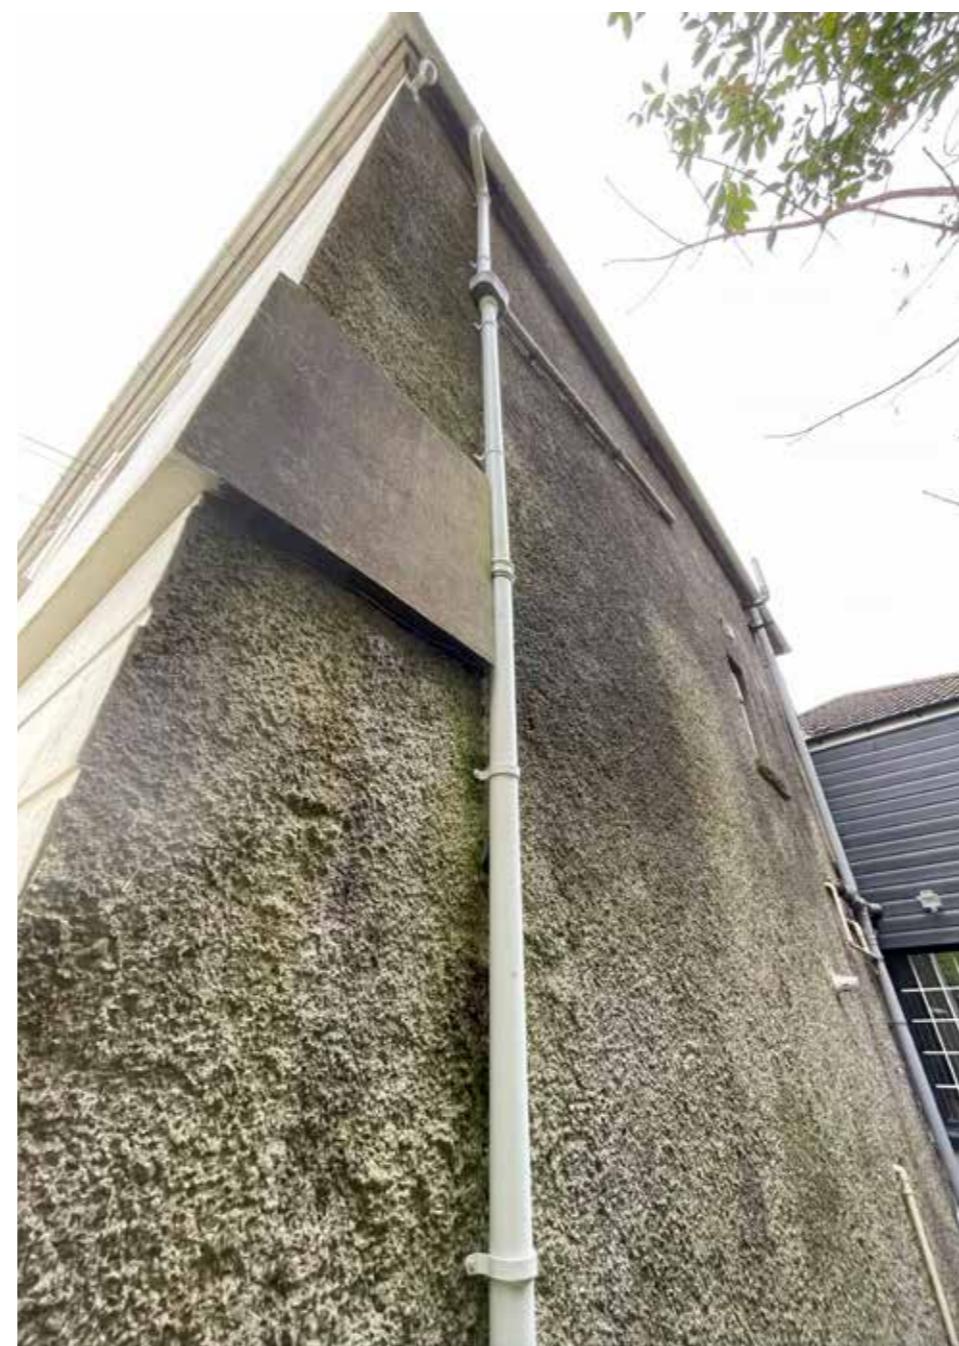
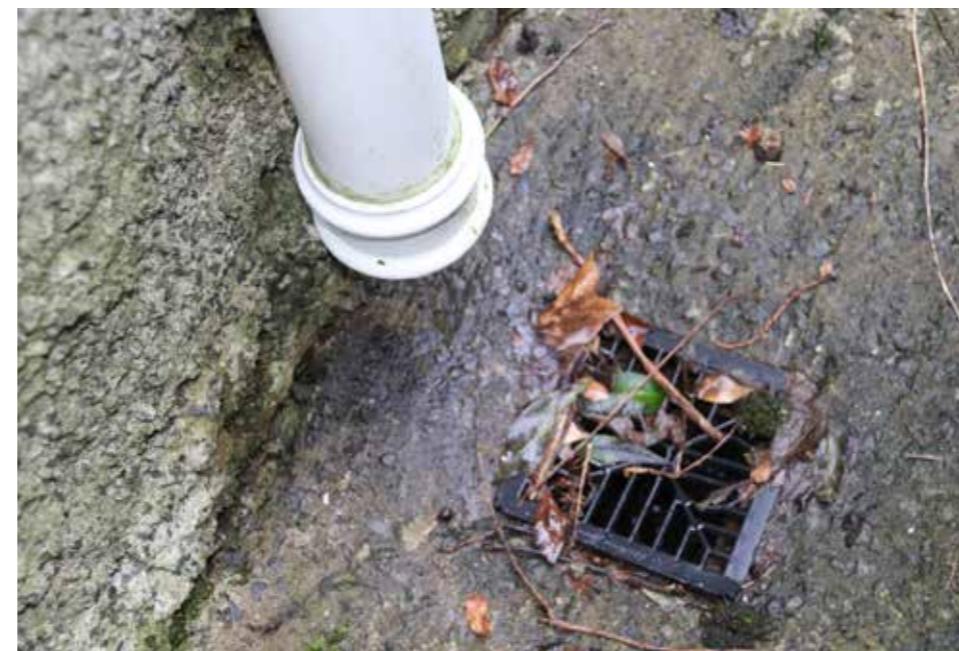
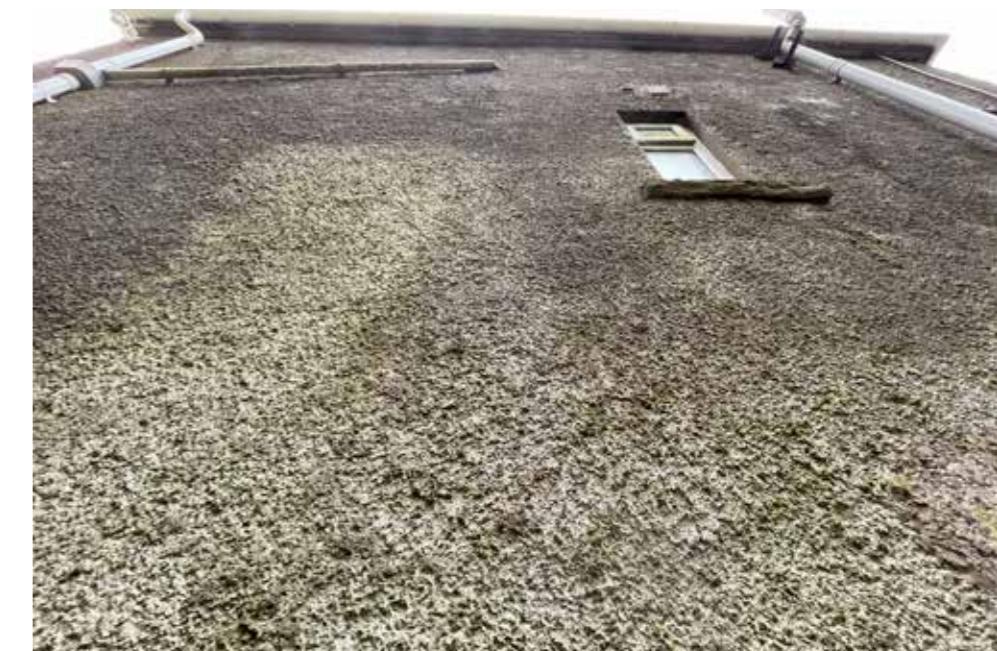
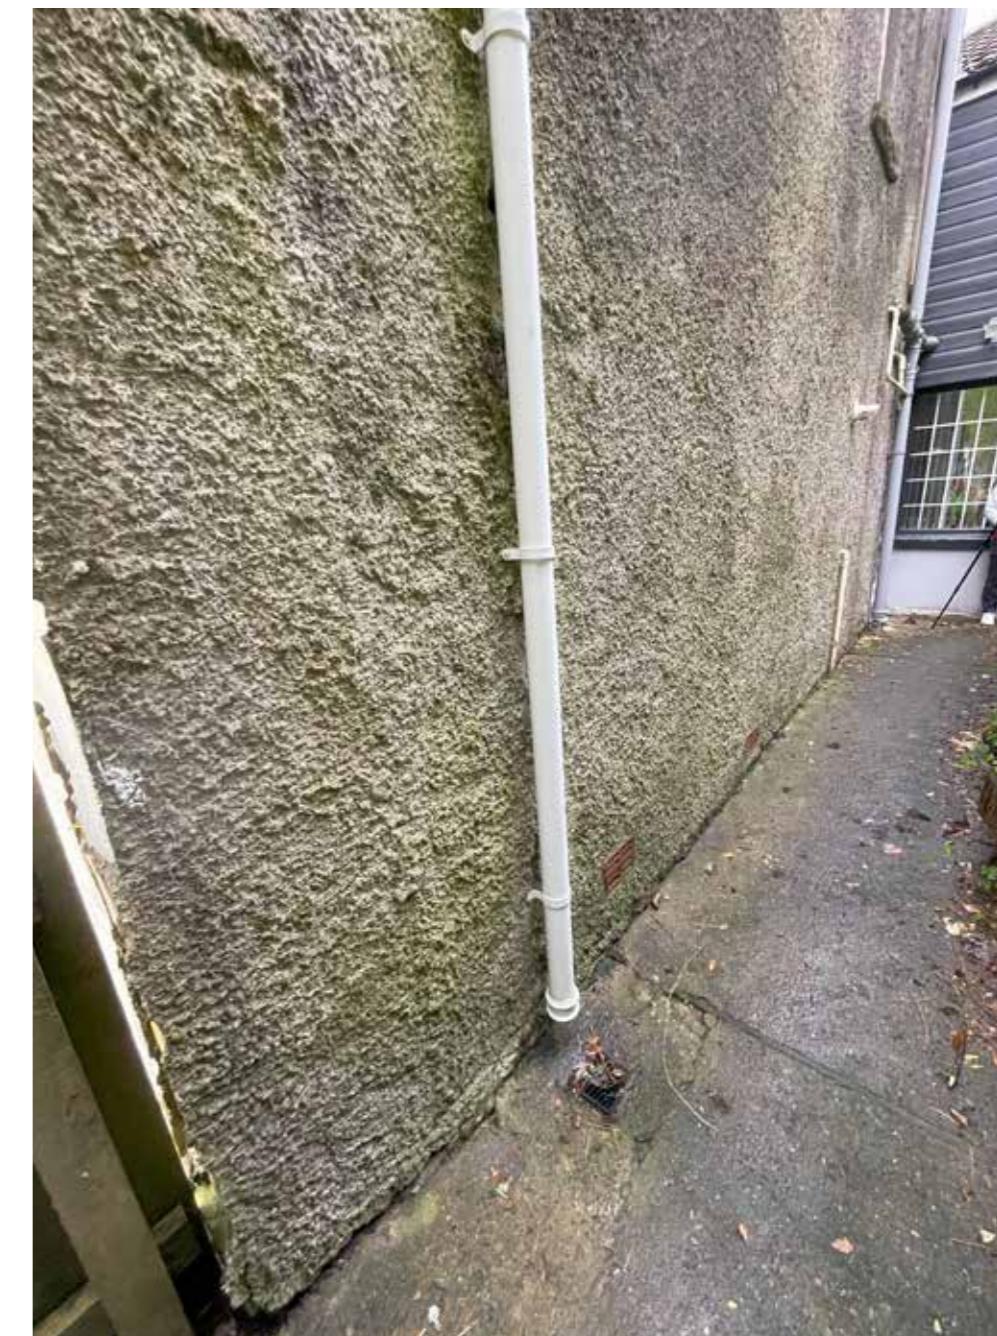
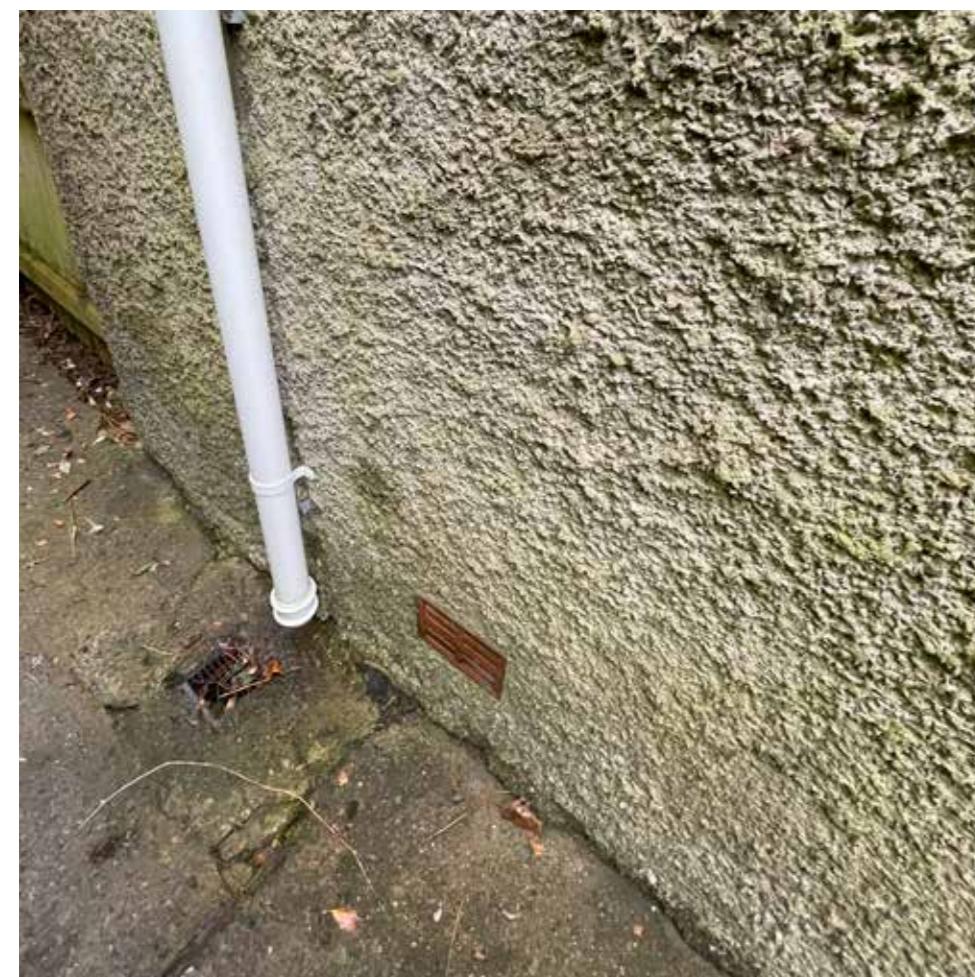
4.0 Side (East) Elevation

The 3no. windows on this elevation are timber-framed and all incorporate double-glazed panes. There is a sash window to the ground floor and two part-top-hung casements part-fixed windows to the first floor. All would benefit from a light rub back and re-coat.

It is recommended that all joints in all pipework is checked and any issues with either pipes or joints addressed.

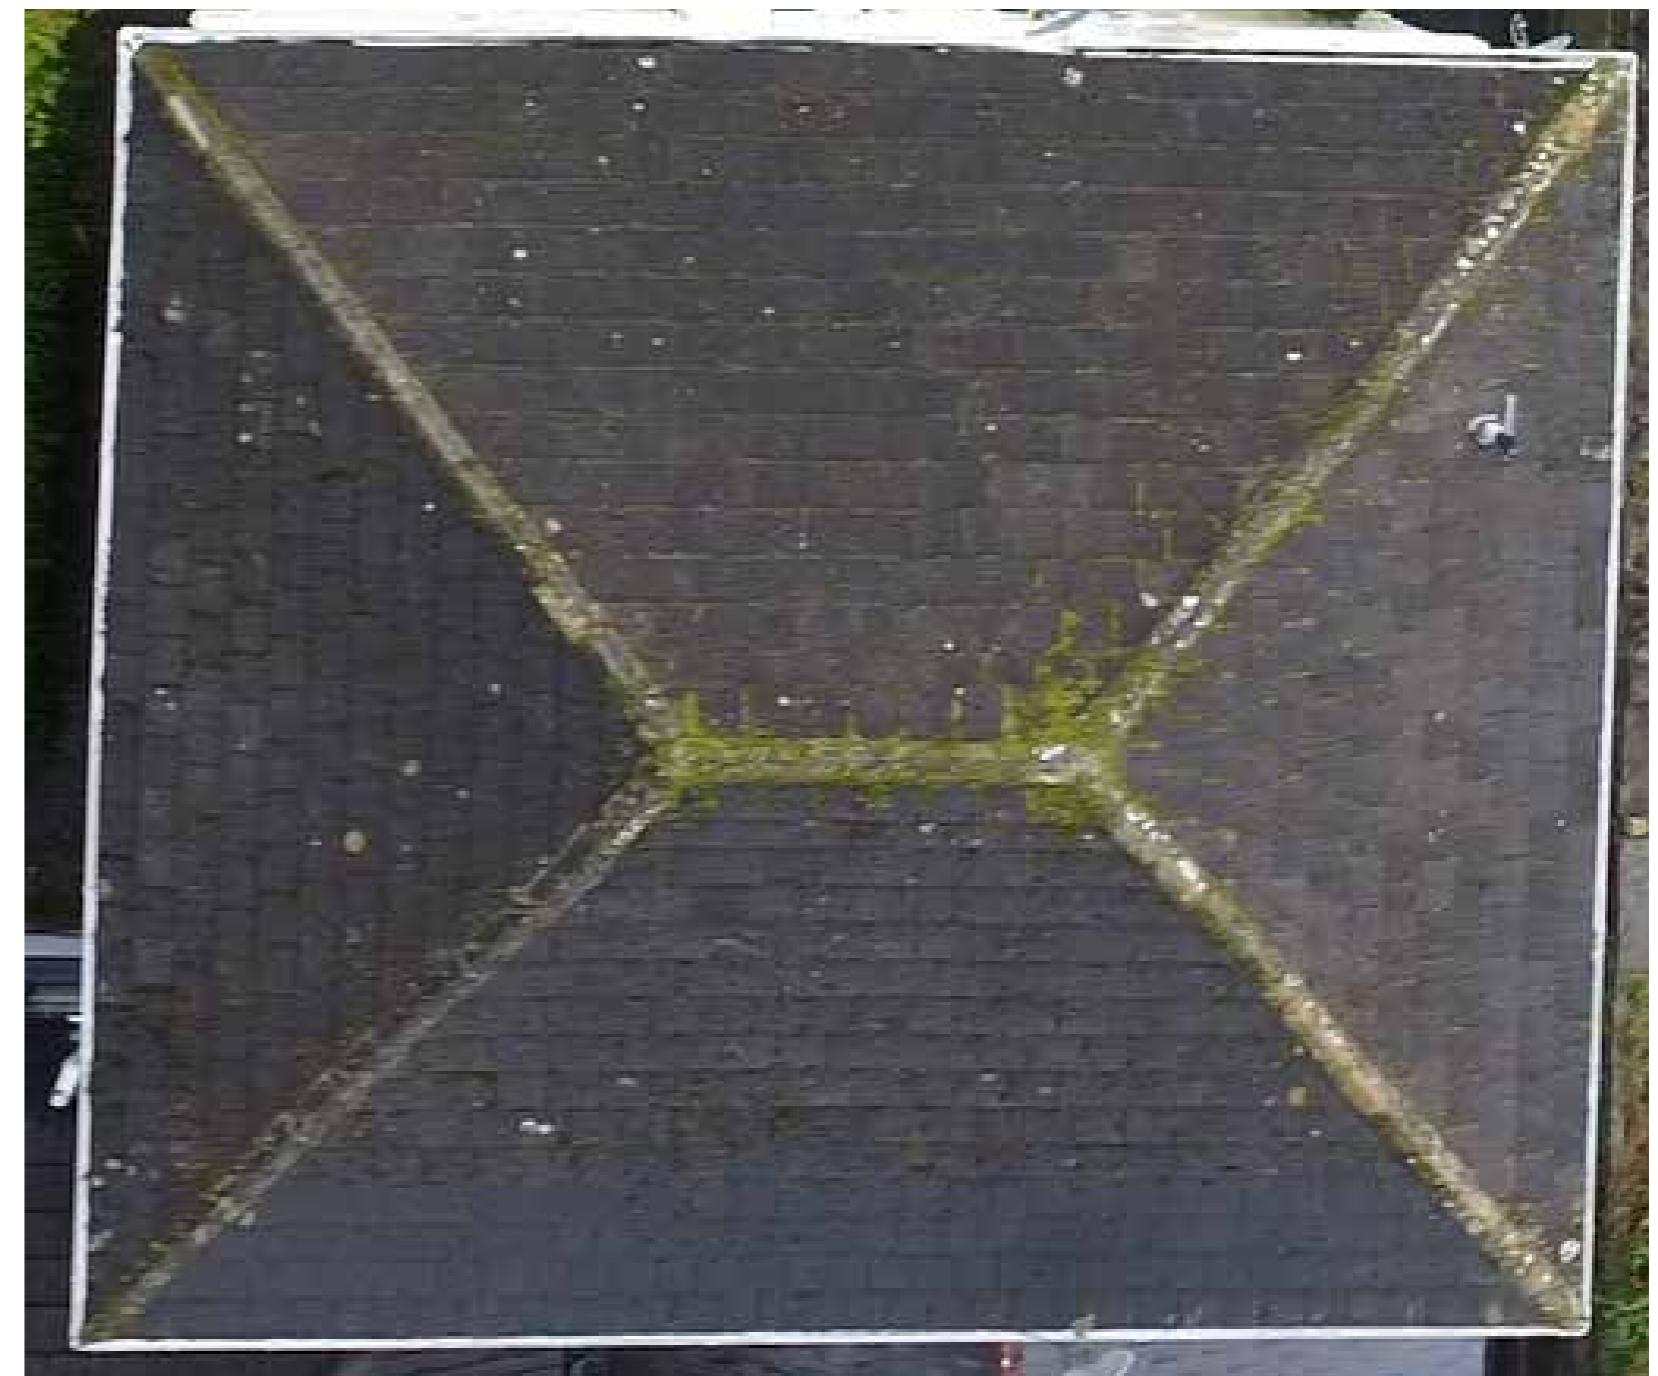
The roof is a simple rectangular hipped roof, covered in concrete tiles and rounded concrete ridge and hip tiles. The surface of the tiles is heavily mossed on the ridge and some hips. However, there do not appear to be any lost tiles, nor slipped tiles, and only a small number of broken tiles. In this regard, the roof covering appears to be in a reasonable condition. To the north pitch, it appears as though the bottom four courses have been replaced in the more recent past. One of those 'new' tiles is broken down the middle - see red box on next page.

It is noticeable that there are no chimneys penetrating the roof. With a number of fireplaces inside, there would have been at least two chimneys, possible four, penetrating the roof. These have all been removed. It does not appear as though the tops of these flues have been vented since the chimneys were removed, which is a worrying sign.

The roof would benefit from a clean of all of the moss, and the edges of the roofing membrane cut back; but no significant work is suggested to the roof covering.
