Primrose Hill, Merthyr Tydfil

RECORD OF BUILDING AND CONDITION ASSESSMENT REPORT, WITH REPAIR PROPOSALS

.....
(449)2503-GVWP-A-HIS-P01

Date: 05.03.25

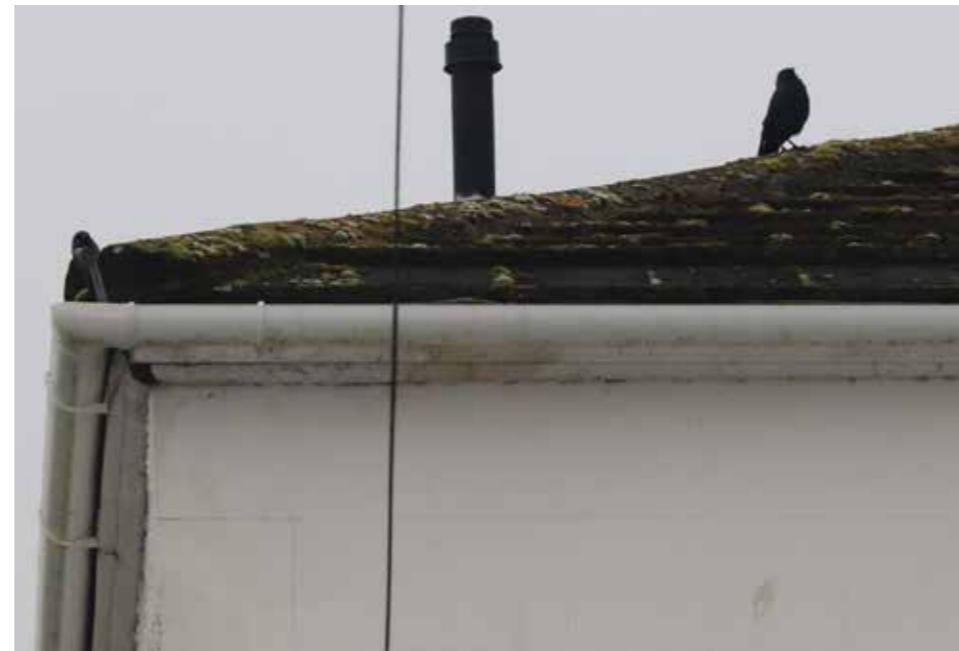
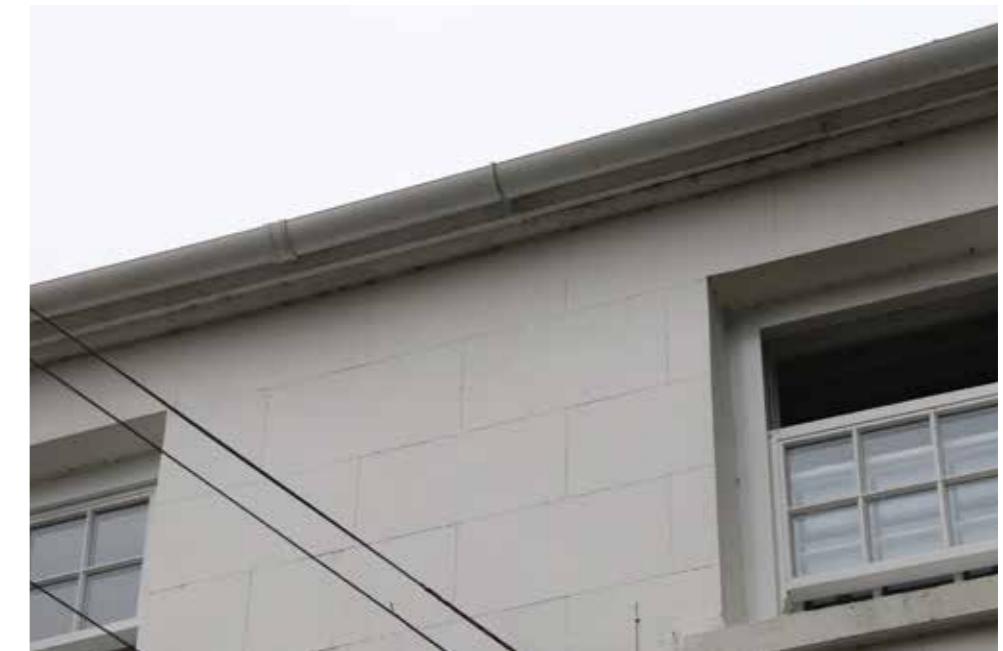
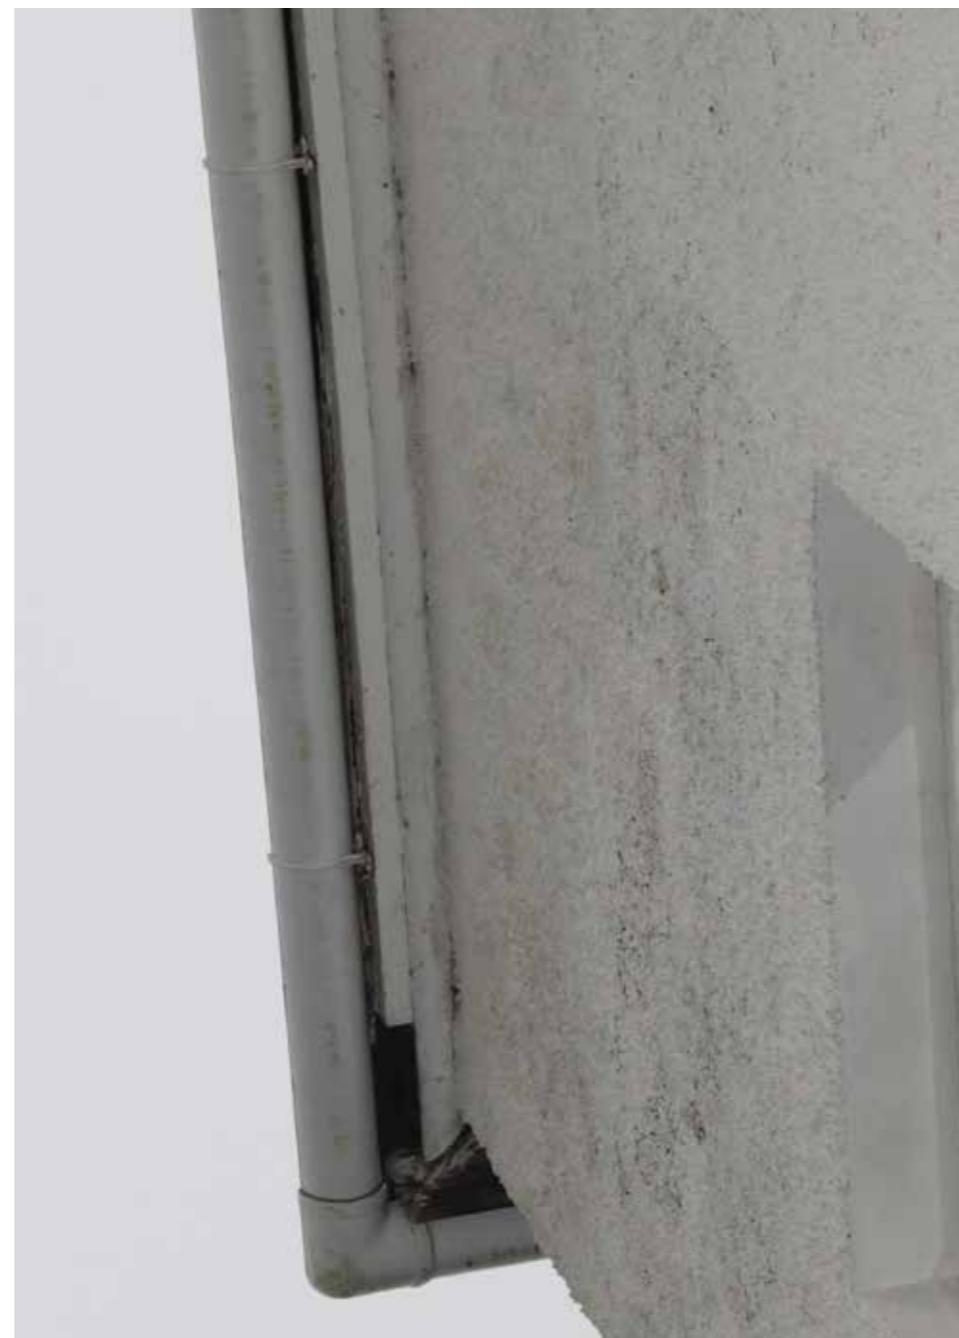
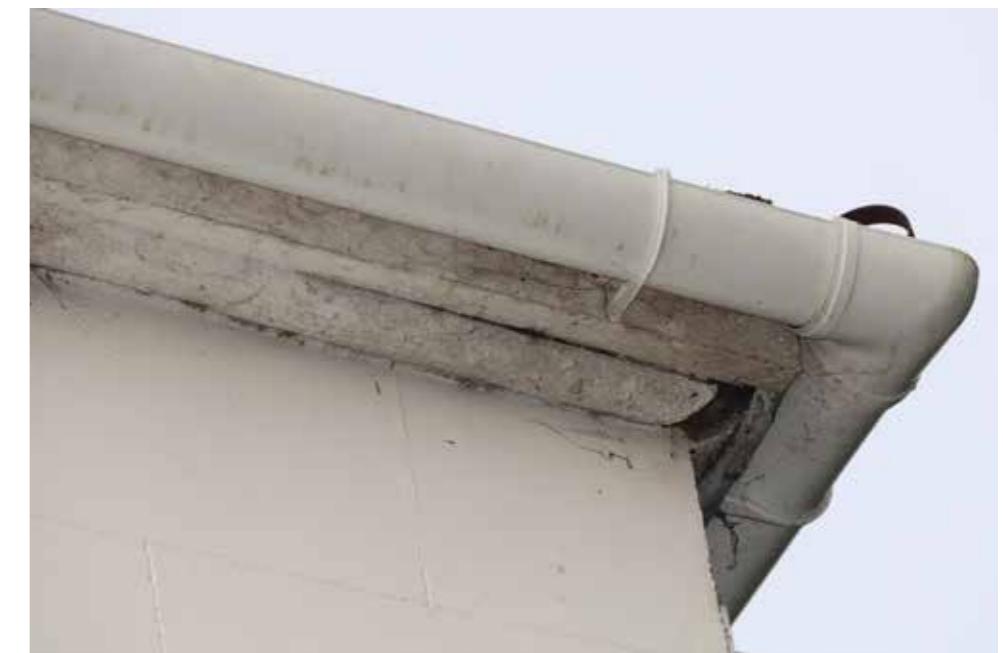
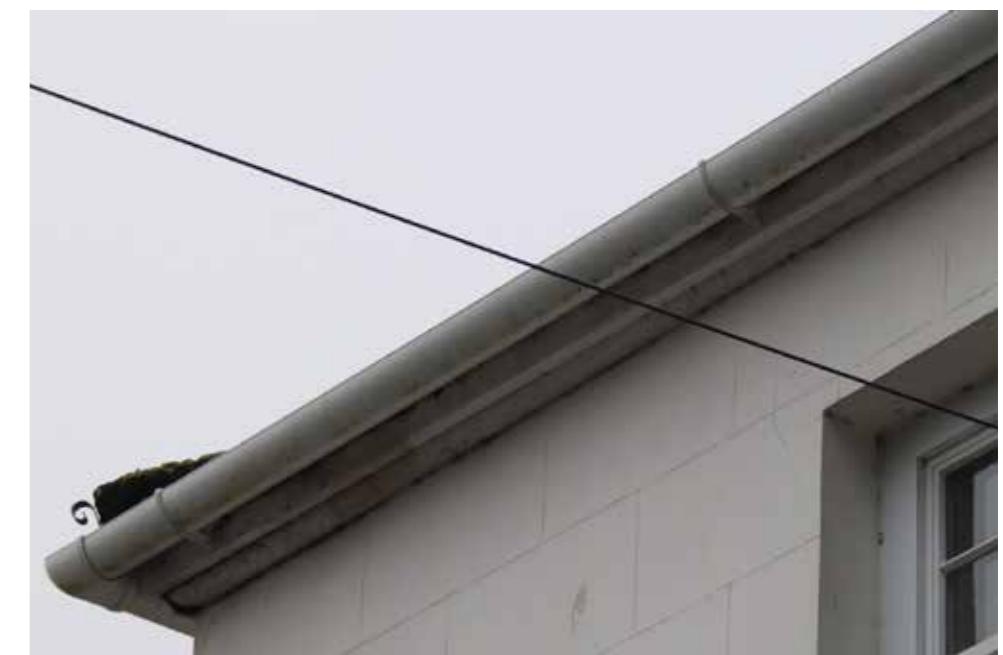
It is not possible to determine the condition of the fascia and soffit from this distance; and so it will be necessary to review them in more detail once scaffolding is up.

This being said, they appear to be in a reasonable condition, and may only be in need of a rub down and re-paint.

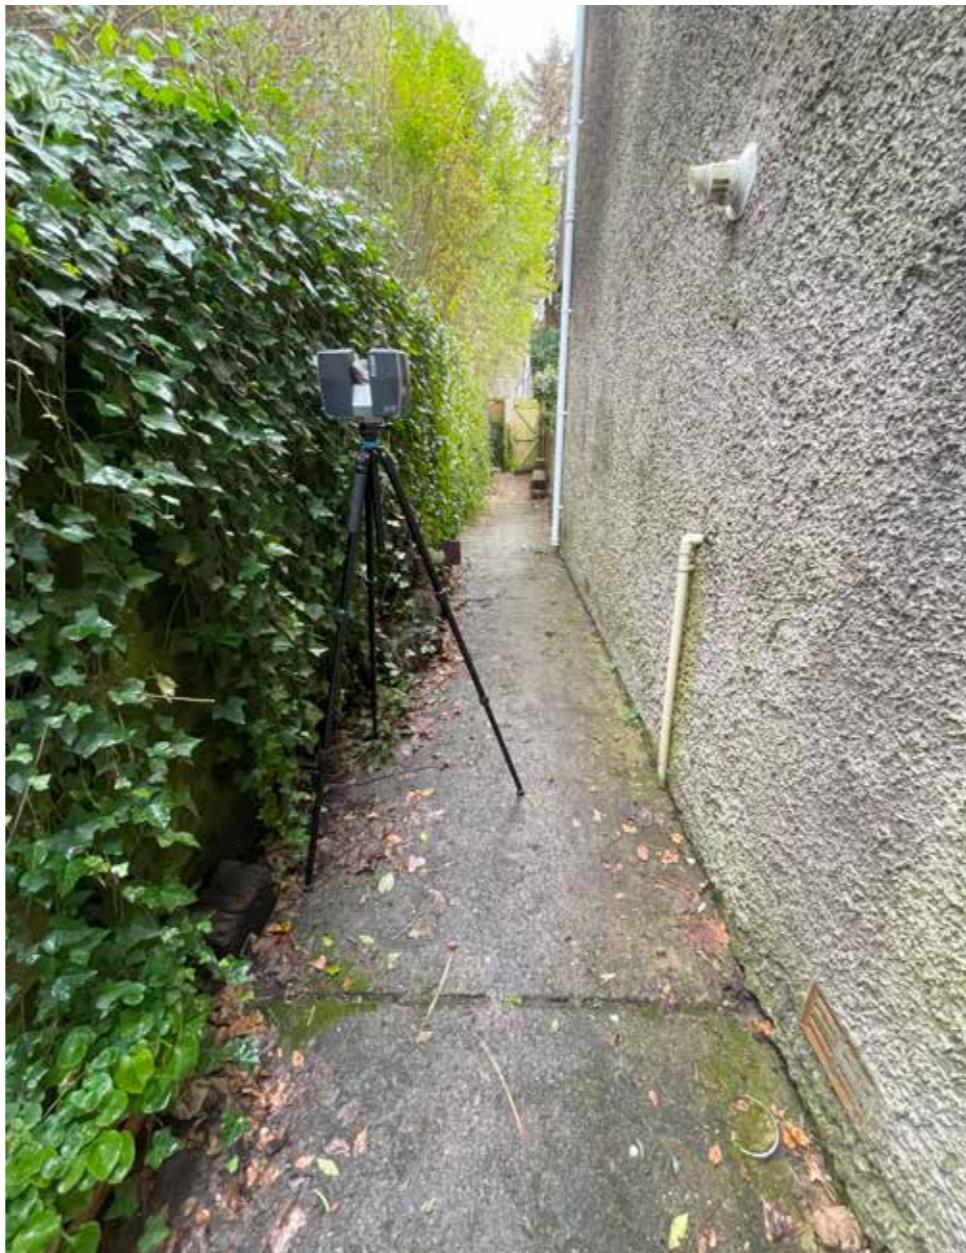
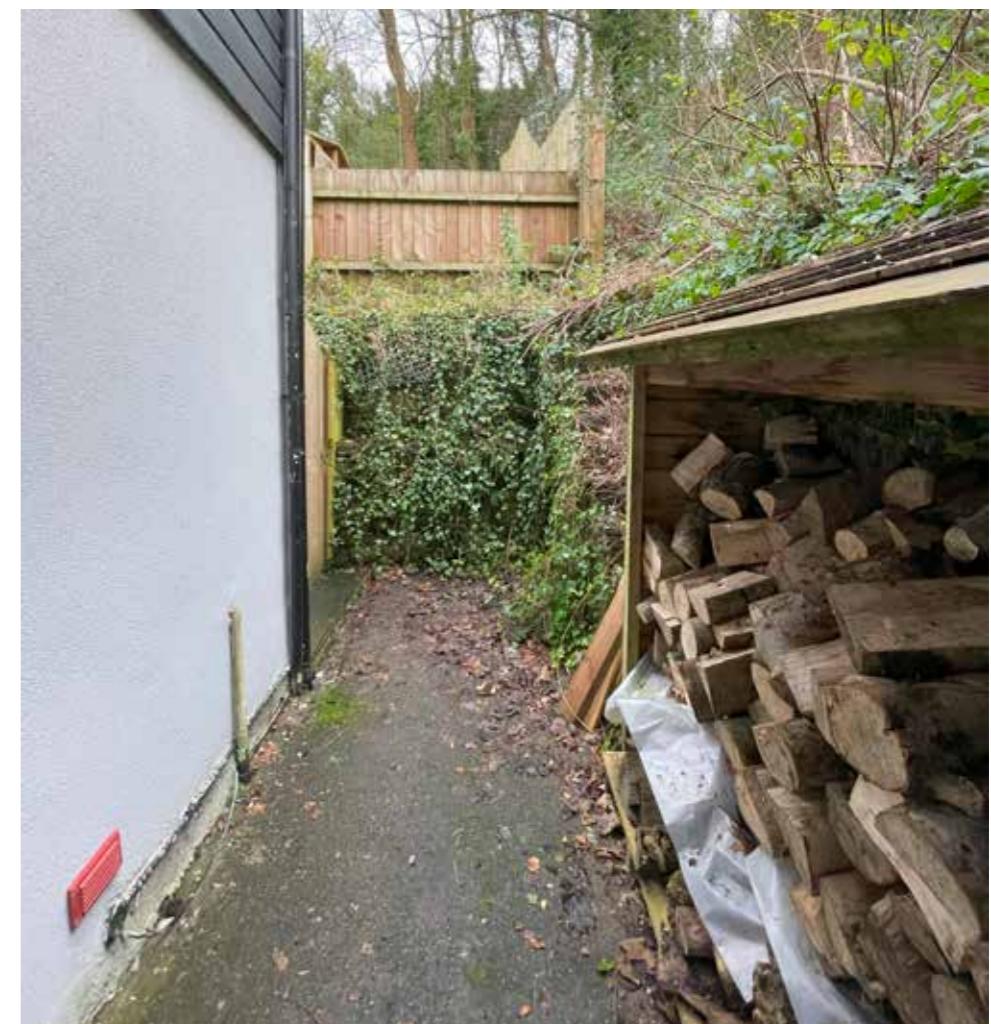
8.1 Side Path

The side path has a concrete surface which appears to be in a reasonable condition.

There is a timber boarded fence between the path and the front garden to Primrose Hill.

This path constitutes a 'Right of Way' to the property behind and to the north of Primrose Hill, which is accessed via a timber boarded gate - see top right photo.

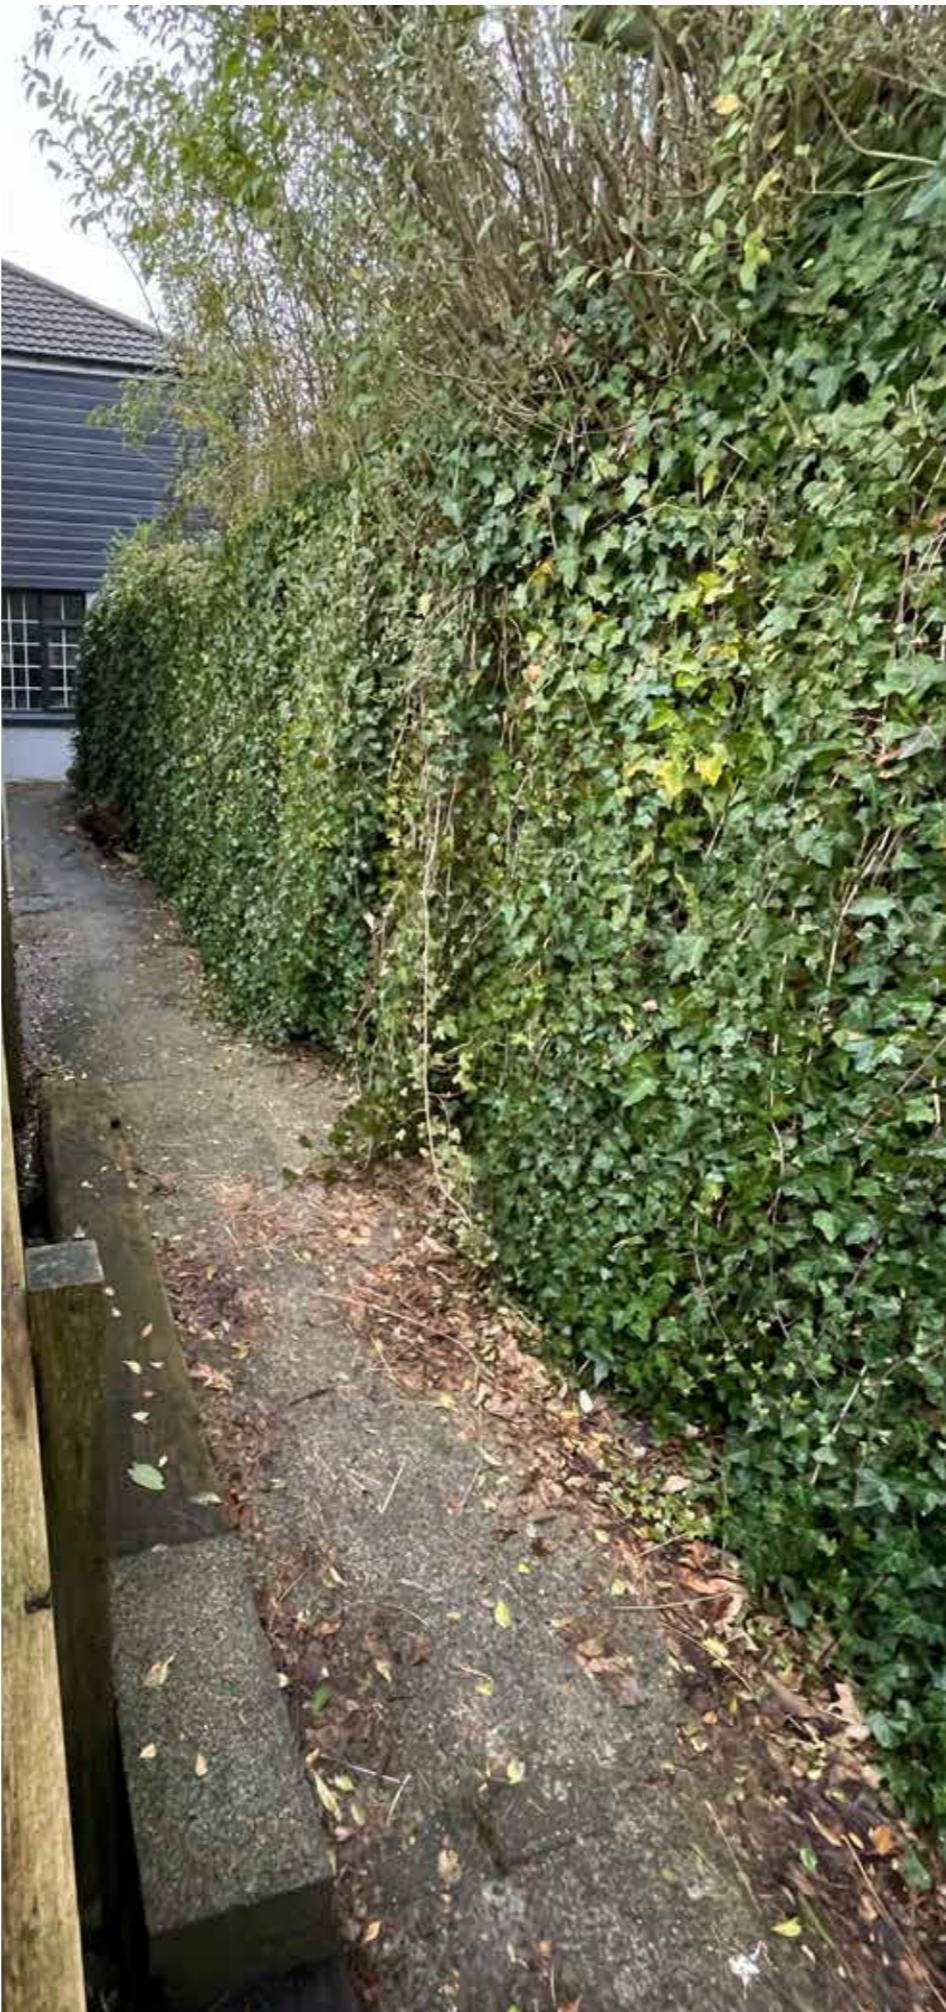
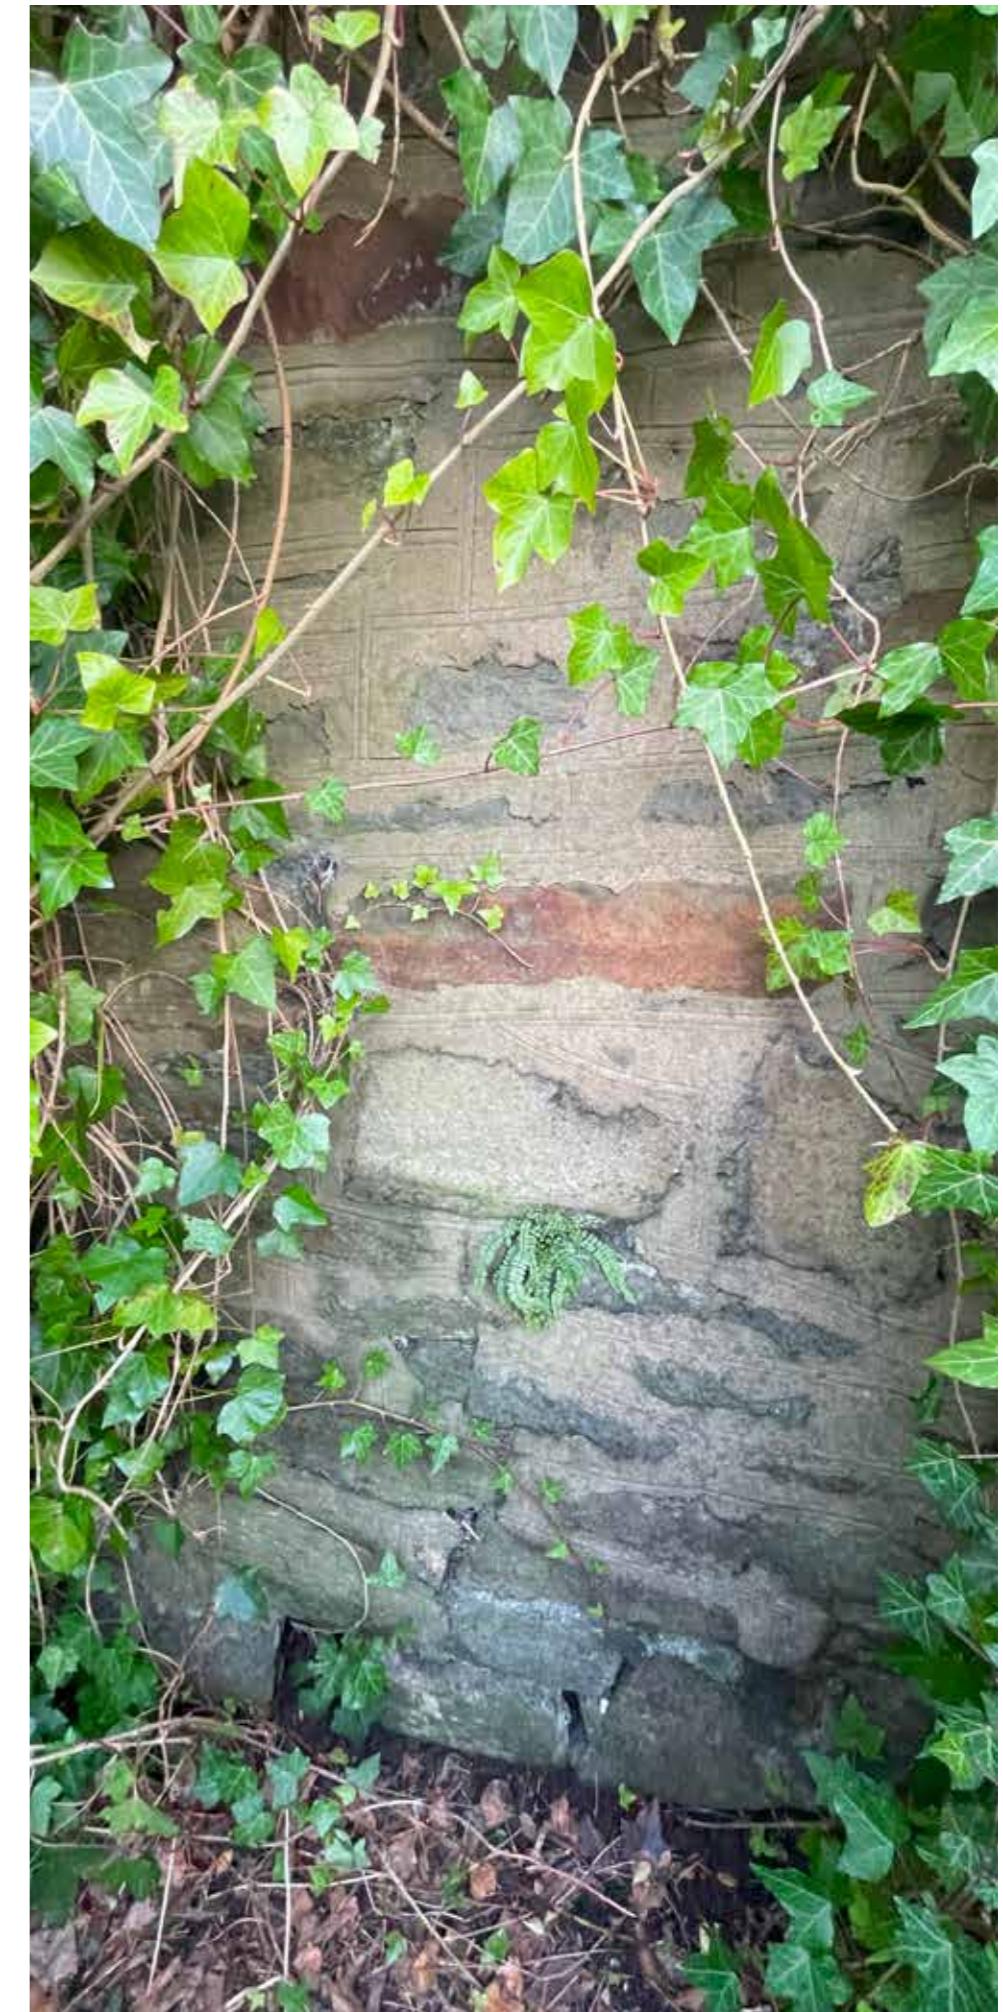
8.2 Retaining Wall

Covered by ivy and other vegetation, to the side of the path, east of Primrose Hill, is a retaining wall, approximately 3m high, made of rubble stonework. It is assumed that the stones are bedded on a lime mortar (albeit not confirmed) and that it used to be pointed in a lime mortar; however, it is apparent that the wall has more recently been pointed in a cementitious mortar, using a buttering / part rendering which has covered much of the stonework. The wall is covered in vegetation, to face and top, and so the wall could barely be inspected; however, there is concern about the use of cement for the pointing and for the restriction this will have put to the passage of moisture through the wall.

A 'makeshift' drainage hole was apparent at the base in one location; however, it is not clear whether there is a full drainage provision to this wall. That being said, percolation tests undertaken to the ground above suggests a good level of natural drainage in the ground above this wall.

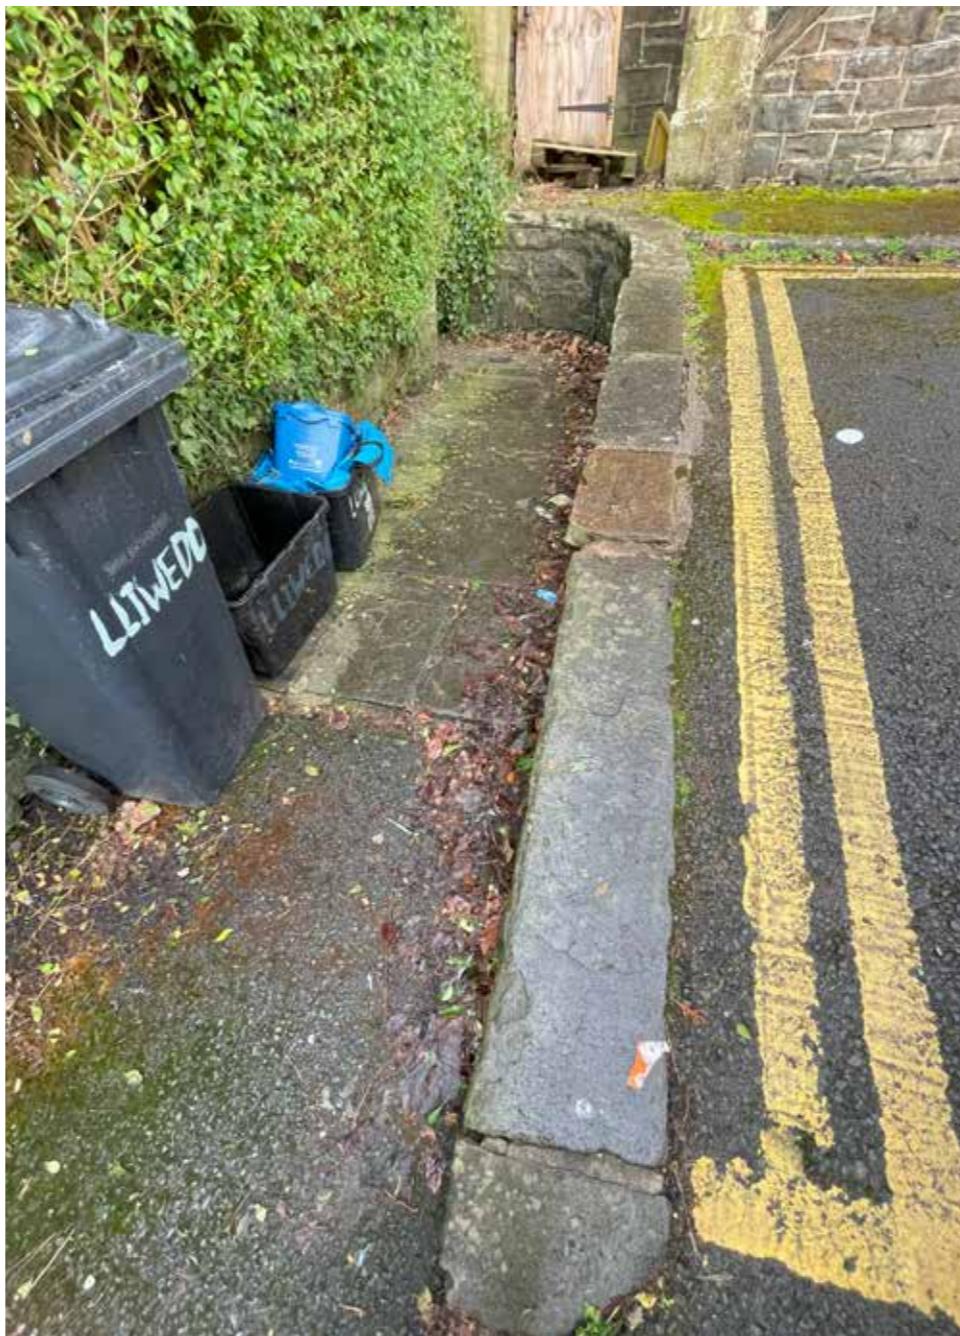
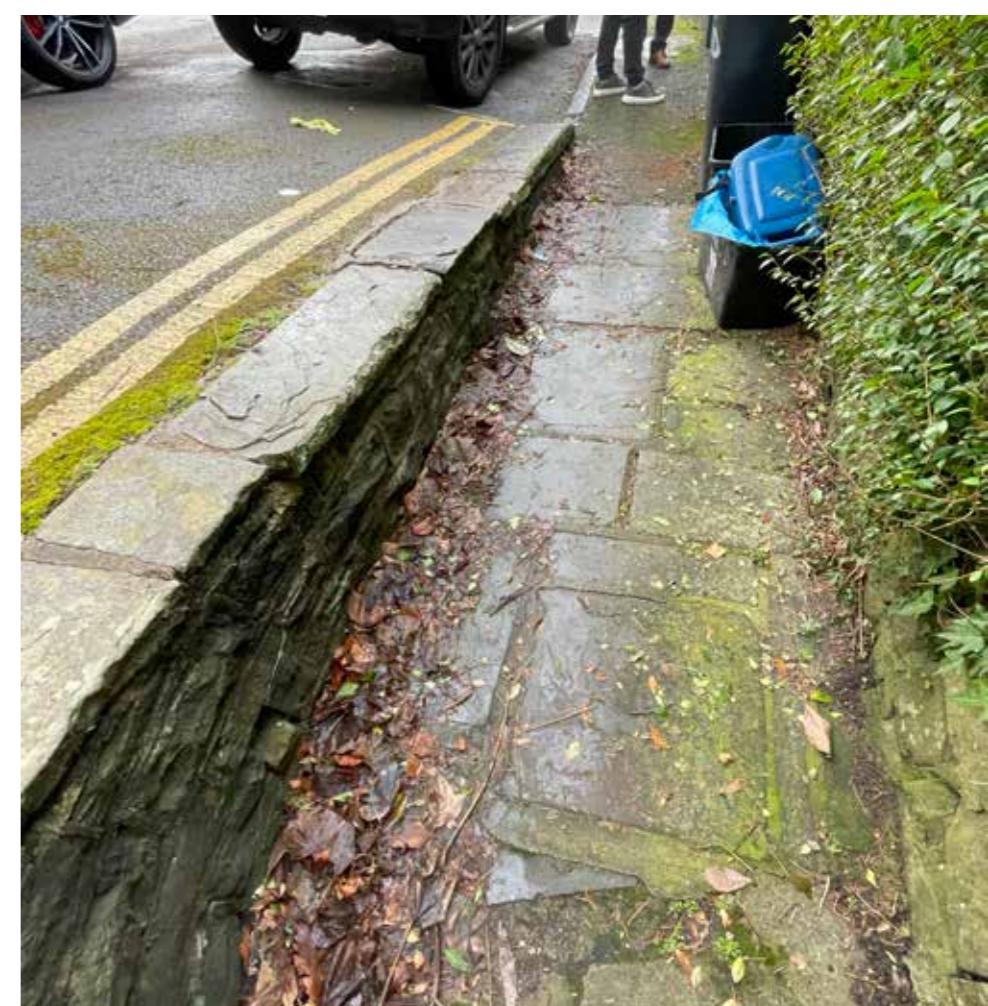
9.1 Front Pavement

Between the tarmac road and the front wall to Primrose Hill's front garden there is a row of coping stones and then a drop to an area of stone flag paving. The tarmac is sloped, whilst the flagging is level, with the stone-capped wall acting as a retaining wall for the sloped road. The retaining wall then curves around at the top, leading towards the Right of Way path. At the bottom of the path is a set of three stone steps faced on the risers in blue-black engineering brick.

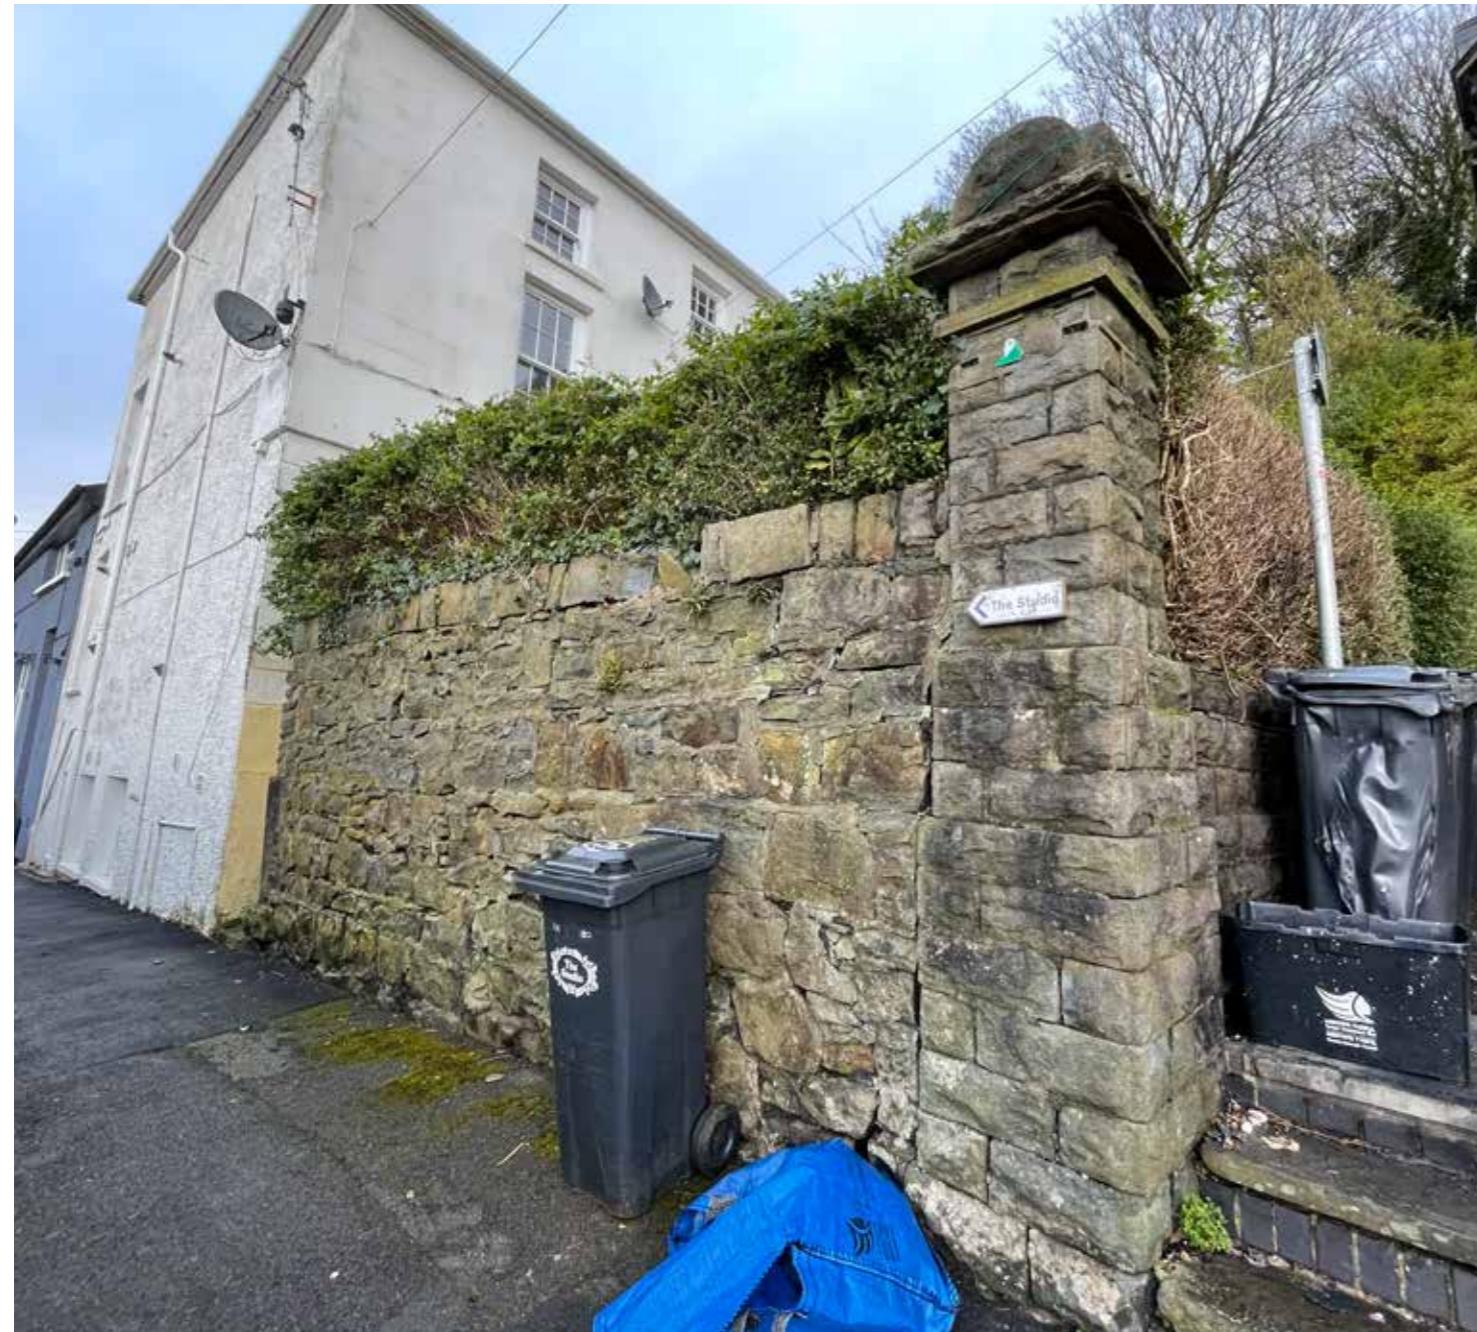
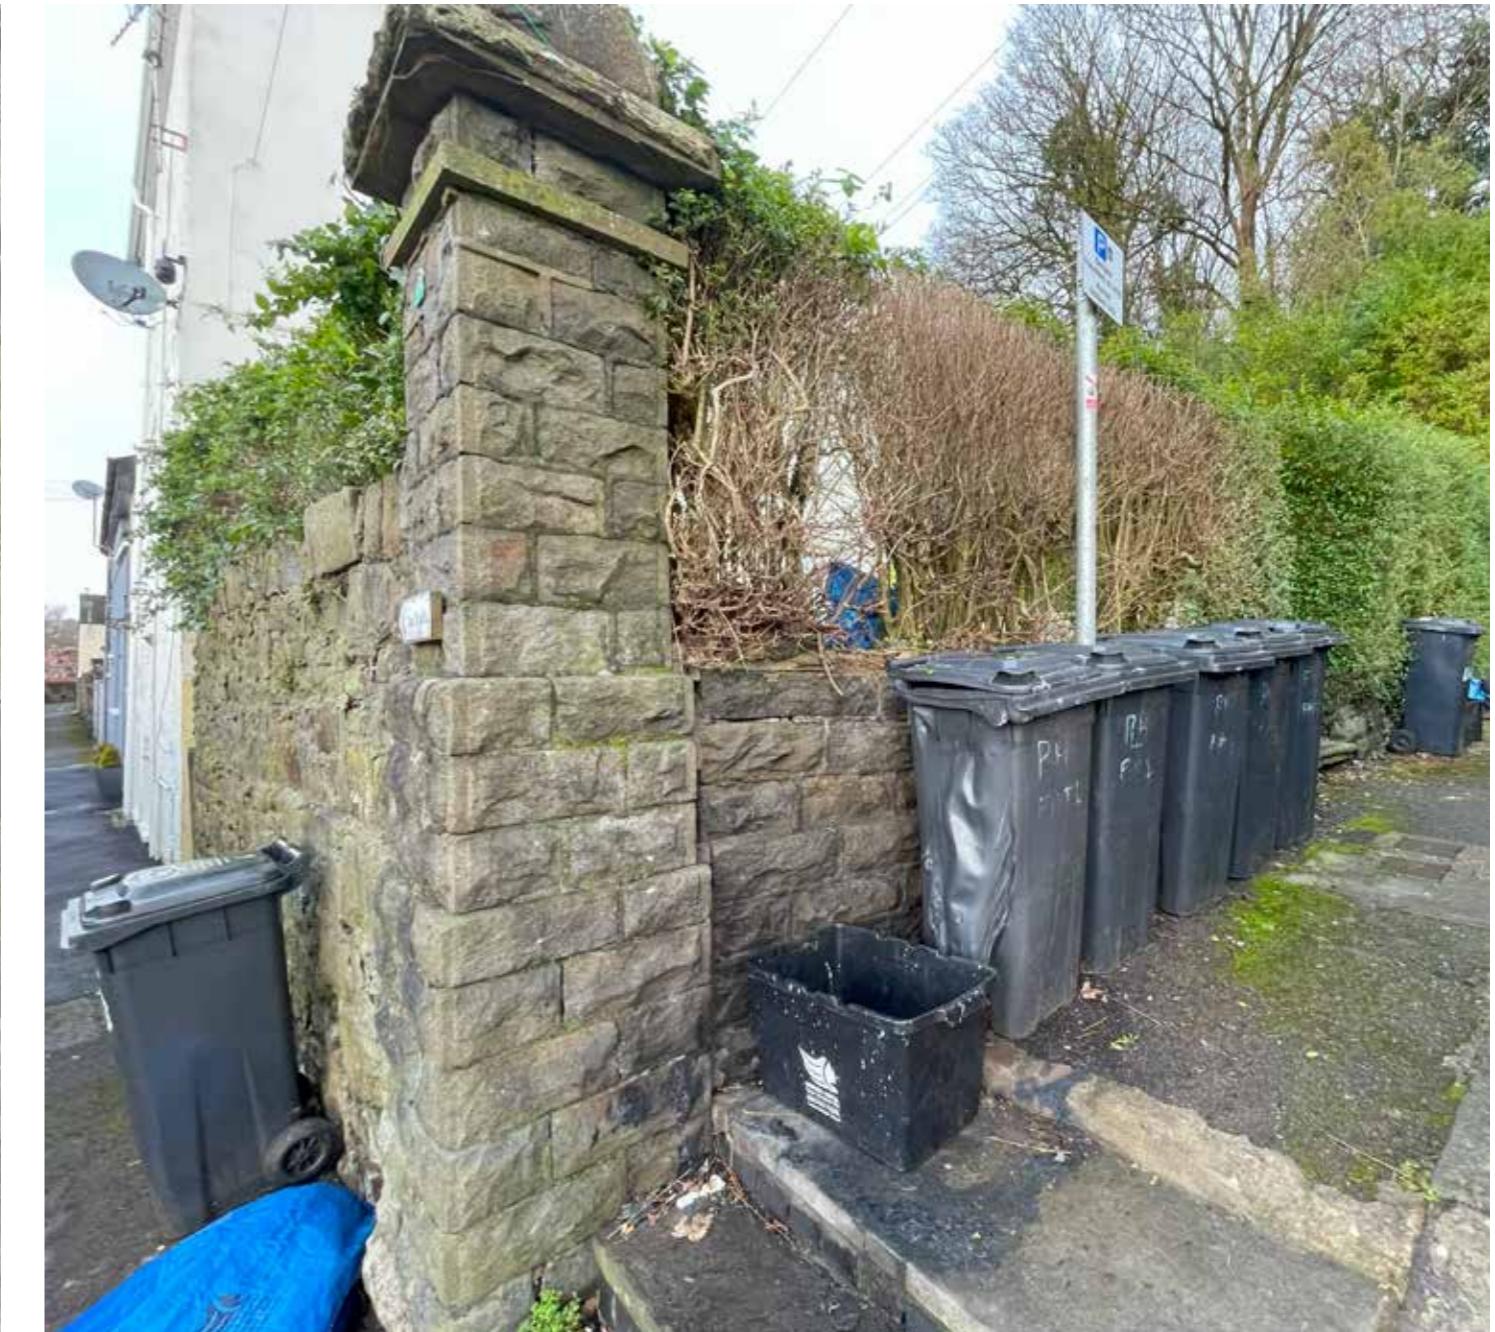
9.2 Front and Side Walls

To the west and south of the front garden is a pennant rubble stone enclosure wall, part retaining on the west. On the corner is a square, tall gate-post.

The stonework is bedded in lime mortar. In the past, it has been re-pointed in cement mortar; however, a fair bit of that has broken up and fallen away. Many of the joints are recessed and in need of pointing.

The proposals involve raking out the joints and removing what remains of the cement pointing, and re-pointing the whole wall in a lime mortar.
