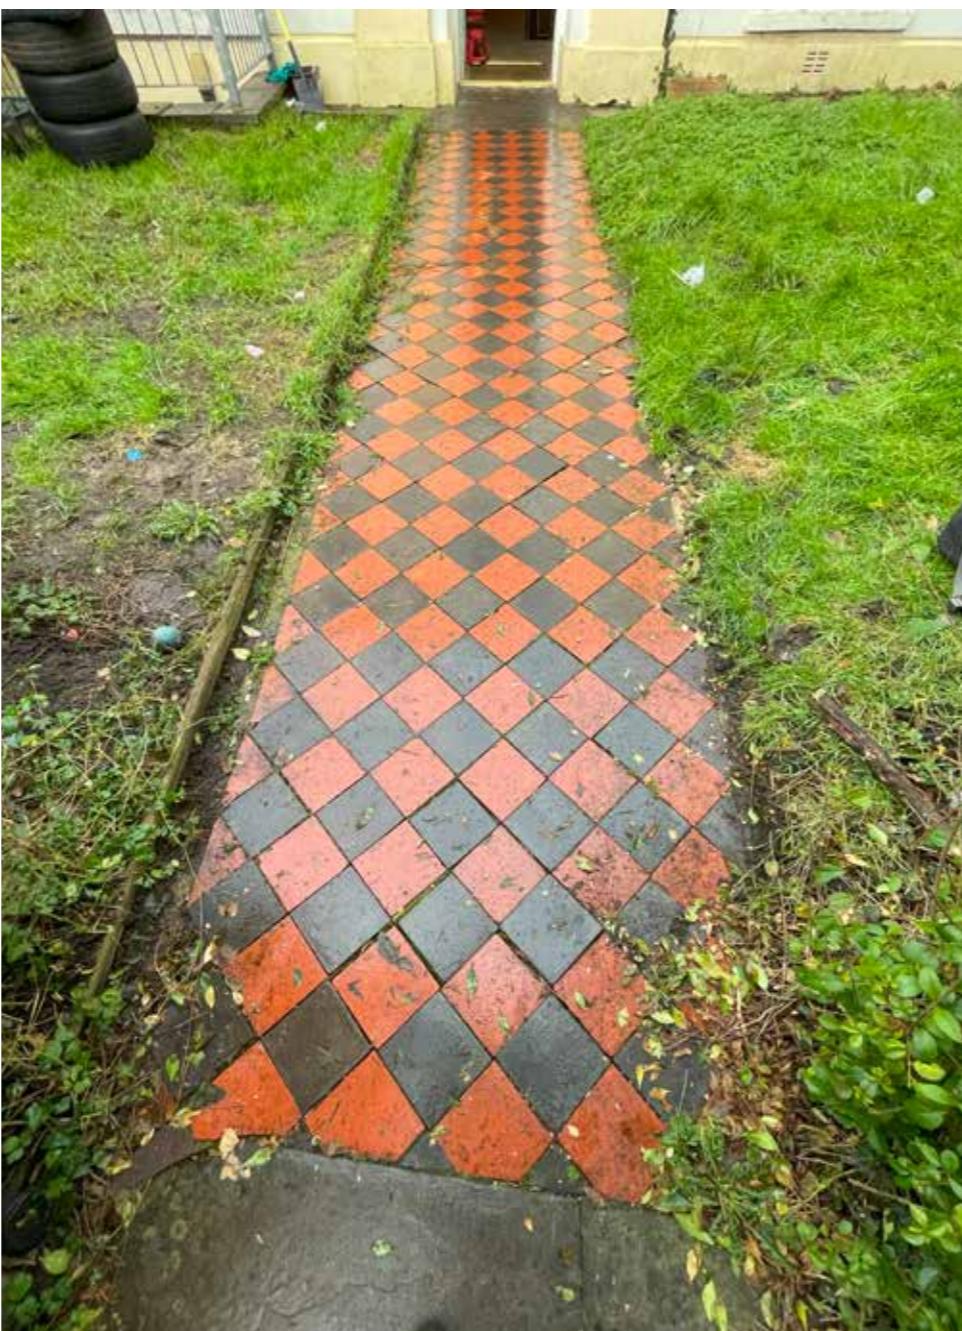
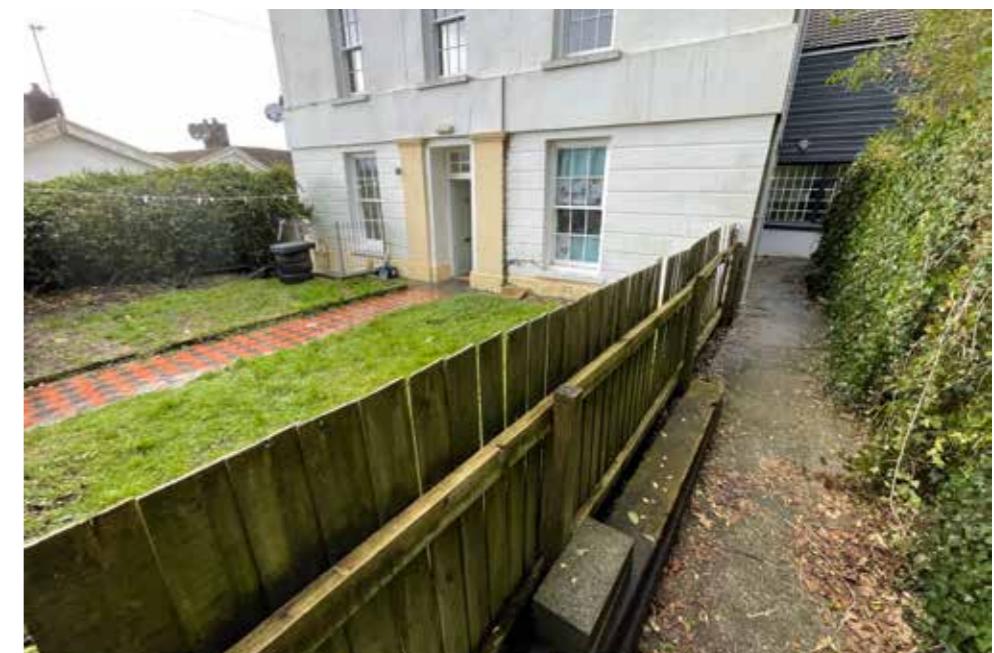
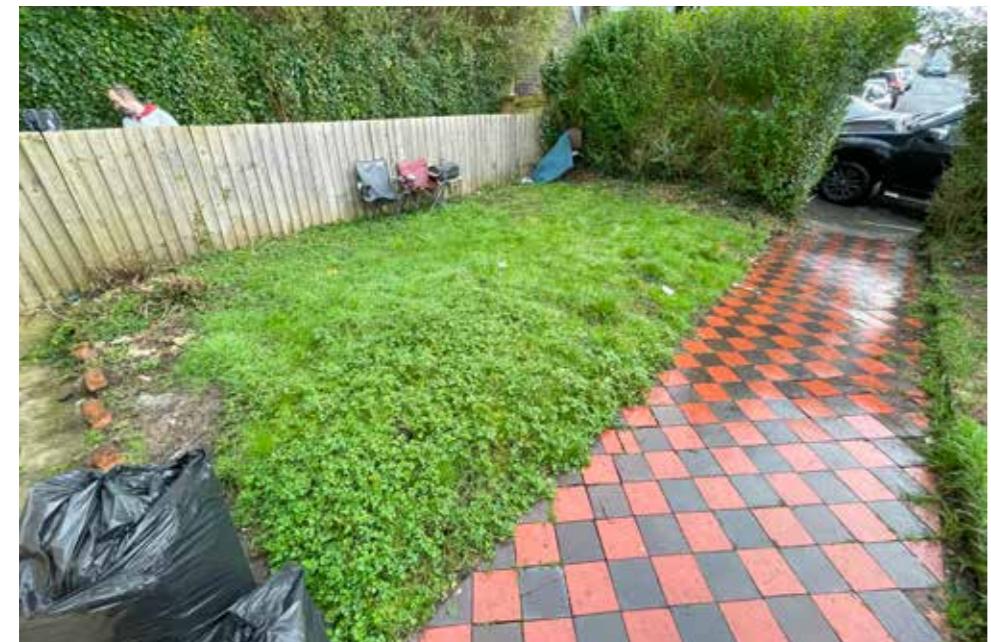
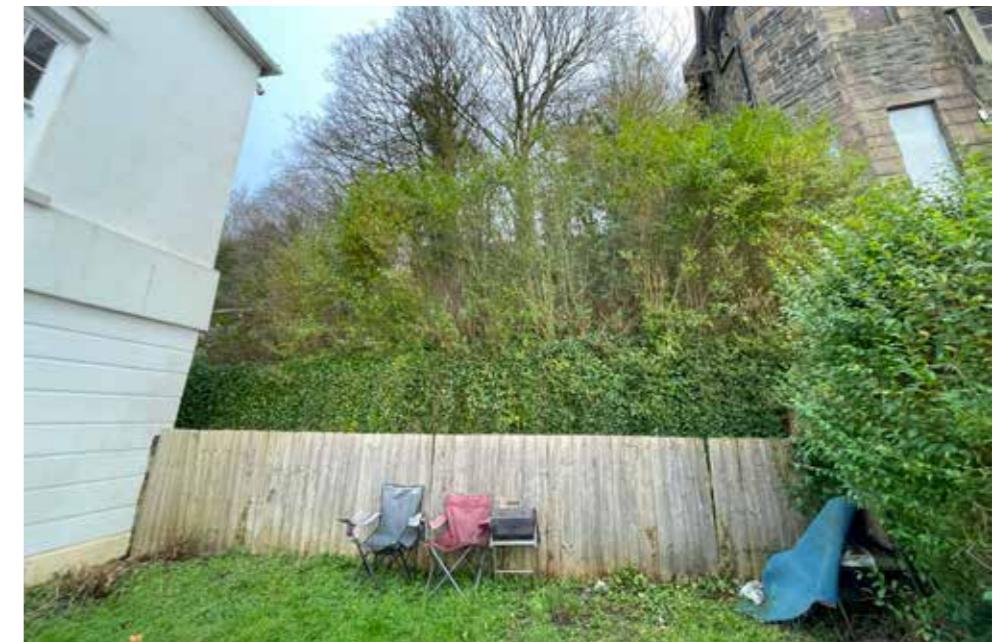
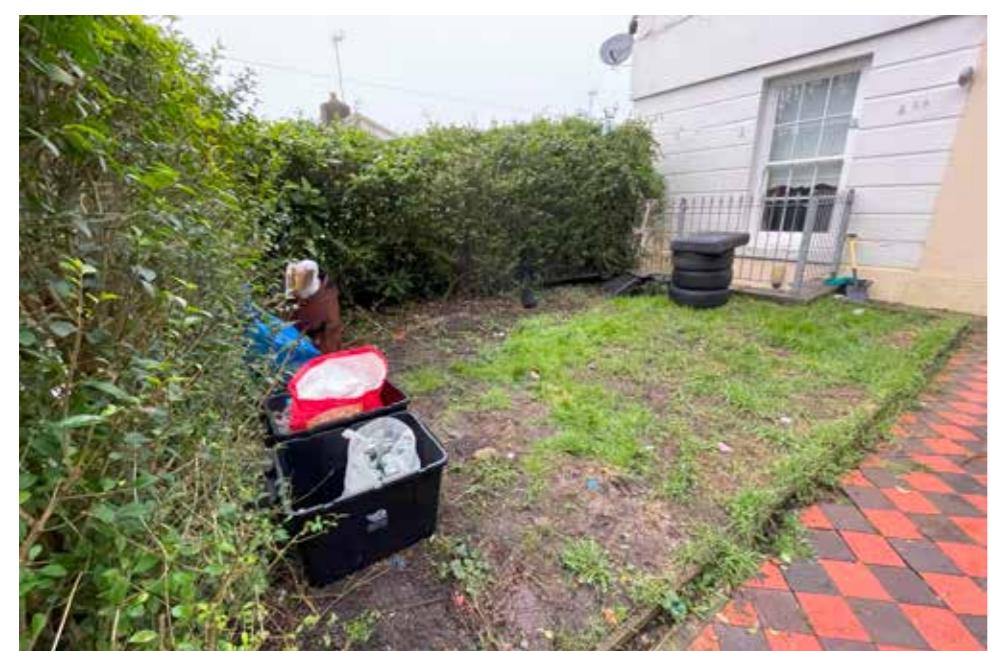
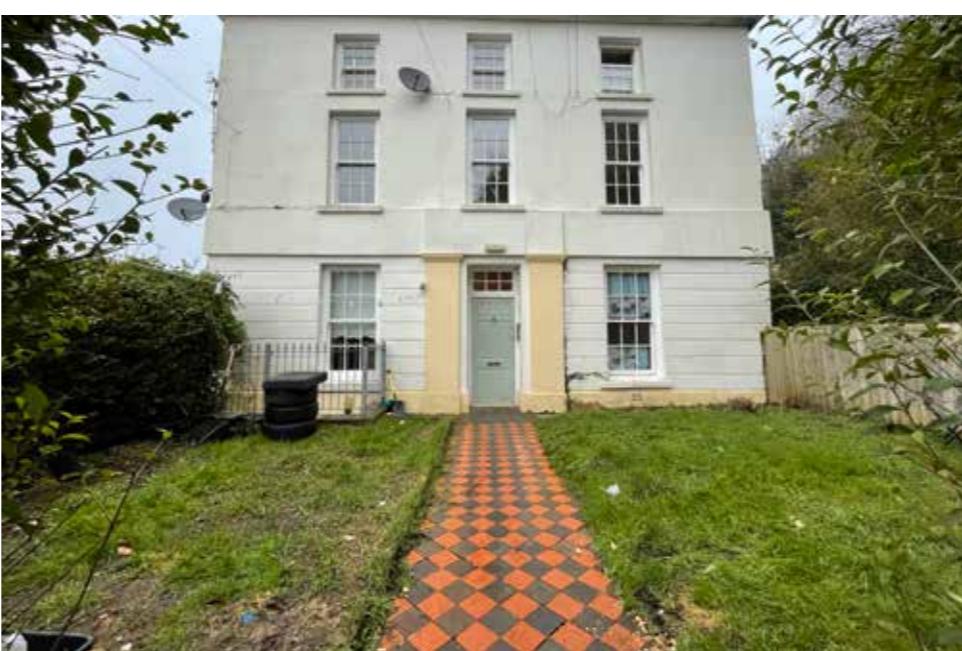
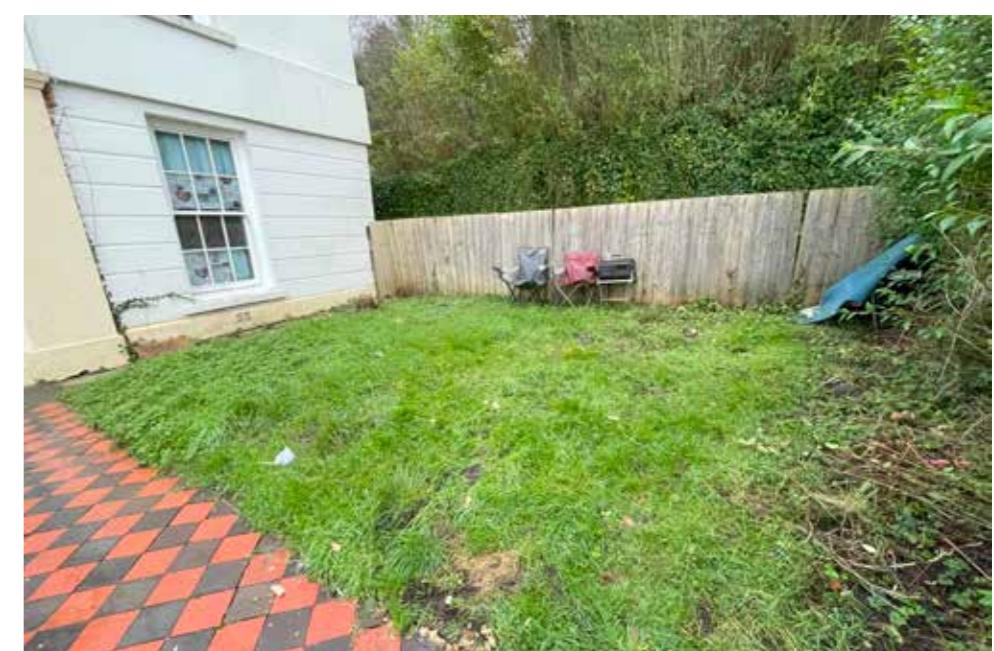
9.3 Front Garden

The front garden is turfed on both sides of a terracotta and black diamond-pattern quarry tiled path, running from the opening in the front wall to the entrance door.

The tiling is in a reasonable condition; however, there are a small number of damaged tiles and most of the grouting has been lost.

It is proposed that those damaged tiles are replace like-for-like and the whole area is re-grouted.

During any construction works, it is very important that this path is protected from further damaged.

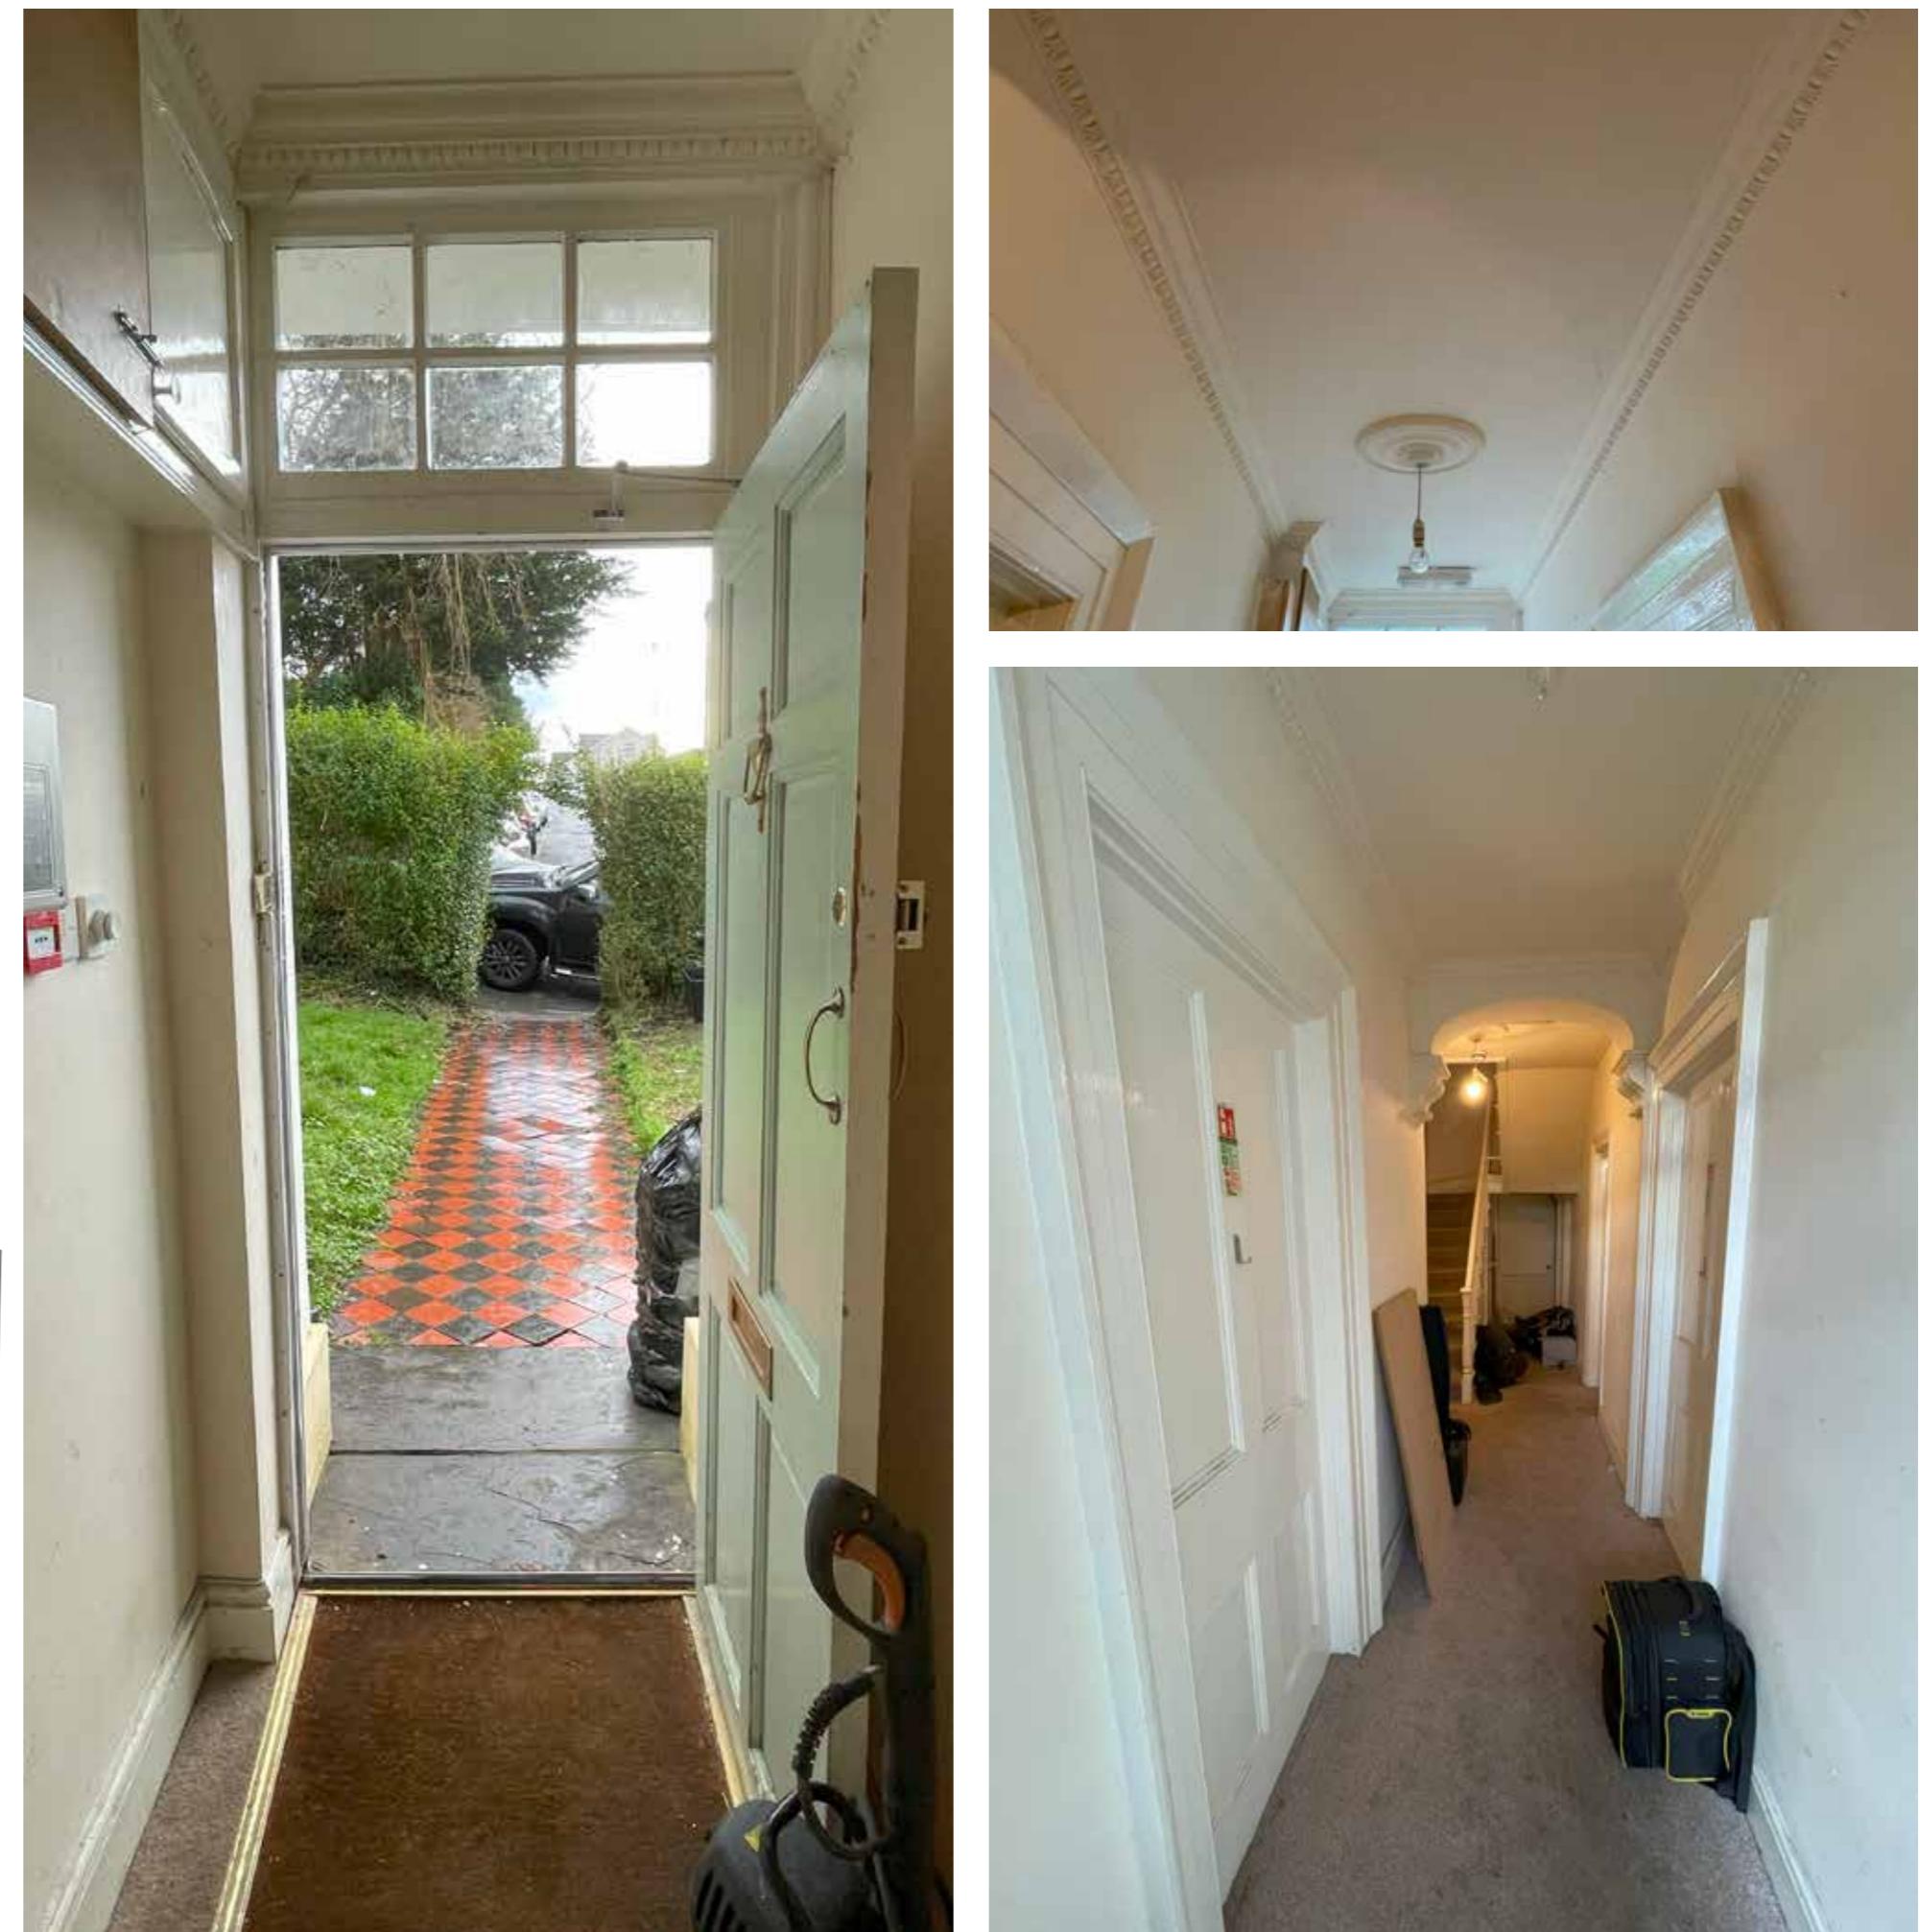
10.0 Interior - Ground Floor - Entrance Corridor

There are a number of scars on the paintwork; however, generally, the fabric and finishes are in a reasonable condition.

The floor is carpeted, which is a little worn, and there is a matwell at the front.

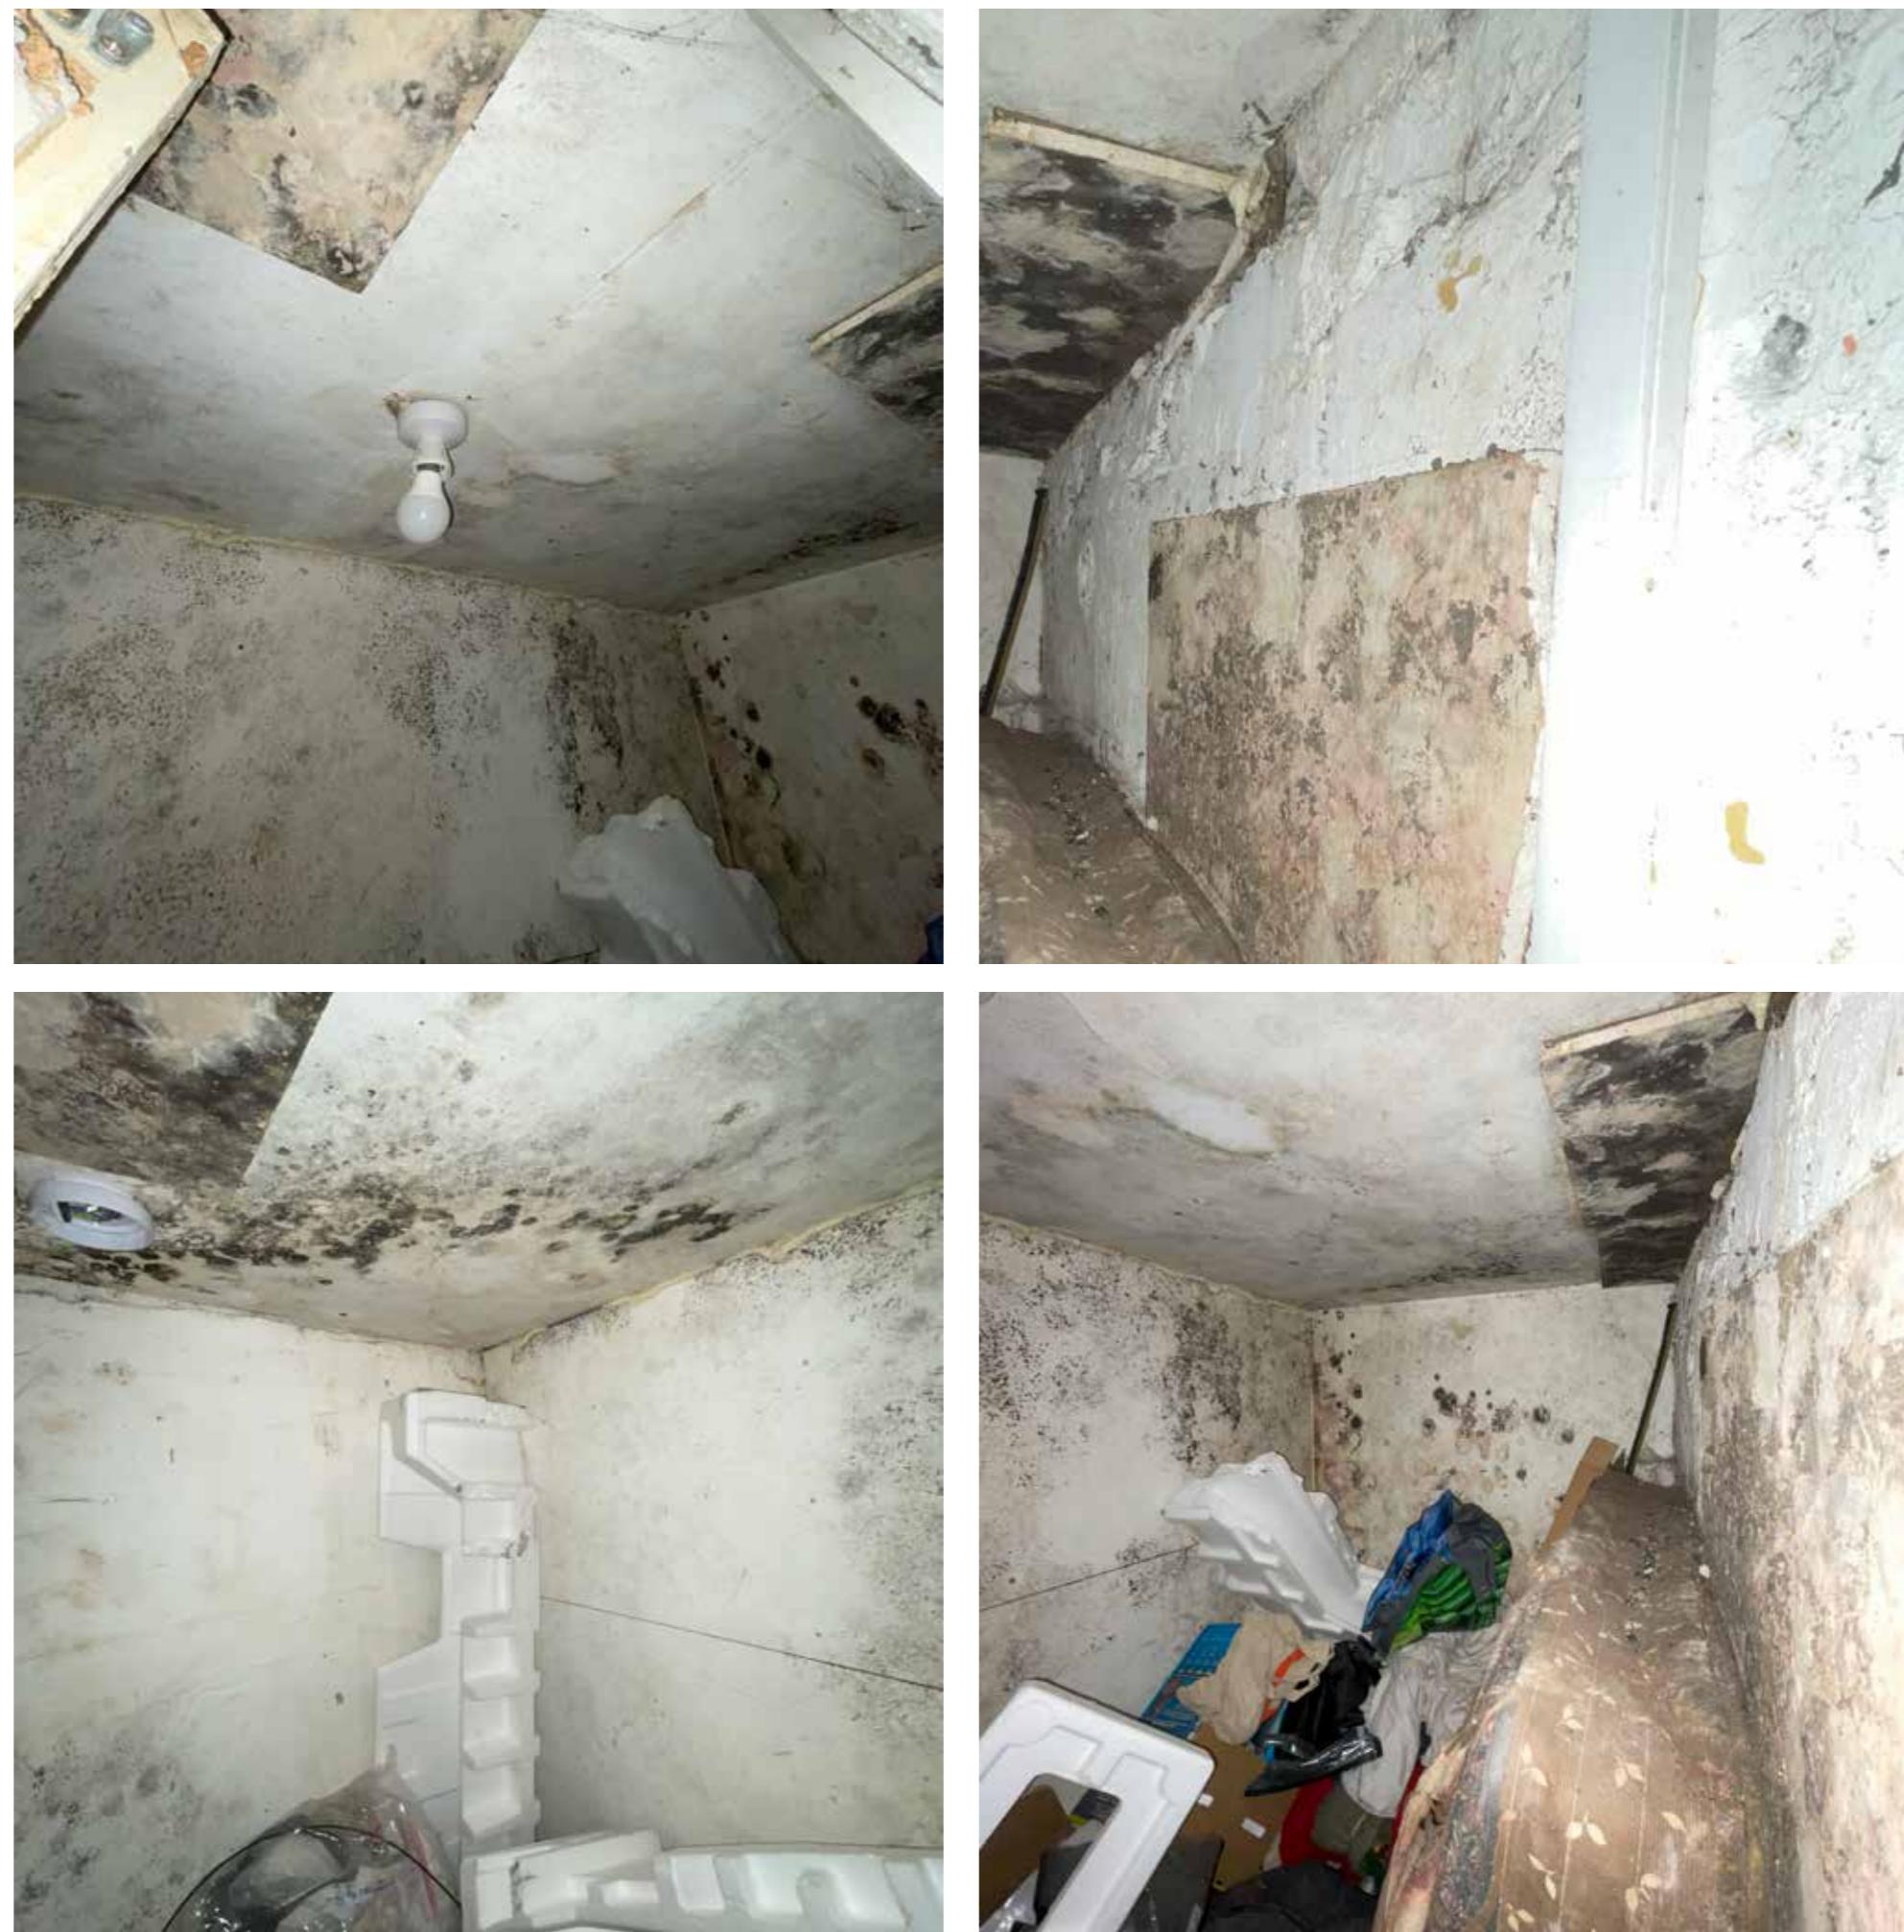
10.0 Interior - Ground Floor - Rear Store Room

The masonry enclosure store at the back of the corridor is 'landlocked' with the building behind and the matching store above. It is suffering from damp and mould growth on all four walls and the soffit. Containing various elements, an completely dark inside, it is difficult to get a good appreciation for its detailed condition.

There appears to be no ventilation at all to the space, and no heating. To that end, condensation and mould growth, with cold bridging to the envelope, is inevitable.

The proposals involve adding a heating source to the space and providing ventilation. This is likely to be in the form of a door transfer grille at the bottom and top of the door, in order to encourage some cross ventilation. However, given that this will be used as a store, and it is within a fire escape route, the grilles will need to be intumescent fire-rated grilles. This intervention will need to be discussed with the Building Control Officer.

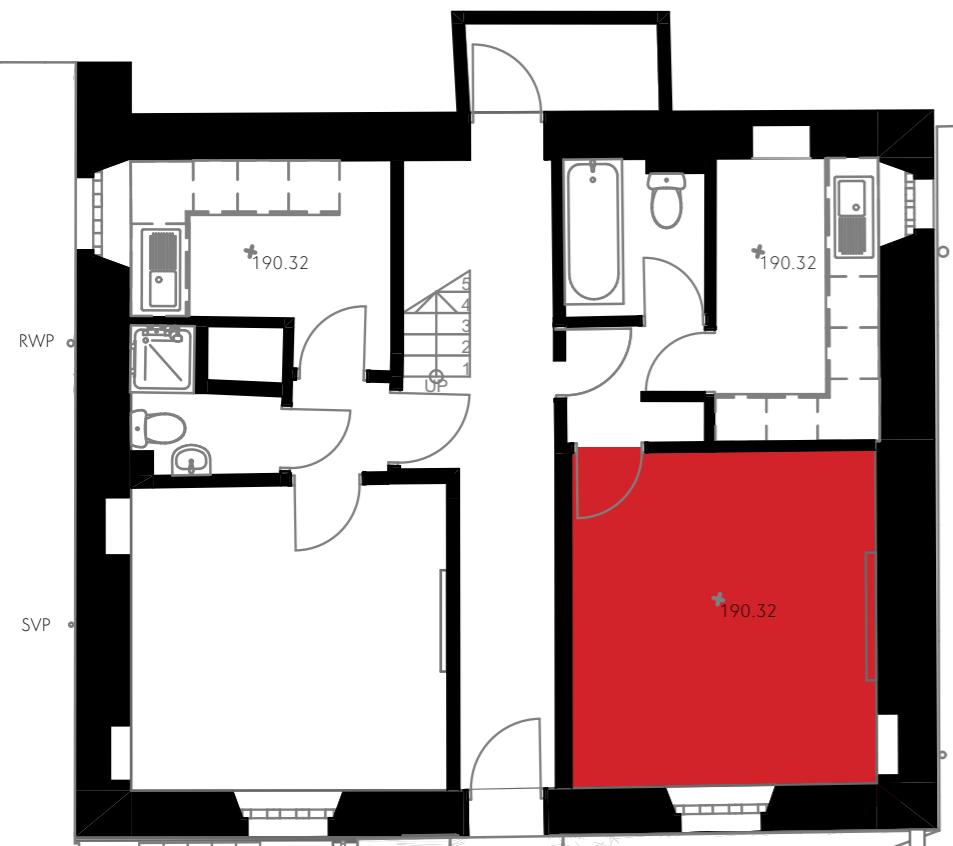
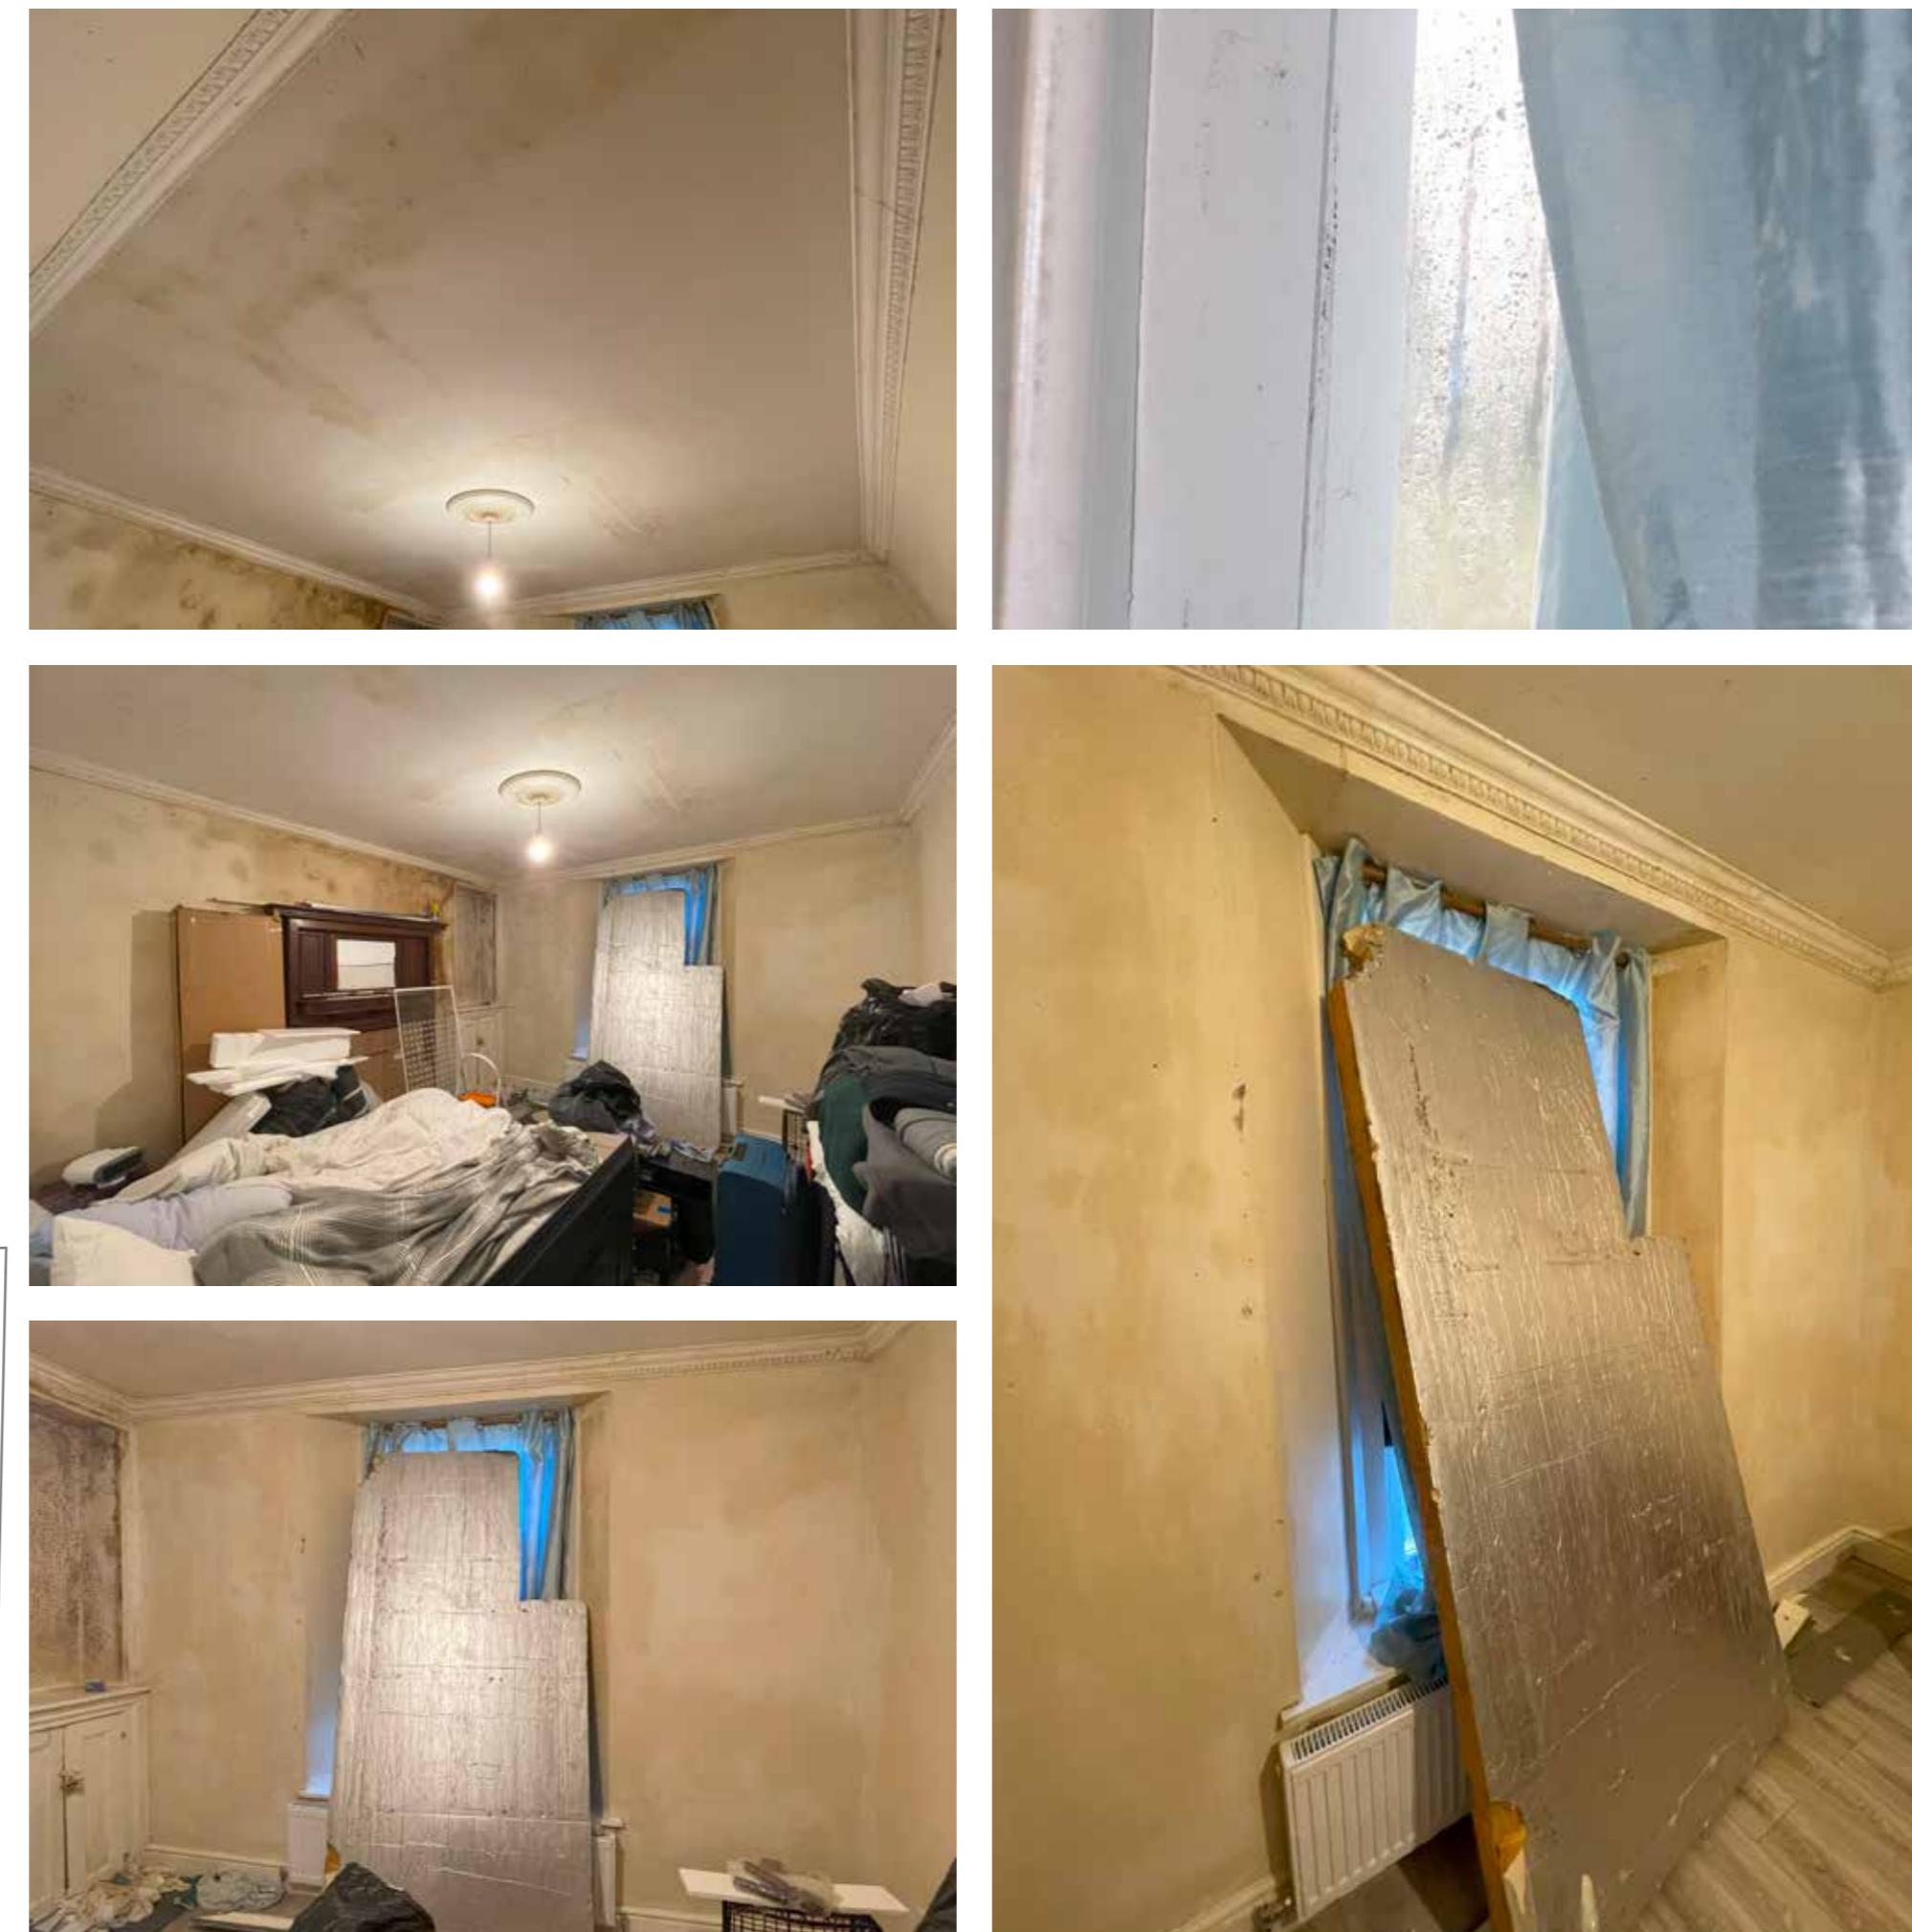
10.0 Interior - Ground Floor - East Flat Front Room

Whilst, also of painted plastered walls and ceiling, with egg-and-dart cornice and ceiling rose; this room and flat is coated with staining and wet - to walls and ceiling - and large areas of mould growth. One questions why this flat is so bad, whilst the matching flat on the other side is not. Indeed, the window is double glazed, and new. The proposals will involve removing all of the plaster and investigating the masonry behind. There could be defects in the walls; there could be cold-bridges; there could be damp coming in from outside and, unable to escape, it has saturated the walls, causing damp conditions internally. However, the level of condensation in this flat is extremely high - note the water streaming down the window, which is new and double-glazed. One feels that part of the problem may be with the tenant's living habits. There appears to be no background heating on (we were advised that the boiler did not always work); it does not look like the windows were often opened to ventilate the space; insulation had been applied to the inside face of walls (thereby stopping any warmth getting into the walls and drying them out); and it looked like washing was regularly dried in the space and cooking a regular thing, with questionable hood ventilation.

There may well be an issue with the walls; they may well be holding moisture unable to escape due to the cementitious render and gypsum plaster; there may well be gaps in the construction and/or cold-bridges. This will all need to be investigated once the render and plaster is off. However, there is also poor heating (maybe none), poor ventilation (arguably none) and a lot of moisture-producing activity inside. We are also aware that the tenants regularly clean down the walls. This may also be adding moisture into the plaster.

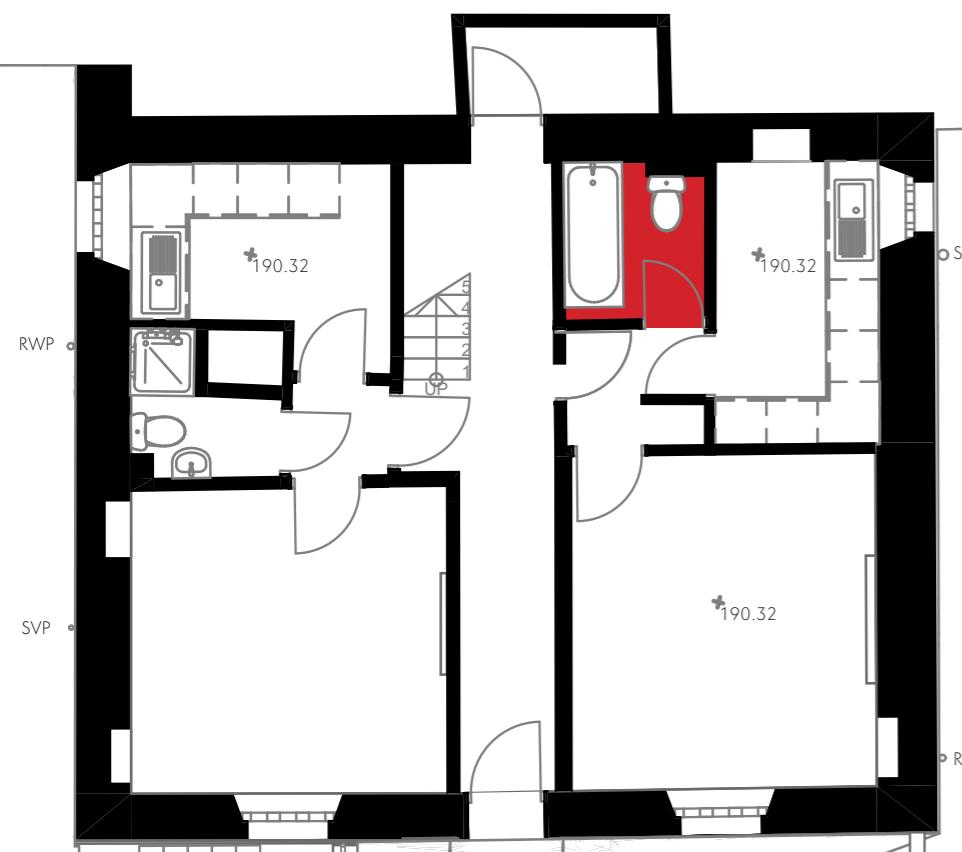
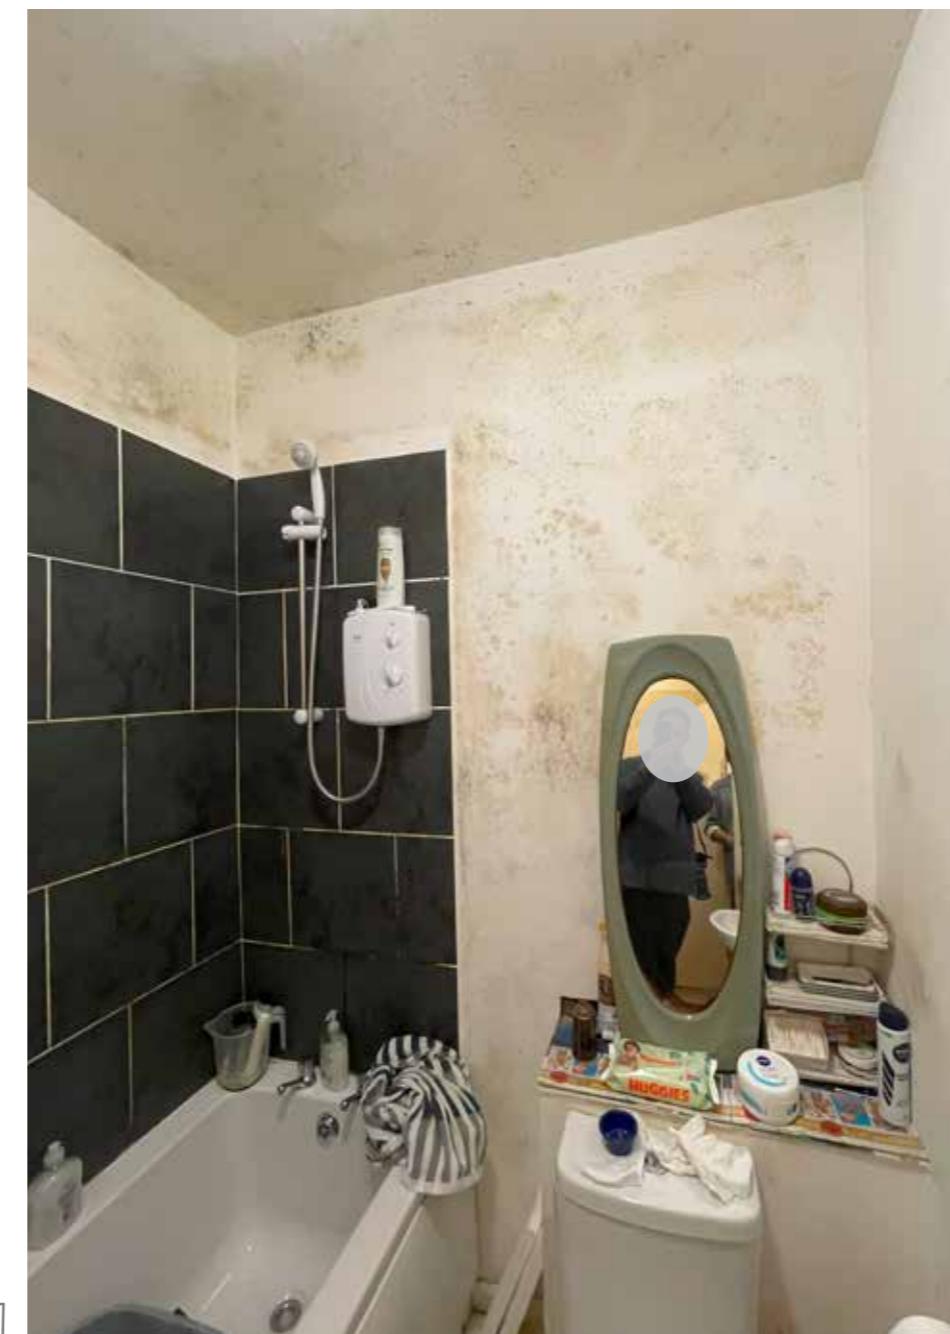
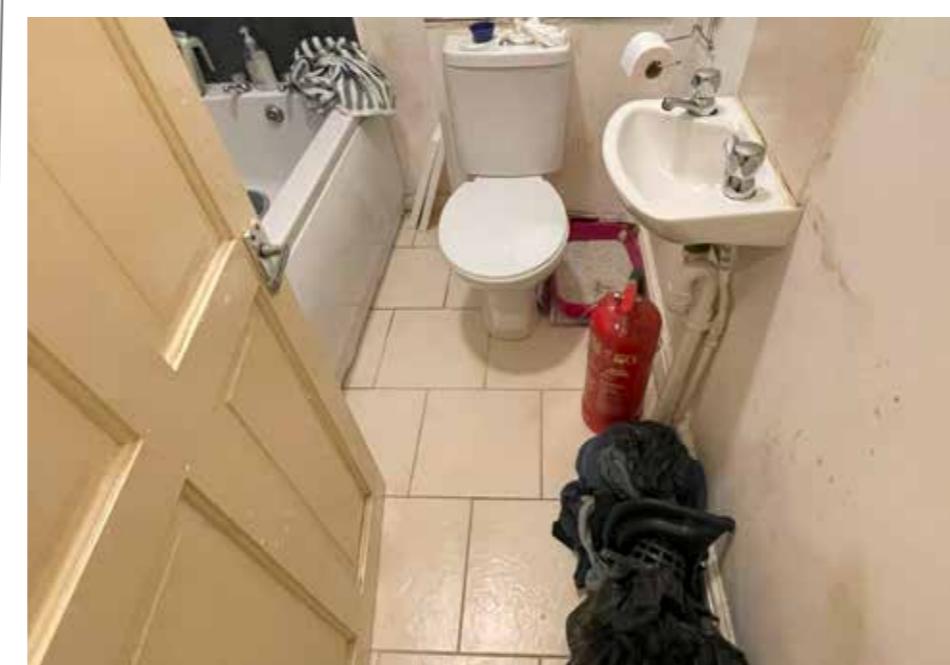
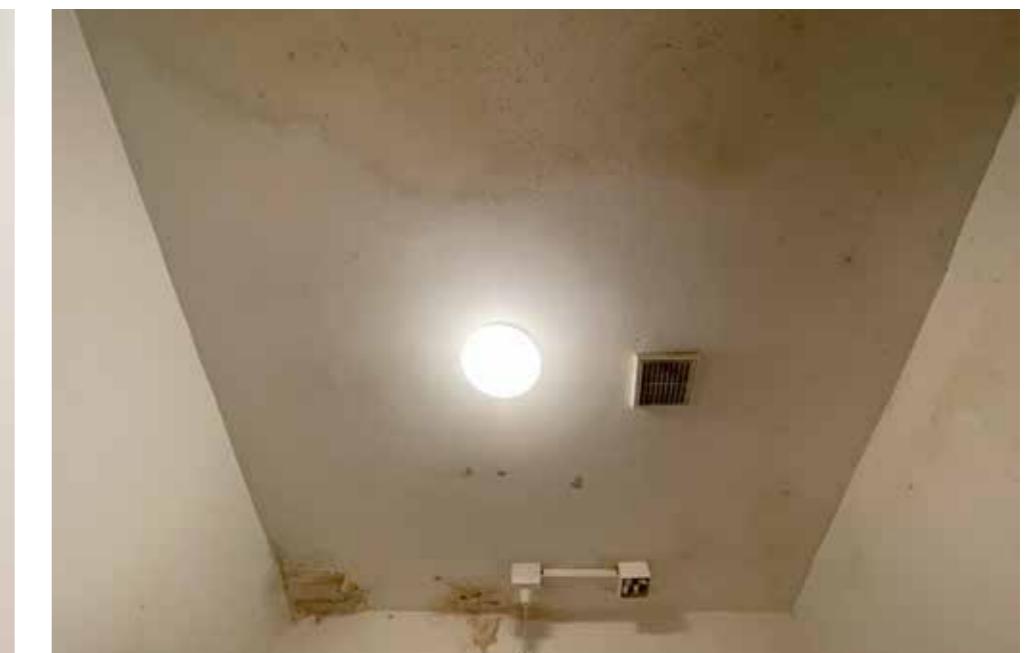
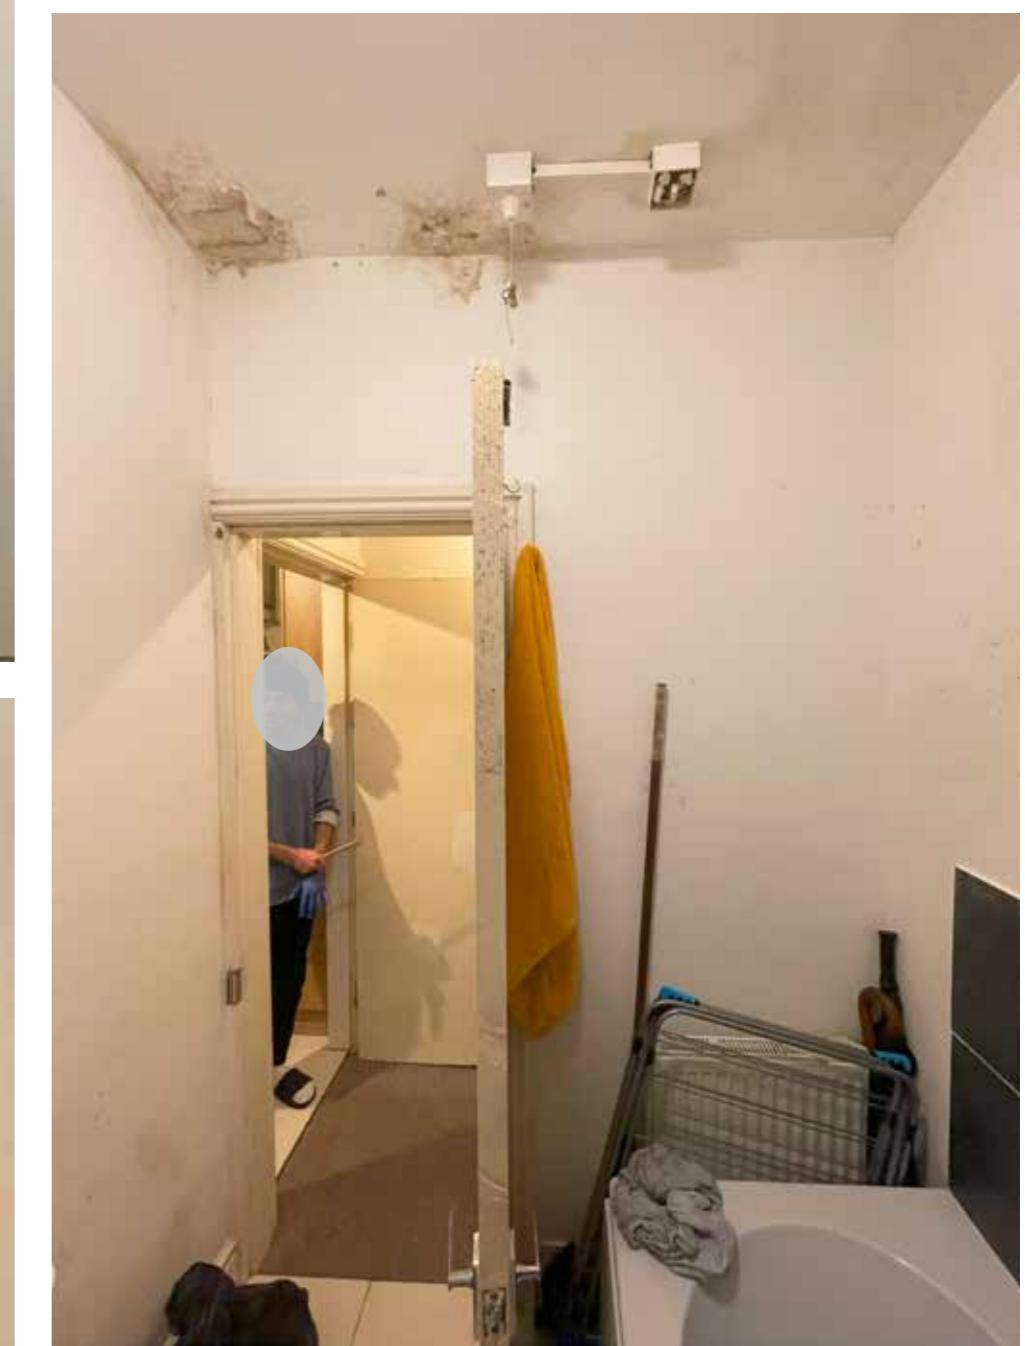
10.0 Interior - Ground Floor - East Flat Bathroom

The bathroom is of the same painted plastered walls and ceiling (with no cornice), a ceramic tile floor and a timber four-panelled door. The walls are also covered, in part, with ceramic tiling, which means that it is not possible to see whether there is also bad mould and saturation behind the tiles. However, there is clearly mould to all of the walls and the ceiling.

There is a vent in this room; however, that is inefficient and insufficient for removing the moisture produced in this room. As a result, the moisture is condensing on the walls and causing mould and staining.
