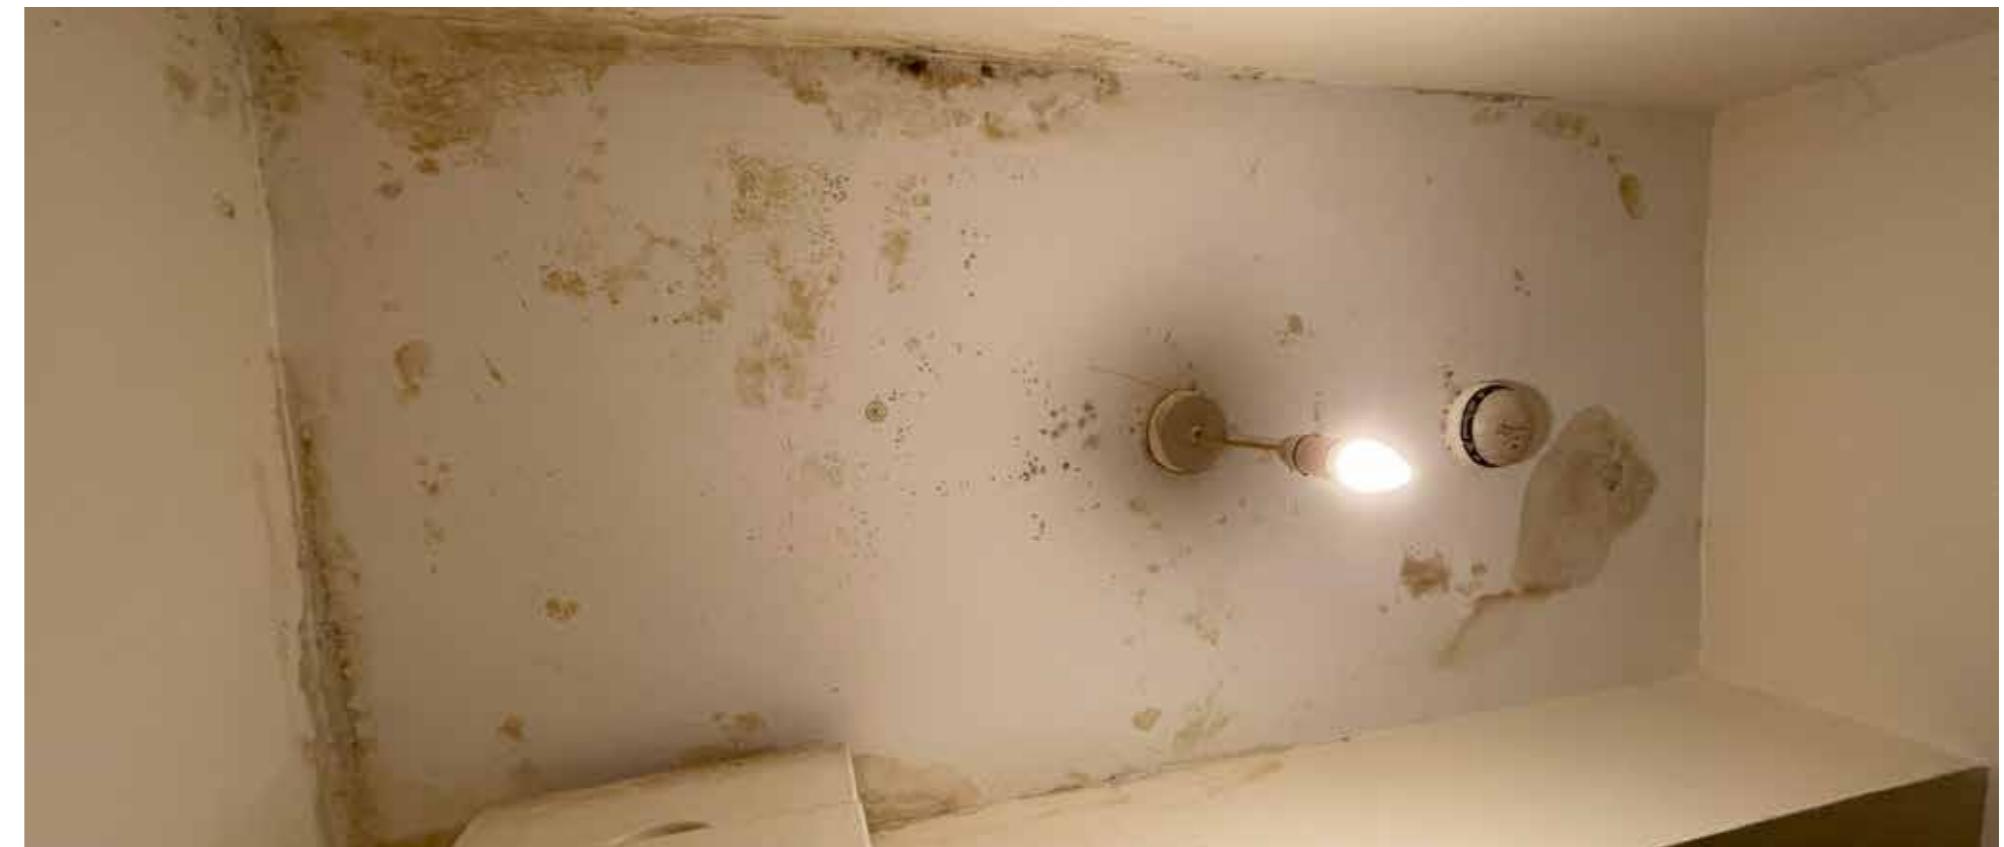
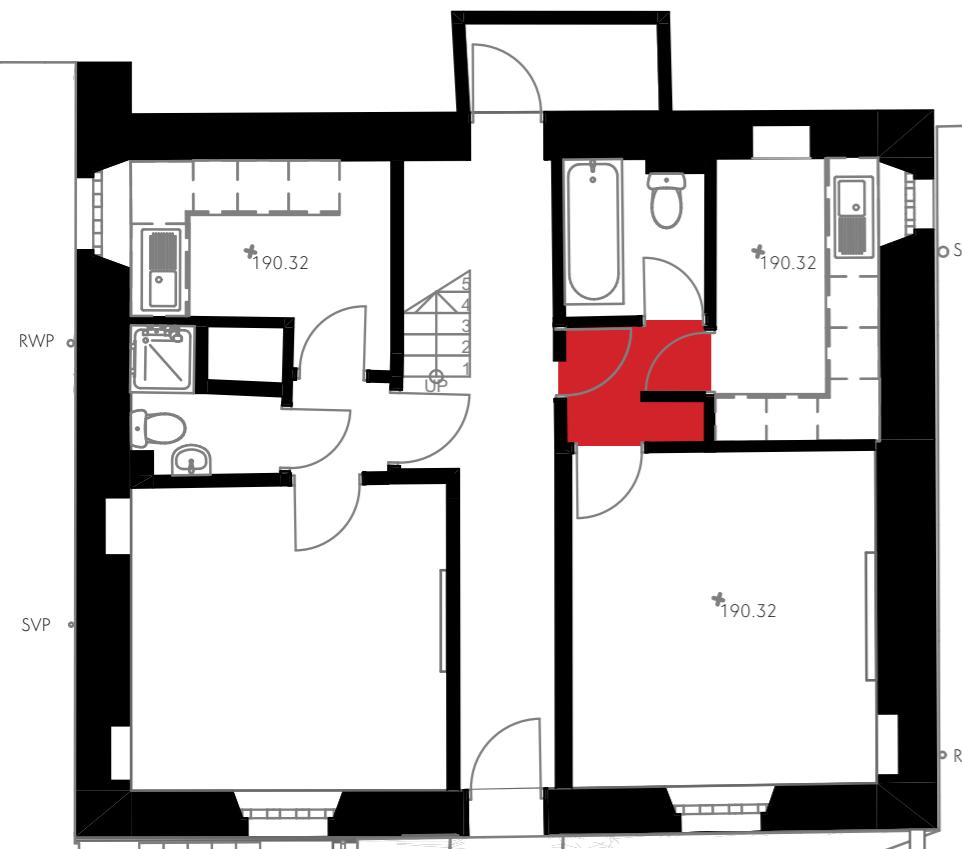
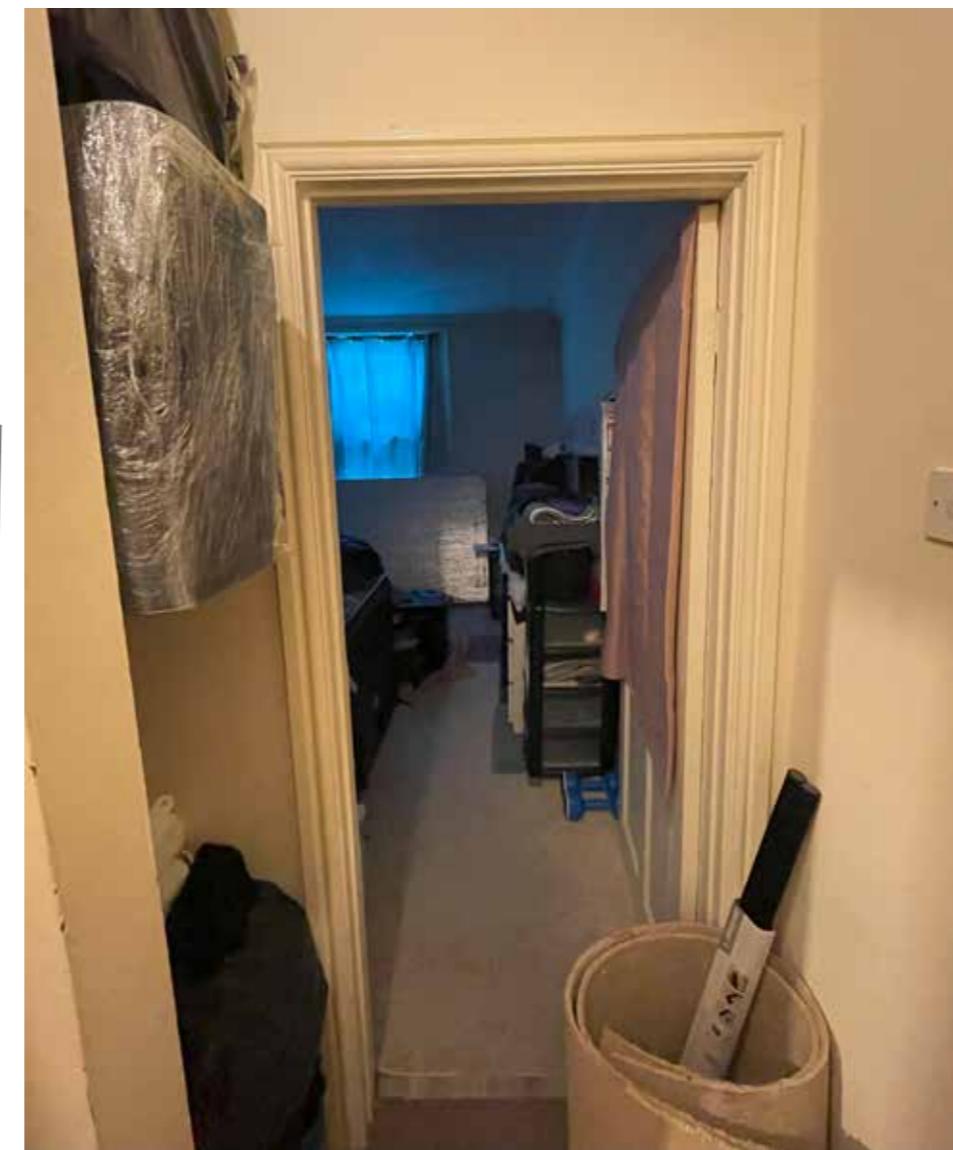
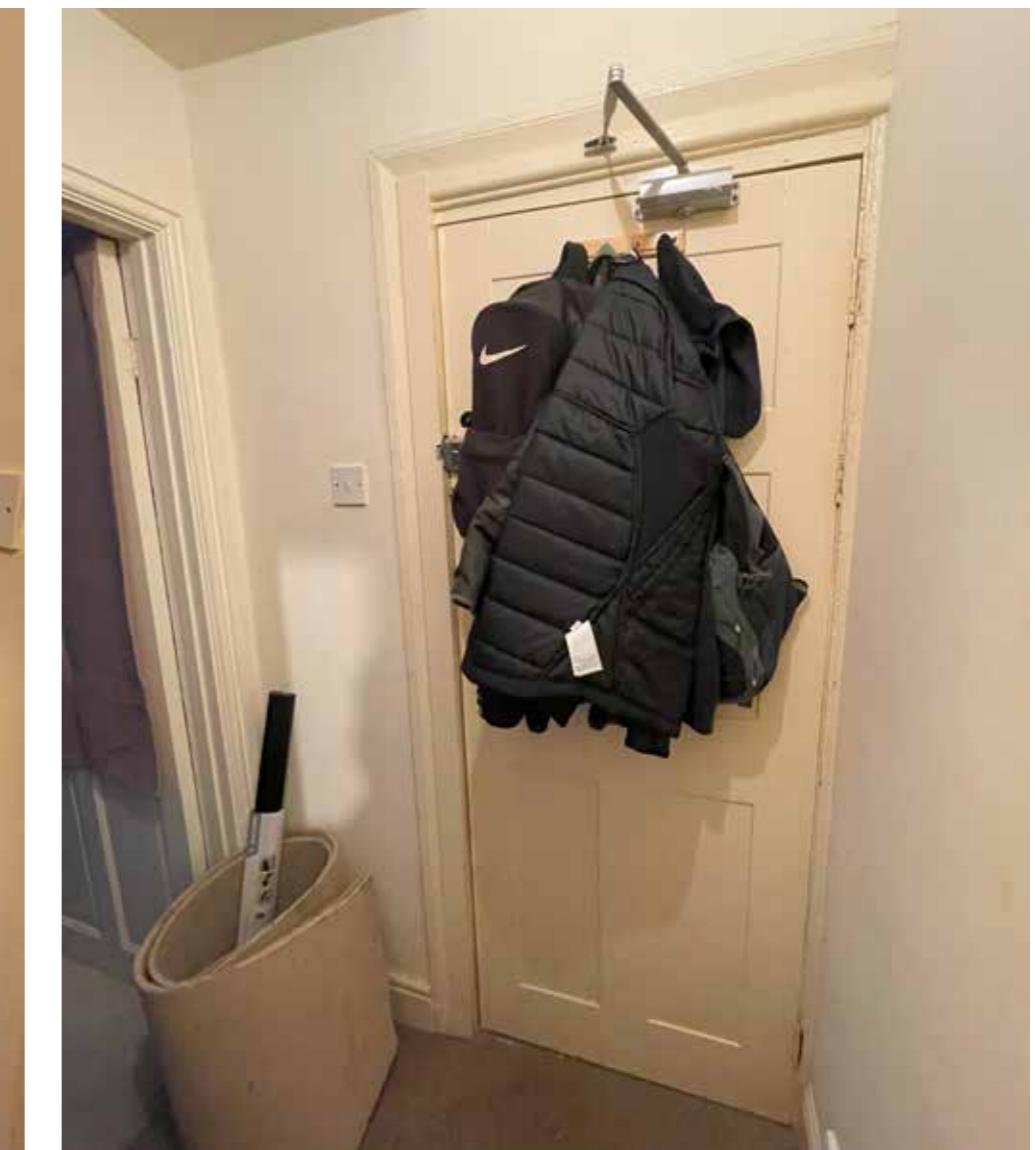
10.0 Interior - Ground Floor - East Flat Lobby

There is no obvious sign of significant staining and mould on the plastered walls to the lobby; however, it is very bad at the plastered ceiling. There is no means of ventilation in this space (which collects moisture from the bathroom, kitchen and bedroom) and no apparent means of heating. As a result condensation is not controlled.

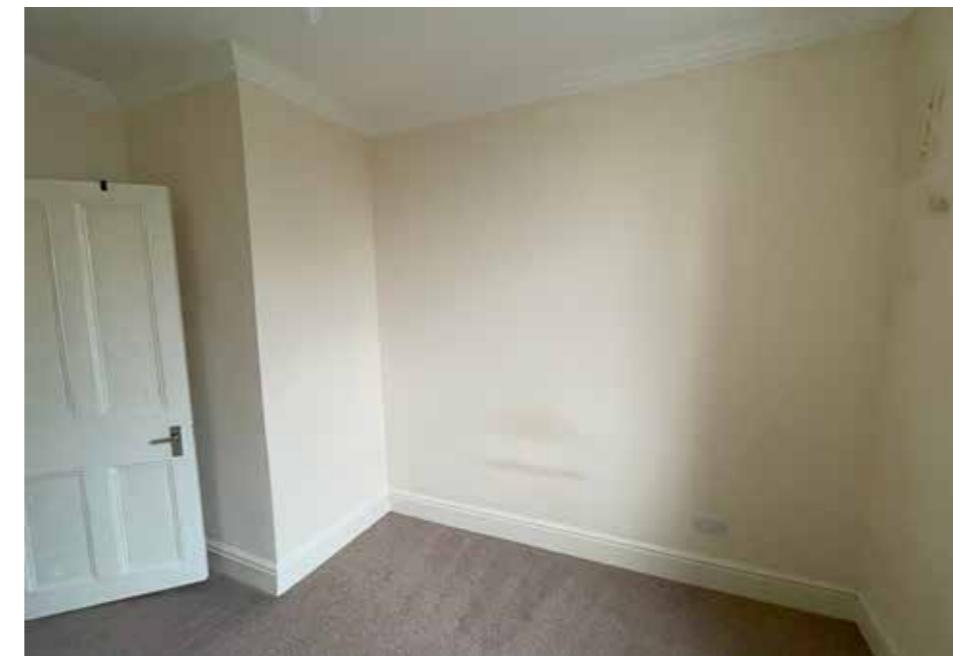
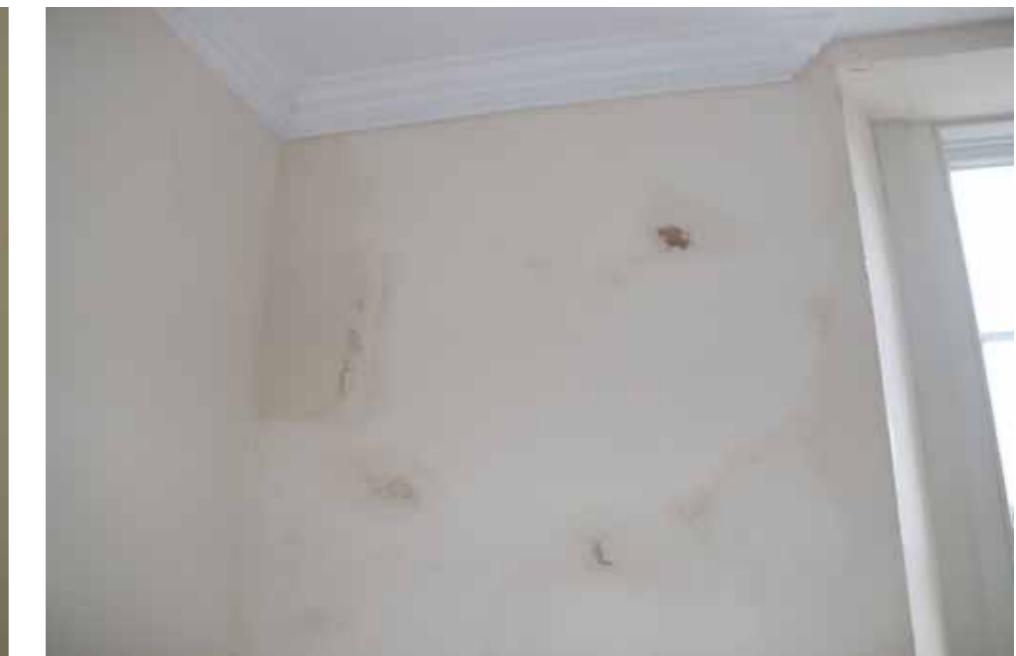
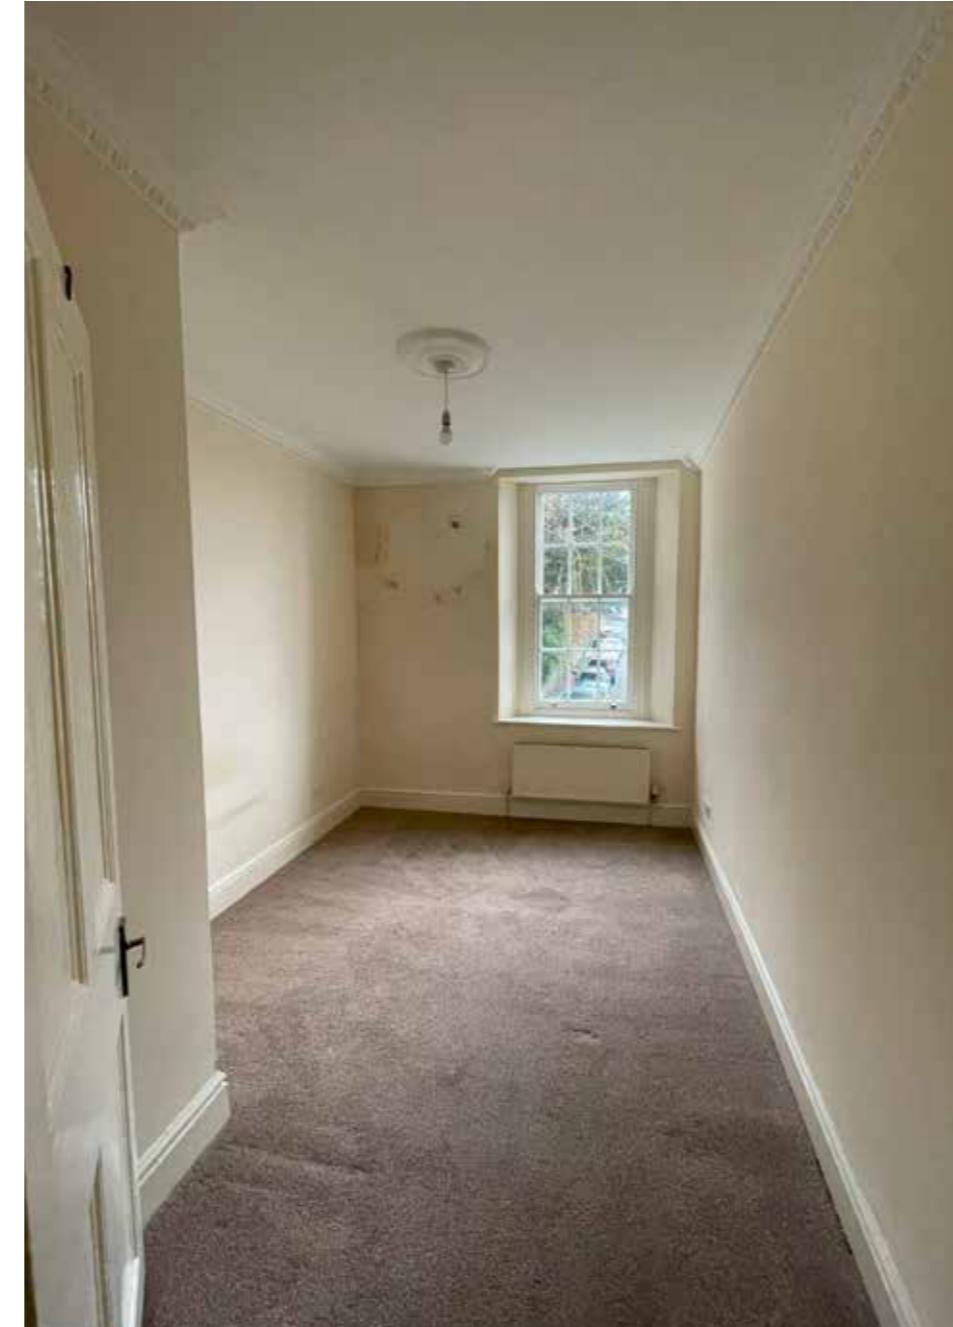
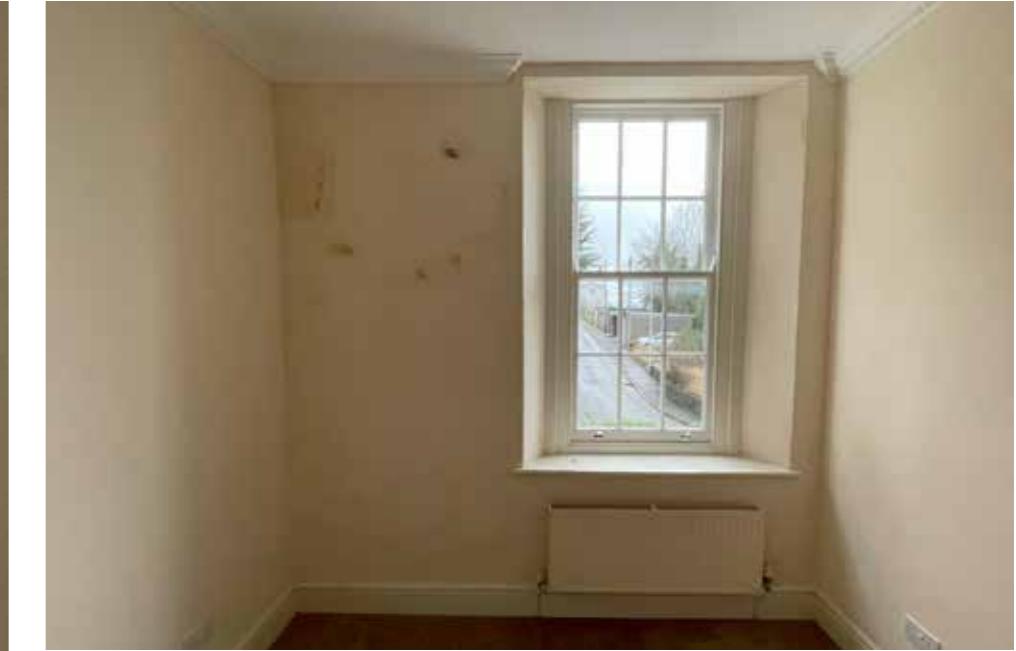
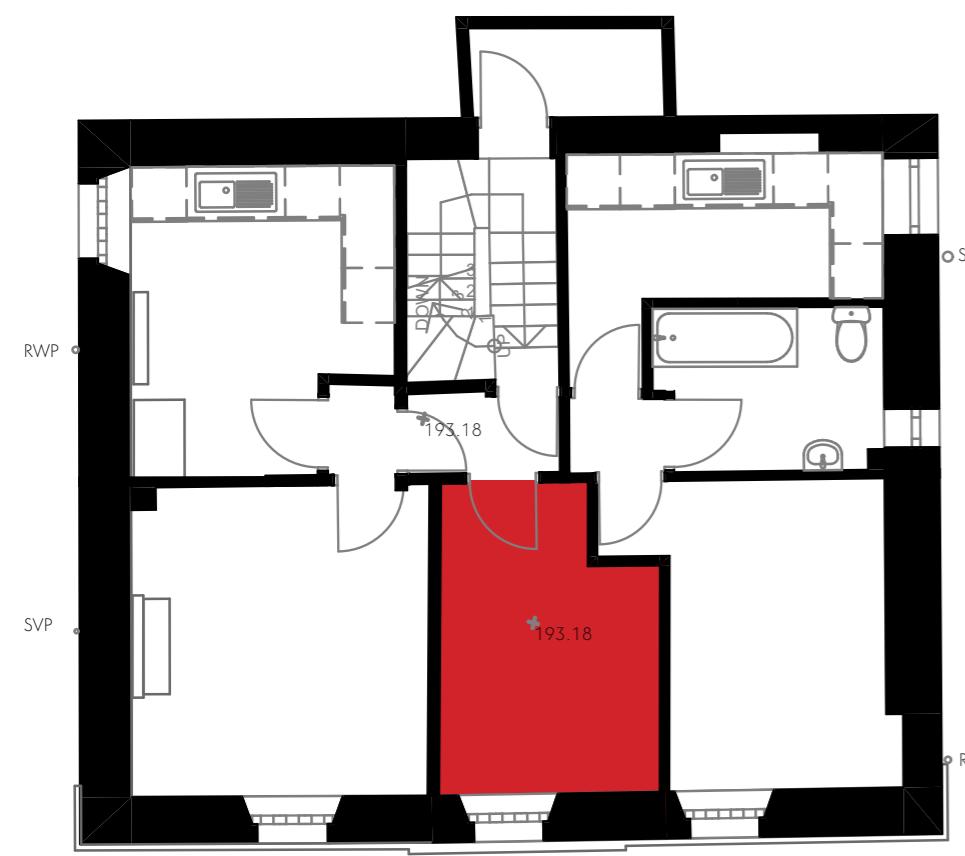
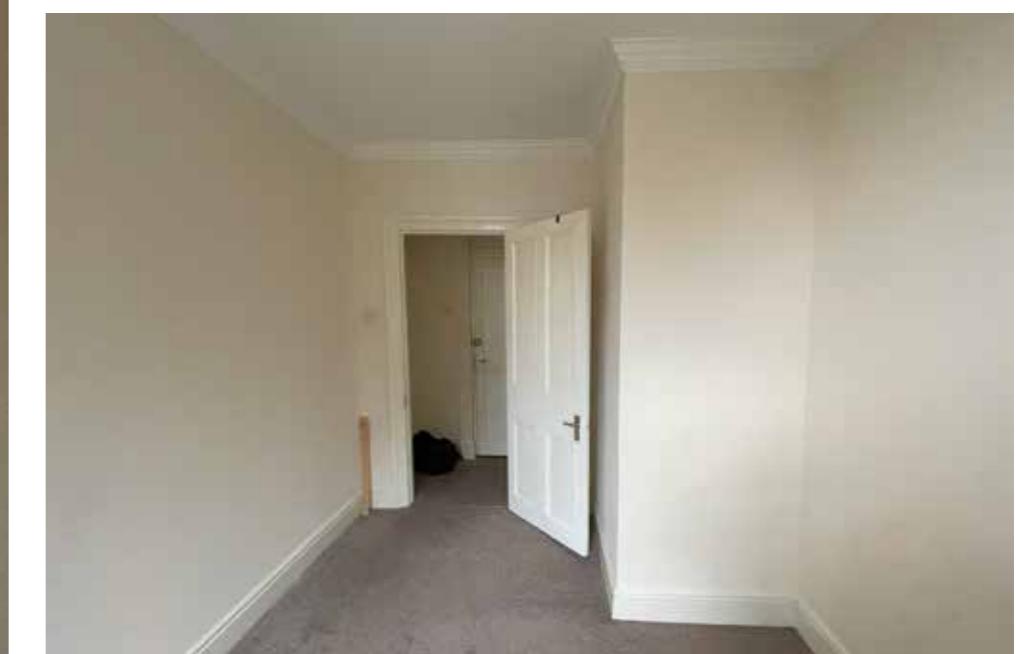
11.0 Interior - First Floor - Central Room

There is water-staining, dampness, spalled plaster and crystallised salts on the external front wall to the left of the window (see photo below). There is a significant amount of cracking render on the outside just above this point. This might explain how the inside face of the wall is damp - water has been getting behind the render, cannot evaporate externally and so is finding its way to the inside face of the wall, and drying, leaving salt crystals. The plaster needs removal and a new lime plaster applied.

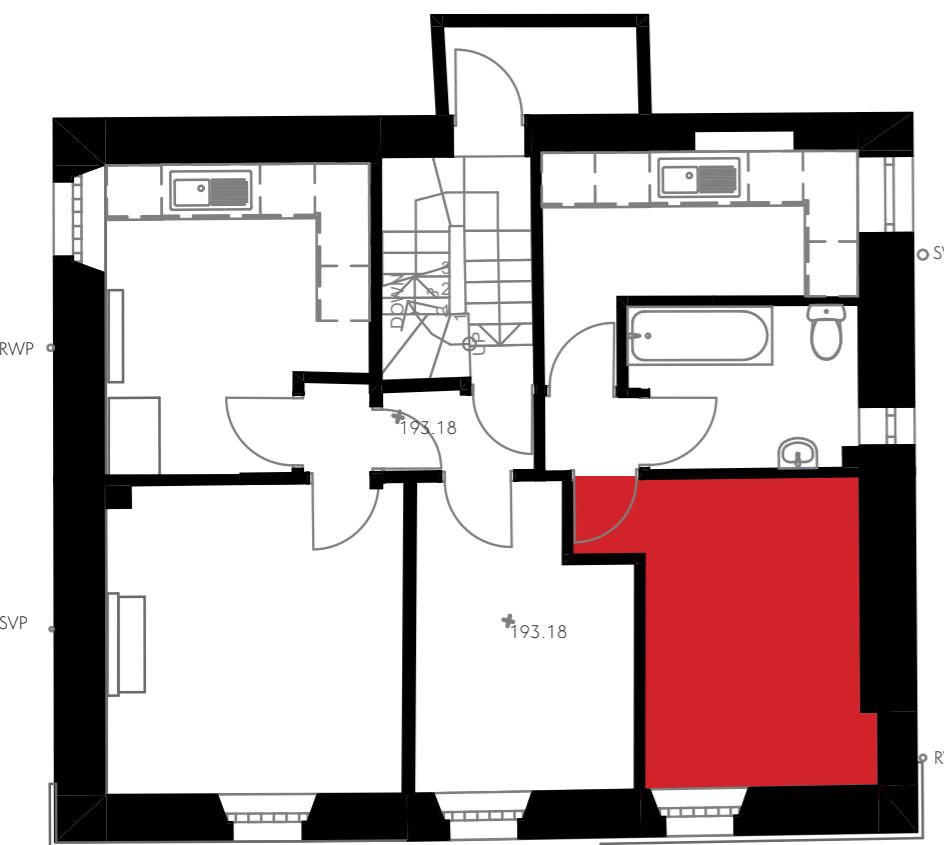
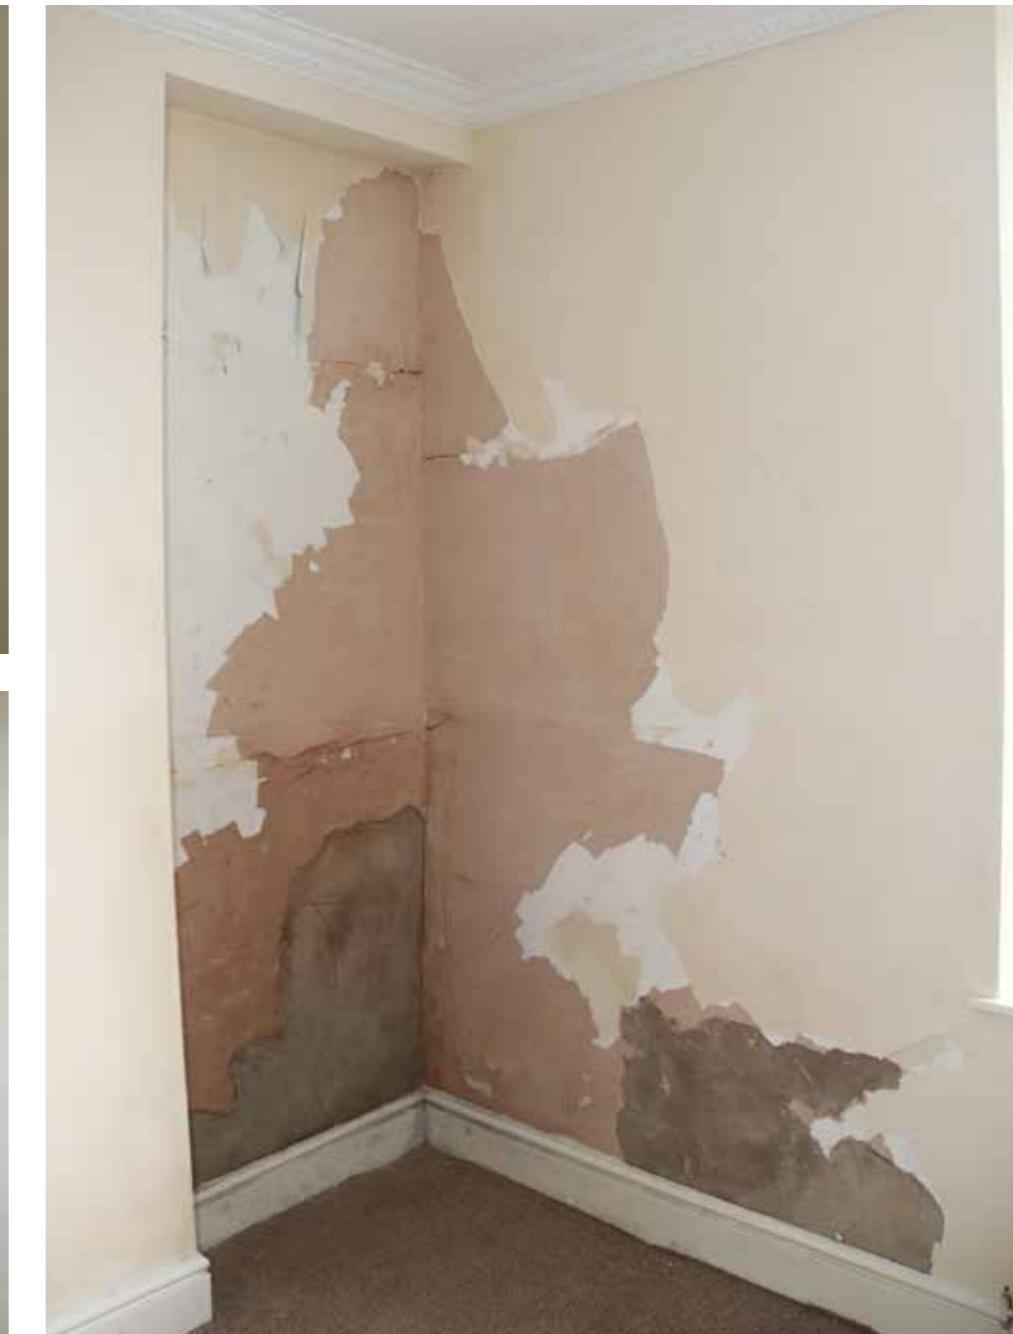
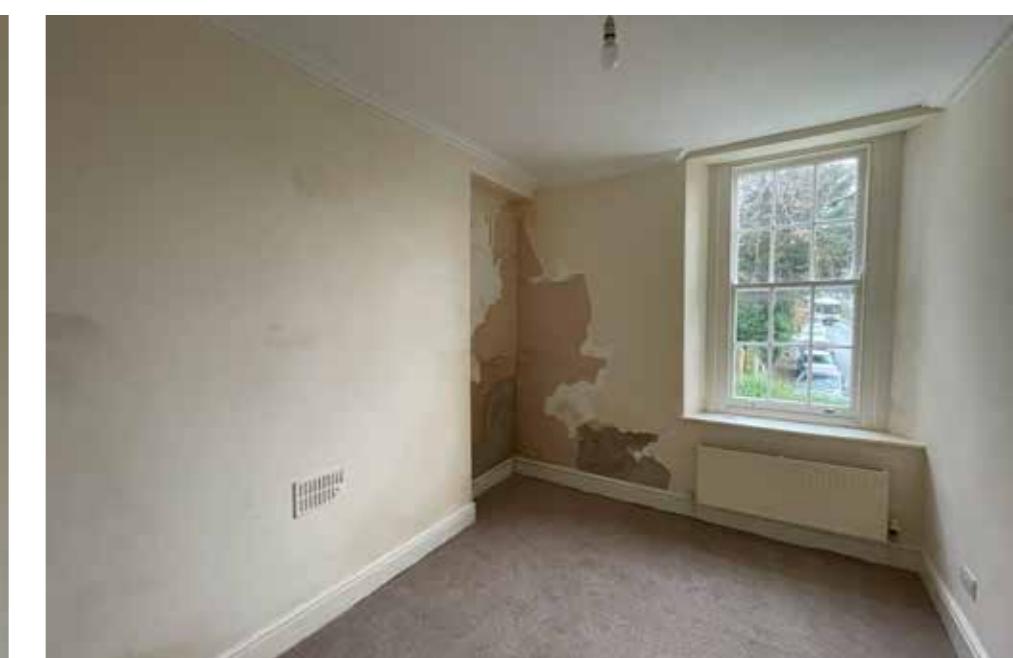
11.0 Interior - First Floor - South East Room

In the south east corner of the room - which is the external corner - there is a large area of peeling paint, cracking plaster and damp. There has recently been some cementitious plaster repairing of this area. This is where the wall thins out to form this recess, and hence forms a greater cold-bridge. The surface of the thicker wall (where the fireplace used to be) is also showing signs of dampness. This is the corner and side wall of the building where the wall is at its dampest in the ground floor below. This certainly suggests that there is a damp build-up to this part of the wall. It is an area of wall where the render externally is looking especially dark, stained and damp; and it is the area where there is a rain water downpipe, which might have been leaking; and an area where the old chimney breast may not be suitable vented.

The proposals involve the removal of the internal plaster and, probably, the removal of the external render. The chimney flue is to be vented at top and bottom, and in the middle; and the rainwater downpipe is to be replaced.

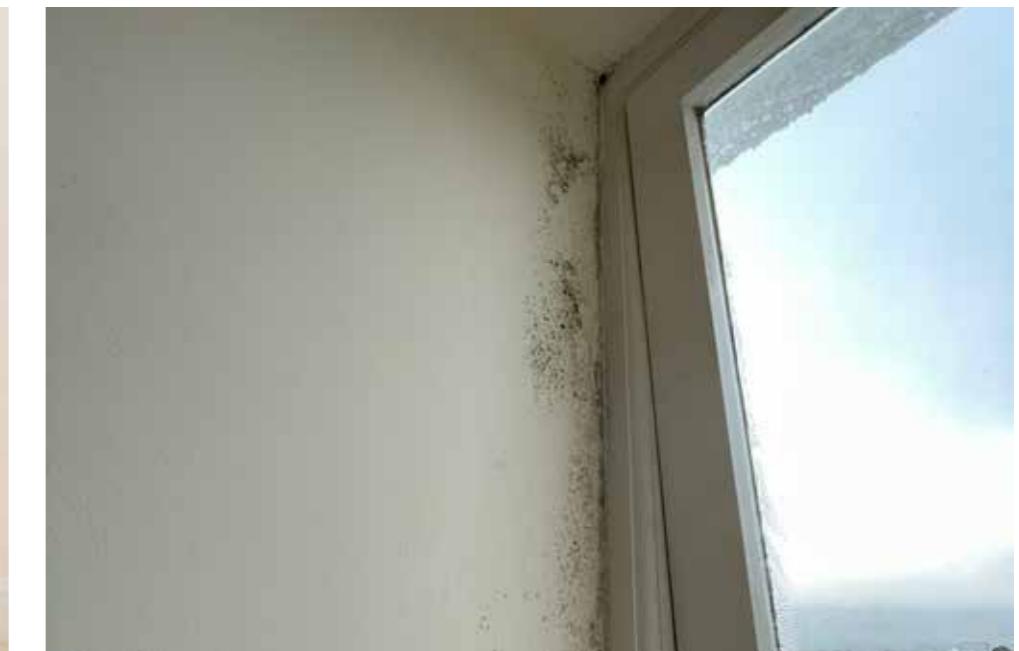
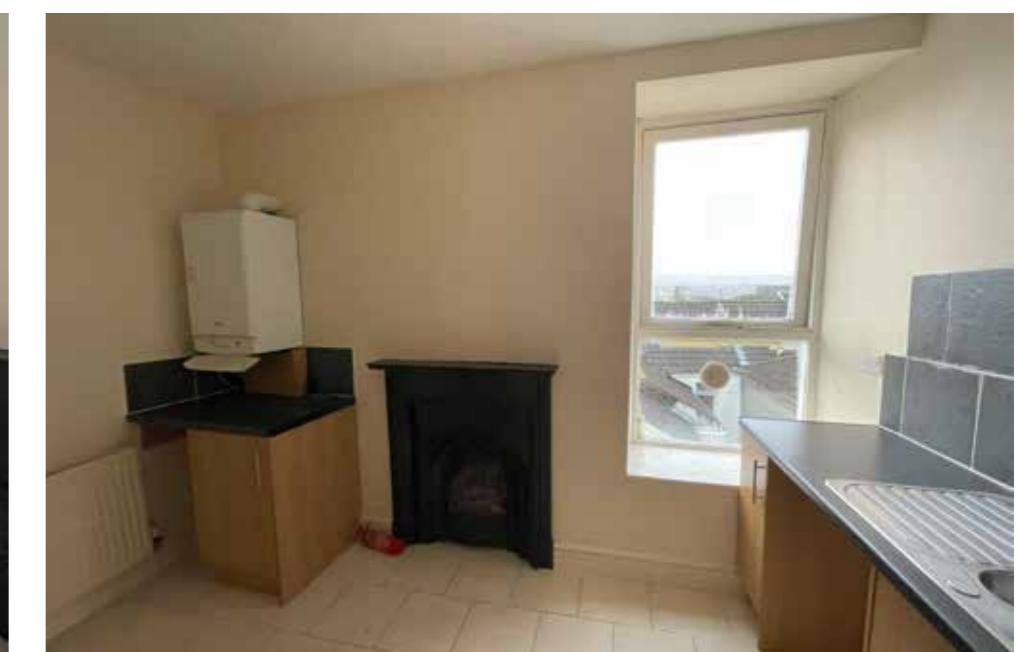
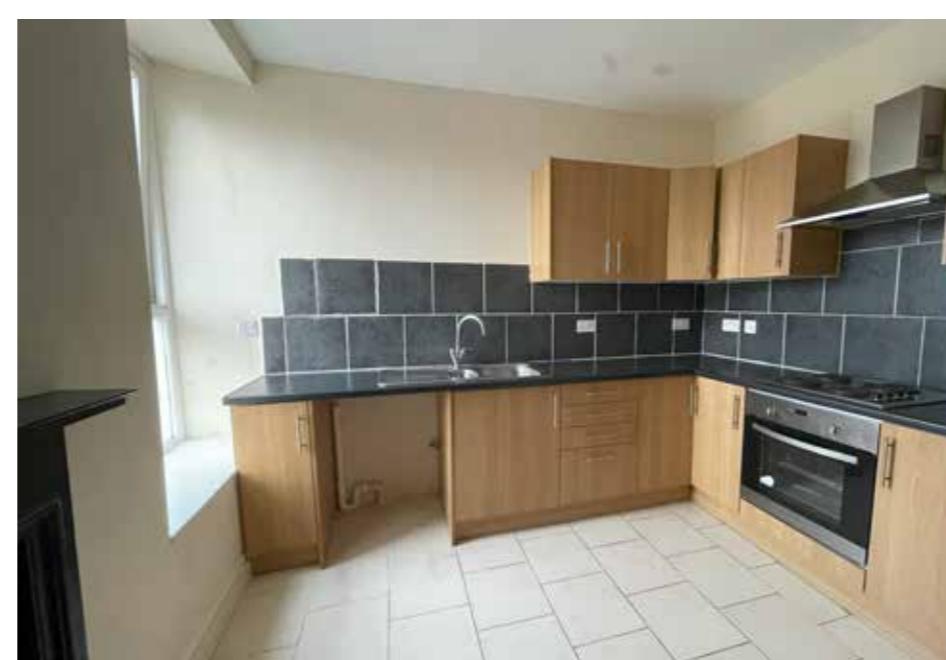
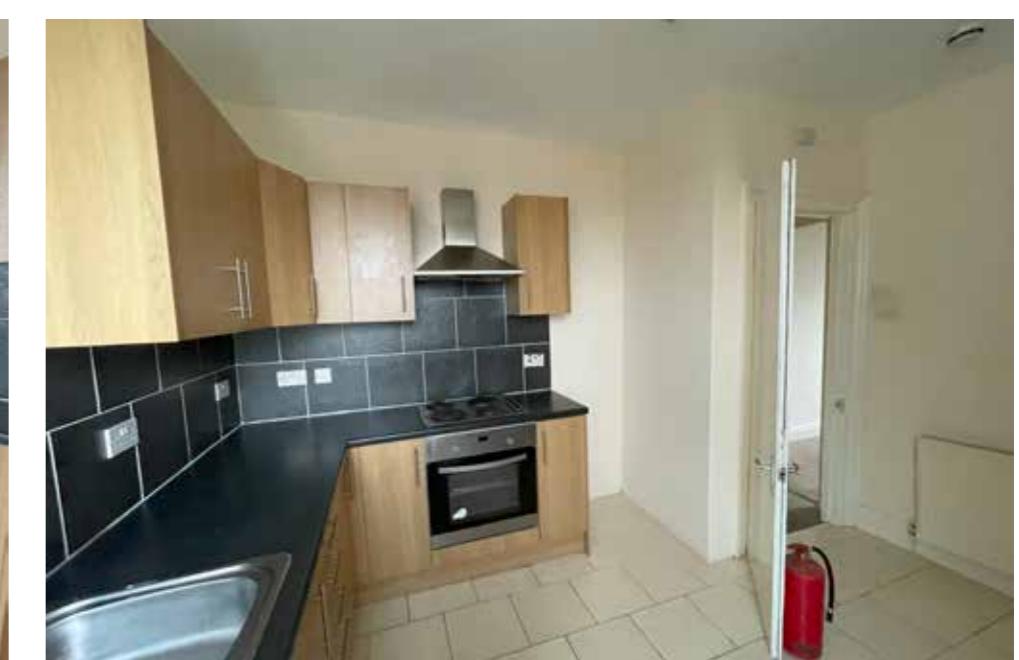
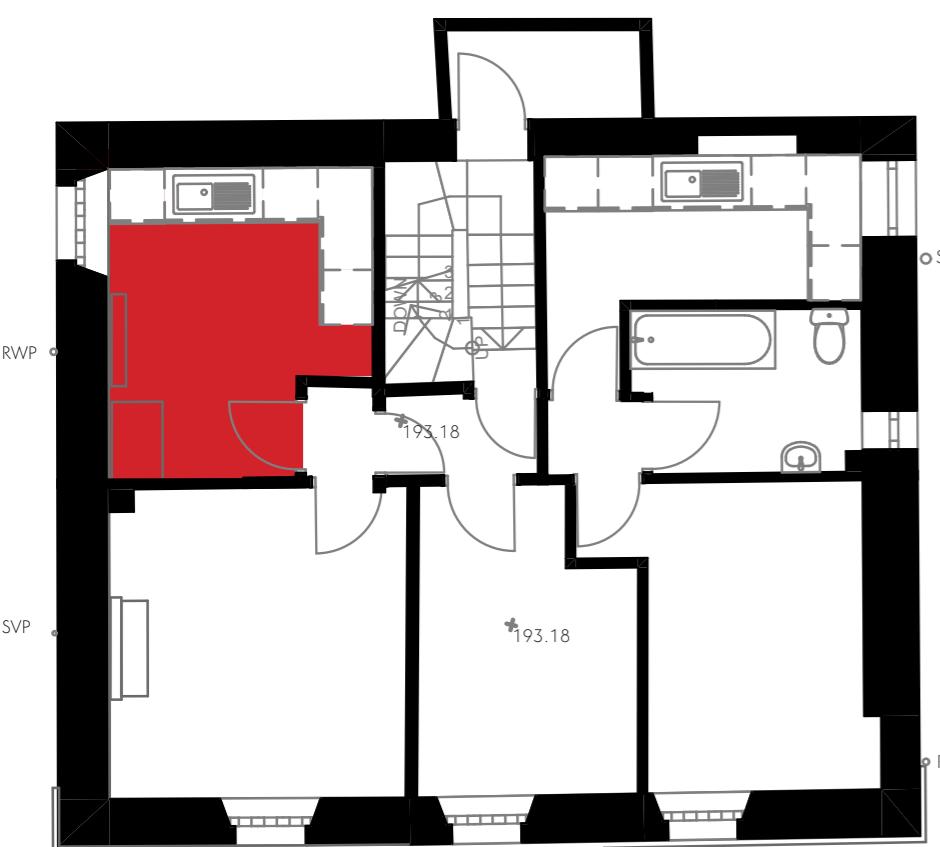
11.0 Interior - First Floor - Rear Kitchen

The condition of this room is reasonable; however, there is mould growth around the window, which suggests cold-bridging and condensation. This is not helped by the fact that the window is single-glazed. As such, the proposals replace this with Slimline double-glazing.
