## Primrose Hill, Merthyr Tydfil

### Structural Condition and Appraisal Report

# Primrose Hill, Merthyr Tydfill Mechanical Conditioning Report

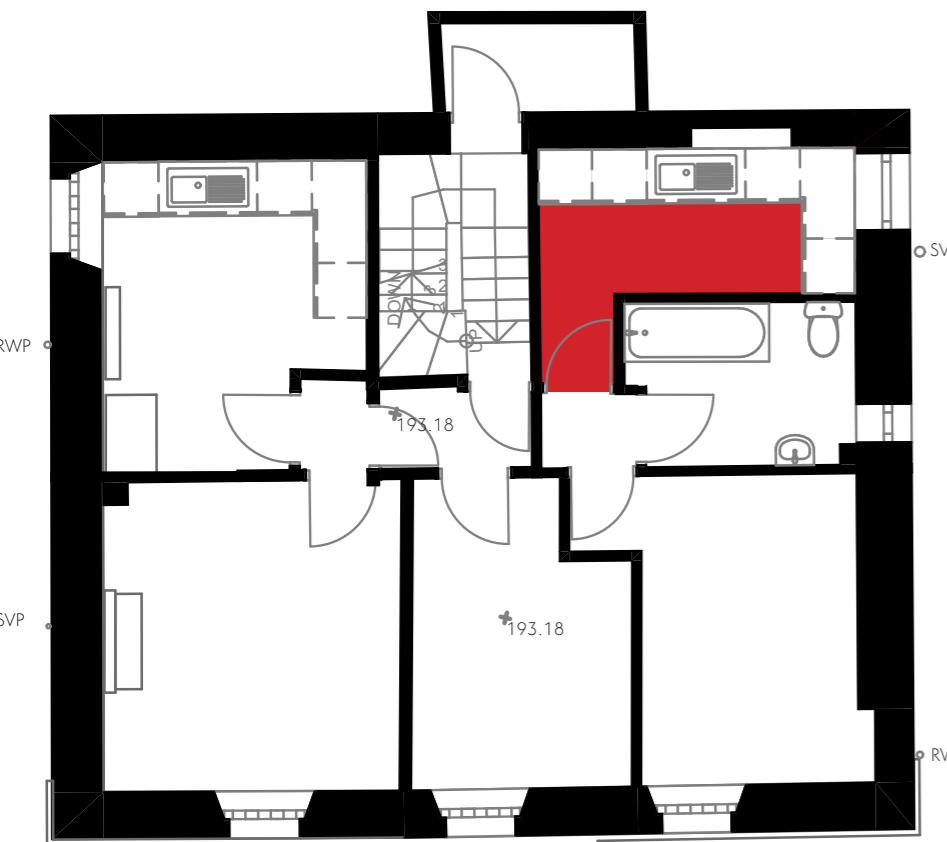
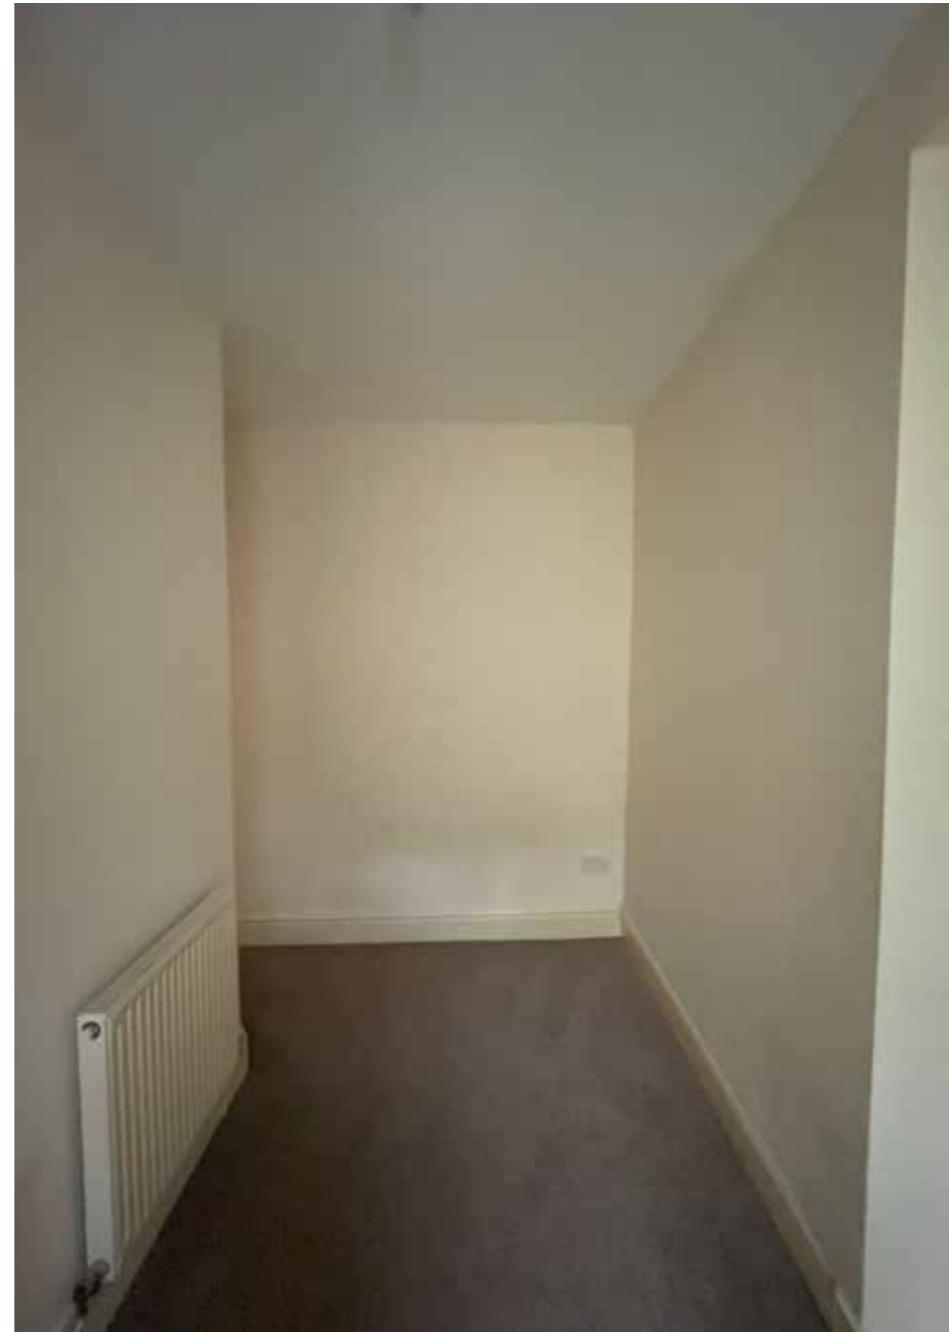
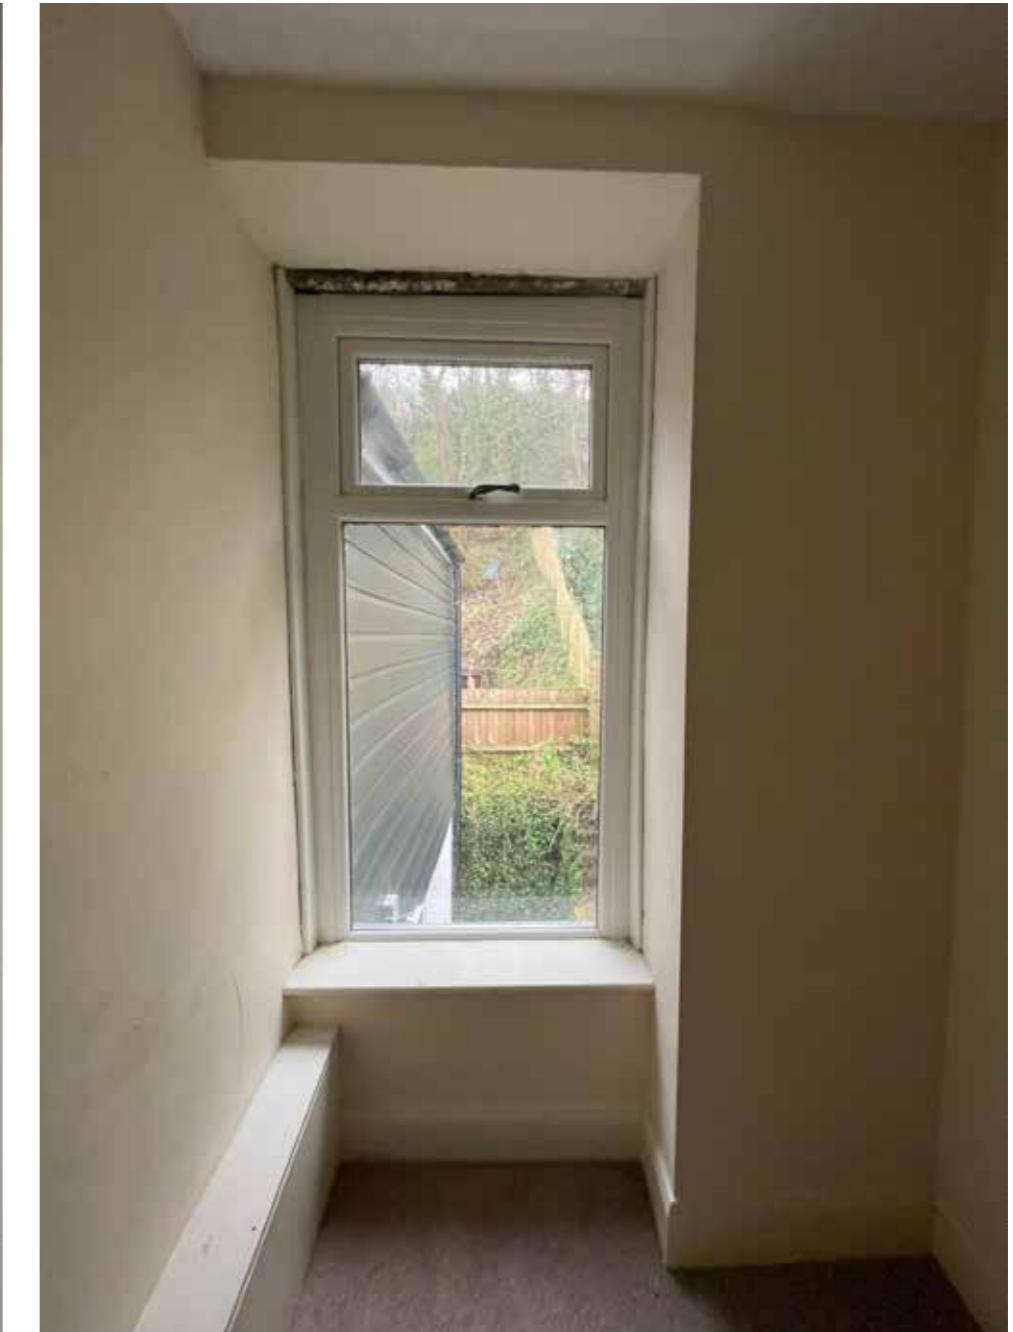
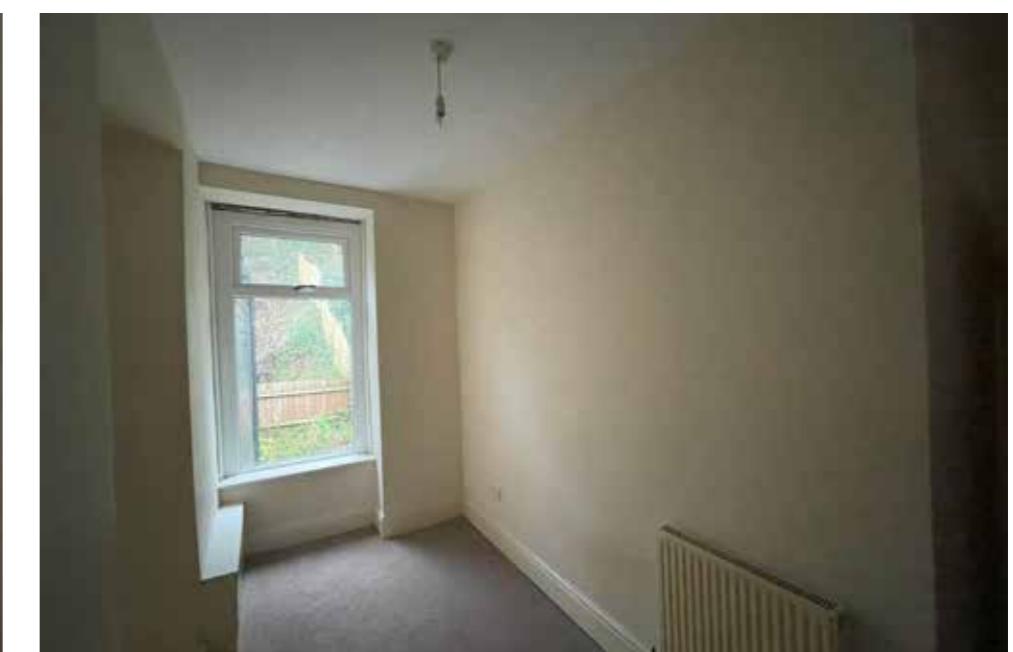
## 11.0 Interior - First Floor - Rear East Room

The condition of the room is reasonable; however, it was noted that there was a bit of a slope to the timber floor. A more detailed inspection of this, and all floors, is recommended in due course, when the carpet can be taken up.

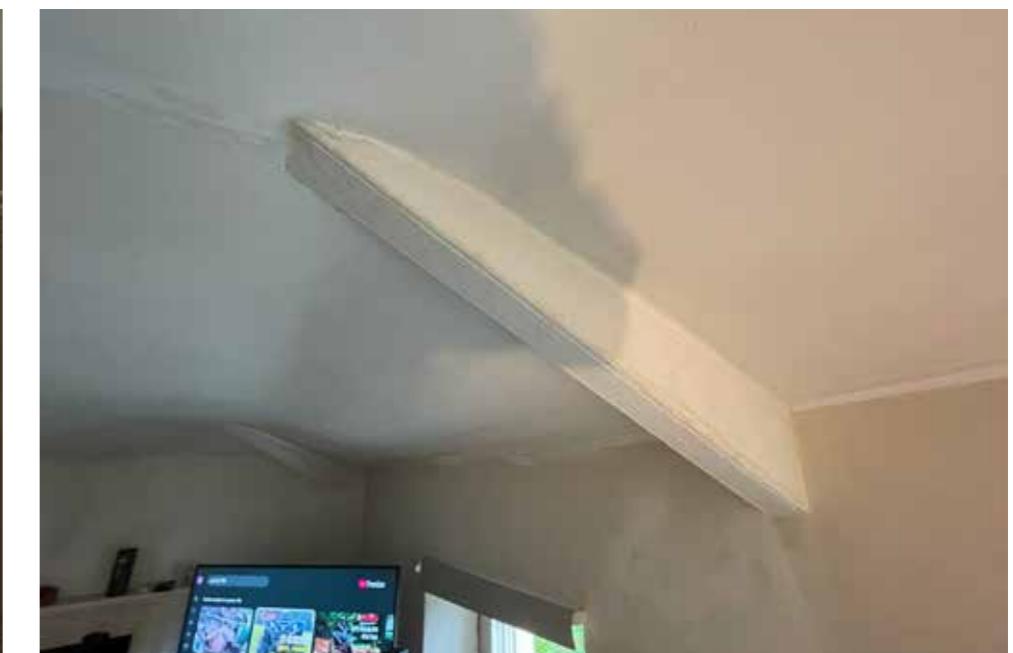
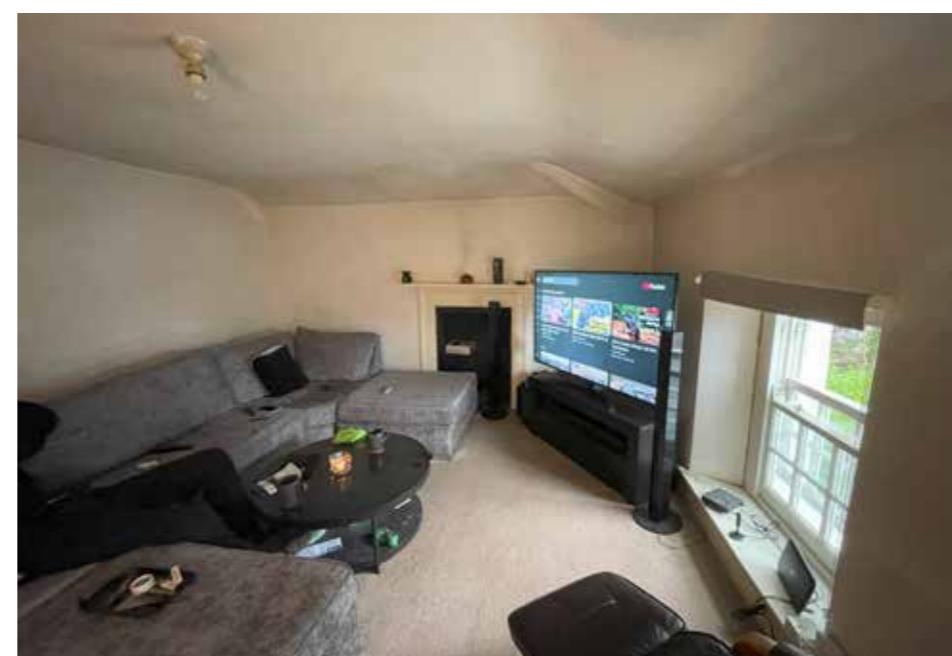
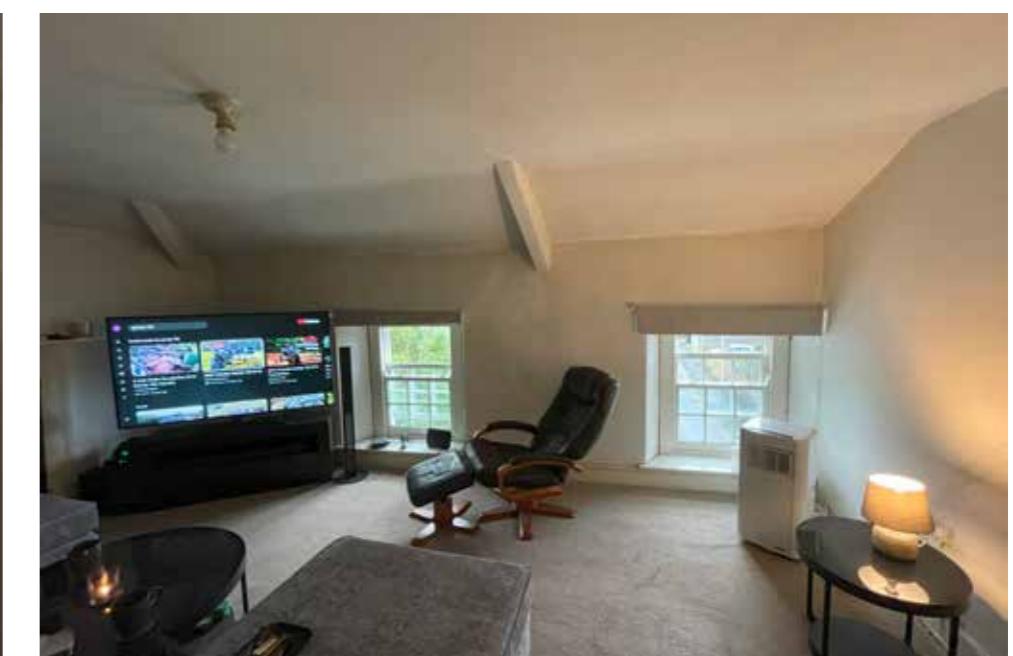
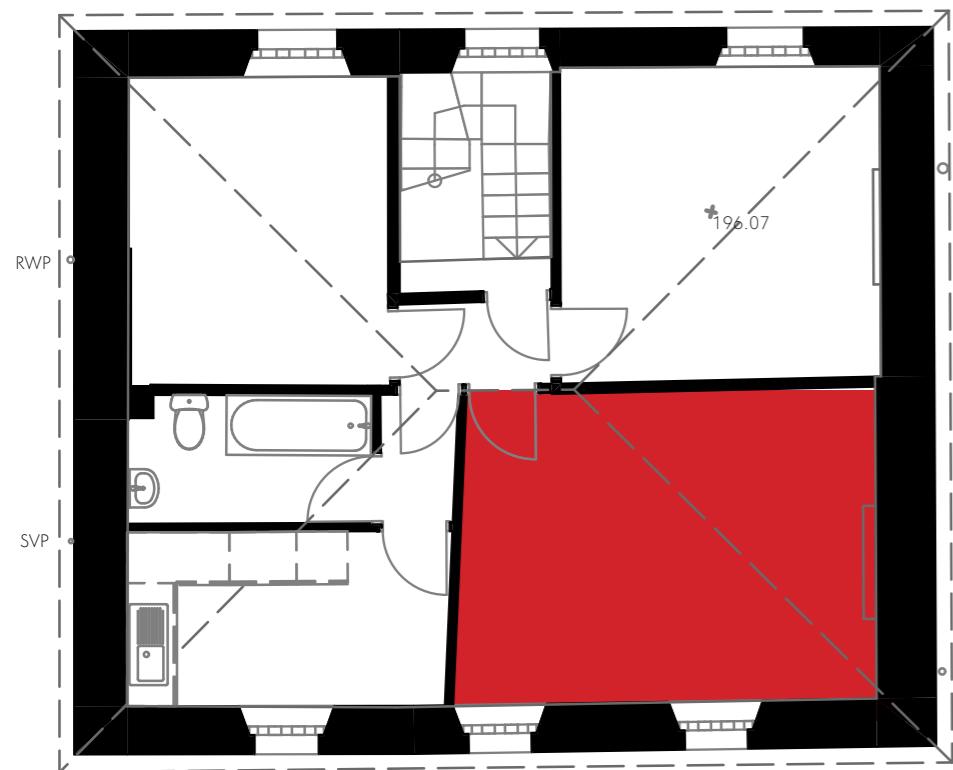
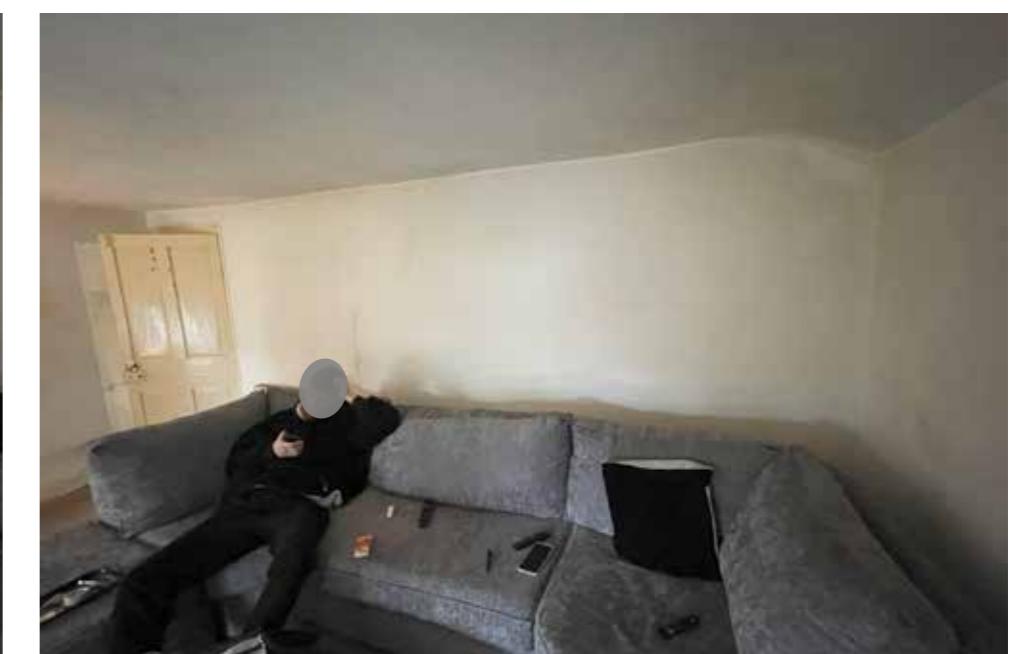
## 12.0 Interior - Second Floor - Front South East Room

There is some staining on the walls and ceiling, albeit not significant or of too much concern; and there appears to have been some areas of crack repair, fairly recently, to some of the plasterwork on the walls.

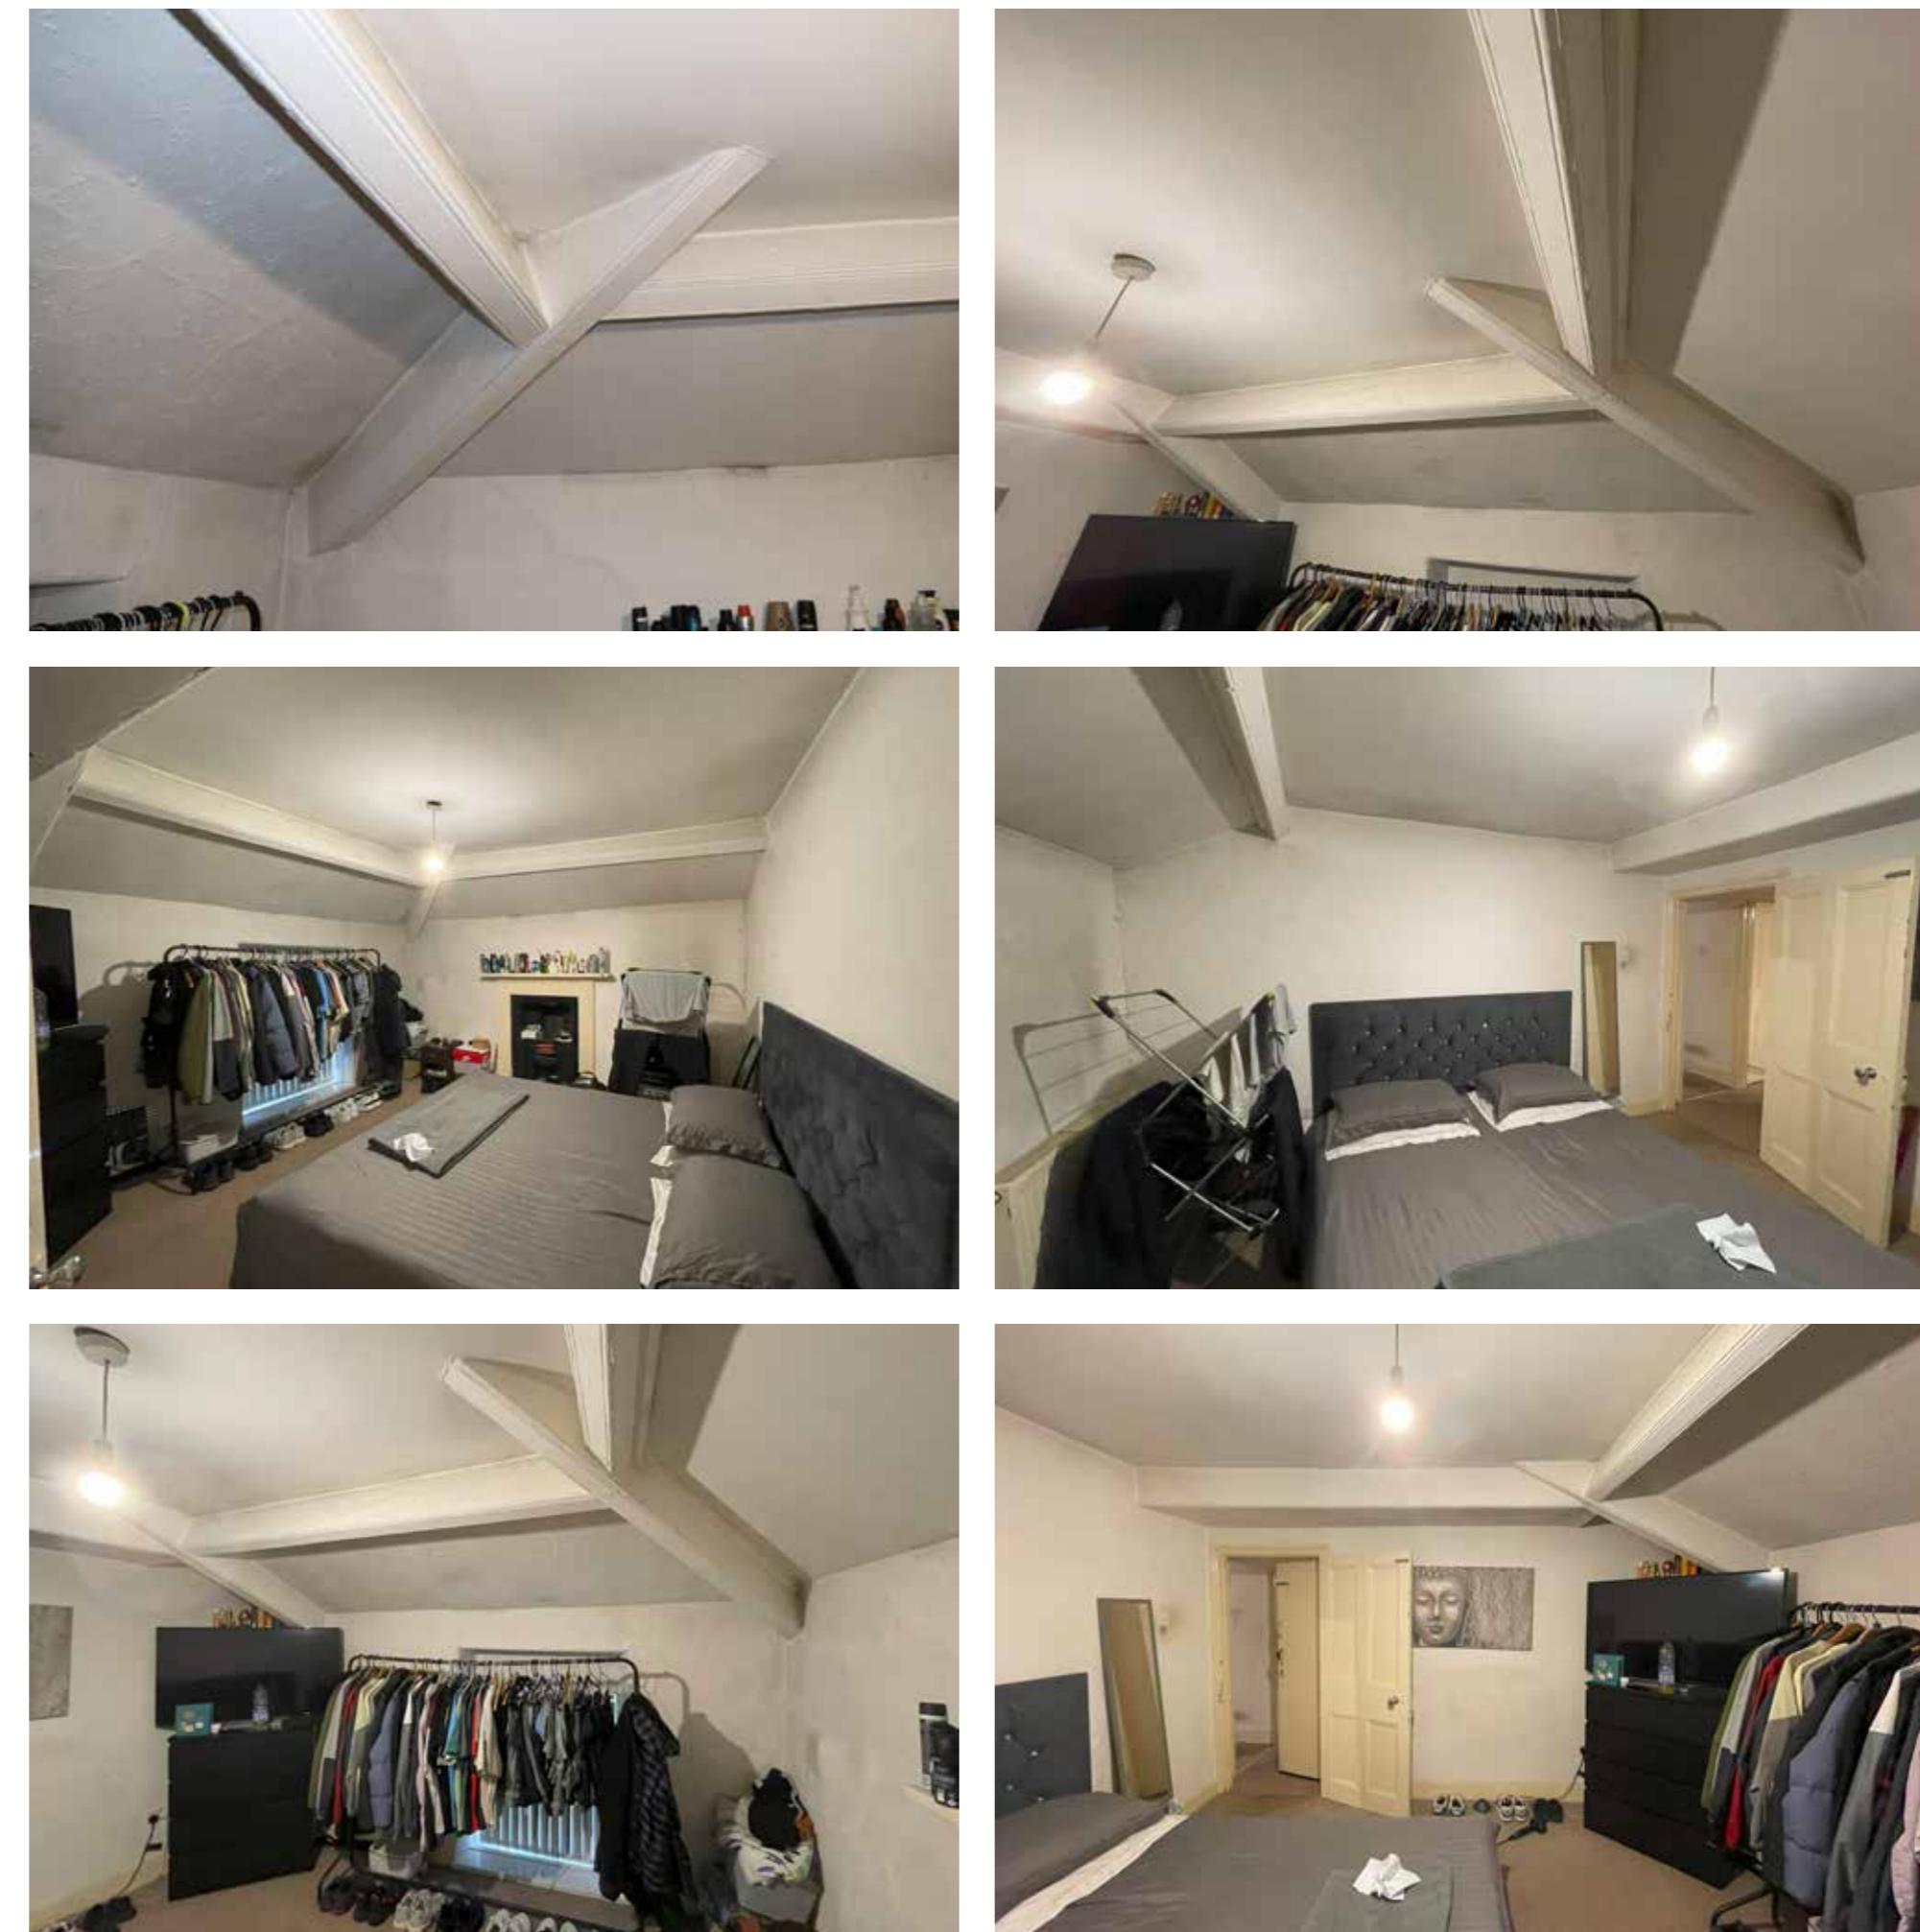
## 12.0 Interior - Second Floor - Rear North East Room

There is some cracking and staining on the walls and ceiling, particularly on the external east wall; albeit not significant or of too much concern.

- 3.2.2 Minor but extensive cracking was observed to the plaster through the wallpaper in the rear bedroom 2F and there are signs that the walls have been replastered. This is not of immediate structural concern but warrants further investigation to confirm the condition of the underlying masonry fabric.

- Inspection of internal and external masonry walls. For the external walls, we recommend removing localised patches of existing plaster to expose the face of the masonry walls to help confirm construction and condition of the underlying masonry. We also recommend undertaking removal of finishes or localised opening up works to several of the internal walls

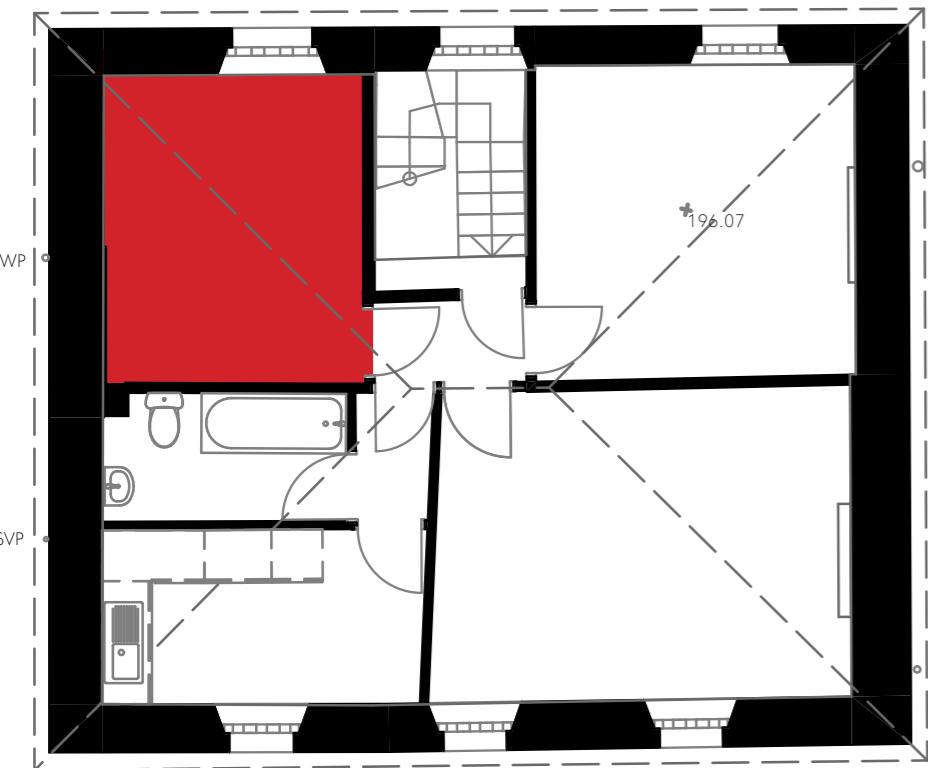
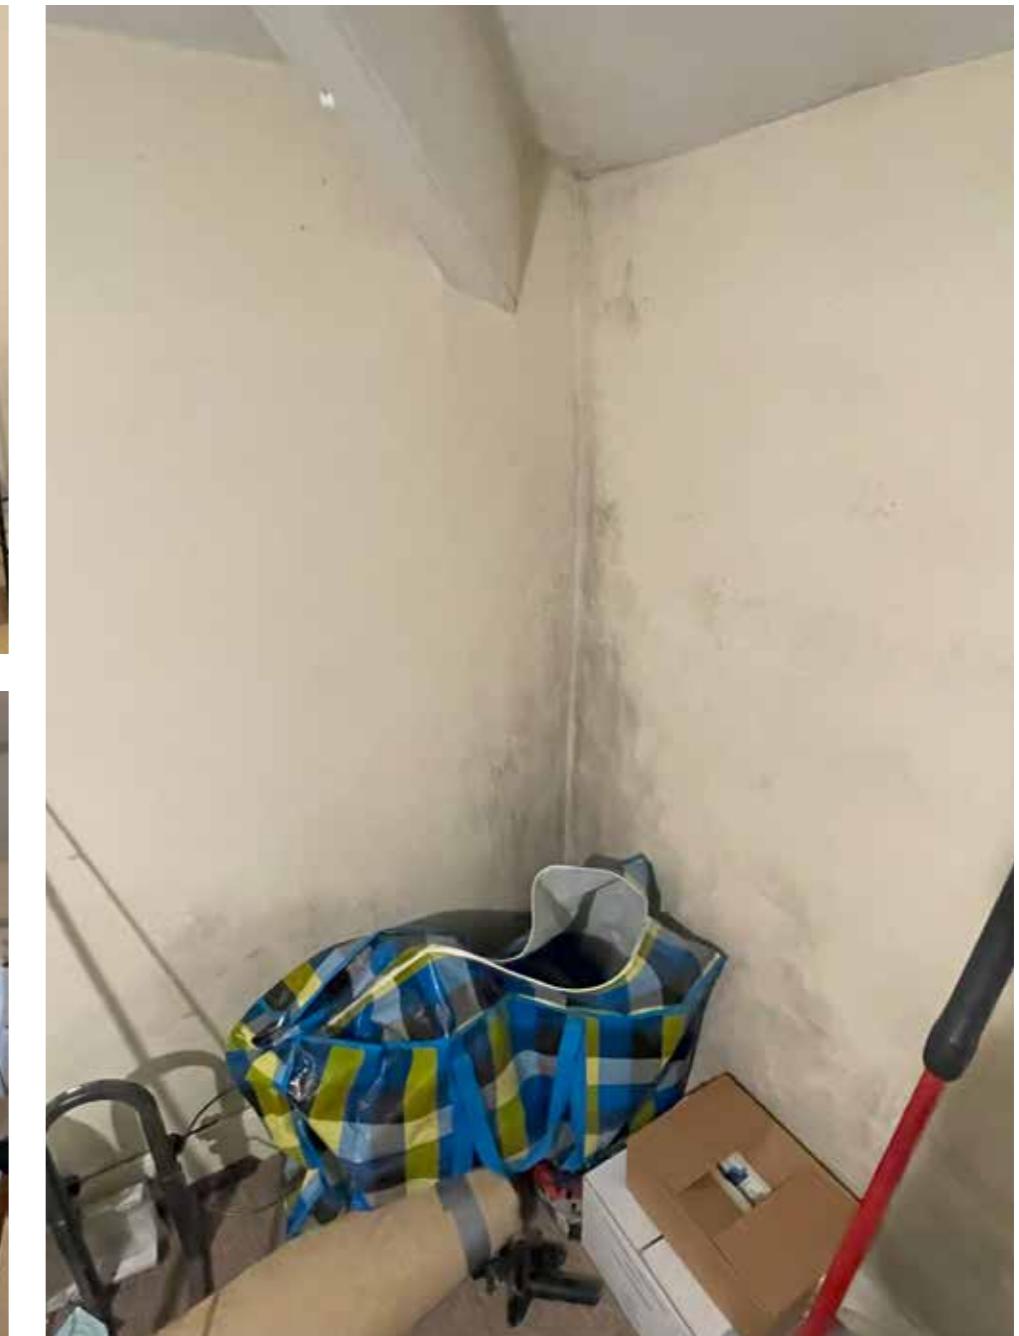
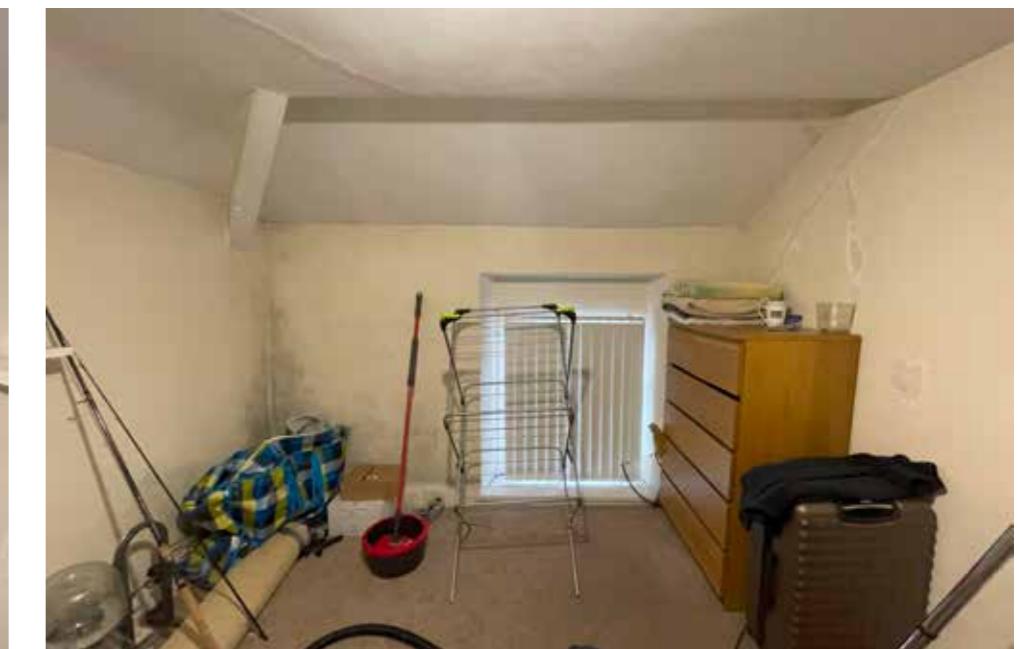
## 12.0 Interior - Second Floor - Rear North West Room

There is some staining on the walls and ceiling; and there appears to have been some areas of crack repair, fairly recently, to some of the plasterwork on the walls. The worst area of staining is to the external north west corner. This will require the plaster to be removed to see what is causing this.

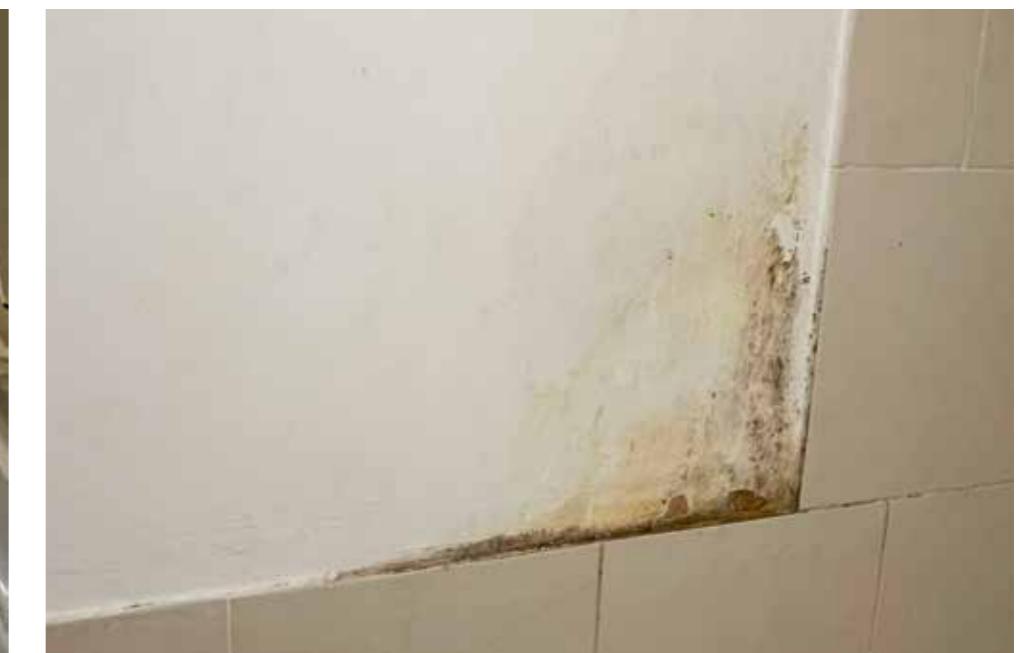
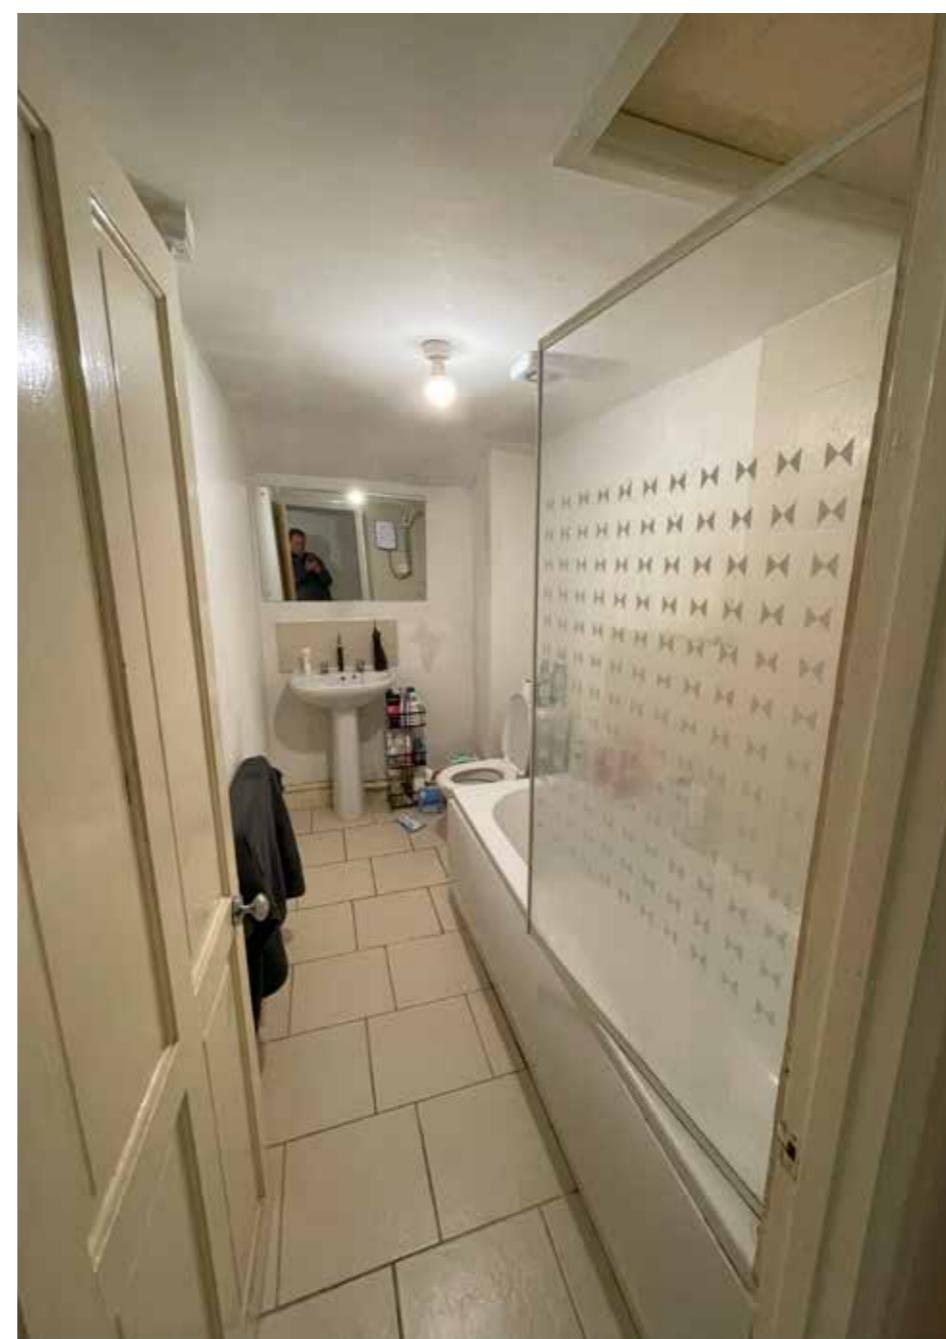
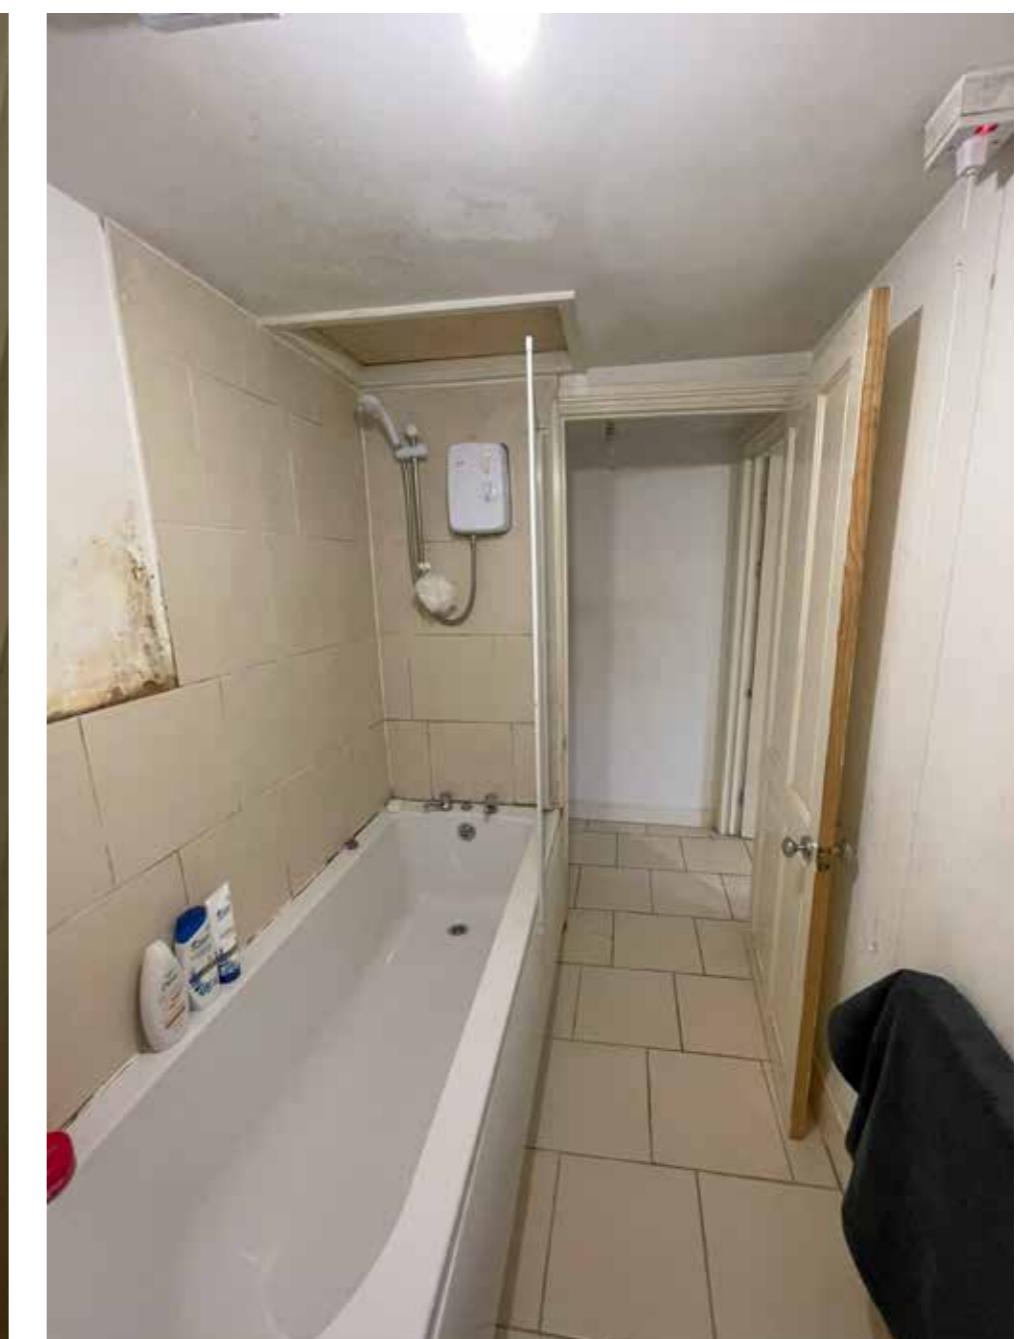
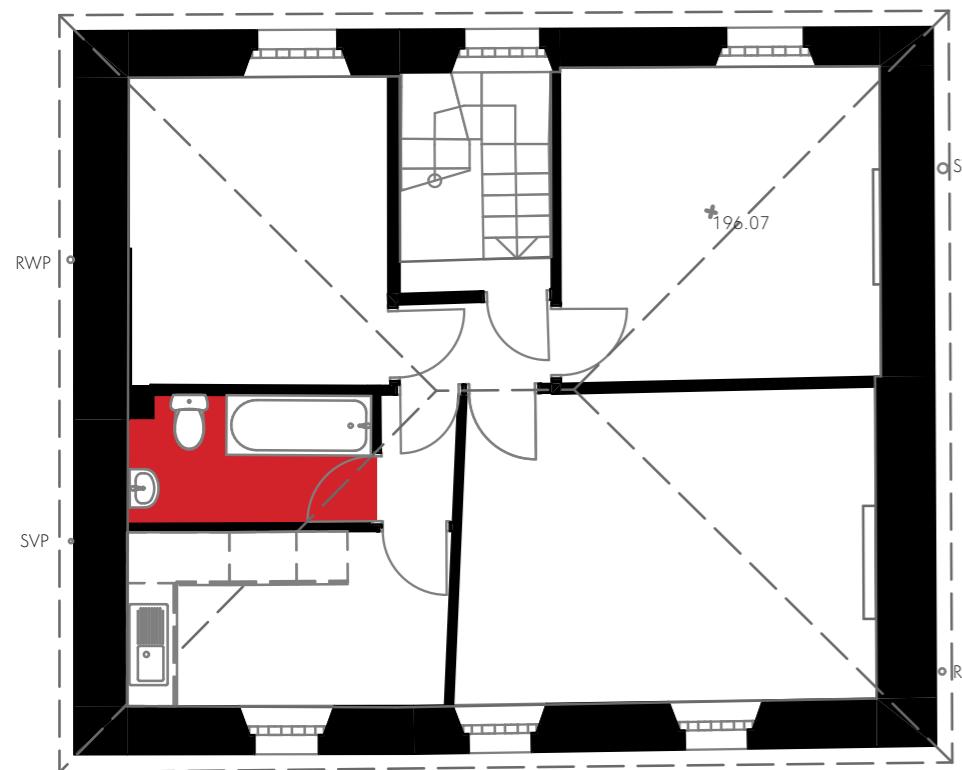
## 12.0 Interior - Second Floor - Bathroom

There is mould on one part of an internal wall; however, this is likely to be a case of moisture build-up and insufficient ventilation.

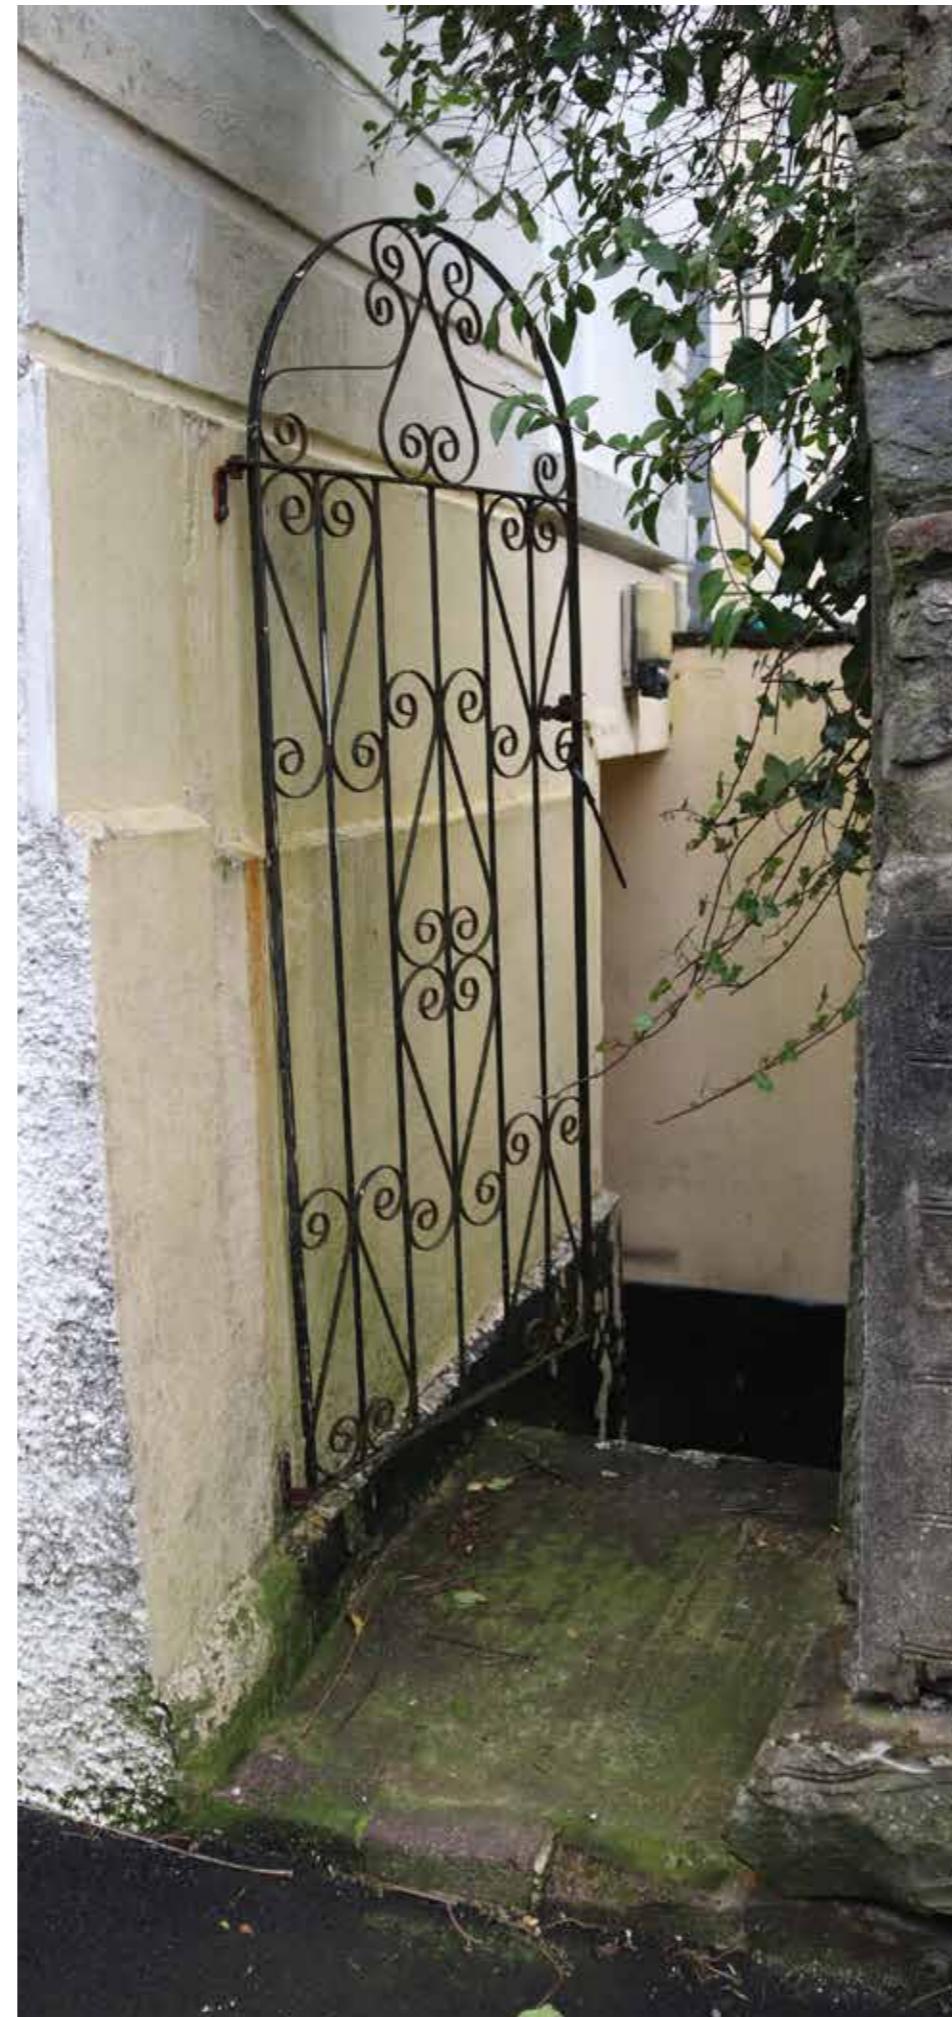
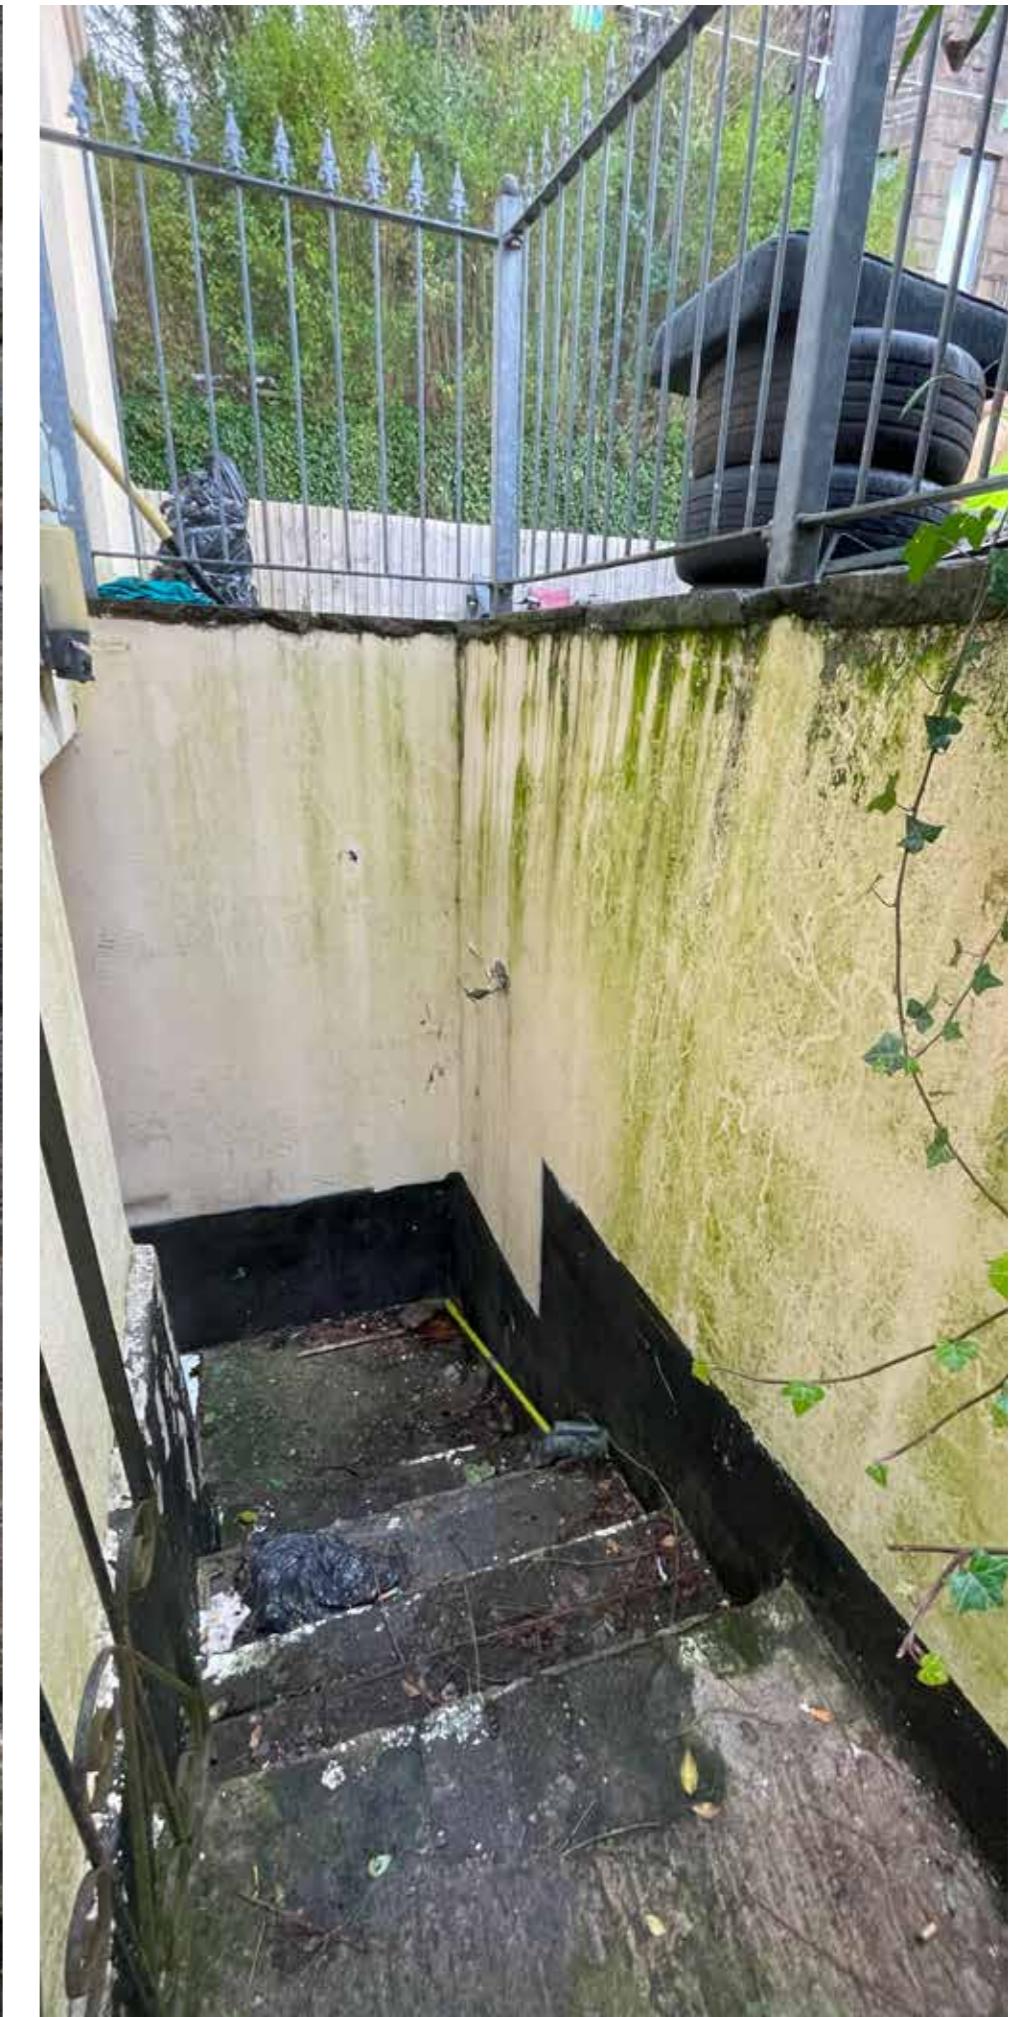
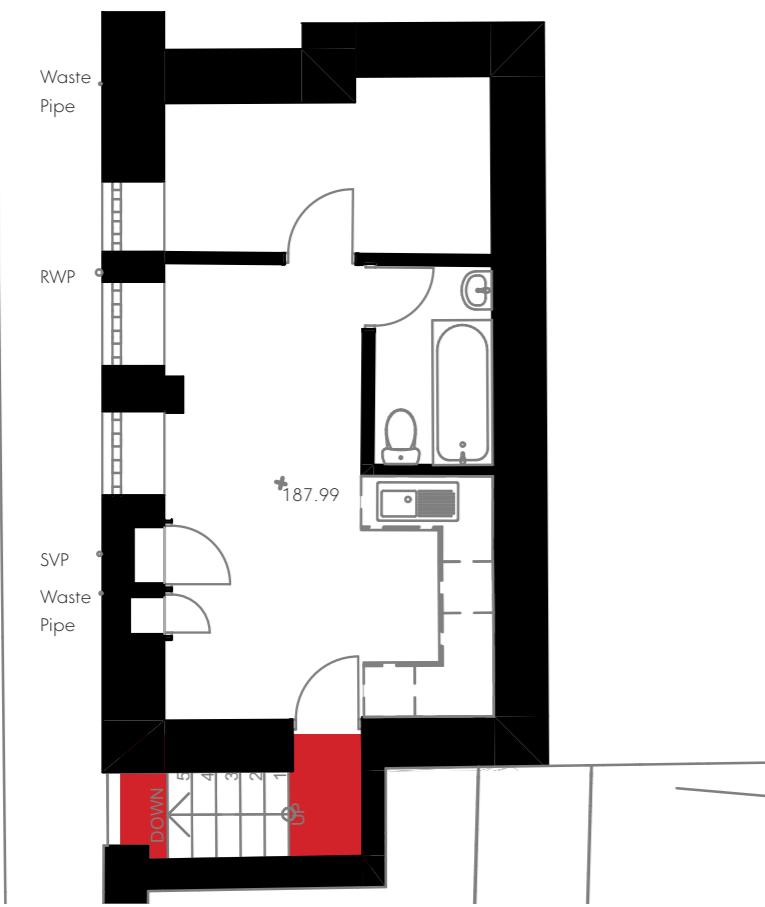
### 13.0 Interior - Lower Ground Floor Flat Entrance

The proposals involve a good clean of the steps and the application of safety nosings to each step, as they are currently potentially slippery.

The outer wall is proposed to be cleaned of the organic staining and repainted. The inner wall is proposed - as with the rest of this elevation - to be hacked off and a new, lime render applied.
