## Primrose Hill, Merthyr Tydfil

### Structural Condition and Appraisal Report

# Primrose Hill, Merthyr Tydfill Mechanical Conditioning Report

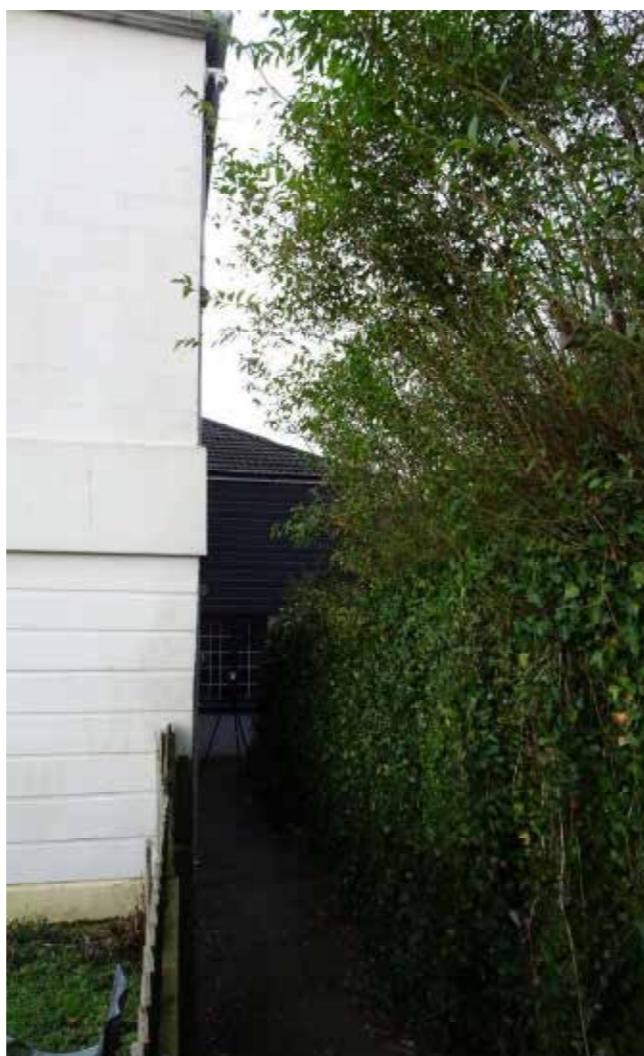
- 2.8.1 To the east of the building is an approx. 3m tall stone masonry retaining wall which is fully retaining an upper garden. The wall appears to comprise rubble stone masonry likely bound and originally pointed in lime mortar similar to the walls of the neighbouring Synagogue. The wall is currently covered with vegetation (ivy) and there is extensive vegetation / shrubs growing out of the head of the masonry therefore the wall was generally not inspectable.
- 2.8.2 The front elevation of the wall is heavily pointed in cement which is assumed to be a more recent repair.

- 3.5.1 The eastern retaining wall appears to be in reasonable condition and seems reasonably plumb where locally visible through the vegetation, however the elevation is generally covered with vegetation. The exact extent of distress / deterioration is unknown.

- 4.5 For the existing retaining wall, ongoing vegetation growth puts the masonry fabric at risk of further deterioration if left unaddressed with the potential to cause structurally significant harm to the existing fabric. The shrubs growing out of the head of the wall have the potential to accelerate degradation and risk localised loss of masonry which could fall from height unpredictably. The wall is also heavily pointed in cement which has the potential to trap water and accelerate degradation particularly considering the wall is fully retaining the upper garden which naturally drains towards the rear of the wall.

- For the external retaining wall, allow for removing the full face of vegetation and all shrubs along the wall head including their roots. Removal of shrubs may require the localised dismantling of the upper say 400mm of the wall heads to allow full root growth therefore allow for dismantling and rebuilding the upper 400mm of masonry.

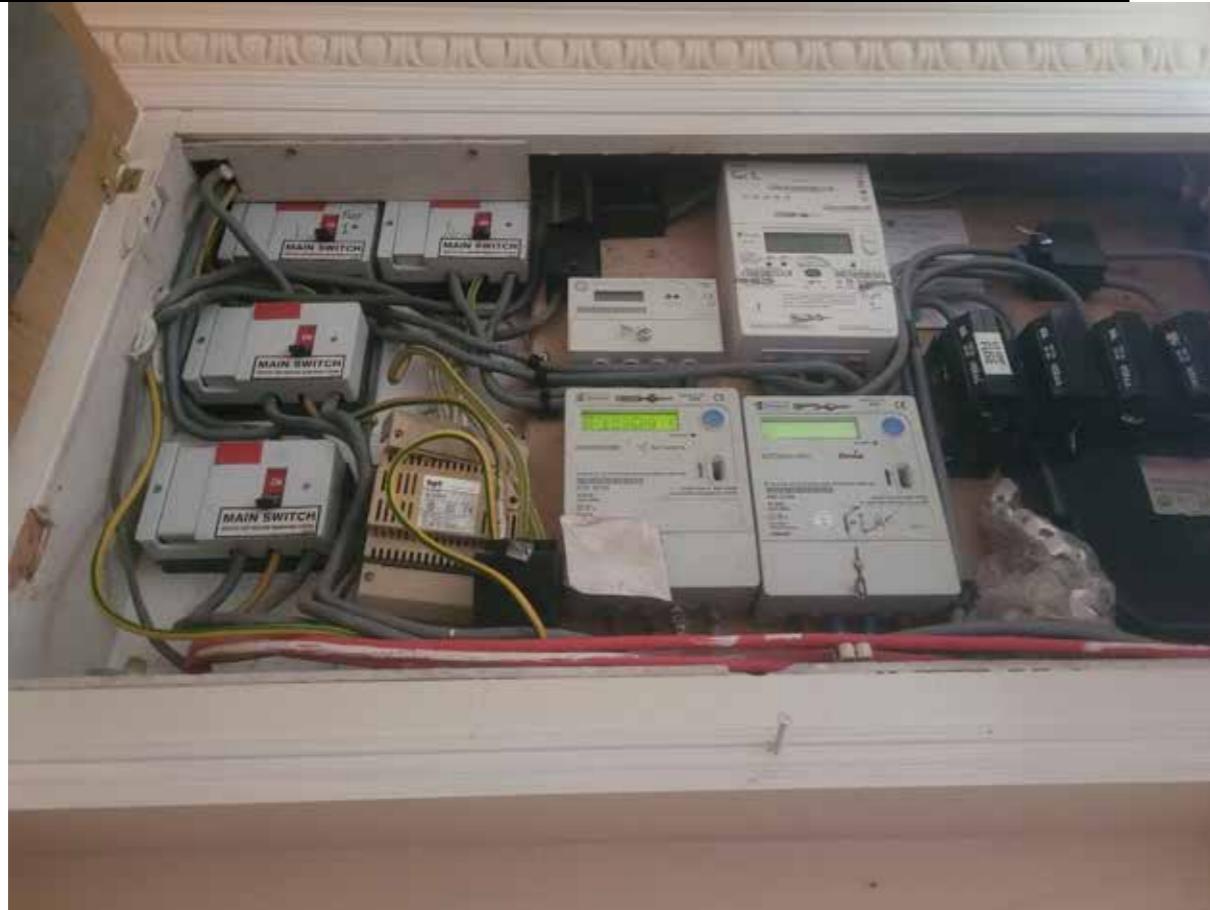
The electrical supply is a 60 Ampere three phase 4-wire TN-S 400/230-volt 50Hz. PME (TN-C-S) and although installed in an untidy ad-hoc method there are no visual signs of any thermal damage or stress to the conductors.

The despite being more than 25 years old incoming DNO service cut out is in a satisfactory condition, the Energy meters are in a good condition and a future life span of 15– 20 years can be expected from this equipment.
