# Tree Condition Survey

Trees on land at  
Cygnet Ty Alarch

Location: **Ty Alarch, Park Terrace, Merthyr Tydfil, CF47 8UY**

Report reference number: **TCA-KC/TYALARCH/002**

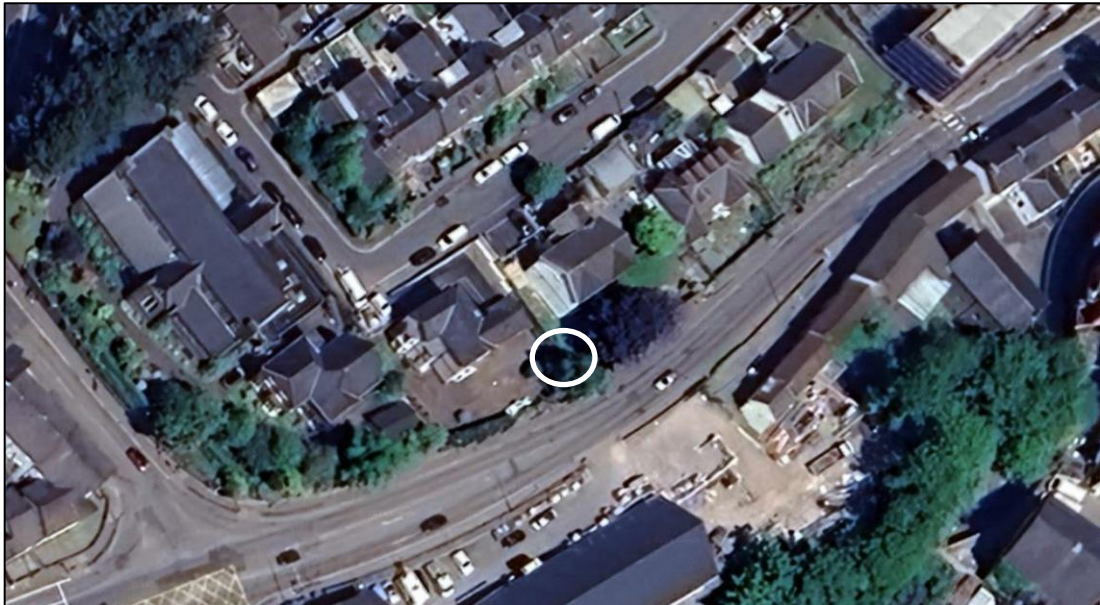
**Figure 2.** Location of birch tree.

- 6.3 Detailed information on the birch tree is provided at appendix one. The location of the tree is shown in figure two below.
- 6.4 The tree is located in an area bordered by the client's property to the north west; neighbouring dwellings/buildings to the east; public highway (Pontmorlais W) and pedestrian footway to the south and steps and path to the west. The trees are located in raised ground contained by the client's 1.8m stone boundary wall and access steps up from Pontmorlais W. The trees are exposed to prevailing winds.

- 7.2 At the recent survey, I observed ongoing development works in progress on the land to the east. The original wall has been replaced with a retaining structure showing significant sized blocks. Ground levels have been raised and rely on the new structure holding back the weight of infill.

- 7.3 I discussed the construction of the wall with the staff member who accompanied me on my survey. She informed me that excavations for the structure were extremely close to the base of the tree and went down some considerable distance in order to provide sufficient foundation and engineering to allow the raising of the structure and final infill.

- 7.4 In my opinion it is reasonably foreseeable that such works will have caused significant loss of structural roots of the birch tree such that roothold is likely to be compromised.

High likelihood of compromised structural roots which presents an unacceptable risk of whole tree failure.

- 10.1 I recommend that T001 birch is felled and replaced by a new tree close within the grounds of Ty Alarch.
- 10.2 The work should be carried out within three months.
- 10.3 Notification to the local planning authority will be required – see section 5 and figure 1.

Fell.
