*Report No. BC/MB/04.19.04/2.*

# **Site Investigation Report: Proposed New Club House at the Wern Sports Field.**

**Merthyr Rugby Club.**

# Site Investigation Report: New Club House, Land at the Wern Sports Ground.

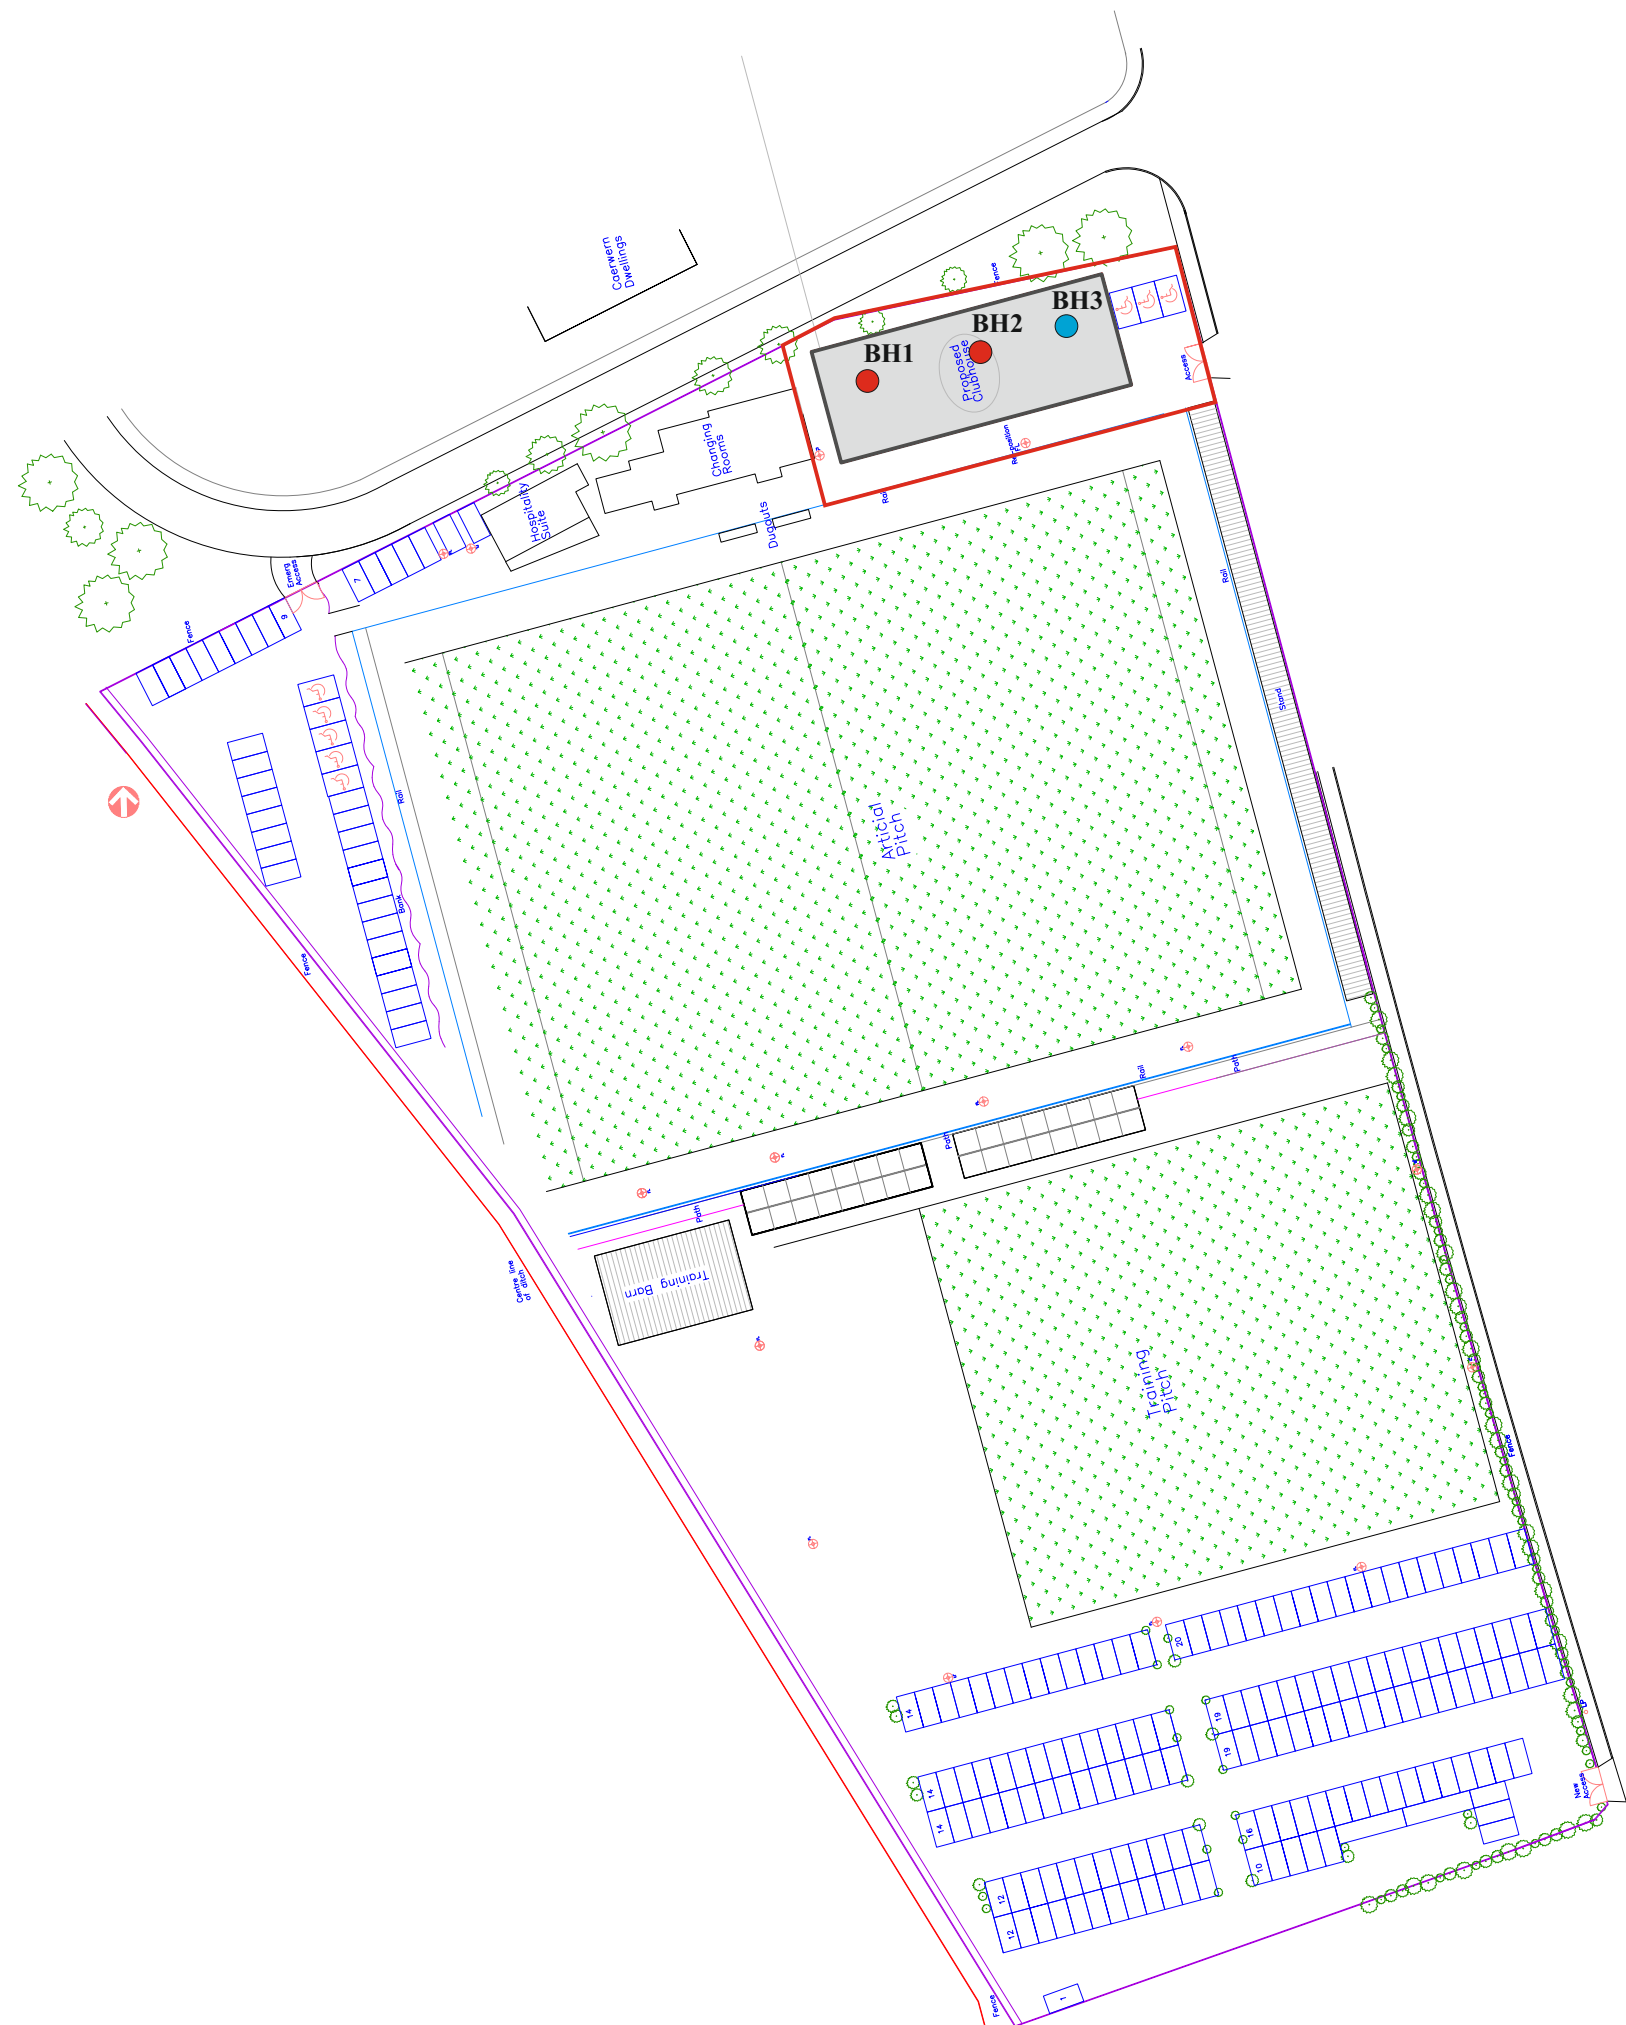
Drawing No: BC/MB/04.19.04.05.

Old workings were encountered in Boreholes 1 and 2; Borehole 3 encountered no old workings. In Borehole 1 old workings were encountered between 22.0m and 23.5m; the old workings were 'soft drilling' interpreted as being backfilled old workings. In Borehole 3 particularly hard drilling was encountered between 24m and 26m; this band of hard drilling is interpreted as being an ironstone vein and correlates with the old workings encountered in Borehole 1. It is generally accepted that the upward migration of mining voids chokes off where the thickness of strata is ten times the height of the original mining void (strata:void ratio of 10:1) and the process stops. The strata:void ratio for the above old workings is 10.3:1; the old workings are not likely to collapse to reach rockhead, where the coal measures are overlain with between 5m and 7m of sand and gravel deposits.

Borehole 2 encountered old workings between 15.0m and 17.3m; the workings were encountered as soft drill, broken ground and voids. The strata:void ratio for these workings is 3.6:1, posing a high risk of the workings collapsing to the surface.

Both sets of old workings encountered in the boreholes relate to ironstone veins. The upper set of old workings encountered in Borehole 2 poses a high risk of collapsing to the surface and it is recommended that they are stabilised by means of a drilling and grouting programme.

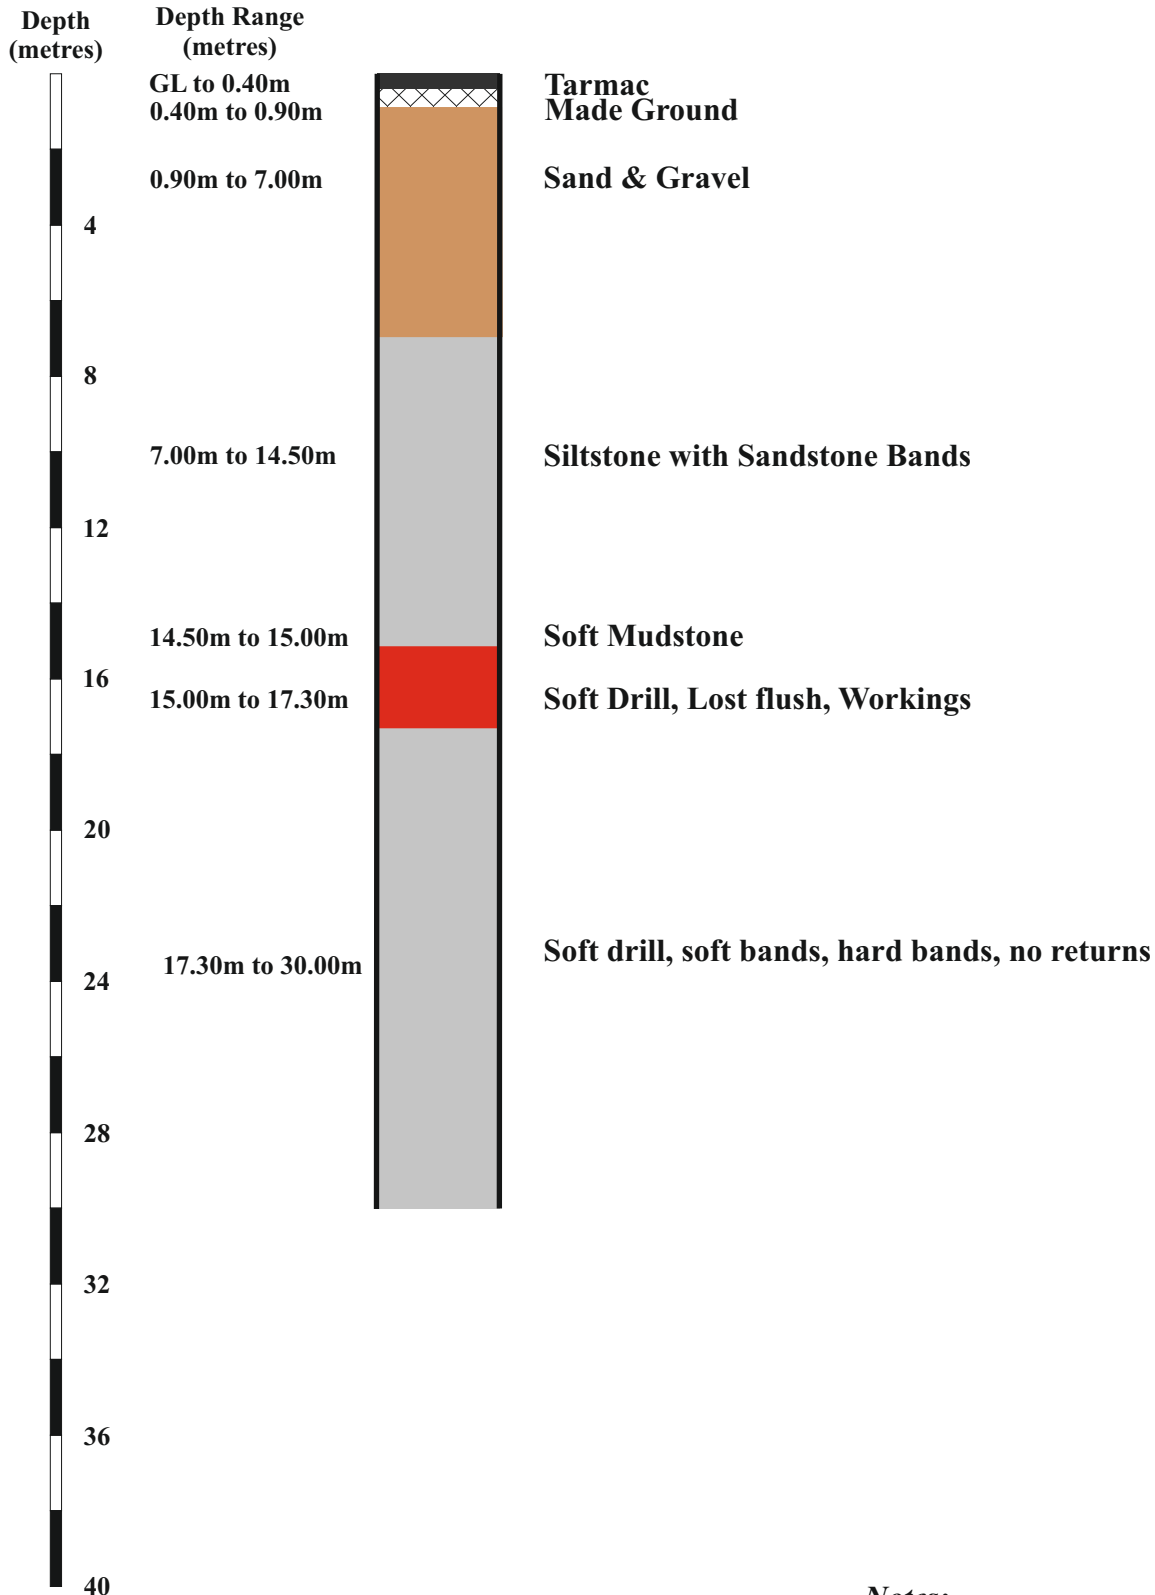
### *Borehole No. 1*

The lower set of old workings encountered in Borehole 1 do not pose risk of collapsing to rockhead.
