**PENTREBACH HOUSE, MERTHYR**

**PRELIMINARY ROOST**

**ASSESSMENT (PRA) REPORT**

Document Ref: E26146901 / Doc 01 – September 2026

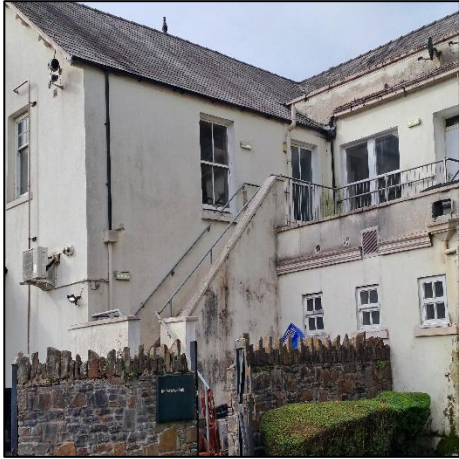
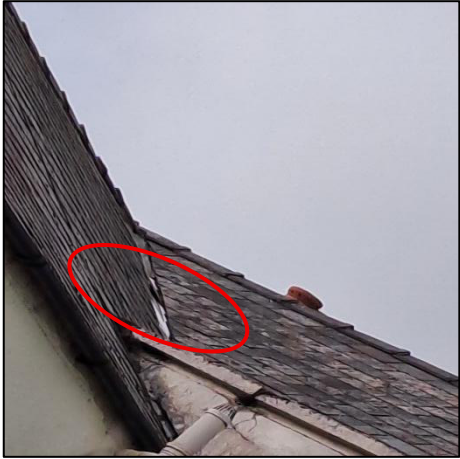
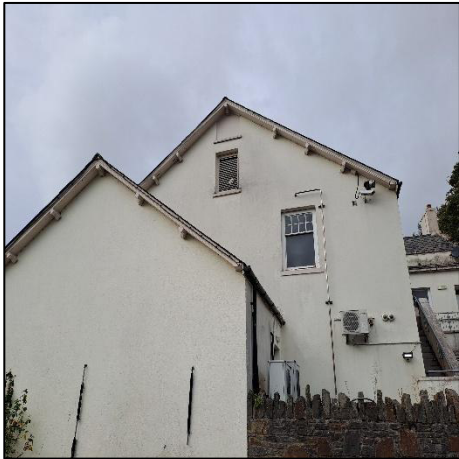
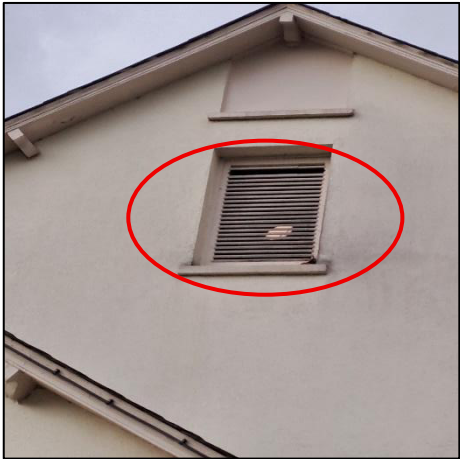
| <b>Eastern Elevation</b> | <p>The roofing at the eastern elevation consists of both pitched and flat roof. All the windows are timber framed and while they show signs of wear and tear, they are all sealed with no gaps present.</p> <p>No gaps are visible in the ridge tiles, and all tiles are present with none missing. To the north of the eastern elevation there is a small possible gap in the lead flashing where 2no. pitch roofs meet. All other lead flashing in this area appears well sealed.</p> <div style="display: flex; justify-content: space-around;"> </div> <p>Also, to the northern area of the eastern elevation was noted a window below the apex on the gable end that appears slatted and open and lit from the inside. Additionally, there appears to be damage to the fascia on the gable end that has resulted in a possible cavity where the fascia meets the guttering. A small gap is present in the flashing of the gable end near to where it meets the guttering and also a small gap was noted under a tile on the lower level roof.</p> <div style="display: flex; justify-content: space-around;"> </div> |

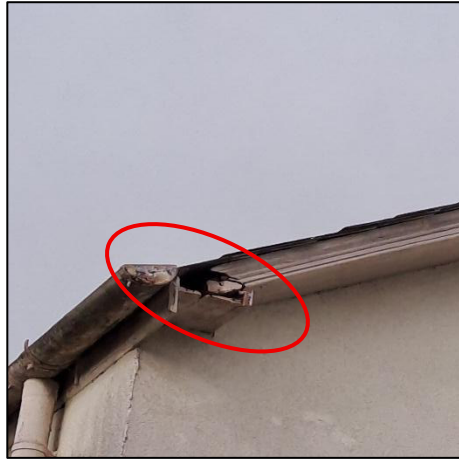
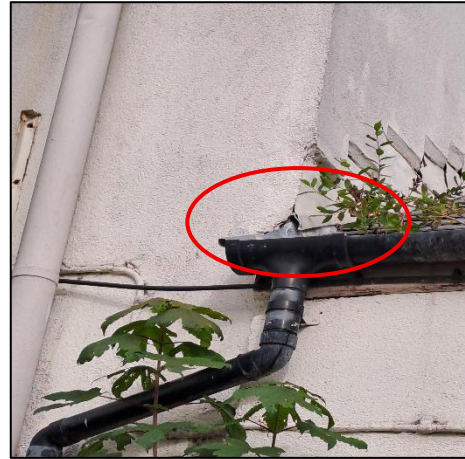
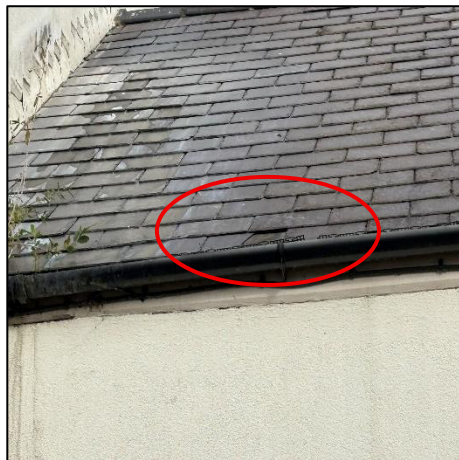
Adjacent to the gable end was noted an outdoor bin storage area along with some steel ventilation shafts. No gaps or potential access points were noted in this area.

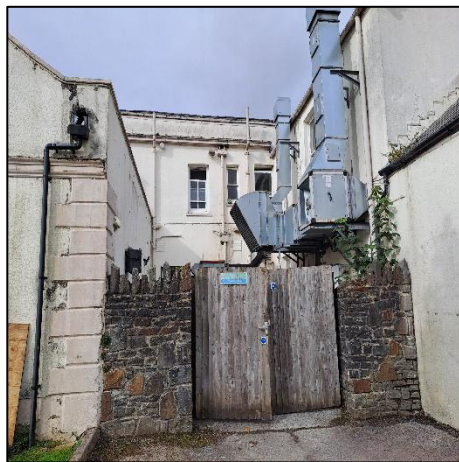
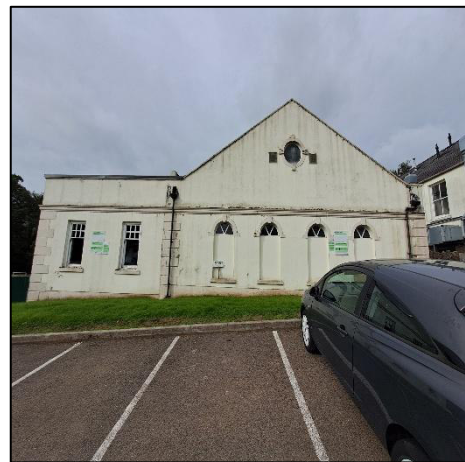
Further south along the eastern elevation were a row of ground floor windows and a circular window below the apex. These were all sealed and no gaps or potential access points were identified in this area.

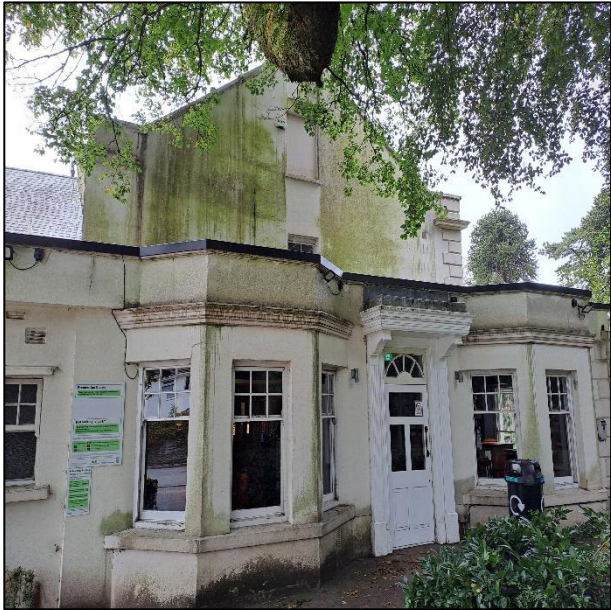
| <b>Internal – Ground Floor</b> | <p>This area is still in use as a restaurant and office spaces, therefore regular disturbance and bright interior lighting present. This area is unlikely to support roosting bats or nesting birds and no further inspection was undertaken on this level.</p> |

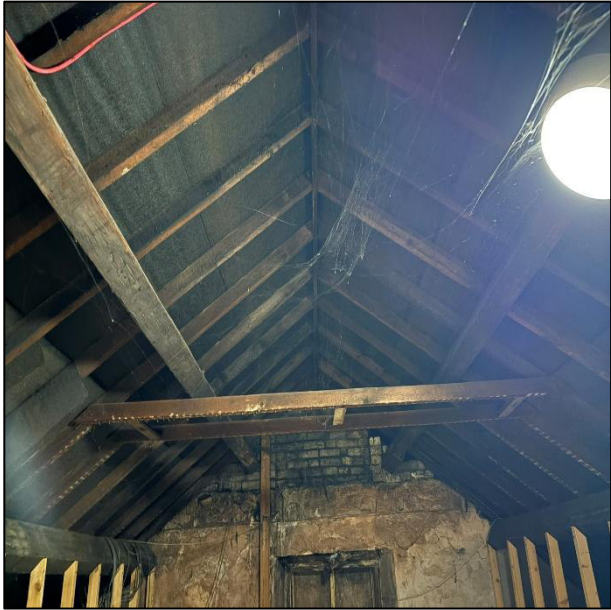
| <b>Internal – First Floor loft space</b> | <p>The internal loft space extends over the ground floor north to south with an annexe to the east. The loft is boarded centrally with exposed beams above and to either side of boarding, there was also evidence of this area being used as storage for the business. The stairs led to a well lit area with a north, south and eastern section separated by fire doors. All the internal roof under felting appeared intact with no rips or tears visible.</p> <p>The northern section contained a blocked-up window to the north which had no gaps or potential access points and there was no visible light could be seen that would indicate gaps in the roof, this the blocked off side areas were dark and this part of the loft had a stable temperature.</p> |

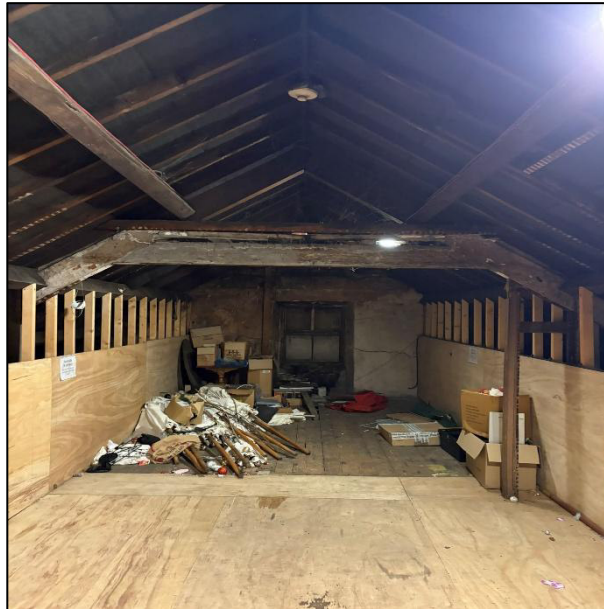
Similarly, the southern section of the loft space showed no gaps and all felting was intact, this part of the loft also had dark areas to the sides a stable temperature. The window at the gable was blocked up as noted from the outside and whilst there was some ingress of nesting material between the window pane and the board there were no gaps that would allow access for bats or birds to enter the loft space.

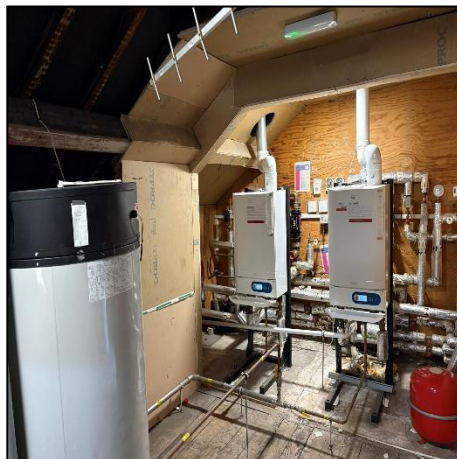
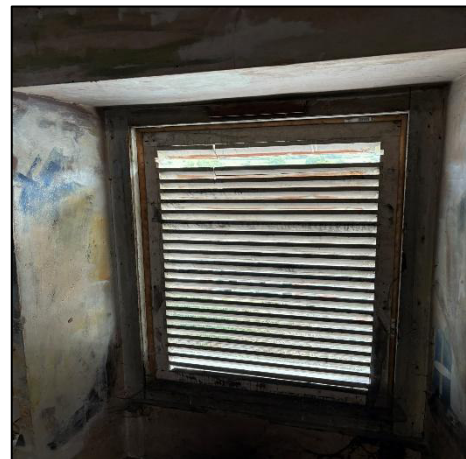
The eastern section was warm, well lit and contained several new heating systems. The slated window noted externally was open with no glass behind the slats.

No evidence of occupation by roosting bats (e.g. droppings, live/dead specimens, staining or feeding remains) or nesting birds (nesting material or droppings) was found in any of the loft areas.

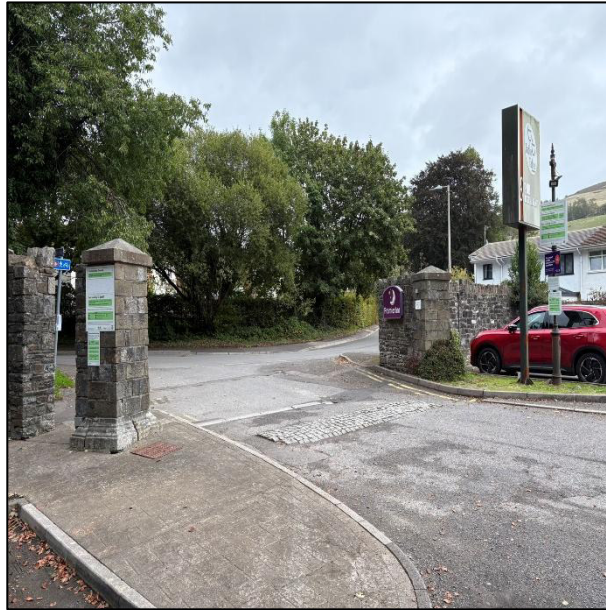
Existing lighting columns are present near to the entrance and the outskirts of the site with existing signage present also at the entrance and within the grounds. No impact is expected from additional lighting in these areas.

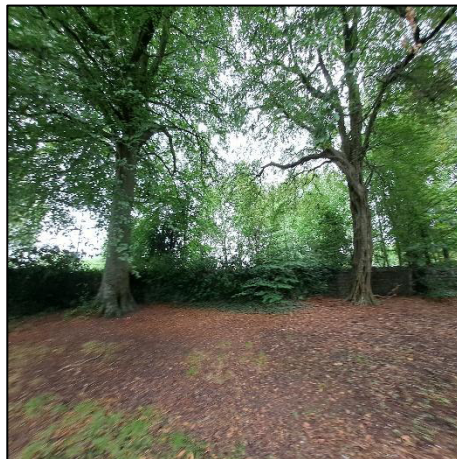
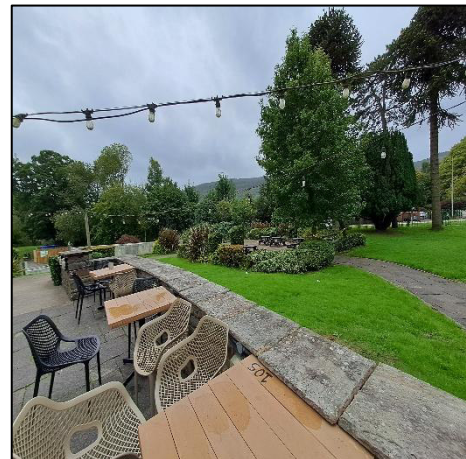
The grounds of the building consists of amenity grassland with parkland trees and ornamental planting. There are large, mature trees within the grounds including 3no. large Beech *Fagus sylvatica* trees, Sycamore *Acer pseudoplatnus* and Monkey Puzzle *Araucaria araucana* trees.

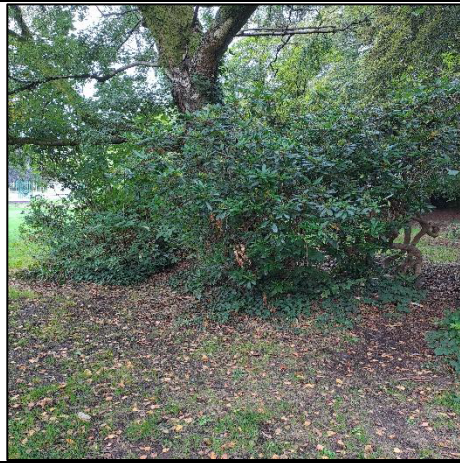
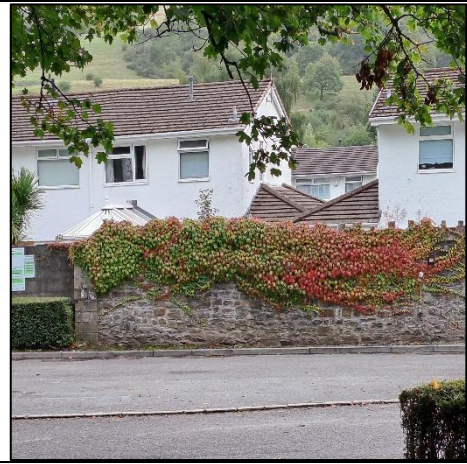
Additionally, there are several incidences of non-native invasive species listed on Schedule 9 of the Wildlife and Countryside Act 1981 (as amended) such as Rhododendron *Rhododendron ponticum* and Virginia Creeper *Parthenocissus quinquefolia*.
