# BAT TREE SURVEY REPORT

HOOVER SITE,  
MERTHYR TYDFIL

<b>Project: Hoover Site, Merthyr Tydfil</b>		
<b>Project Number</b>	K001	
<b>Title</b>	Bat Tree Report	
<b>Document Number</b>	K001 – Bat Tree Report-V1.3	
<b>Client</b>	Walters	
<b>Issue Date</b>	30-Oct-25	
<b>Prepared by:</b>	David Price 30-Oct-25	
<p>This report has been prepared by Sylvan Ecology, with all reasonable skill, care, and diligence within the terms of the Contract with the client. We disclaim any responsibility to the client and others in respect of any matters outside the scope of the above. This report is confidential to the client, and we accept no responsibility of whatsoever nature to third parties to whom this report, or any part thereof, is made known. Any such party relies on the report at their own risk.</p>		
<b>Executive summary</b>		
Site	The survey was conducted on all trees within or on the boundary of the site, to assess their suitability for roosting bat.	
Protected Spp (Bats)	<b>Potential low Impact</b> – Some PRF-I trees were identified on site, that could be utilised by individual trees – Recommendations: impacts negated through mitigation

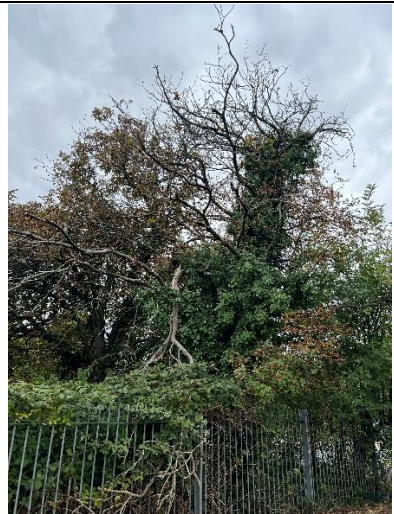
G3	Group of 2: Horse Chestnut ( <i>Aesculus hippocastanum</i> )	11	Mature	Fair	Inaccessible trees thus preventing full inspection and accurate measurement. Prominent specimens of reasonable form. Some dieback within upper crowns.	Dieback is within the upper crown and offers no suitability for bats. There is thin ivy on the trees, though the ivy isn't thick enough to offer roosting potential, its possible that the ivy is obscuring other features, as a result the tree has been categorised as PRF-I.	PRF-I

- 4.1 Trees or groups of a Category PRF-I grade should be considered as constraints and any impacts on these trees should be mitigated.
- 4.2 If trees of a Category PRF-I grade are scheduled to be felled and/or subject to surgery, as per current best practice guidance, the trees will be thoroughly inspected prior to felling and a watching brief of all works that could impact the tree will be undertaken.

- Mitigation**
- 4.5 To mitigate the loss of PRF-I trees, a total of nine new roosting locations will be added to the final site design. This will be done through integrating bat bricks into the new buildings on site.

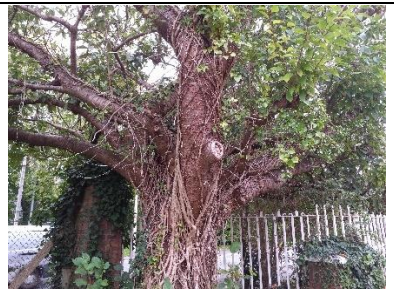
T4	Goat Willow ( <i>Salix caprea</i> )	5	Young	Poor	Naturally regenerated specimen of poor form exhibiting weak basal forks.	N/A	None	N/A
T5	Cherry ( <i>Prunus</i> spp.)	10	Mature	Fair to poor	Prominent specimen that has suffered poor quality pruning work on western side of main stem leading to development of some internal decay within major branches.	Very thin ivy, not suitable for roosting. Minor rot hole, pointing up so likely fills with water, depth is negligible and not suitable for roosting.	None

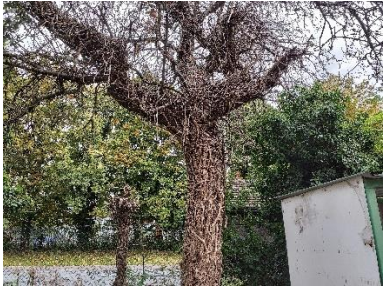
T7	Crab Apple ( <i>Malus sylvestris</i> )	10	Mature	Fair to poor	Prominent specimen that has suffered poor quality pruning work on western side of crown leading to commencement of some internal decay within major branches.	Very thin ivy, not suitable for roosting. Decay in upper branches, thin and not suitable for roosting.	None

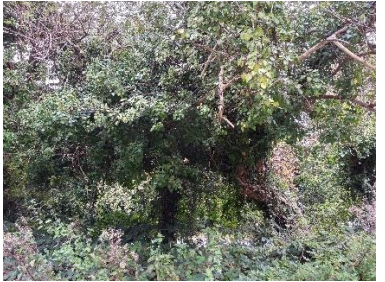
T8	Ash ( <i>Fraxinus excelsior</i> )	10	Middle aged	Poor	Naturally regenerated specimen exhibiting early-stage symptoms of Ash Dieback Disease.	N/A	None	N/A
T9	Crab Apple ( <i>Malus sylvestris</i> )	6	Middle aged	Fair to poor	Tree of variable form that has suffered poor quality pruning on western side of crown.	N/A	None	N/A
T10	Sugar Maple ( <i>Acer saccharum</i> )	5	Young	Poor	Coppice regrowth from decayed stump. These stems are vulnerable to structural failure as they mature.	N/A	None	N/A
G11	Group of: Elder ( <i>Sambucus nigra</i> ), Norway Maple ( <i>Acer platanoides</i> ), Hawthorn ( <i>Crataegus monogyna</i> )	6	Middle aged / Mature	Poor	Naturally regenerated specimens of poor form and vigour. Some specimens exhibit significant basal decay.	Scrubby vegetation, decay in the form of fungus, no suitable PRFs. Ivy is thin and not suitable for roosting, trees too small to have features hidden by ivy.	None

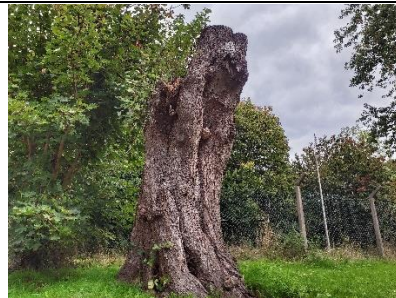
T13	Dead cherry	2				There are rot holes present, but they are very open and offer negligible potential for crevice dwelling bats.	None

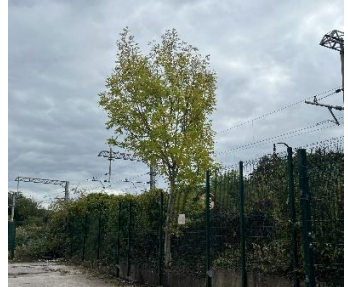
T37	Ash ( <i>Fraxinus excelsior</i> )	9	Young	Poor	Naturally regenerated specimen exhibiting symptoms of Ash Dieback Disease.	N/A	None

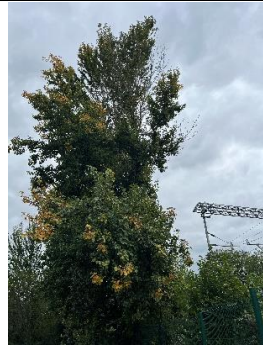
T38	Lombardy Poplar ( <i>Populus nigra</i> 'Italica')	25	Mature	Fair	Prominent boundary tree that has been significantly pruned on western side of crown leading to development of some internal decay within main stem. This specimen is vulnerable to significant structural failure as it matures.	Monitor annually for safety.	None

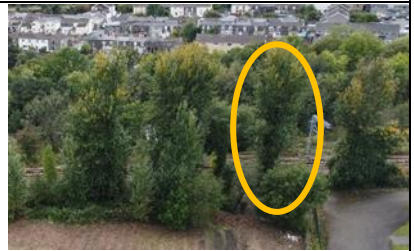
T39	Goat Willow ( <i>Salix caprea</i> )	9	Middle aged	Poor	Scrubby naturally regenerated specimen exhibiting weak basal forks.	N/A	None	
G 40	Group of: Sycamore ( <i>Acer pseudoplatanus</i> )	8	Young	Poor	Naturally regenerated specimens located immediately adjacent to structures. These specimens are unsuitable for retention.	N/A	None	N/A
T41	Lombardy Poplar ( <i>Populus nigra</i> 'Italica')	23	Mature	Fair to poor	Prominent boundary tree whose main stem is heavily colonised by ivy thus preventing full inspection. Historical crown reduction work has led to development of dysfunctional growth in upper crown. This specimen is vulnerable to structural failure as it matures.	There is ivy on the trees, though the ivy isn't thick enough to offer roosting potential, its possible that the ivy is obscuring other features, as a result the tree has been categorised as PRF-I.	PRF-I

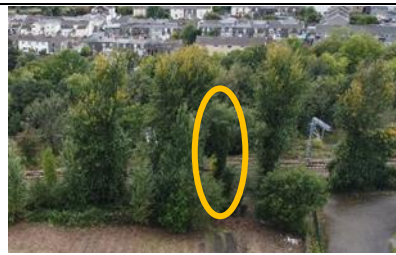
T42	Lombardy Poplar ( <i>Populus nigra</i> 'Italica')	10	Mature	Poor	This specimen has been severely topped leading to significant development of internal decay.	There is ivy on the trees, though the ivy isn't thick enough to offer roosting potential, its possible that the ivy is obscuring other features, as a result the tree has been categorised as PRF-I. PRF-I	PRF-I

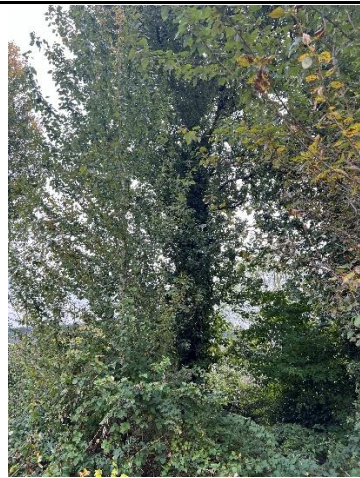
G43	Group of 2: Lombardy Poplar ( <i>Populus nigra</i> 'Italica')	22	Mature	Fair to poor	Prominent boundary trees that have suffered significant crown reduction in the past leading to development of dysfunctional growth in mid and upper crown. These specimens are vulnerable to significant structural failure as they mature.	There is ivy on the trees, though the ivy isn't thick enough to offer roosting potential, its possible that the ivy is obscuring other features, as a result the tree has been categorised as PRF-I. PRF-I	PRF-I

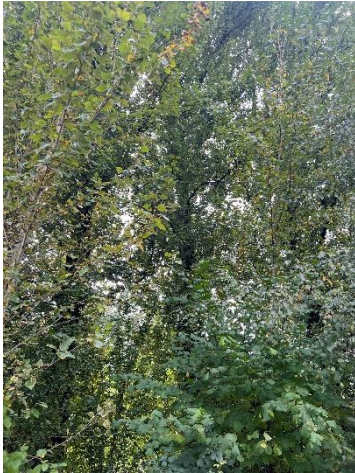
G45	Group of 6: Lombardy Poplar ( <i>Populus nigra</i> 'Italica')	21	Mature	Fair to poor	Prominent linear feature containing trees that have been historically heavily crown reduced leading to development of internal decay in mid and upper crown as well as dysfunctional branch growth. These specimens are vulnerable to significant structural failure as they mature.	Very thin ivy, not suitable for roosting. Some bracket fungus, but no obvious PRFs from decay.	None

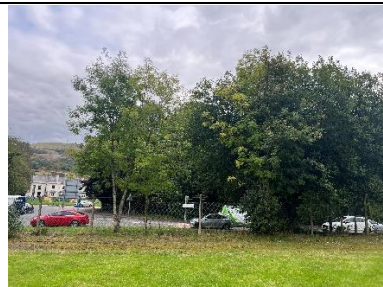
G61	Group of: Ash ( <i>Fraxinus excelsior</i> ), Whitebeam ( <i>Sorbus aria</i> )	11	Middle aged	Poor	Boundary trees of variable form. Ash are infected with Ash Dieback Disease. Whitebeam has suffered significant basal pruning leading to development of internal decay.	No visible PRFs.	None

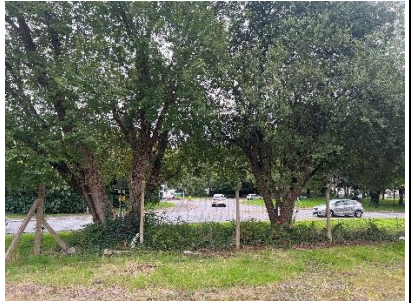
G66	Group of 2: Goat Willow ( <i>Salix caprea</i> )	11	Mature	Fair	Prominent naturally regenerated specimens of a species that is vulnerable to structural failure at the base as it matures.	Light ivy growth, offers negligible roosting potential	None

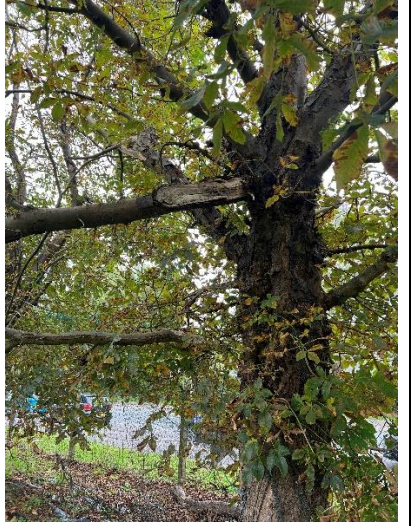
T67	Horse Chestnut ( <i>Aesculus hippocastanum</i> )	17	Mature	Poor	Prominent boundary tree exhibiting significant internal decay within main stem and mid crown.	Some minor rot and damage to the tree, none of which offers viable roosting features. Some lifted bark offering limited roosting offer opportunities for crevice dwelling bats.	PRF-I

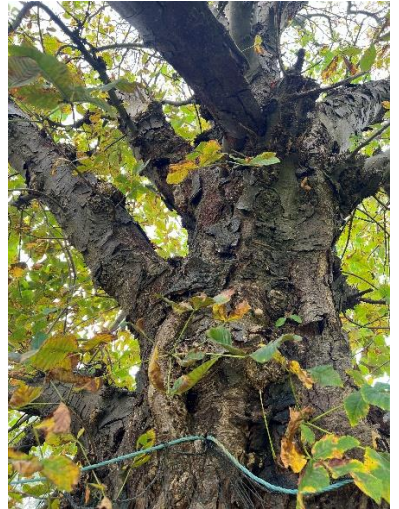
T68	Horse Chestnut ( <i>Aesculus hippocastanum</i> )	17	Mature	Poor	Prominent boundary tree exhibiting significant internal decay within main stem and major limbs.	Some lifted bark offering limited roosting offer opportunities for crevice dwelling bats.	PRF-I

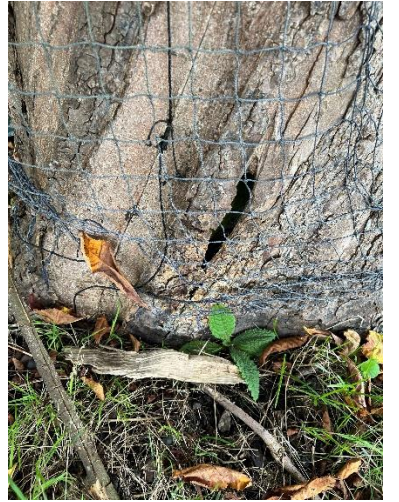
T69	Horse Chestnut ( <i>Aesculus hippocastanum</i> )	18	Mature	Fair	Prominent and isolated boundary tree of reasonable form and vigour.	Small rot hole at the base of the tree. The hole is covered by a net limiting its roosting potential. An inspection with an endoscope found no evidence of roosting bats, the hole only entered a small distance into the tree. Some lifted bark offering limited roosting offer opportunities for crevice dwelling bats.	PRF-I

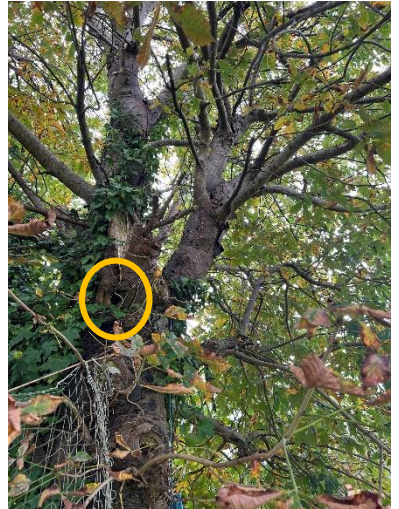
T70	Horse Chestnut ( <i>Aesculus hippocastanum</i> )	16	Mature	Fair to poor	Boundary tree of variable form exhibiting some decay within main branches.	Small rot hole, doesn't go far enough into tree to be a viable roosting feature. Some lifted bark offering limited roosting offer opportunities for crevice dwelling bats.	PRF-I

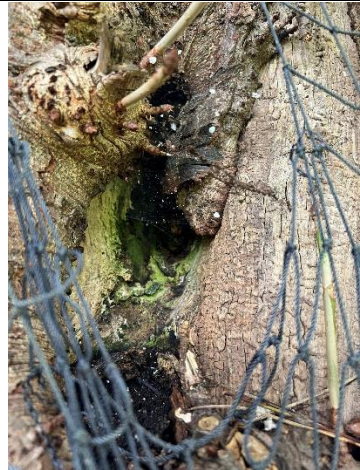
T71	Horse Chestnut ( <i>Aesculus hippocastanum</i> )	19	Mature	Fair to poor	Prominent boundary tree of variable form exhibiting some dieback in mid and upper crown.	Small rot hole, doesn't go far enough into tree to be a viable roosting feature. Some lifted bark offering limited roosting offer opportunities for crevice dwelling bats.	PRF-I

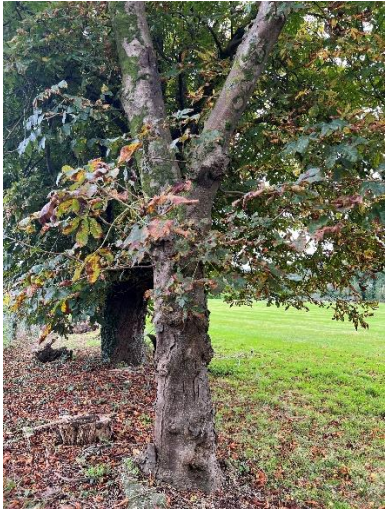
T72	Horse Chestnut ( <i>Aesculus hippocastanum</i> )	17	Middle aged	Poor	Tree of poor form exhibiting significant internal decay as well as decay within major limbs.	N/A	None

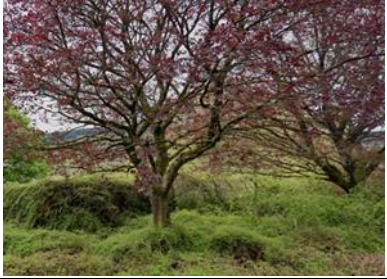
T108 Off site	Norway Maple ( <i>Acer platanoides</i> )	13	Middle aged	Fair	Prominent roadside tree that has suffered significant poor quality pruning on northern and eastern side of lower crown. Possible weakness in lower fork at 2m.	N/A	None
