BAT TREE SURVEY REPORT

HOOVER SITE, MERTHYR TYDFIL

Project Number	K001	
Title	Bat Tree Report	
Document Number	K001 – Bat Tree Report- V1.4	
Client	Walters	
Issue Date	11-Dec-25	
Prepared by:	David Price 11-Dec-25

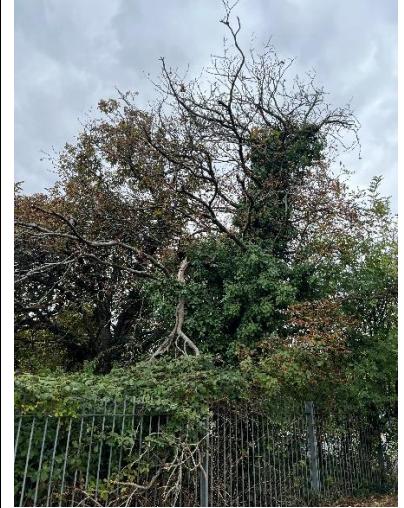
G3	Group of 2: Horse Chestnut (<i>Aesculus hippocastanum</i>)	11	Mature	Fair	Inaccessible trees thus preventing full inspection and accurate measurement. Prominent specimens of reasonable form. Some dieback within upper crowns.	Dieback is within the upper crown and offers no suitability for bats. There is thin ivy on the trees, though the ivy isn't thick enough to offer roosting potential, its possible that the ivy is obscuring other features, as a result the tree has been categorised as PRF-I.	PRF-I

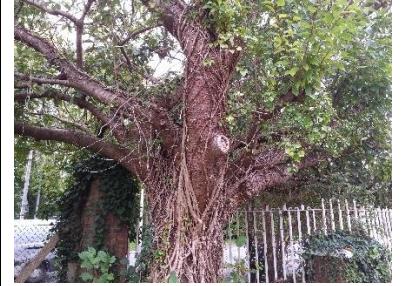
T4	Goat Willow (<i>Salix caprea</i>)	5	Young	Poor	Naturally regenerated specimen of poor form exhibiting weak basal forks.	N/A	None	N/A
T5	Cherry (<i>Prunus spp.</i>)	10	Mature	Fair to poor	Prominent specimen that has suffered poor quality pruning work on western side of main stem leading to development of some internal decay within major branches.	Very thin ivy, not suitable for roosting. Minor rot hole, pointing up so likely fills with water, depth is negligible and not suitable for roosting.	None

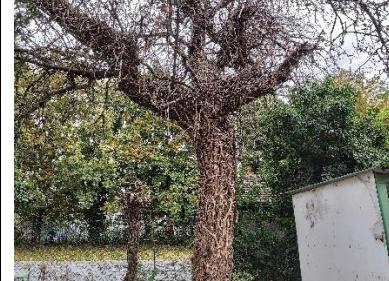
T7	Crab Apple (<i>Malus sylvestris</i>)	10	Mature	Fair to poor	Prominent specimen that has suffered poor quality pruning work on western side of crown leading to commencement of some internal decay within major branches.	Very thin ivy, not suitable for roosting. Decay in upper branches, thin and not suitable for roosting.	None

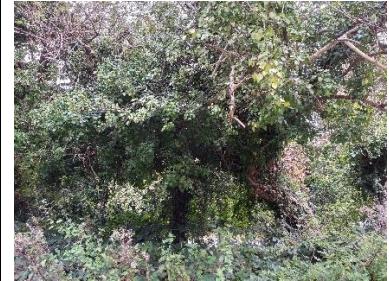
T8	Ash (<i>Fraxinus excelsior</i>)	10	Middle aged	Poor	Naturally regenerated specimen exhibiting early-stage symptoms of Ash Dieback Disease.	N/A	None	N/A
T9	Crab Apple (<i>Malus sylvestris</i>)	6	Middle aged	Fair to poor	Tree of variable form that has suffered poor quality pruning on western side of crown.	N/A	None	N/A
T10	Sugar Maple (<i>Acer saccharum</i>)	5	Young	Poor	Coppice regrowth from decayed stump. These stems are vulnerable to structural failure as they mature.	N/A	None	N/A
G11	Group of: Elder (<i>Sambucus nigra</i>), Norway Maple (<i>Acer platanoides</i>), Hawthorn (<i>Crataegus monogyna</i>)	6	Middle aged / Mature	Poor	Naturally regenerated specimens of poor form and vigour. Some specimens exhibit significant basal decay.	Scrubby vegetation, decay in the form of fungus, no suitable PRFs. Ivy is thin and not suitable for roosting, trees too small to have features hidden by ivy.	None

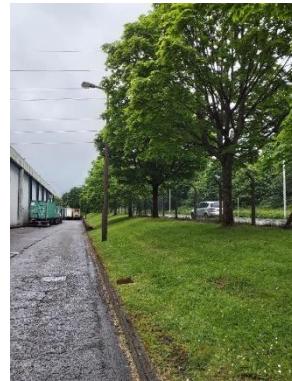
T22	Red Maple (<i>Acer rubrum</i>)	14	Middle aged	Good	Tree of good form and vigour.	N/A	None	N/A
T23	Norway Maple (<i>Acer platanoides</i>)	5	Young	Poor	Naturally regenerated boundary tree of poor form heavily suppressed to the north and west.	N/A	None	N/A
G24	Group of: Norway Maple (<i>Acer platanoides</i>)	15	Middle aged	Good	Prominent trees of good form and vigour.	N/A	None	N/A
T25	Norway Maple (<i>Acer platanoides</i>)	13	Middle aged	Fair to poor	Prominent boundary tree exhibiting significant dieback in centre of crown.	N/A	None

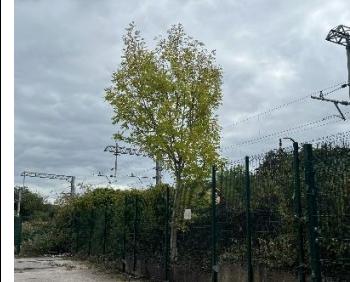
T37	Ash (<i>Fraxinus excelsior</i>)	9	Young	Poor	Naturally regenerated specimen exhibiting symptoms of Ash Dieback Disease.	N/A	None

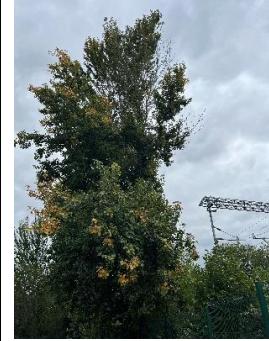
T38	Lombardy Poplar (<i>Populus nigra</i> ' <i>Italica</i> ')	25	Mature	Fair	Prominent boundary tree that has been significantly pruned on western side of crown leading to development of some internal decay within main stem. This specimen is vulnerable to significant structural failure as it matures.	Monitor annually for safety.	None

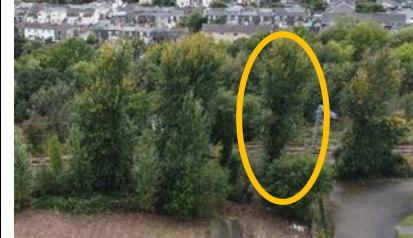
T39	Goat Willow (<i>Salix caprea</i>)	9	Middle aged	Poor	Scrubby naturally regenerated specimen exhibiting weak basal forks.	N/A	None	
G 40	Group of: Sycamore (<i>Acer pseudoplatanus</i>)	8	Young	Poor	Naturally regenerated specimens located immediately adjacent to structures. These specimens are unsuitable for retention.	N/A	None	N/A
T41	Lombardy Poplar (<i>Populus nigra</i> ' <i>Italica</i> ')	23	Mature	Fair to poor	Prominent boundary tree whose main stem is heavily colonised by ivy thus preventing full inspection. Historical crown reduction work has led to development of dysfunctional growth in upper crown. This specimen is vulnerable to structural failure as it matures.	There is ivy on the trees, though the ivy isn't thick enough to offer roosting potential, its possible that the ivy is obscuring other features, as a result the tree has been categorised as PRF-I.	PRF-I

4.5 To mitigate the loss of PRF-I trees, a total of nine *2F Schwegler Bat Boxes* will be added to retained trees on site prior to felling works.

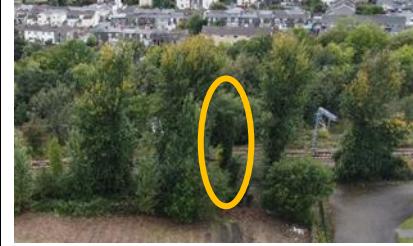
T42	Lombardy Poplar (<i>Populus nigra</i> ' <i>Italica</i> ')	10	Mature	Poor	This specimen has been severely topped leading to significant development of internal decay.	There is ivy on the trees, though the ivy isn't thick enough to offer roosting potential, its possible that the ivy is obscuring other features, as a result the tree has been categorised as PRF-I. PRF-I	PRF-I

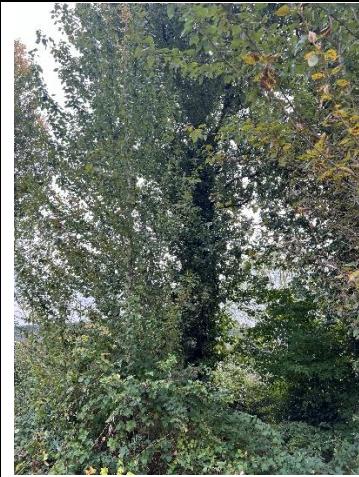
G43	Group of 2: Lombardy Poplar (<i>Populus nigra</i> 'Italica')	22	Mature	Fair to poor	Prominent boundary trees that have suffered significant crown reduction in the past leading to development of dysfunctional growth in mid and upper crown. These specimens are vulnerable to significant structural failure as they mature.	There is ivy on the trees, though the ivy isn't thick enough to offer roosting potential, its possible that the ivy is obscuring other features, as a result the tree has been categorised as PRF-I. PRF-I	PRF-I

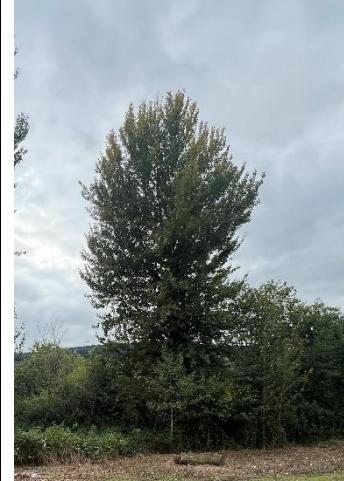
T47	Lombardy Poplar (<i>Populus nigra 'Italica'</i>)	21	Mature	Fair to poor	Isolated and prominent specimen that has suffered significant historical crown reduction leading to development of dysfunctional growth in mid and upper crown. This specimen is vulnerable to significant structural failure as it matures.	N/A	None

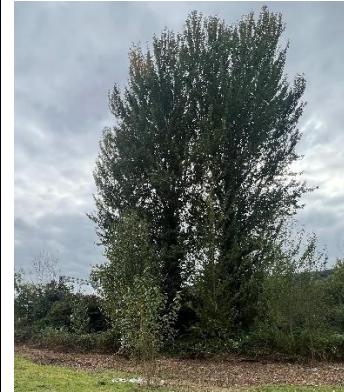
G48	Group of 2: Lombardy Poplar (<i>Populus nigra 'Italica'</i>)	24	Mature	Fair to poor	Prominent boundary specimens that have suffered significant historical crown reduction leading to development of dysfunctional growth in mid and upper crown. These specimens are vulnerable to significant structural failure as they mature.	N/A	None

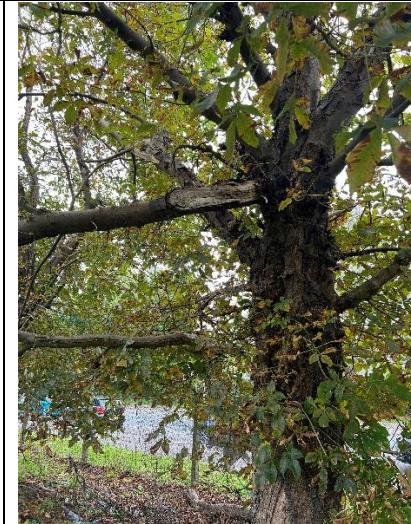
T67	Horse Chestnut (<i>Aesculus hippocastanum</i>)	17	Mature	Poor	Prominent boundary tree exhibiting significant internal decay within main stem and mid crown.	Some minor rot and damage to the tree, none of which offers viable roosting features. Some lifted bark offering limited roosting offer opportunities for crevice dwelling bats.	PRF-I

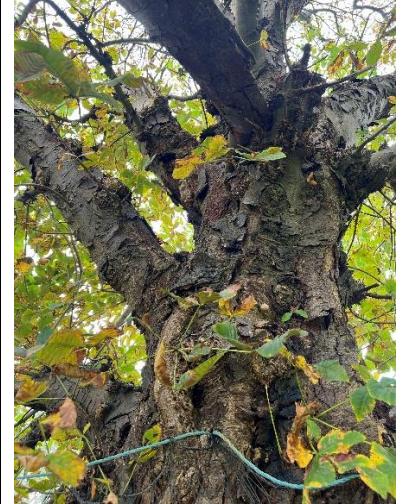
T68	Horse Chestnut (<i>Aesculus hippocastanum</i>)	17	Mature	Poor	Prominent boundary tree exhibiting significant internal decay within main stem and major limbs.	Some lifted bark offering limited roosting offer opportunities for crevice dwelling bats.	PRF-I

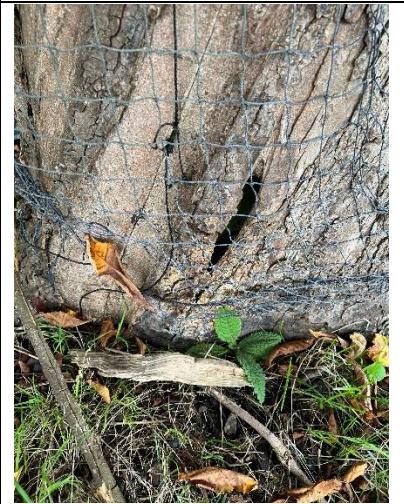
T69	Horse Chestnut (<i>Aesculus hippocastanum</i>)	18	Mature	Fair	Prominent and isolated boundary tree of reasonable form and vigour.	Small rot hole at the base of the tree. The hole is covered by a net limiting its roosting potential. An inspection with an endoscope found no evidence of roosting bats, the hole only entered a small distance into the tree. Some lifted bark offering limited roosting offer opportunities for crevice dwelling bats.	PRF-I

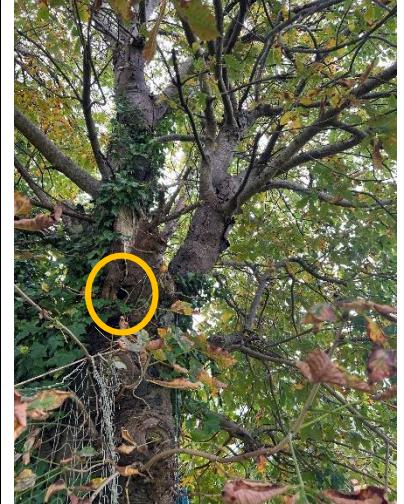
T70	Horse Chestnut (<i>Aesculus hippocastanum</i>)	16	Mature	Fair to poor	Boundary tree of variable form exhibiting some decay within main branches.	Small rot hole, doesn't go far enough into tree to be a viable roosting feature. Some lifted bark offering limited roosting offer opportunities for crevice dwelling bats.	PRF-I

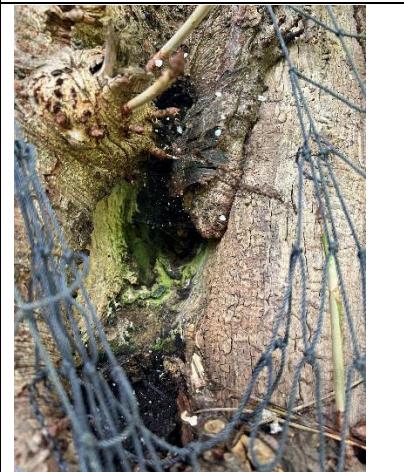
T71	Horse Chestnut (<i>Aesculus hippocastanum</i>)	19	Mature	Fair to poor	Prominent boundary tree of variable form exhibiting some dieback in mid and upper crown.	Small rot hole, doesn't go far enough into tree to be a viable roosting feature. Some lifted bark offering limited roosting offer opportunities for crevice dwelling bats.	PRF-I

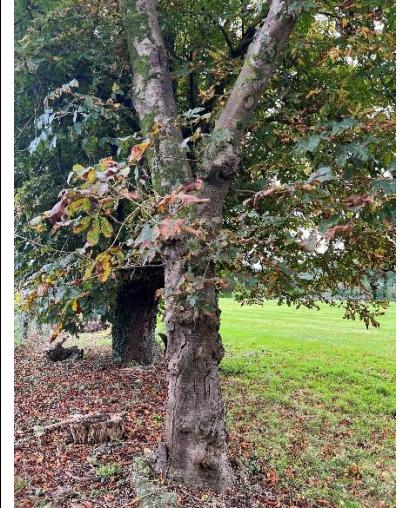
T72	Horse Chestnut (<i>Aesculus hippocastanum</i>)	17	Middle aged	Poor	Tree of poor form exhibiting significant internal decay as well as decay within major limbs.	N/A	None
