## **Bontnewydd Terrace**

### *Structural Inspection Report*

### *Merthyr Valley Homes Ltd*

Project no. 23459-R-600-A

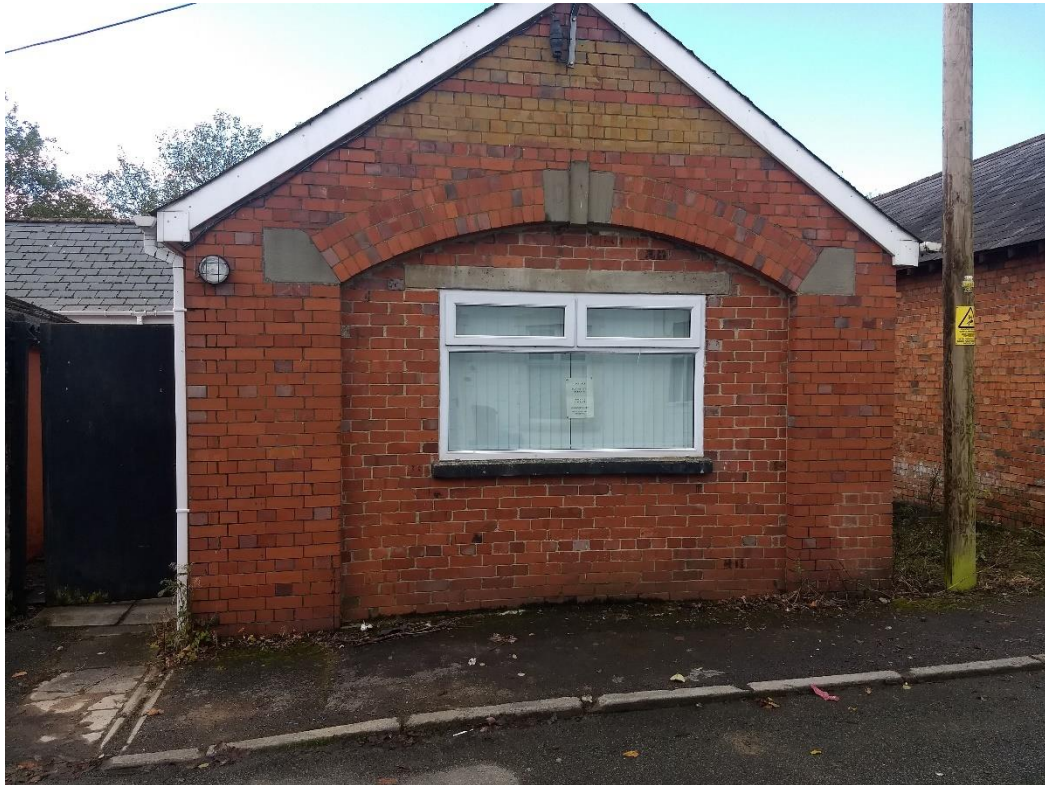
**Photo 1 - North East front elevation of the building**

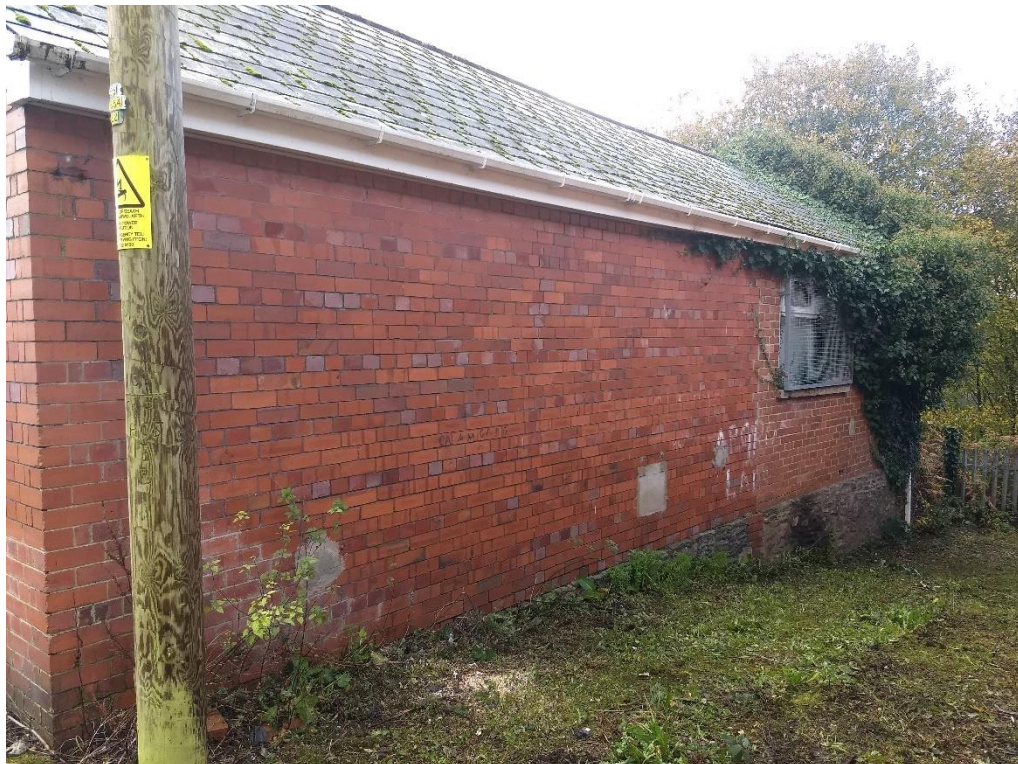
**Photo 2 - North West right hand side elevation**

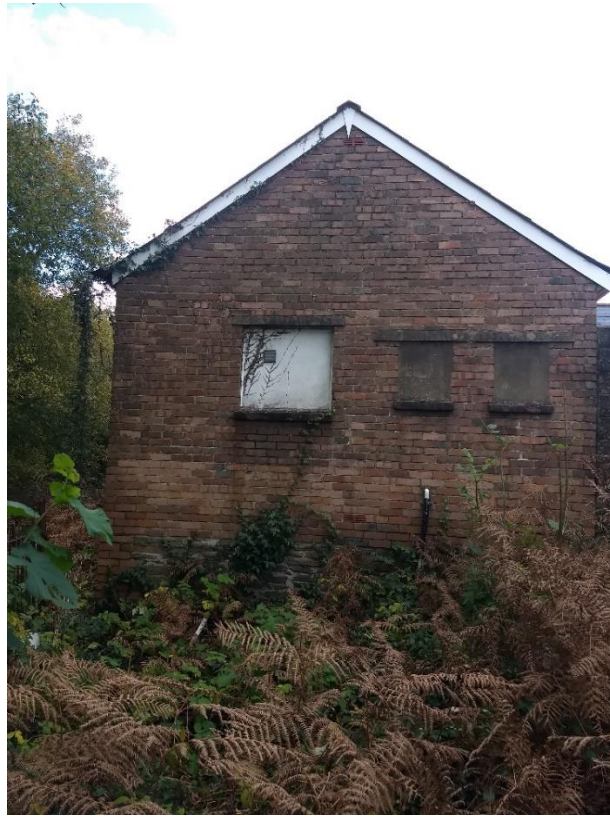
| Photo Ref. | Condition | Stability Issue | Remedials | Comments |
|---|---|---|---|---|
| 3 | Access to Southeast left hand side elevation is blocked with overgrown vegetation | N | General Maintenance | Elevation could not be fully inspected |

**Photo 3 - Part of the South East left hand side elevation**

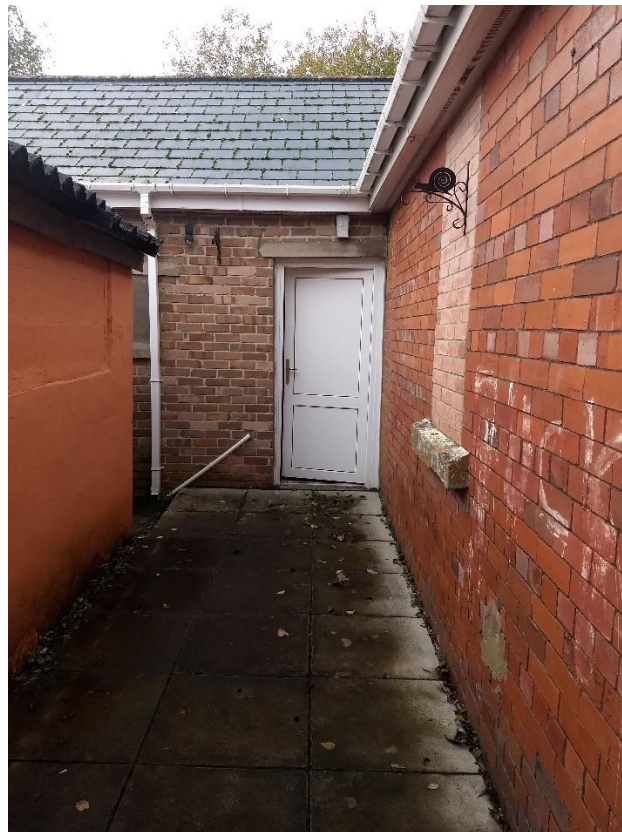
**Photo 4 - Part of the North East and South East elevation**

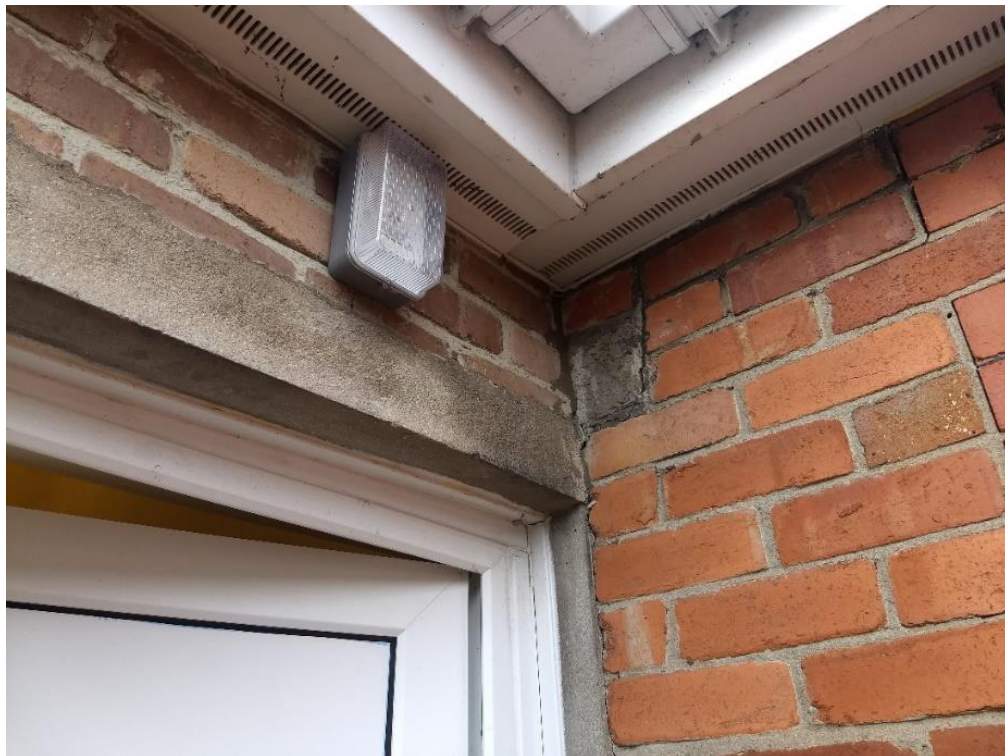
- 2.2 Based on the different types of bricks used for the construction of the external walls and the different construction methods that were used (Photograph 5), it appears that the building might have been built in two or three stages as shown on the sketch in Figure 1 Appendix 2. The oldest part of the building is indicated as Part 1 and the more recent additions to the building are indicated as Part 2 and 3.

**Photo 5 - Three different type of bricks**

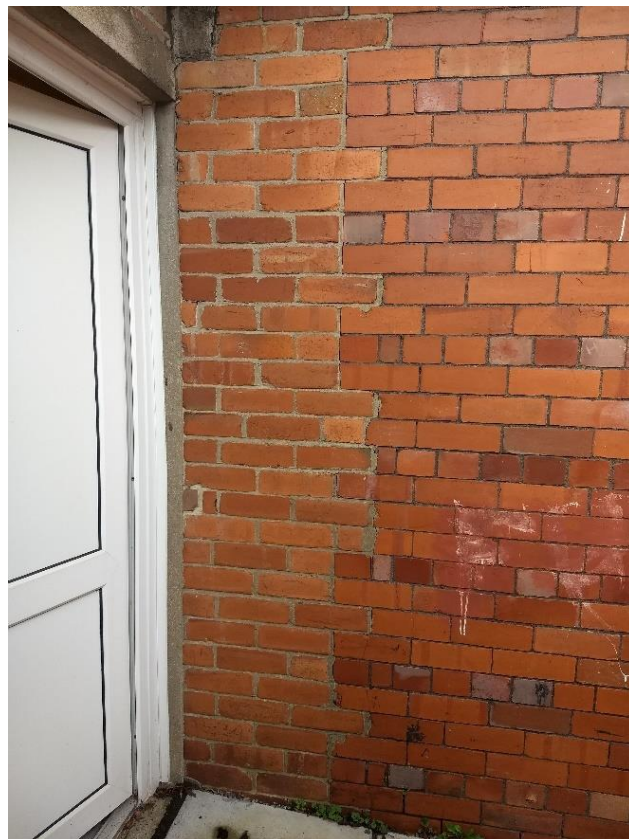
| Photo Ref. | Condition | Stability Issue | Remedials | Comments |
|---|---|---|---|---|
| 6 | Crack between Part 1 and Part 2 external wall next to the main entrance | N | Crack stitch repair and re-decoration and check for wall ties. | Potentially due to lack of movement joints or differential thermal and moisture movement between the two brick types. |

**Photo 6 - Oldest Part 1 (right hand side) and later built Part 2 (left hand side) external masonry wall joined together with a key brick every three courses at the South East elevation**

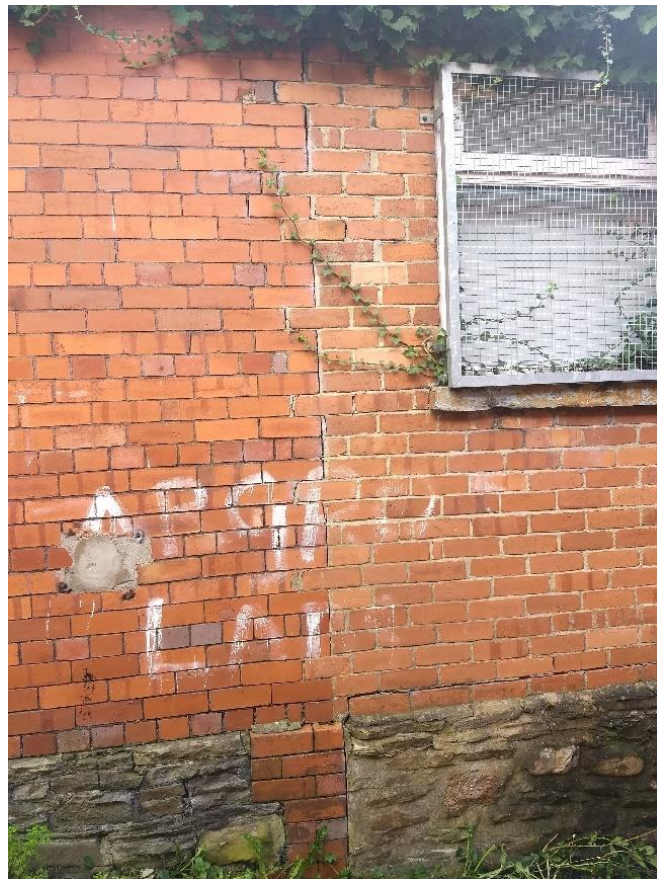
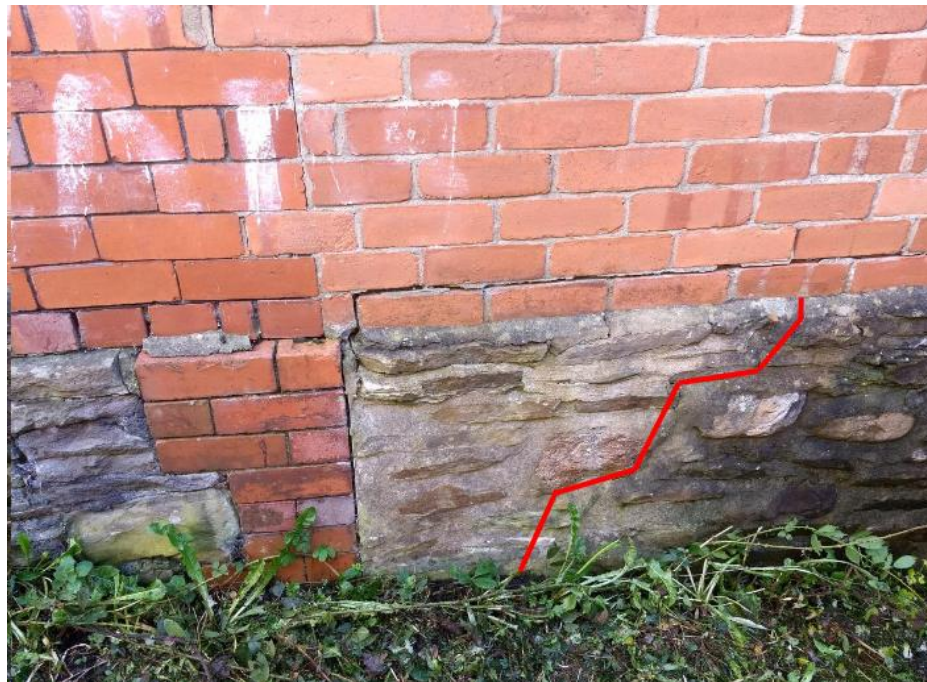
| Photo Ref. | Condition | Stability Issue | Remedials | Comments |
|---|---|---|---|---|
| 7,8 | Crack between the Part 1 and Part 2 external wall at the Northwest right hand side elevation ranging from 10mm at the bottom to 15mm at the top of the wall | Y | Underpinning foundation and providing a new vertical movement joint. | New external wall is tilting away from the older external wall possible settlement. A contributing factor may be thermal and moisture movement. |

- 5.4 The external walls on the Northwest elevation appear to be suffering from subsidence which affects both Northwest and Southwest elevations. If so this would need to be remediated by stabilisation of the wall foundations by underpinning or the removal and re-building of the walls and foundations may be required or alternatively monitoring of the walls and foundations for ongoing movement to confirm if it is historic or ongoing.

**Photo 7 - Older Part 1 (left hand side) and later built Part 2 (right hand side) external masonry wall joined together with a key brick every three courses at the North West elevation**

**Photo 8 - Older Part 1 (left hand side) and later built Part 2 (right hand side) North West elevation- cracks marked with red line indicating settlement**

- 5.3 Further investigation is needed to confirm if the differential settlement on the Northwest elevation is historic or ongoing before works commence. Similarly further investigation is needed to determine whether the cracks internally on the Southwest wall are due to foundation movement.

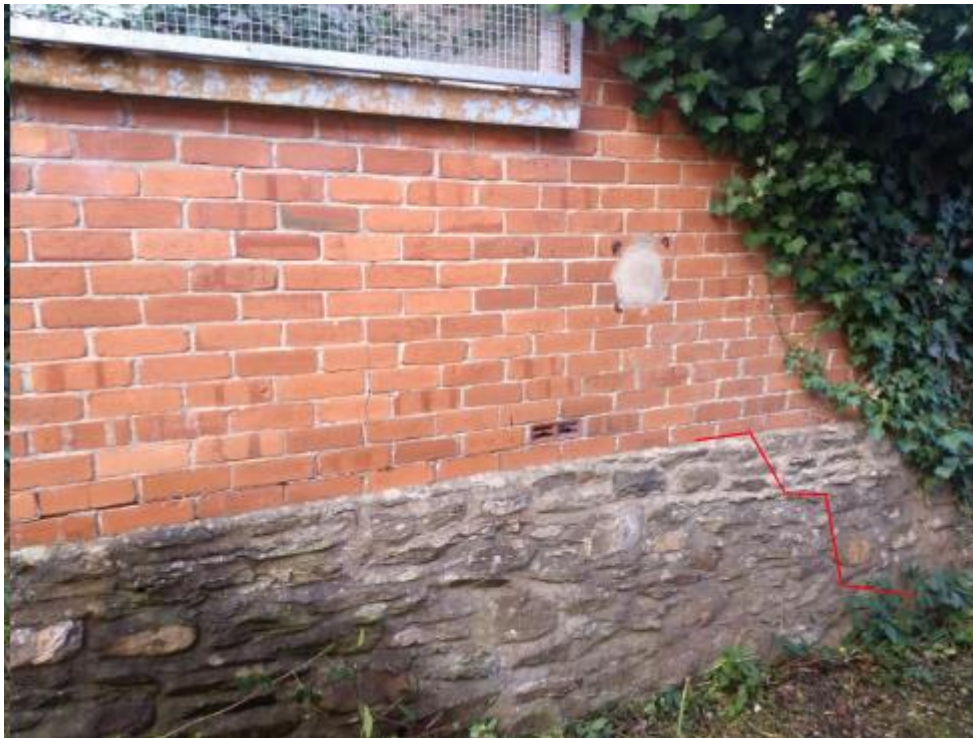
**Photo 9 - Later built Part 2 North West elevation- cracks marked with red line indicating settlement, air brick showing.**

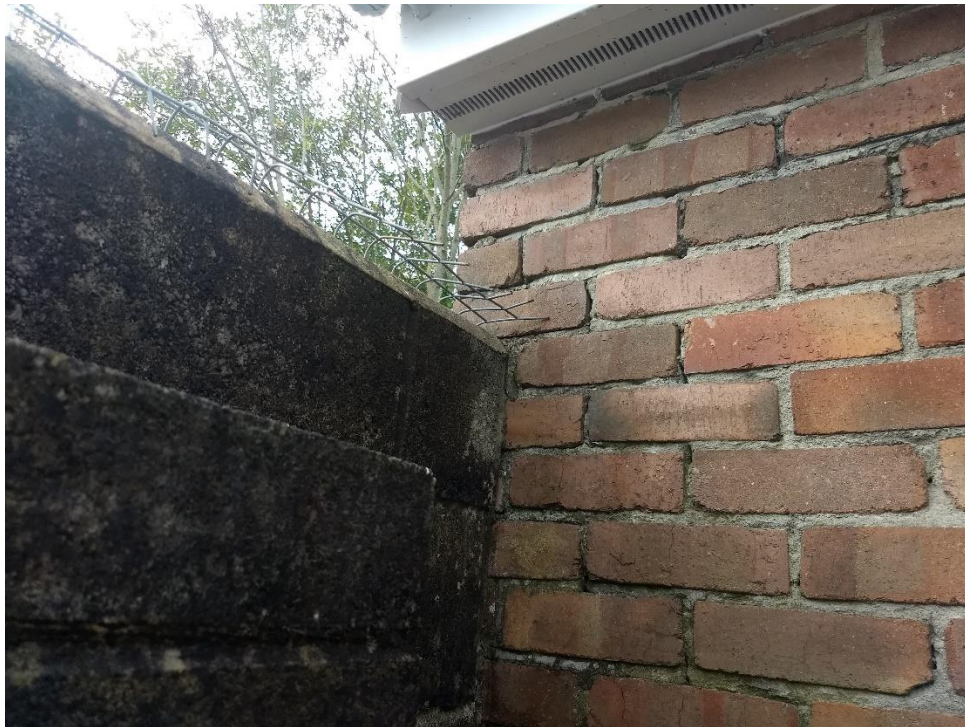
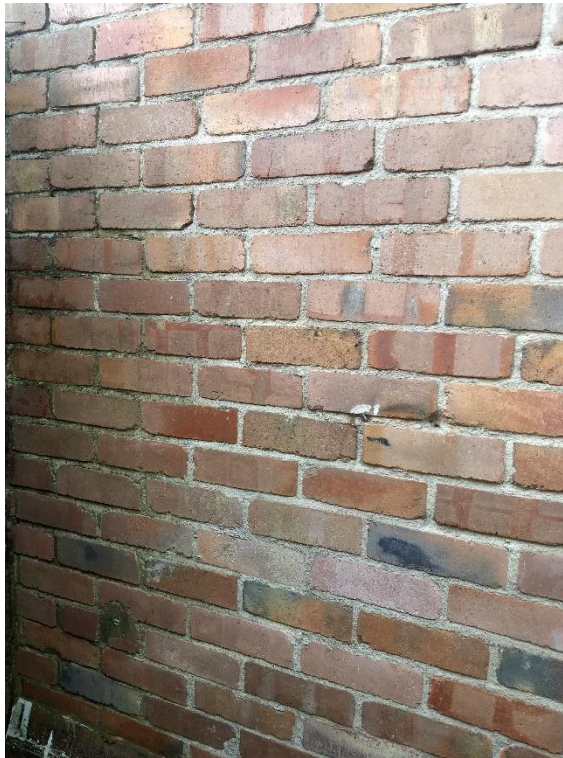
| Photo Ref. | Condition | Stability Issue | Remedials | Comments |
|---|---|---|---|---|
| 10, 11 | Mortar joints of the external wall are washed away at the top left-hand side of the Southeast elevation of Part 3 | N | Joints to be raked out and repointed with cementitious mortar | |

**Photo 10 - External wall at top left part of South East front elevation where partially filled joints are shown (Part 3)**

**Photo 11 - External wall at left part of South East front elevation where partially filled joints are shown (Part 3)**

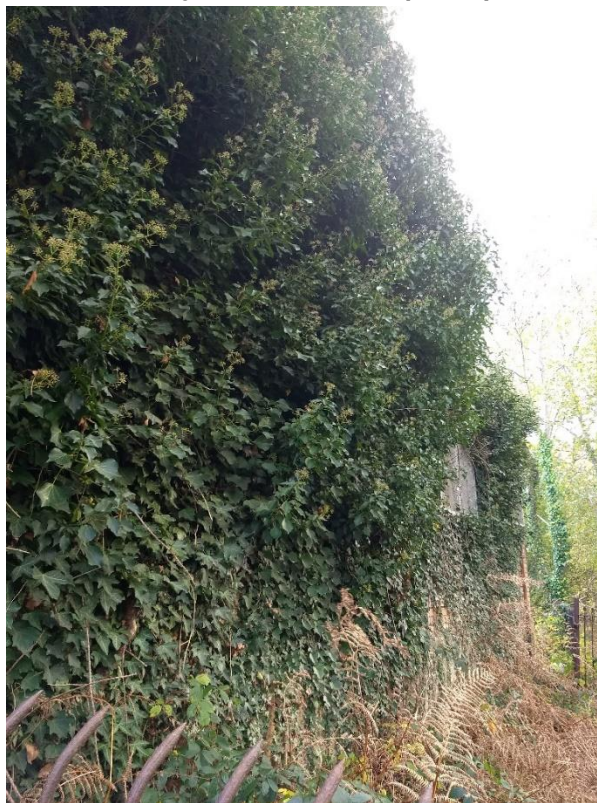
| Photo Ref. | Condition | Stability Issue | Remedials | Comments |
|---|---|---|---|---|
| 12 | Southwest rear elevation is covered with vegetation | N | General Maintenance | Elevation could not be fully inspected |

**Photo 12 - South West rear elevation covered with over grown vegetation**

- 5.1 The vegetation on the Southwest elevation needs to be removed and the wall needs to be inspected.
- 5.2 Crack stitching using small diameter stainless bars would need to be undertaken to the areas highlighted in section 3.0.

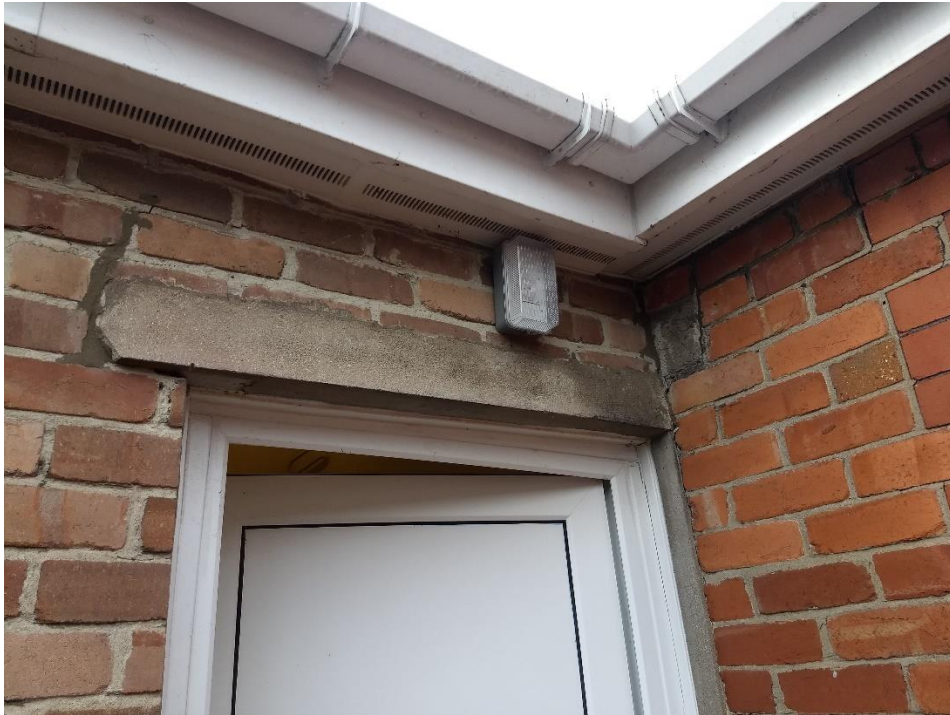
| Photo Ref. | Condition | Stability Issue | Remedials | Comments |
|---|---|---|---|---|
| 13 | Stress relief crack at the top left corner over the end bearing of the concrete lintel above the entrance door at the front Northeast elevation | N | General maintenance and re-decoration | Potentially due to lack of movement joints. Lintel is poorly installed. |

**Photo 13 - Stress relief crack at the corner of the concrete lintel above the front entrance door**

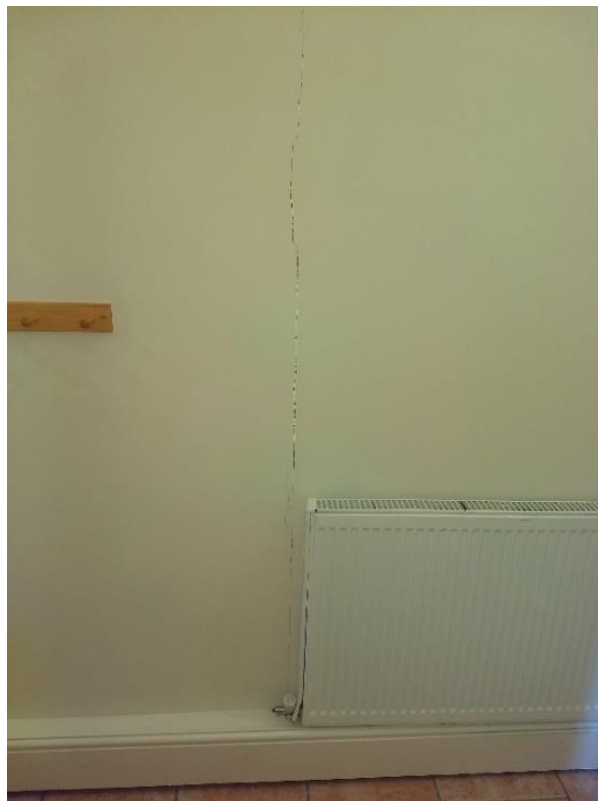
| Photo Ref. | Condition | Stability Issue | Remedials | Comments |
|---|---|---|---|---|
| 14 | Gaps below skirting boards of the internal masonry wall on the side facing the corridor ranging from 15mm to 25mm max | Y | Relaying the slab or refilling/grouting the fill | Possibly due to settlement of the slab |
| 14 | Crack in wall where an opening looks to have been blocked up on internal masonry wall on the side facing the corridor | Y | | Differential thermal movement which may also have been exacerbated by settlement. Wall is proposed to be removed |

- 5.5 The cause of the gap below the skirting board on the internal masonry wall is likely attributed to settlement on the ground bearing slab. The internal floor level will need to be checked and as a consequence of the suspected slab settlement, potentially the floor slabs may need to be removed and re-laid with suitably compacted engineered fill below to prevent any ongoing settlement taking place.

**Photo 14 - Internal masonry wall, side facing the corridor. Gap below the skirtings and the floor ranging from 15-25mm max. Crack on the wall at the location of the blocked opening**

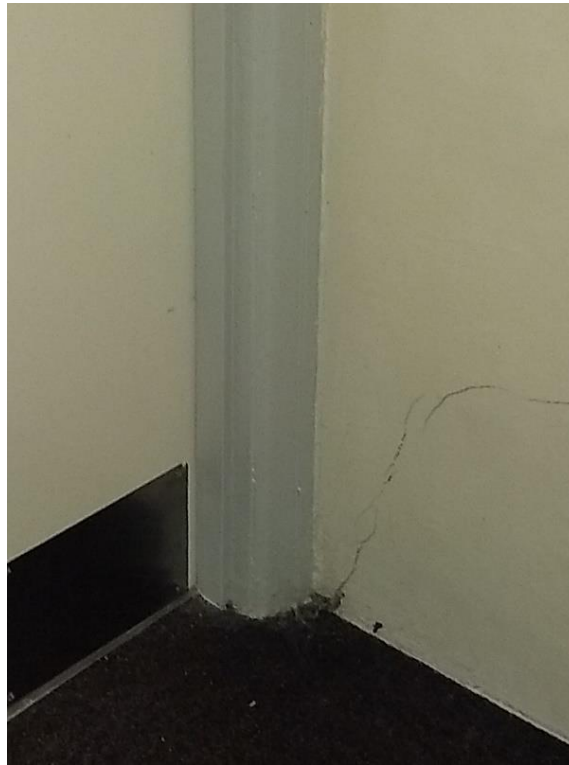
| Photo Ref. | Condition | Stability Issue | Remedials | Comments |
|---|---|---|---|---|
| 15 | Diagonal cracks in the bottom corner of the internal masonry wall on the side facing the storeroom | Y | | Possibly due to settlement. Wall is proposed to be removed |

**Photo 15 - Internal masonry wall, side facing the storeroom, with crack at the bottom corner**

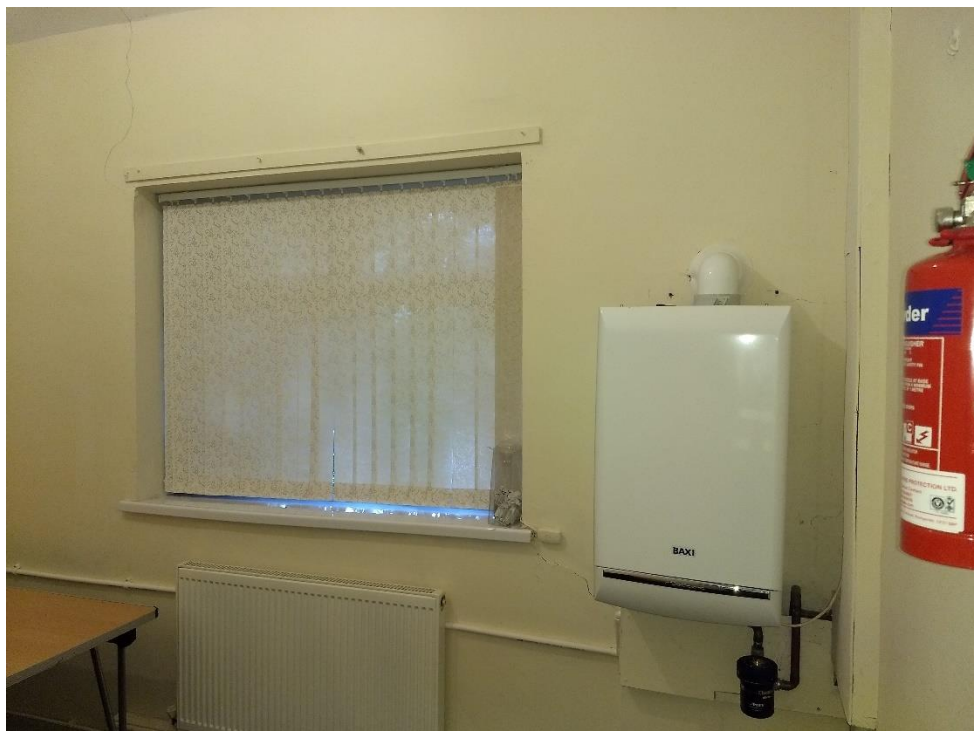
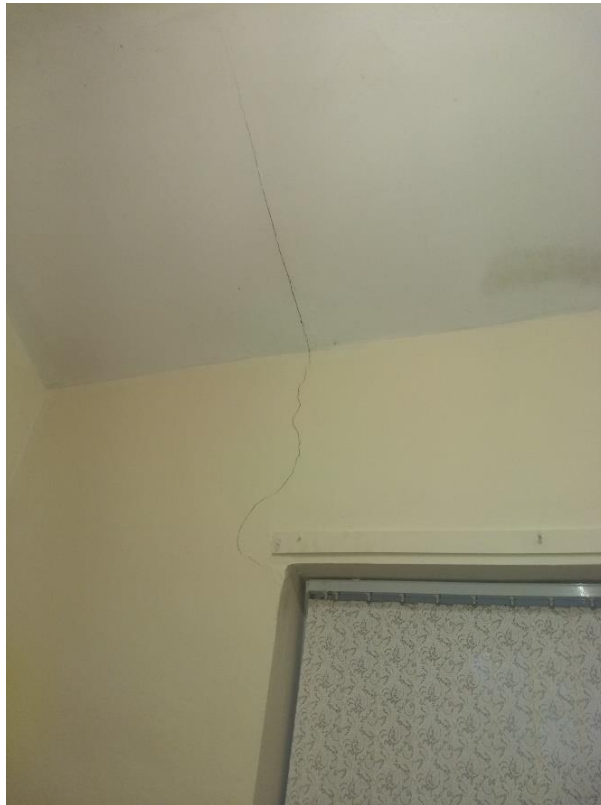
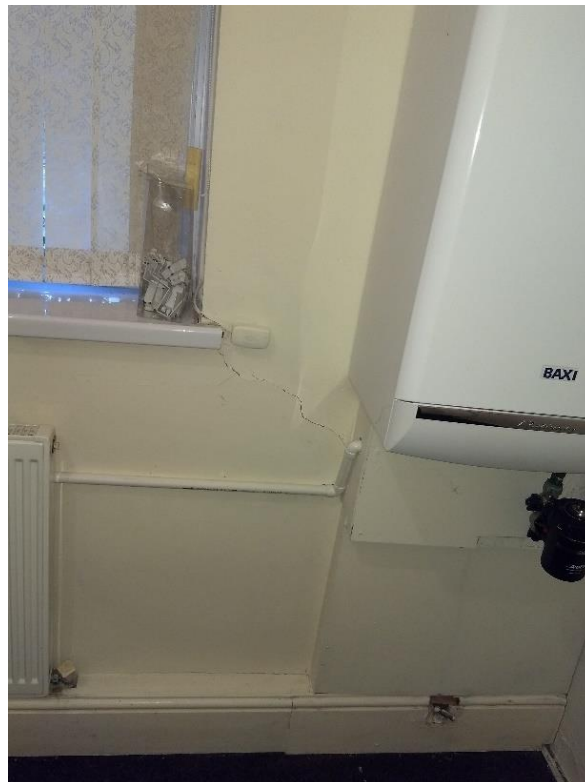
| Photo Ref. | Condition | Stability Issue | Remedials | Comments |
|---|---|---|---|---|
| 16,17, 18 | Diagonal cracks in the window at the storeroom at the top left corner and bottom right corner. | Y | Crack stitch repair and re-decoration. | Possibly differential thermal and moisture movement. Northwest elevation needs to be cleared of vegetation. |

**Photo 16 - Diagonal cracks at the top left and bottom right corner of the window in the storeroom (photos 17 & 18 show a closer view)**

**Photo 17 - Stress relief diagonal crack at the top left of the window in the storeroom**

**Photo 18 - Stress relief diagonal crack at the bottom right corner of the window in the storeroom**

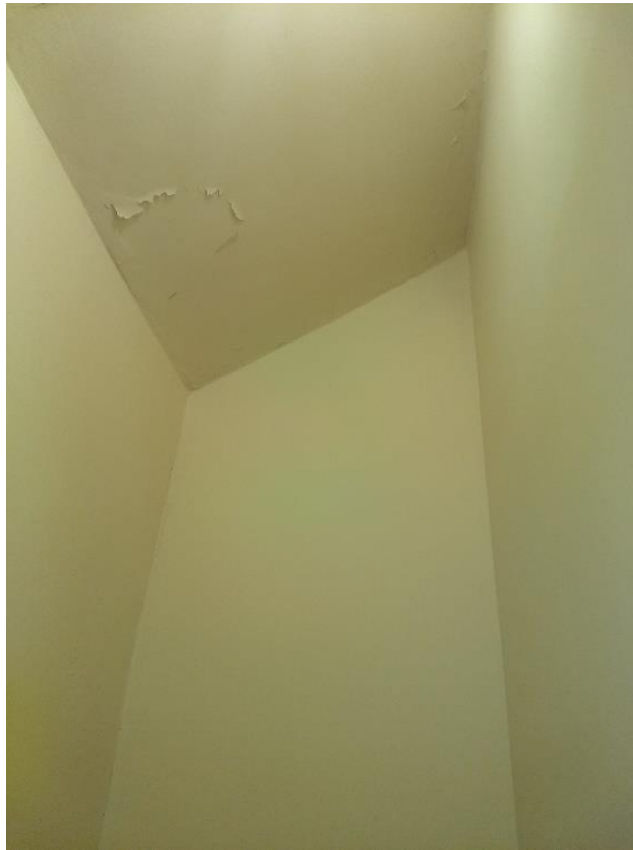
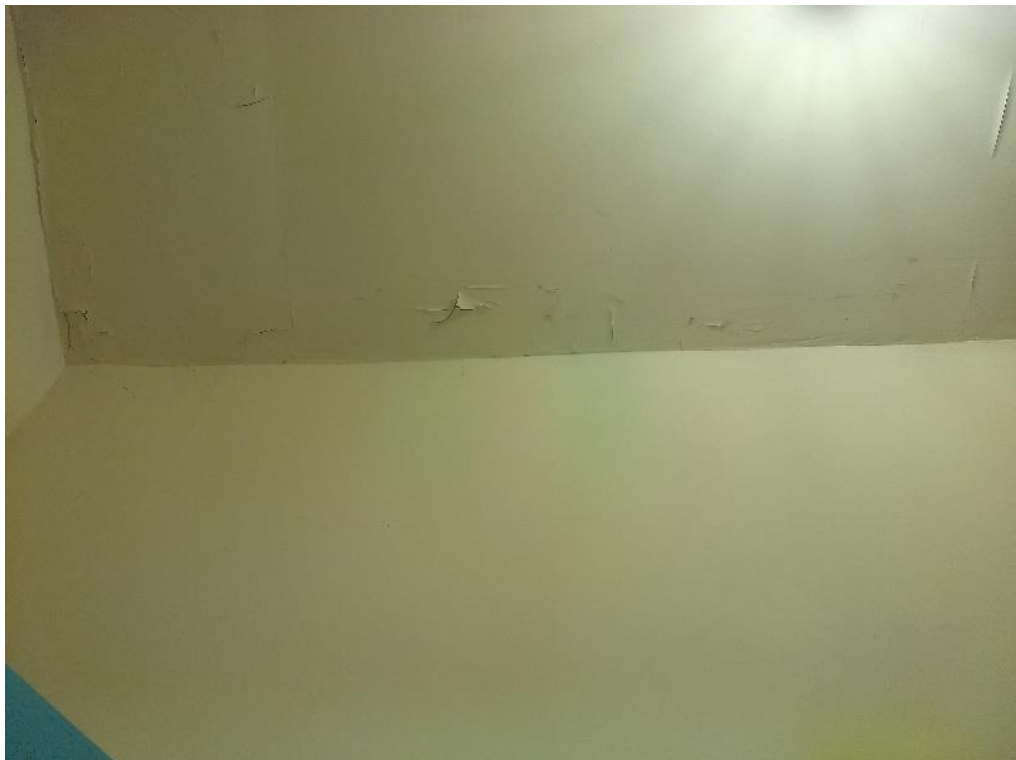
| Photo Ref. | Condition | Stability Issue | Remedials | Comments |
|---|---|---|---|---|
| 19, 20 | Crack at the ceiling of the male wet room | N | General maintenance and re-decoration | |

**Photo 19 - Crack at the ceiling in the male wet room**

**Photo 20 - Crack at the ceiling in male wet room**

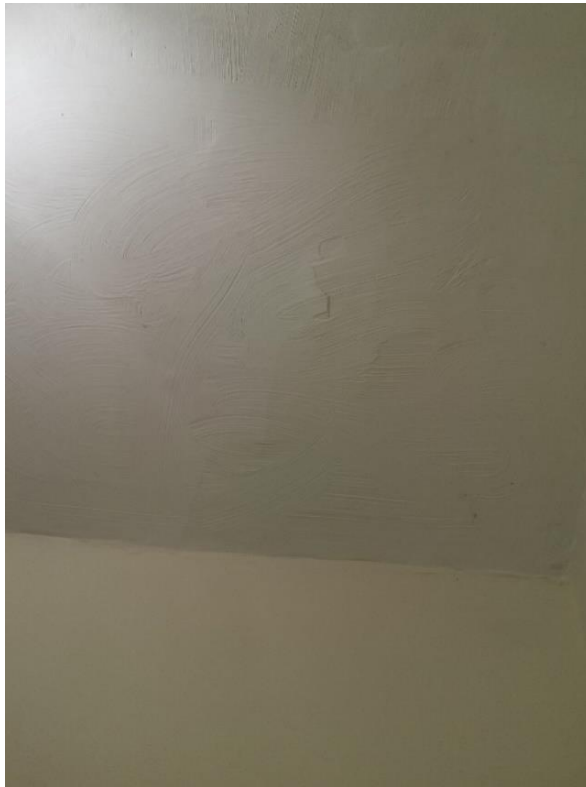
| Photo Ref. | Condition | Stability Issue | Remedials | Comments |
|---|---|---|---|---|
| 21 | Crack at the ceiling of the female wet room | N | General maintenance and re-decoration | |

**Photo 21 - Crack at the ceiling in female wet room**

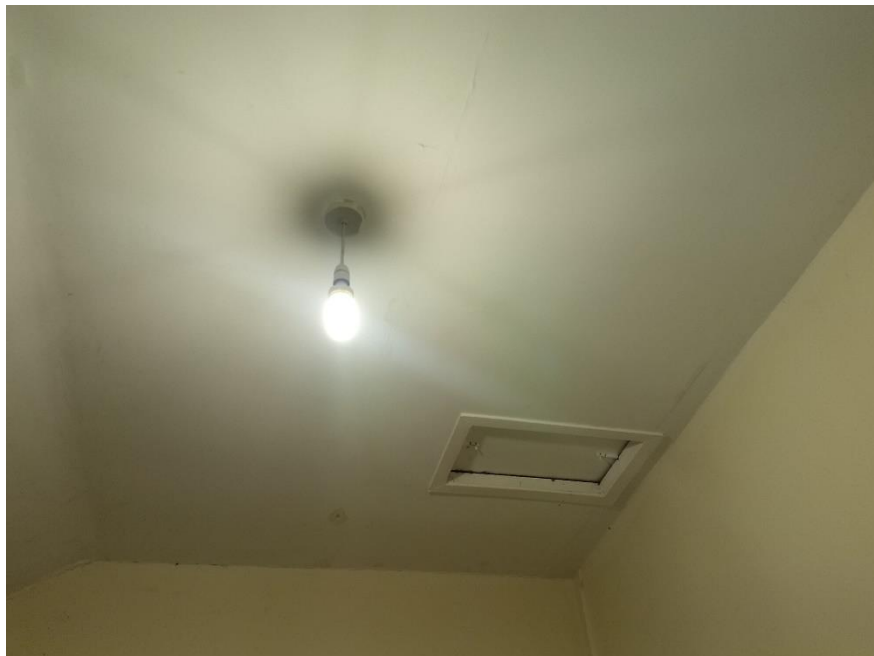
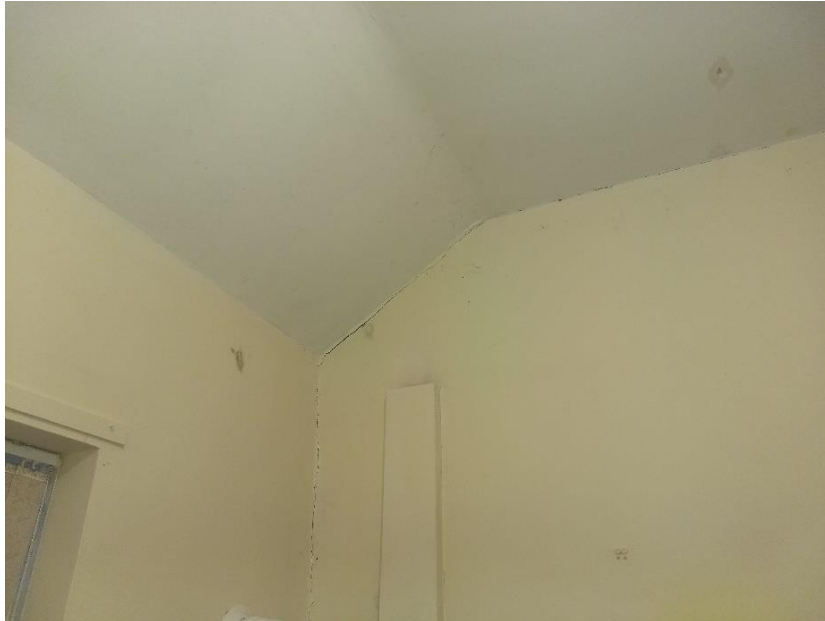
| Photo Ref. | Condition | Stability Issue | Remedials | Comments |
|---|---|---|---|---|
| 22, 23 | Cracks at the ceiling of the storeroom and crack at the joint between the ceiling at the store room and the adjacent masonry internal and external masonry walls | Y | Further investigation required | Possibly due to differential thermal movement or settlement |

**Photo 22 - Crack at the ceiling in the storeroom**

**Photo 23 - Crack at the joint between the ceiling in the storeroom and the masonry internal and external walls**

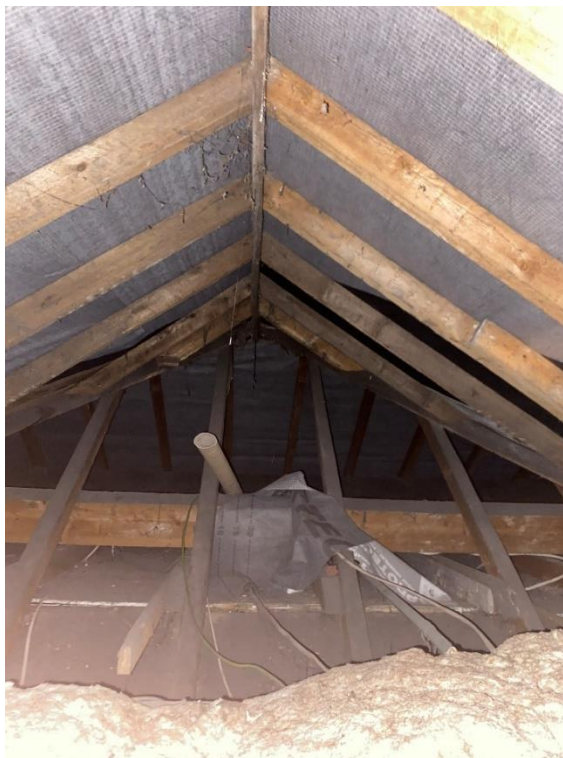
- 2.4 Internally there are masonry walls and stud partitions. In Figure 2 Appendix 2, the masonry walls have been indicated with green and orange colour. The green masonry walls are approximately 300mm thick and appear to be a load bearing as it supports some of the roof rafters and ceiling joists (Photograph 24). The orange colour masonry walls are 100mm thick and appears to be non-load bearing, but further investigation is needed to confirm this in case they are supporting ceiling joists. The rest of the walls shown on the floor plan are stud partitions.

**Photo 24 - Part of the roof, rafters and ceiling joists appear to be supported on the 300mm internal masonry wall**

- 5.7 Further assessment / safe access of the roof structure in Part 3 the building is required to confirm if the roof or ceiling structure is supported off the internal masonry walls proposed to be removed. If the ceiling joists are supported off the internal walls this is not so significant to remove and replace with suitably sized joists however if the roof structure is supported, then steelwork will be required. Access is limited to the roof void in part 3 of the building and various animal droppings cover the insulation over the ceiling joists making it unsafe to crawl from one roof area to another.

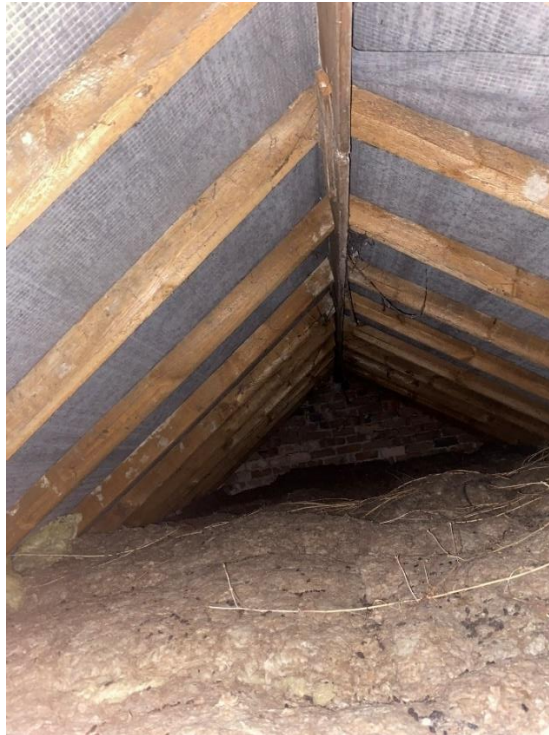
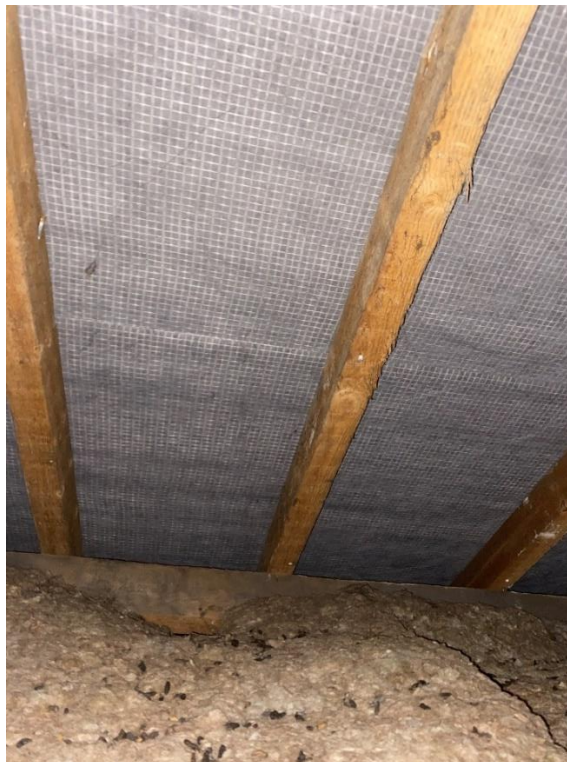
- 2.5 The ground floor typically appears to be a ground bearing concrete slab.
- 2.6 The roof has been formed with cut rafters spanning from the timber ridge board to the external walls with one purlin close to ceiling level (Photographs 25 & 26). The rafters appear to be in good condition with insulation at ceiling level. It appears that the rafters are not supported on the internal 100mm masonry walls, but the thick insulation hindered the inspection so further investigation is needed, it is expected that the ceiling joists will be supported off the 100mm thick brick wall. Externally the roof does not have any signs of sagging or damage and it appears to be in a good condition.

**Photo 25 - The roof has been formed with cut rafters spanning from the ridge timber beam to the external walls**

**Photo 26 - Part of the roof showing rafters and the purlin close to ceiling level**

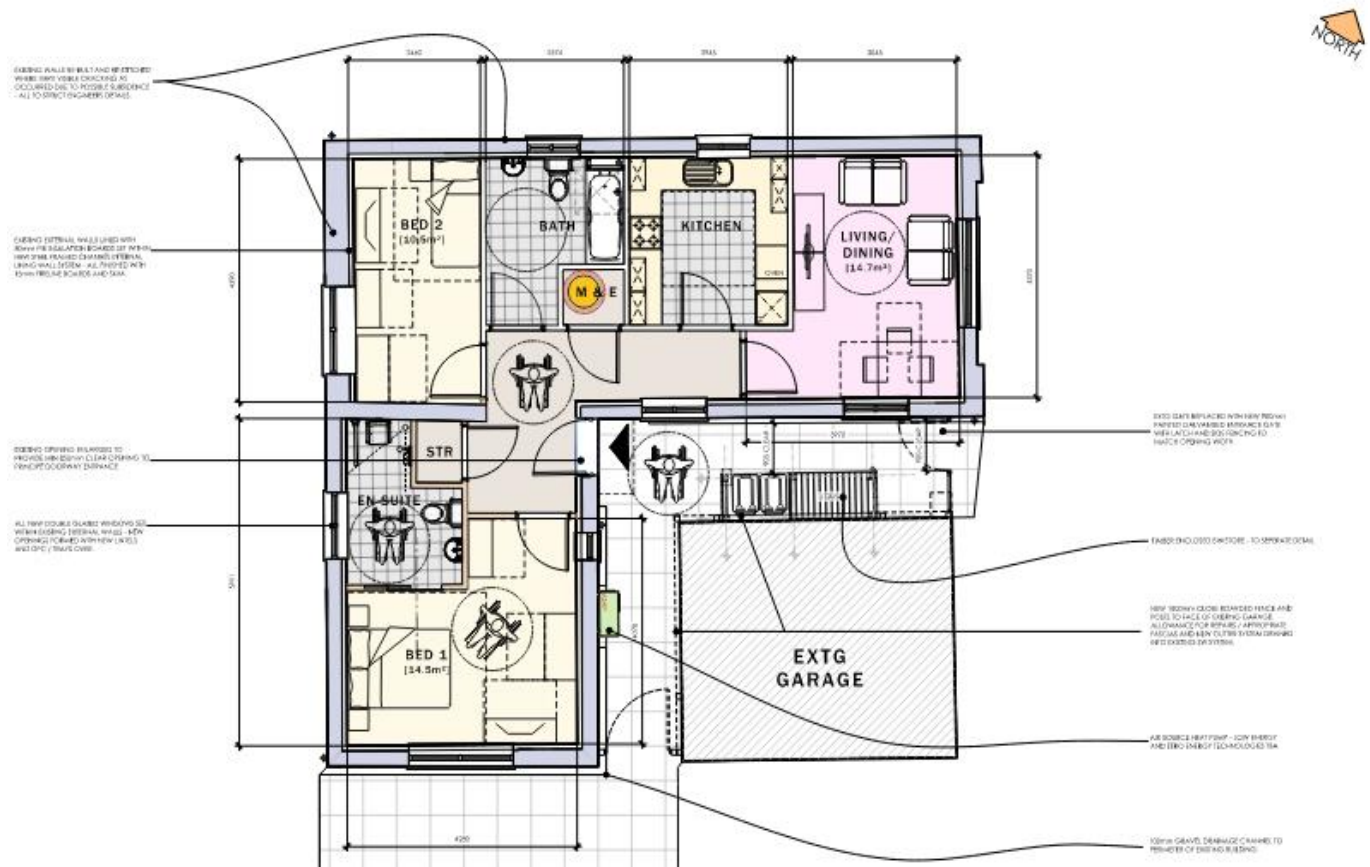
**Figure 3– Proposed layout by Le Trucco design**

- 4.1.1 With regards the proposed internal alterations provided by Le Truccodesign, dwg no LTS379.00.0 in Appendix 2, Figure 3, it is proposed that the 100mm thick internal walls will be removed and the new internal walls will be formed using stud partitions.

- 4.1.2 A section of the 300mm internal masonry wall separating the main hall from the corridor and the storeroom will be removed to accommodate wheelchair access. Removing this section of internal masonry will affect the roof trusses above. Any roof trusses or rafters supported directly off the internal masonry proposed to be removed will require further assessment and additional steel supports will be required. The load redistribution to the foundation will also need to be carefully considered.

- 4.1.3 The stability of the external walls may be affected by removal of the internal masonry wall and small piers may be required but this is subject to detailed assessment.

- 4.1.4 The proposed window openings can be formed by propping the walls and introducing lintels to support the masonry above the opening before removing the bricks. New openings in the external wall will require concrete lintels, sills and cavity wall ties to be installed around the opening.

- 4.1.5 Internal doorways can be blocked up with typical blockwork tied to the surrounding masonry.
