# Arboricultural Assessment Survey 2019

## Arboricultural Assessment of trees within boundary of Edwardsville School, Edwardsville, Merthyr Tydfil.

**Andrew Taylor**  
**Arboriculturalist**

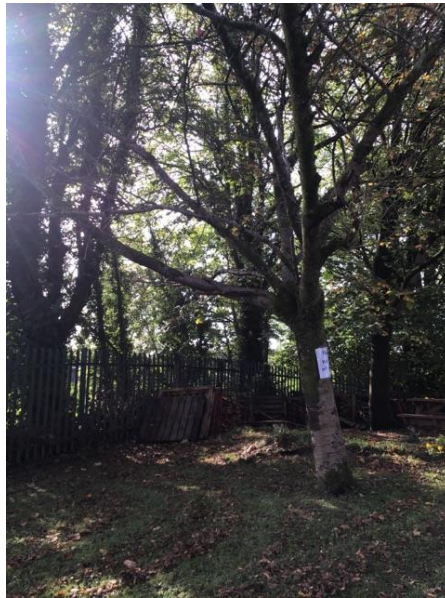
| Tree ID | Height (m) | Age Class | Width (mm) | Priority | Structural Condition | Common Name | Physical Condition | Recommendations | Species |
|---|---|---|---|---|---|---|---|---|---|
| 2682 | 6 | M | 350 | 1 year | Poor, significant deadwood and fungal associations | Bird cherry | Poor | Fell | Prunus padus |

Image 1: Tree ID- 2682 – Dead Cherry near path

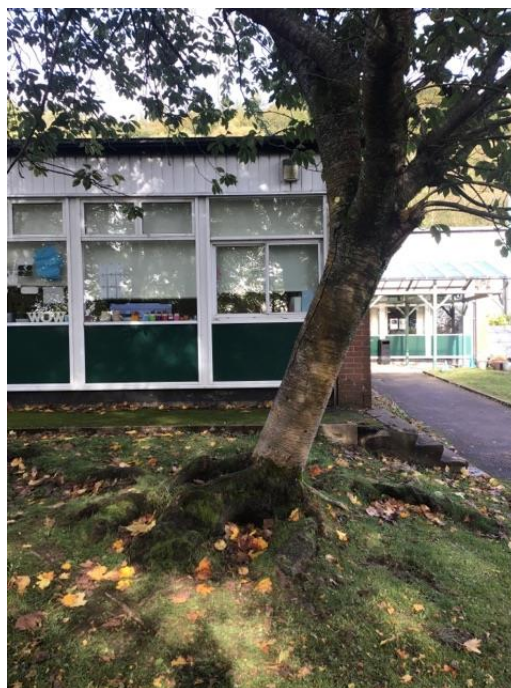
| Tree ID | Height (m) | Age Class | Width (mm) | Priority | Structural Condition | Common Name | Physical Condition | Recommendations | Species |
|---|---|---|---|---|---|---|---|---|---|
| 2684 | 5 | M | 350 | 1 year | Raised root plate and significant lean towards path. | Bird cherry | Fair | Fell for safety | Prunus padus |

Image 2: Tree ID 2684 leaning cherry towards path with raised rooting profile

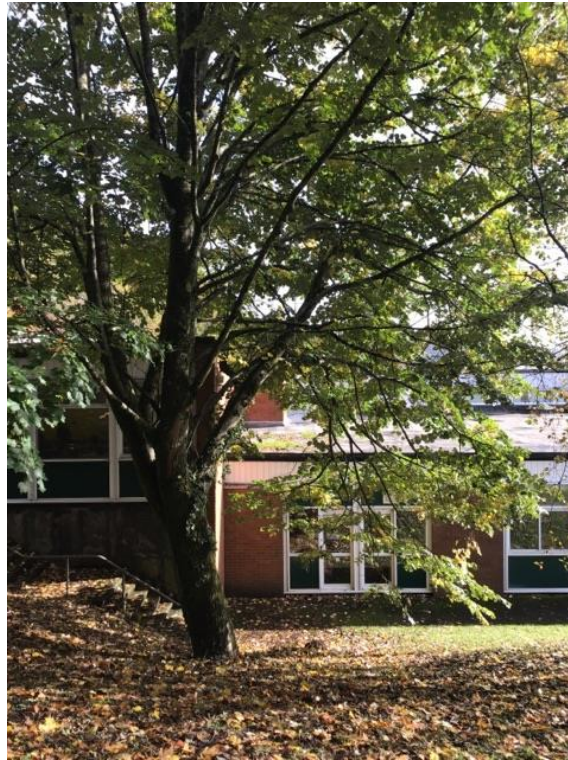
| Tree ID | Height (m) | Age Class | Width (mm) | Priority | Structural Condition | Common Name | Physical Condition | Recommendations | Species |
|---|---|---|---|---|---|---|---|---|---|
| 2701 | 14 | M | 600 | 1 year | Large canopy and limbs, close to and causing conflict with building | Large leaved lime | Good | Remove to prevent incident | Tilia platyphyllos |

**Image 3: Tree ID 2701. Large leaved lime located close to building will cause future damage and issue.**

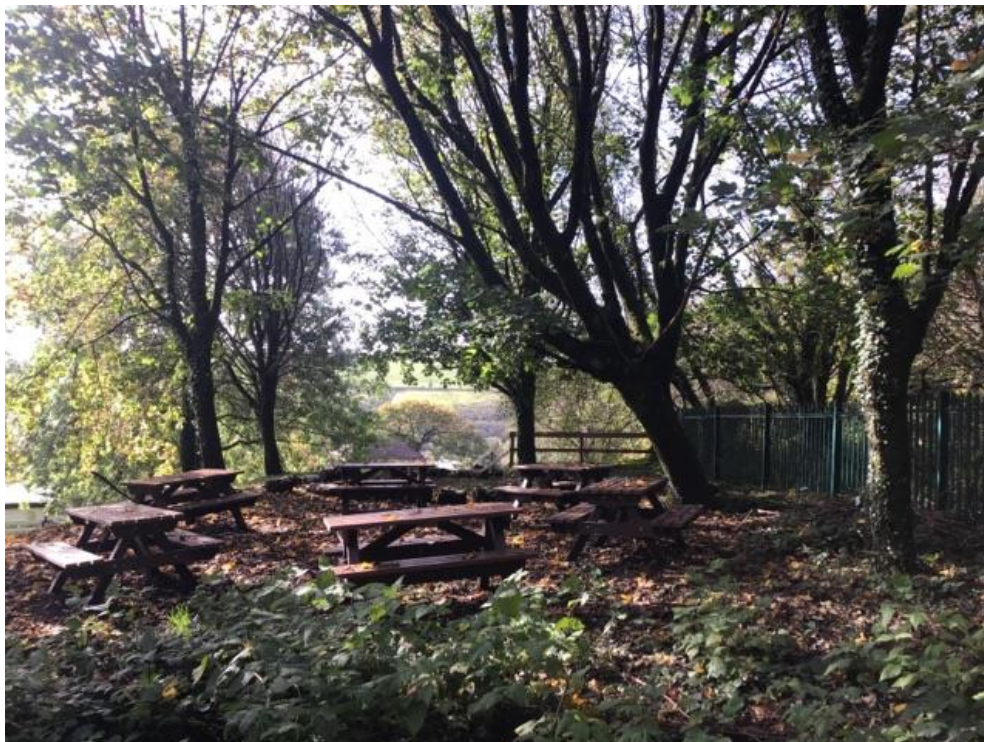
| Tree ID | Height (m) | Age Class | Width (mm) | Priority | Structural Condition | Common Name | Physical Condition | Recommendations | Species |
|---|---|---|---|---|---|---|---|---|---|
| 2705 | 12 | M | 600 | 1 year | Poor, heavy lean towards bench area, raised root plate and surface roots, minor fungal bodies on buttresses | Norway maple | Good | Fell | Acer platanoides |

**Image 4: Tree ID 2705. Heavily leaning tree over benches, remove for safety**

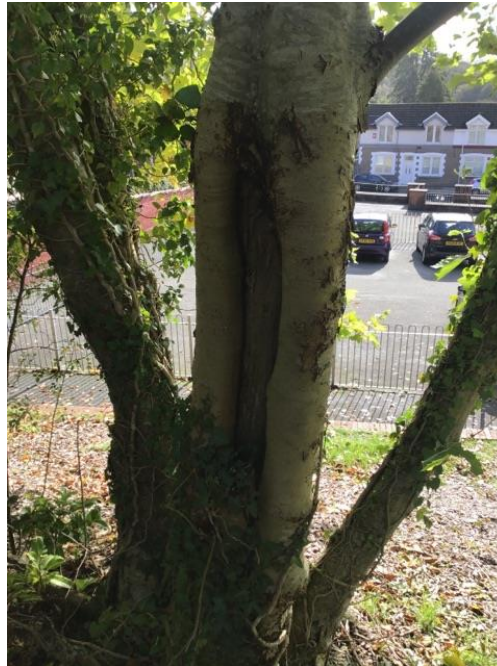
| Tree ID | Height (m) | Age Class | Width (mm) | Priority | Structural Condition | Common Name | Physical Condition | Recommendations | Species |
|---|---|---|---|---|---|---|---|---|---|
| 2721 | 8 | SM | 450 | 1 year | Multistem, stem closest to playground has had previous failure and cavity formed. | London plane | Good | Remove limb closet to play area | Platanus x hispanica |

**Image 5: Tree ID 2721, large cavity on London plane close to playground, remove defective limb.**

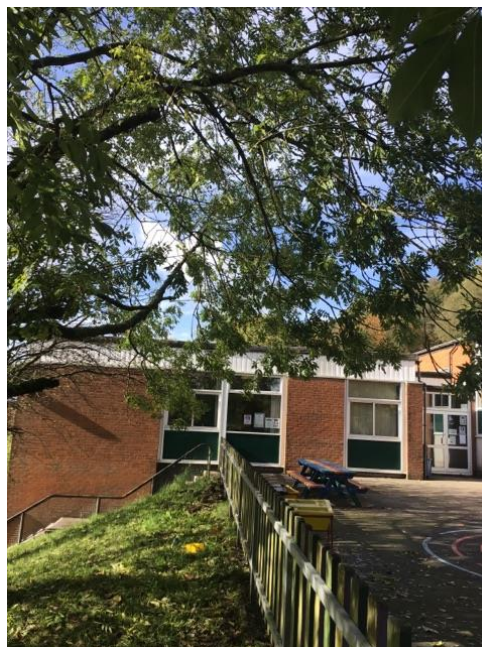
| Tree ID | Height (m) | Age Class | Width (mm) | Priority | Structural Condition | Common Name | Physical Condition | Recommendations | Species |
|---|---|---|---|---|---|---|---|---|---|
| 2722 | 8 | SM | 550 | 1 year | Previously cut stubs need removing, low canopy interference with play area | Ash | Good | Raise canopy, remove Stubbs and cut back limbs away from play area | Fraxinus excelsior |

**Image 6: Tree ID 2722 , Ash overhanging playground, protruding limbs to be removed to eradicate issues.**
