Project Title:  
**Brynhyfryd Chapel, Thomas Street, Treharris**

Project No:  
**25.5962**

Date:  
**June 2025**

## **STRUCTURAL APPRAISAL**

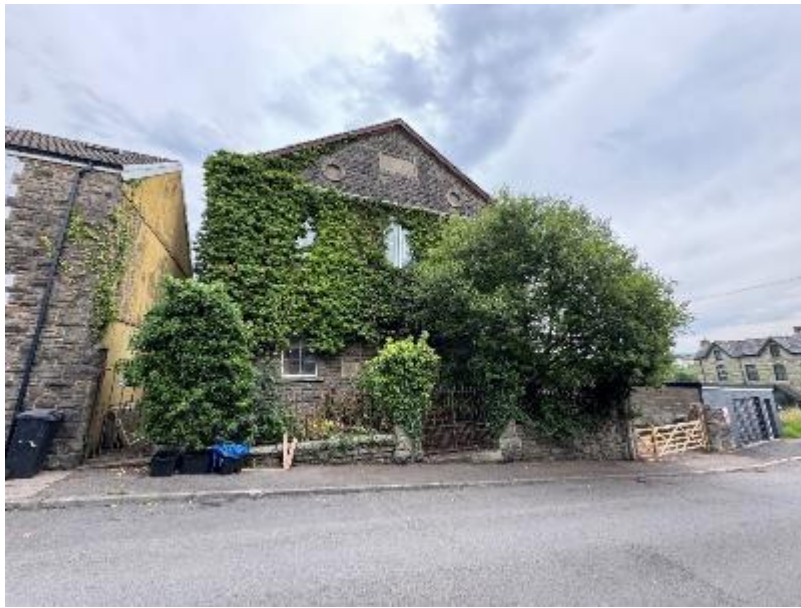
**Photograph 1: Front elevation of Brynhyfryd Chapel, Treharris**

- 3.2** The front elevation of the former chapel was heavily covered in vegetation (Photograph 1), so a detailed structural inspection of the wall could not be undertaken. However, on our second visit, the contractor had locally removed some of the vegetation to the lower reaches, and it appeared the roots had not penetrated the mortar bed joints (Photograph 2). Whilst allowance should be made to some repointing works, based on our investigations to date, this is likely to be limited.

- 4.3** Following a full asbestos survey, we would recommend a site wide clearance of all loose debris, materials and rubbish.
- 4.4** The vegetation to the external elevations should be removed at the earliest opportunity, and any necessary repointing works carried out using an appropriate mortar mix specification.

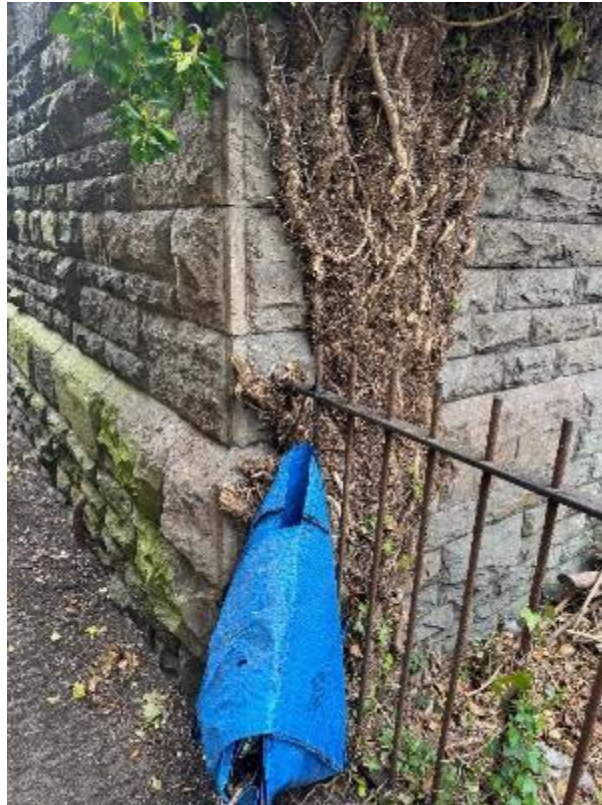
**Photograph 2: Partial vegetation removal to the front elevation**

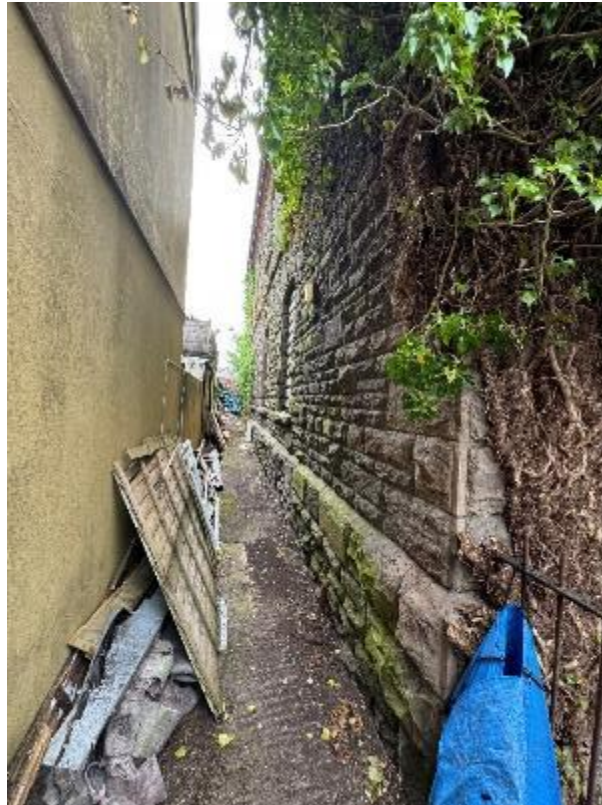
- 3.3** Access into the building is currently via a narrow side path to the North elevation. At low level, the external wall on this side appeared to be in a reasonable structural condition, without any obvious signs of significant structural defect (Photograph 3).

**Photograph 3: North side elevation of the Main Chapel building**

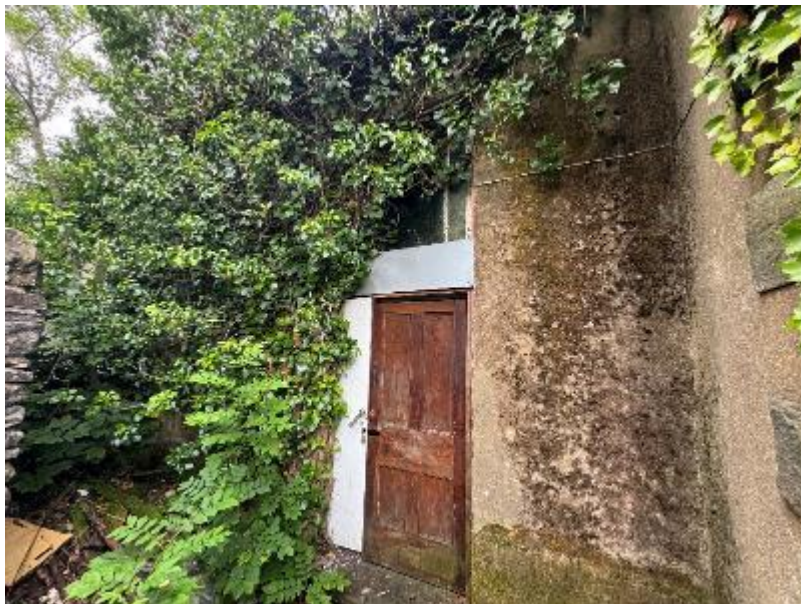
- 3.4** A small side door provides access into the two rear extensions and the Main Chapel (Photograph 4). The North side elevation of the rear extension was heavily vegetated, and it appeared some roots had penetrated the fabric of the structure.

**Photograph 4: Existing entrance door into the rear extension and Main Chapel**

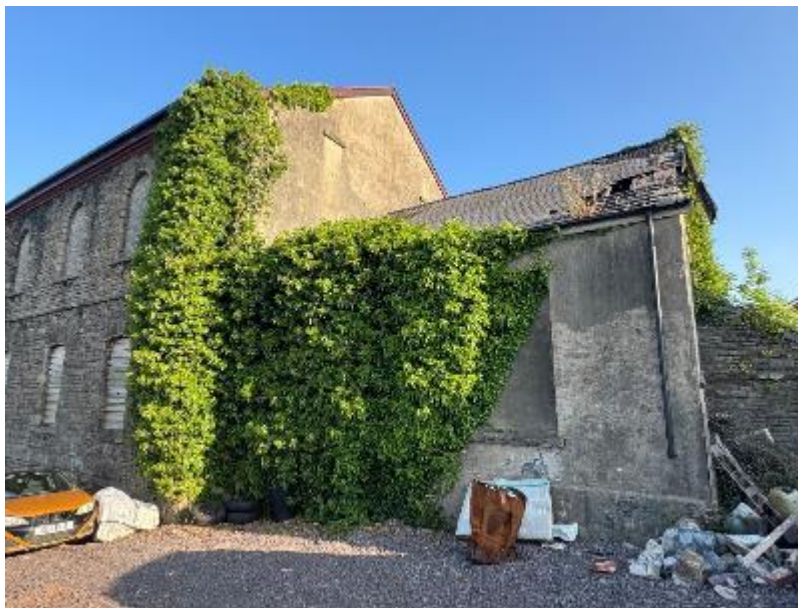
- 3.5** The larger single-storey rear extension, connected directly to the main chapel, was in a poor state of repair, with many missing slates and extensive vegetation to the side and gable elevations (Photographs 5 & 6). Internally, it appeared there had been a partial collapse of the ceiling and possibly some of the secondary roof structure elements (Photograph 7). Due to the amount of discarded material in this area of the building, it was not possible to inspect the floor structure, but looking at the level differences around the building, it is likely the South side elevation is partially retaining. The adjacent property owner advised us that the long South side and rear elevations were against private land, so our inspection was limited, as we were politely asked to leave. As we understand, both rear extensions are set to be demolished as part of the works, which based on their current structural condition is a sensible approach. It is likely some regrading works and possible new retaining structures will be needed to cater for the level changes, which may require Party Wall notices to be served. Separate advice should be sought in this regard.

**Photograph 5: Existing rear extensions (South Elevation)**

- 4.5** A Party Wall surveyor should be engaged to advise on the demolition of the rear sections of the building, and the demolition contractor should be made aware of any the potential level differences with the adjacent property. It would be advisable for the demolition contractor's RAMS to be reviewed and commented upon by the engineer, at least 10 days prior to the commencement of the demolition works.

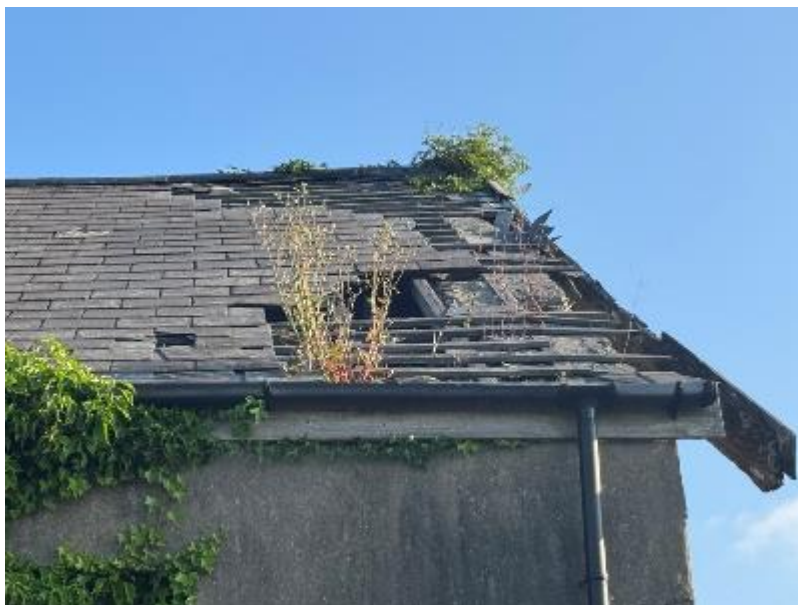
**Photograph 6: Missing slates and damaged roof structure (Rear Extension)**

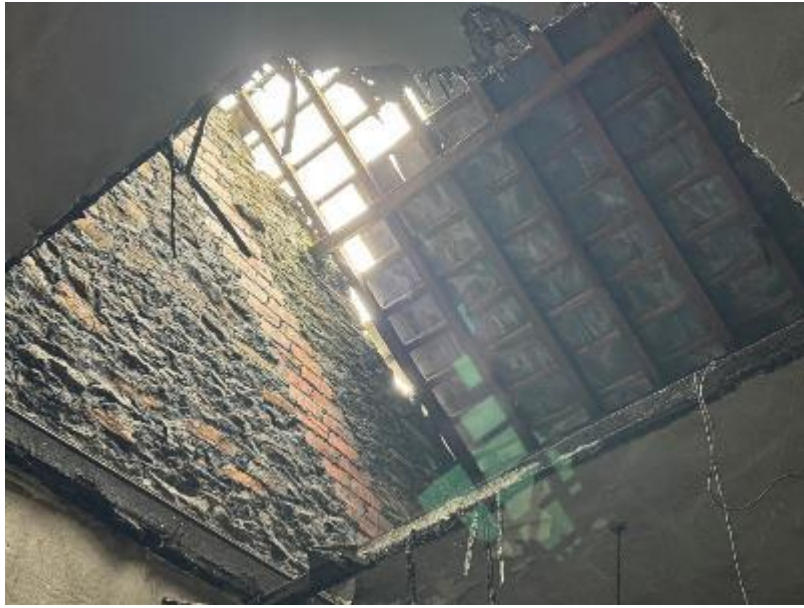
**Photograph 7: Defective ceiling / roof structure (Rear Extension)**

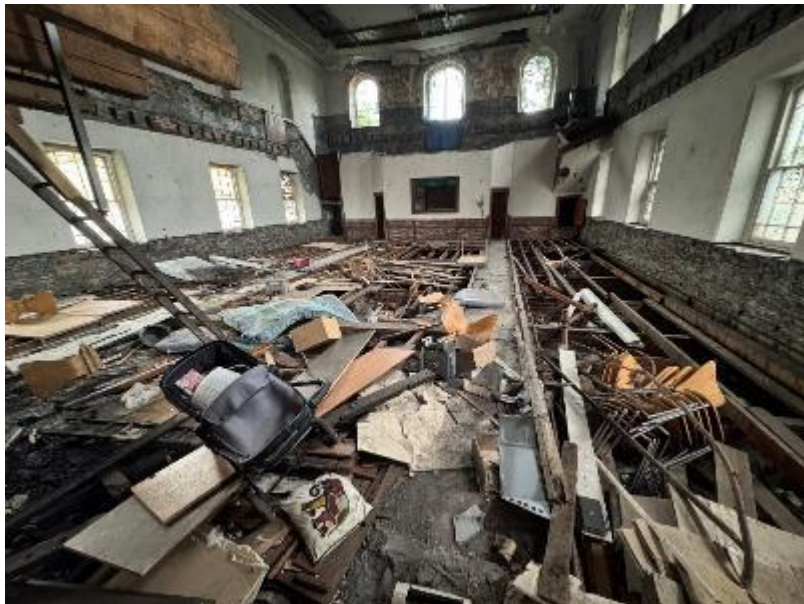
- 3.6** Within the Main Chapel, large areas of the floor coverings had been removed and there were a lot of loose timbers and other discarded materials on the floor (Photograph 8). All the upper floor chapel seating, supporting columns, and pews had also been removed, with small pockets in the wall where the supporting timber structure used to rest (Photograph 10).

**Photograph 8: Main Chapel (General View – looking West)**

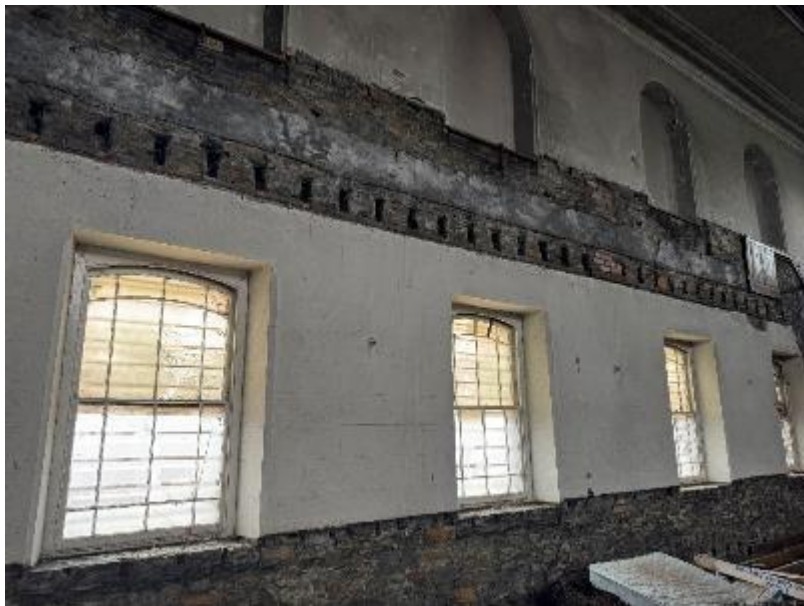
**Photograph 10: Redundant wall pockets for the timber upper floor chapel seating**

- 4.12** All fire damaged structure should be removed and the gable end stone wall inspected for any fire damage, following removal of wall coverings.
- 4.13** The holes where the former upper floor was supported should be made good and infilled with masonry,

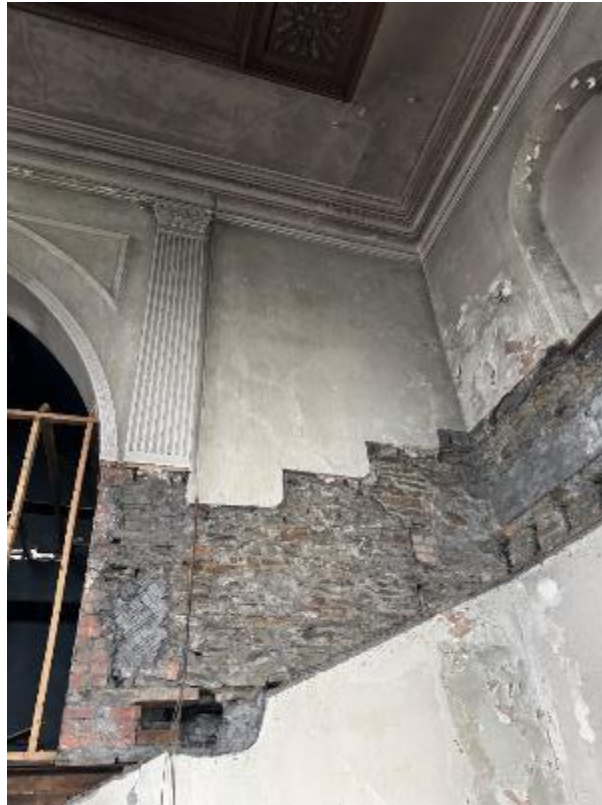
- 3.7** Generally, the external walls to the side and front elevations were found to be in a reasonable structural condition, but on the East gable elevation there was some localised structural distress to the masonry, where the primary upper floor chapel beams were built into the wall (Photographs 11 & 12). In addition, there was a large vertical crack in gable wall, adjacent to the South elevation (Photograph 13), which may be related to localised ground movement and rainwater run-off from the roof, as the crack extended to GF level.

**Photograph 11: Structurally distressed stone to the East gable elevation**

- 4.11** Post demolition, we would recommend a trial pit is excavated in the proximity of the vertical crack in the East gable elevation wall, and the ground inspected by the engineer for further written advice. As a minimum, and subject to the findings of the trial pit inspection, it is likely a crack stitch repair by Cintec or another approved specialist contractor will be required to restore the structural integrity of the gable end wall. In addition, the gaps in the stone wall should be infilled with masonry and any loose or embedded timber removed.

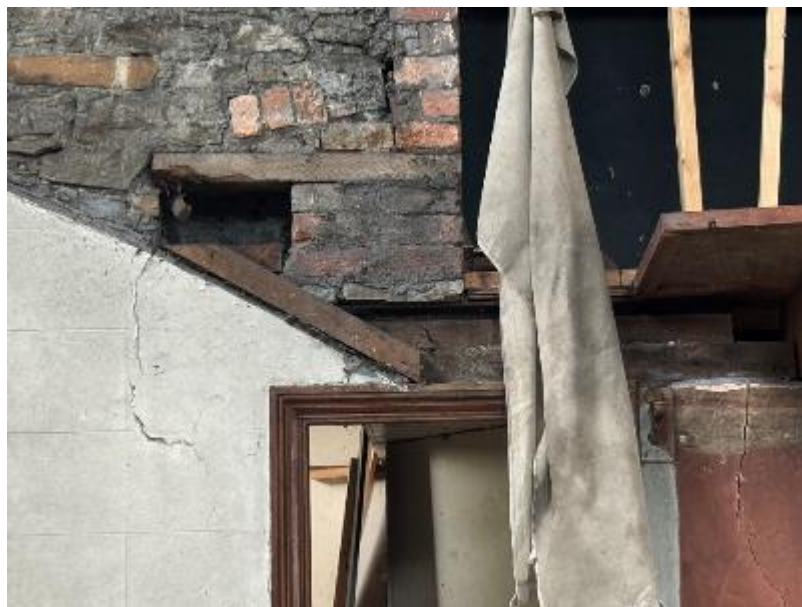
**Photograph 12: Some localised cracking at the past beam end bearing locations**

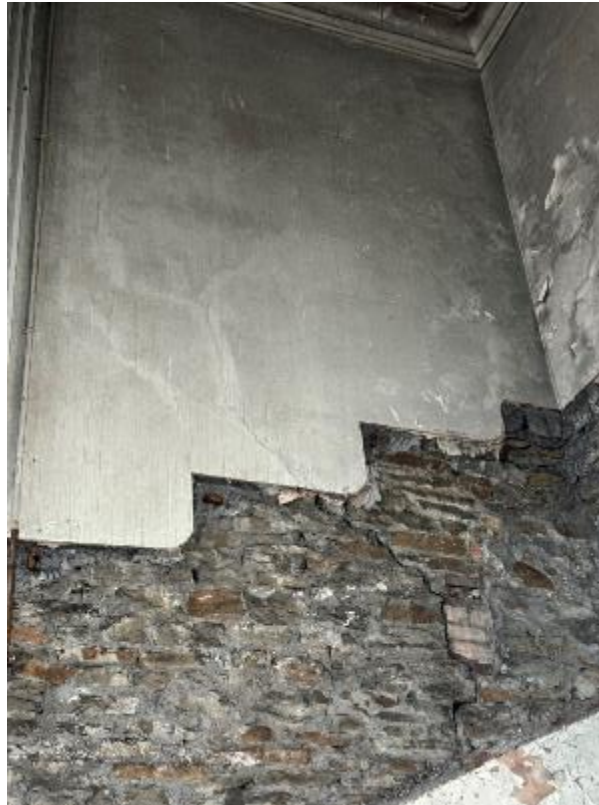
**Photograph 13: Large vertical crack in the gable elevation wall**

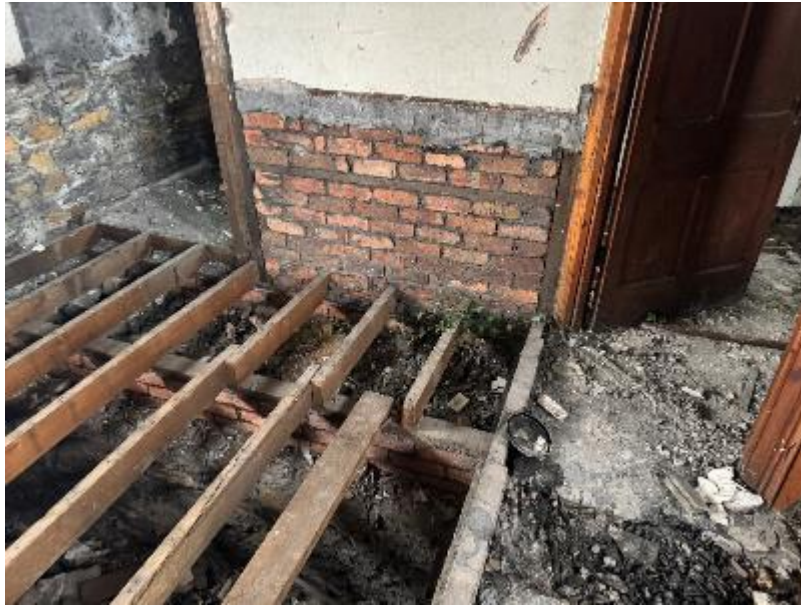
- 3.8** The ground floor was predominately suspended timber joists, nominally 130 x 45 @ 400ctr. of unknown grade. These were supported on approximately 400mm wide solid stone walls, with three courses of single skin brickwork to the underside of the floor joists (Photograph 14). The spacing of the sleeper walls varied between 1.6-2.2m. Given their age, the timbers appeared to be in a reasonable structural condition. There was random rubble fill between the walls, and in one area we noted potential asbestos roof sheets (Photograph 15). We noted that there were some sections of solid floor in the Main Chapel, these appeared to be the aisles between the pews and the area local to the former main entrance.

**Photograph 14: Mainly suspended timber joisted floor on brick/stone sleeper walls**

- 4.18** Following the removal of the suspended timber GF joist, any loose, missing, or damaged bricks should be made good or replaced. Subject to the approval of the end user, any stakeholders and warranty providers, we would recommend the timber floor is replaced with new tanalised and treated timber joists. It would be advisable to ensure the existing vents are all clear, prior to closing-up of the floor. New galvanised steel beams will be required off the existing load-bearing walls to support the new internal timber load-bearing walls and 1F structure.

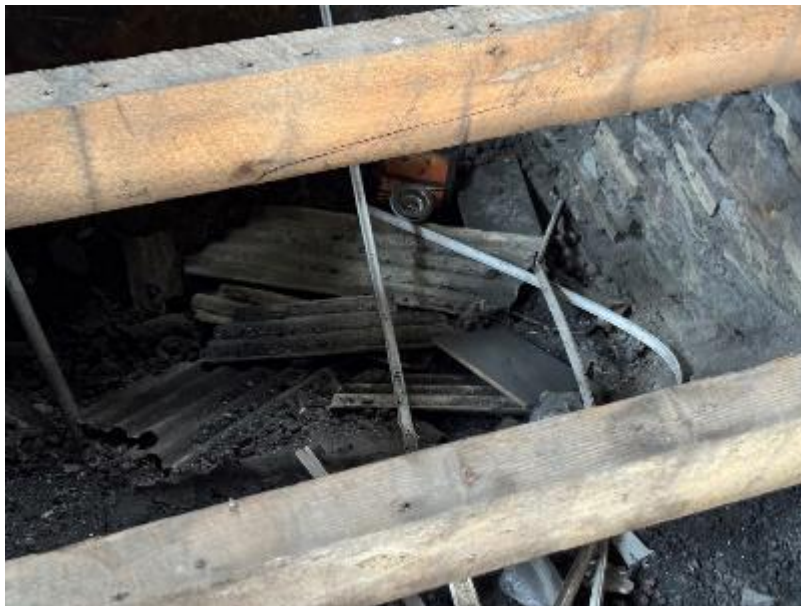
**Photograph 15: Potential corrugated asbestos roof sheets**

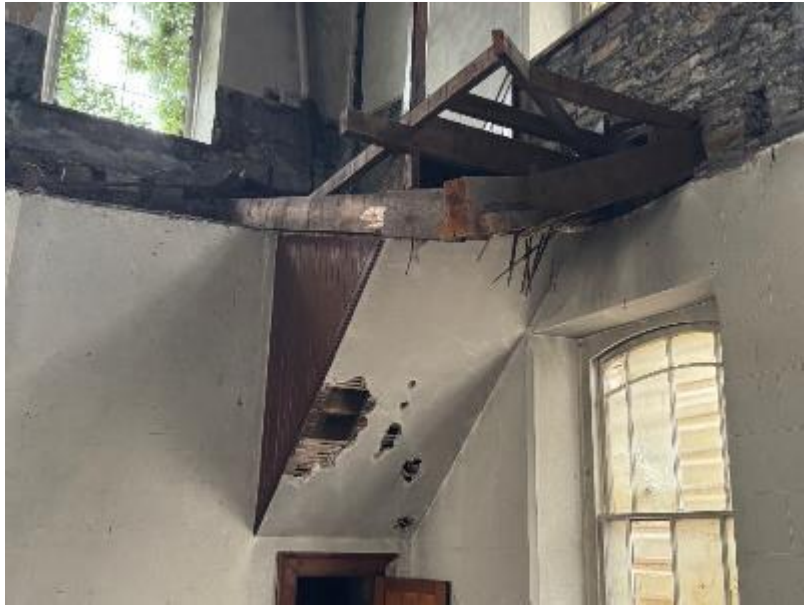
- 3.9** There was a partially demolished timber staircase leading up to the former upper floor seating area, which is currently in a poor condition and potentially liable to collapse (Photograph 16). This should be cordoned off to prevent unauthorised access, prior to removal.

**Photograph 16: Structurally unsound redundant timber stairs**

- 4.15** The internal non-load bearing single leaf masonry wall between the entrance lobby and Main Chapel, together with the redundant timber staircase can be safely demolished, as part of the demolition works.

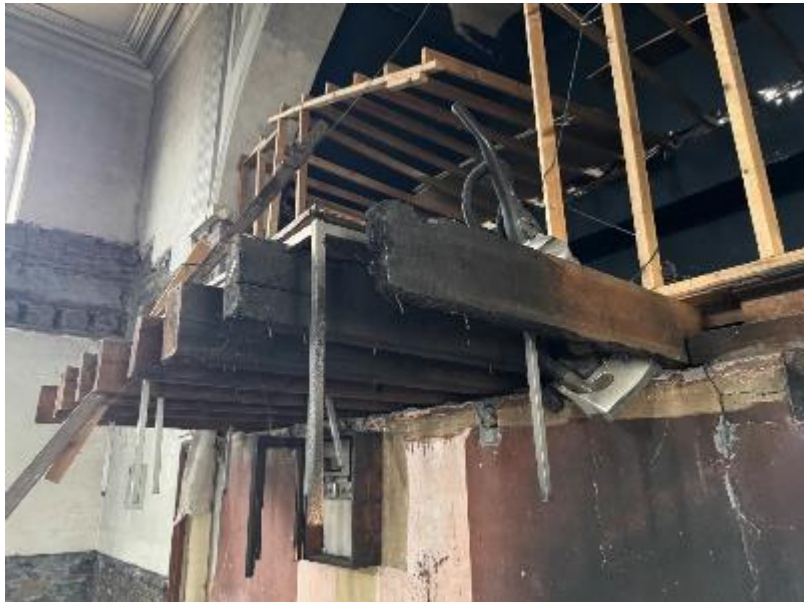
- 3.10** Beneath the former organ, there appeared to have been a small fire. Several of the timbers were noted to be charred (Photograph 17) together with the GF timber floor joists and door architrave. Whilst these elements are to be removed as part of the works, further checks on the structural integrity of the supporting masonry should be carried out following the removal of the wall coverings to confirm future load-bearing capabilities. The timber studwork over had failed but was still partially supporting several boards at ceiling level. Access to this area should be restricted to a competent demolition contractor (Photograph 18)

**Photograph 17: Fire damaged structure**

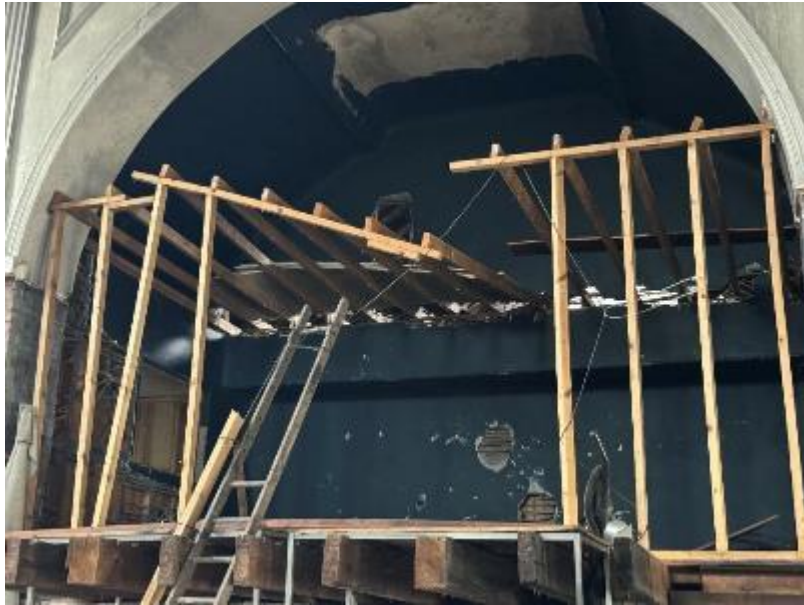
**Photograph 18: Failed timber stud framing (Note: multiple loose boards at ceiling level)**

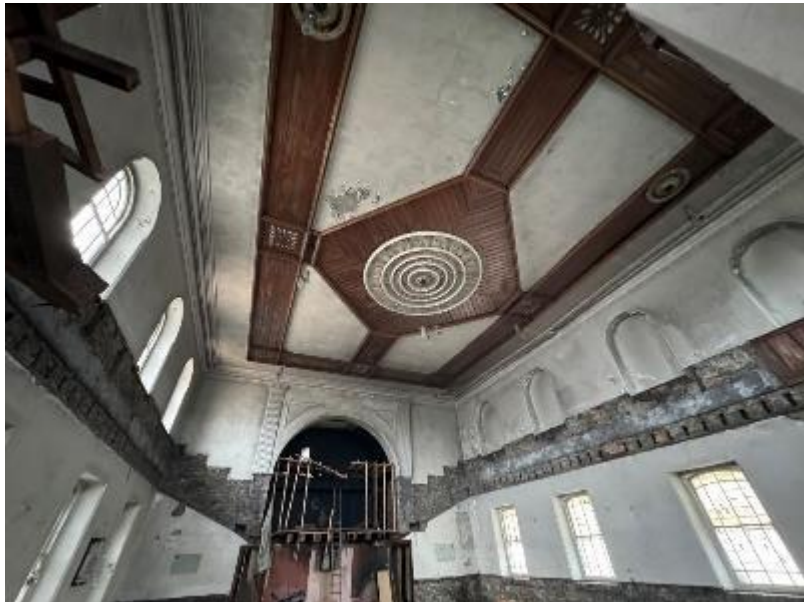
- 3.11** Due to the existing ceiling in the Main Chapel, it was not possible to view the structural condition of the main roof structure (Photograph 19). However, we did note some water ingress damage to the lath & plaster ceiling & architectural feature cornice, adjacent to the West gable elevation (Photograph 20). When viewed externally, this is likely due to some missing slates (Photograph 21). A further high-level inspection will be necessary off suitable access equipment to establish whether the water ingress has caused any structural damage, but given the condition of the general ceiling this is likely to be minimal.

**Photograph 19: Existing ceiling in the Main Chapel**

- 4.14** The ceiling over the Main Chapel should be removed to enable a thorough inspection of main roof structure to be carried out. In addition, the roof coverings should be inspected and replaced where necessary. The missing slates at ridge level adjacent to the West gable elevation should be replaced, and the copings inspected for water ingress.

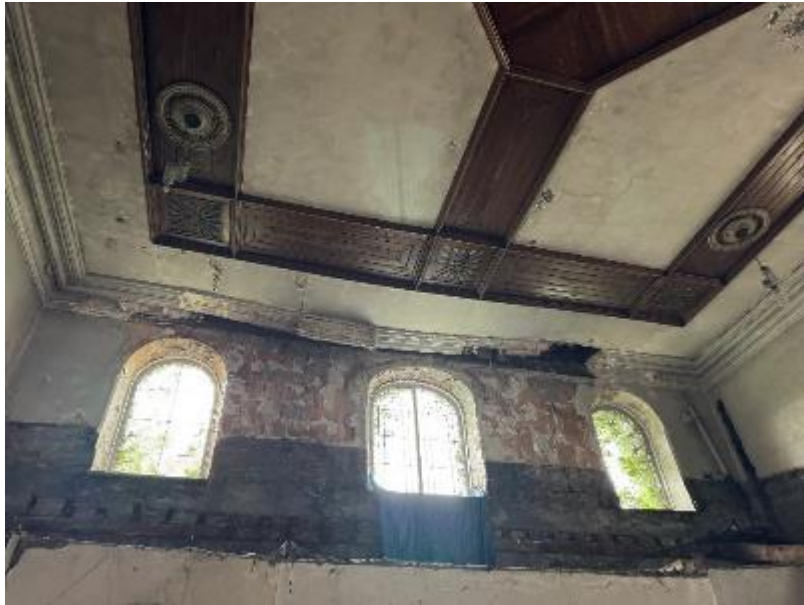
**Photograph 20: Part damaged ceiling & cornice in the Main Chapel  
(likely due to water ingress)**

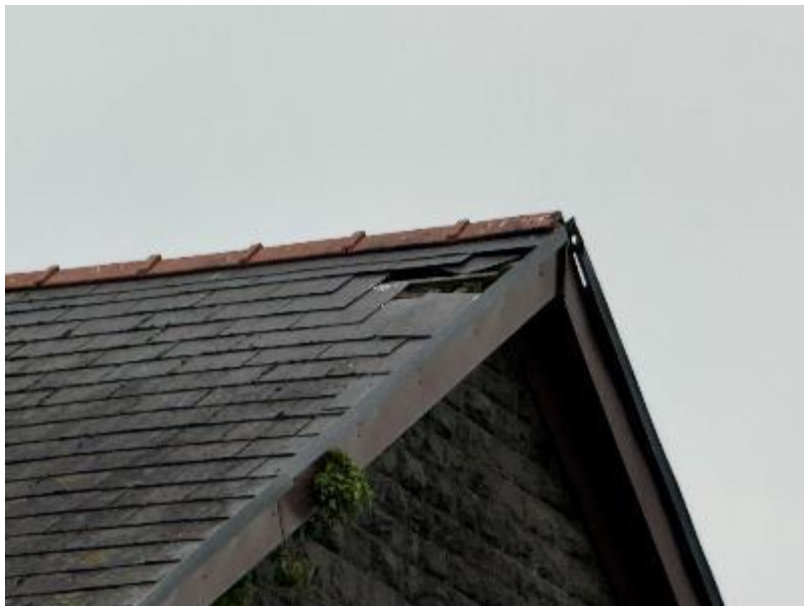
**Photograph 21: Some missing slates to Main Chapel roof (West gable elevation)**

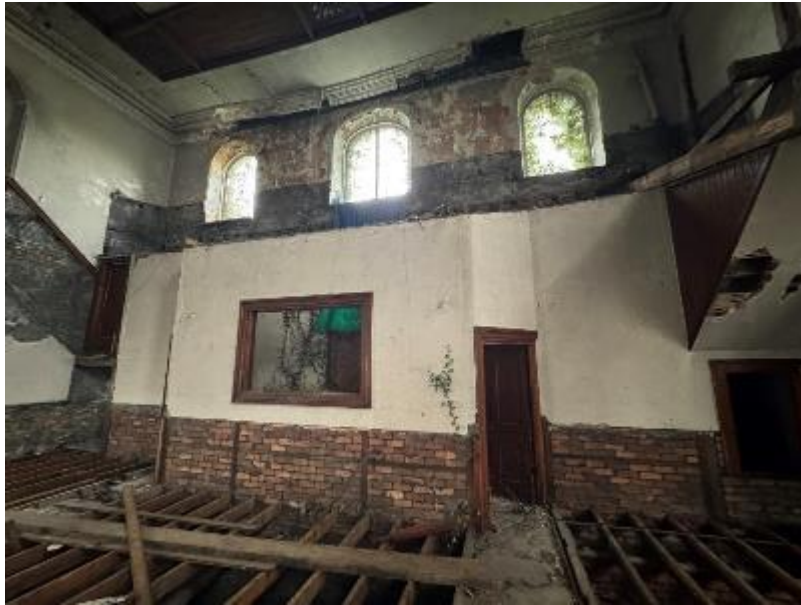
- 3.12** There was a single skin brickwork wall in the Main Chapel that separated the former seating area and the main entrance lobby. The wall showed some minor signs of structural distress, but as it will be demolished as part of the works we will not comment further on its condition.

**Photograph 22: Brickwork separating wall between the Main Chapel / Entrance Lobby**

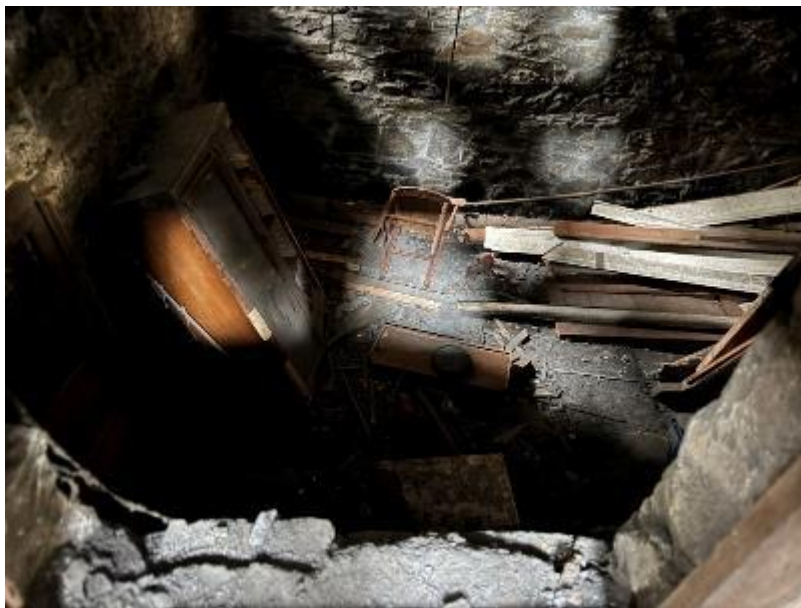
- 3.13** There is a large basement below the Main Chapel that extends from the South elevation to the central area between the one of the former aisle walkways (Photograph 23). Access into the basement appears to be from an external door in the South elevation, which is on third-party land. If possible, it would be advisable to infill the basement with clean non-deleterious materials, as this will balance out the pressure on the existing retaining walls. We noted some of the brickwork walls around the basement were damaged and defective, so suitable allowance should also be made for isolated repair works (Photograph 24). It appeared that the aisle walkway spanned over the basement (Photograph 25), so some intrusive tests will be required to determine whether there is sufficient reinforcement in the slab.

**Photograph 23: Partial basement beneath the Main Chapel**

- 4.16** Consideration should be given to masonry infilling the door leading to the basement and backfilling the area with suitable inert granular material. We recommend these works to reduce the lateral pressure on the retaining wall.

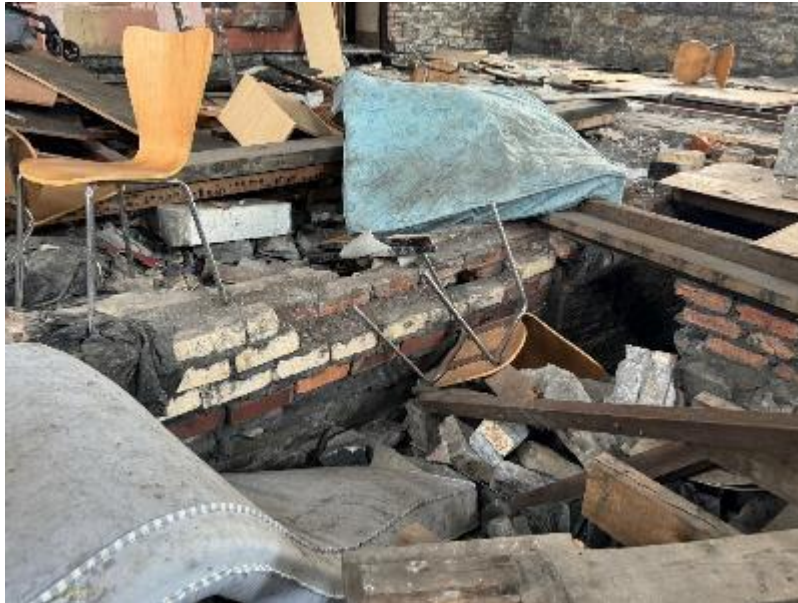
**Photograph 24: Damaged and defective masonry local to the basement**

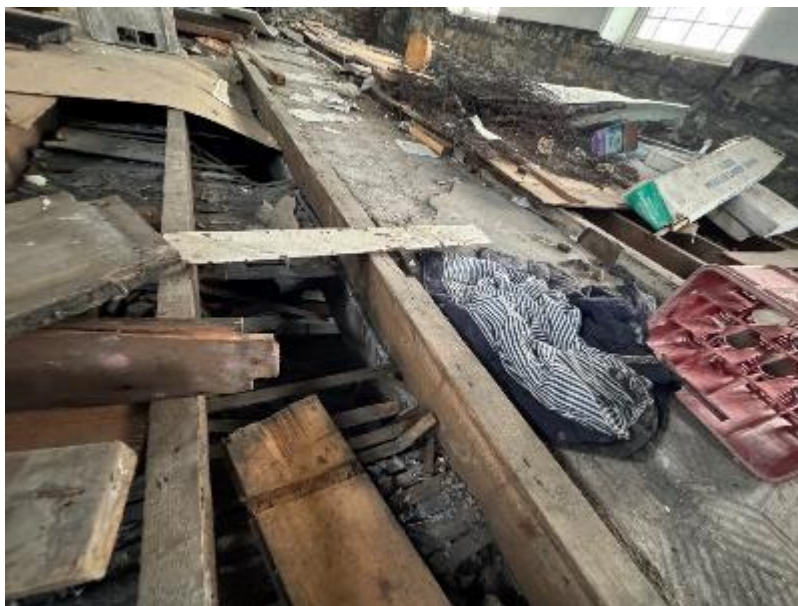
**Photograph 25: Concrete slab spanning over the basement walls**

- 4.17** A small section of the floor that spans over the basement should be exposed to enable the existing reinforcement to be inspected and verified by the engineer.

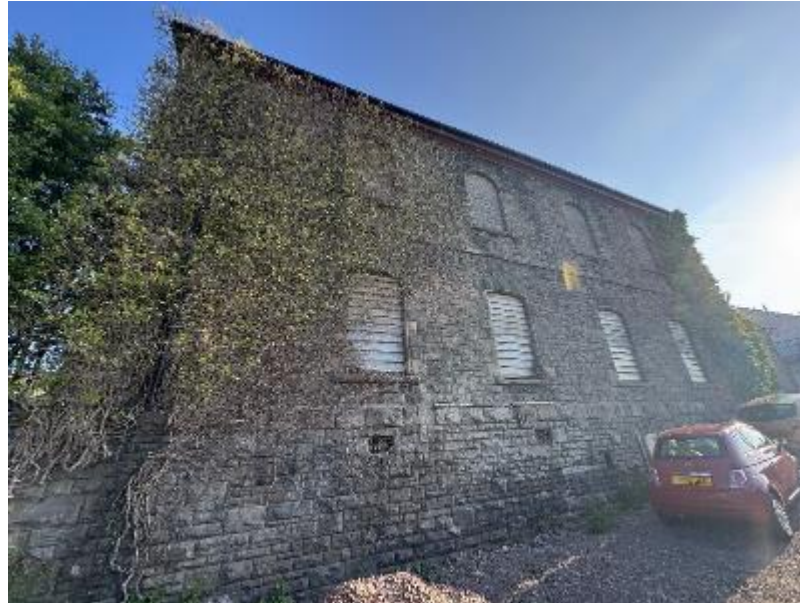
- 3.15** There was some vegetation growth to the Main Chapel South elevation, and the rainwater downpipes did not appear to be positively connected to the below ground drainage system (Photograph 26). However, the stonework appeared to be good order with minimal required structural works.

**Photograph 26: Main Chapel (South Elevation)**

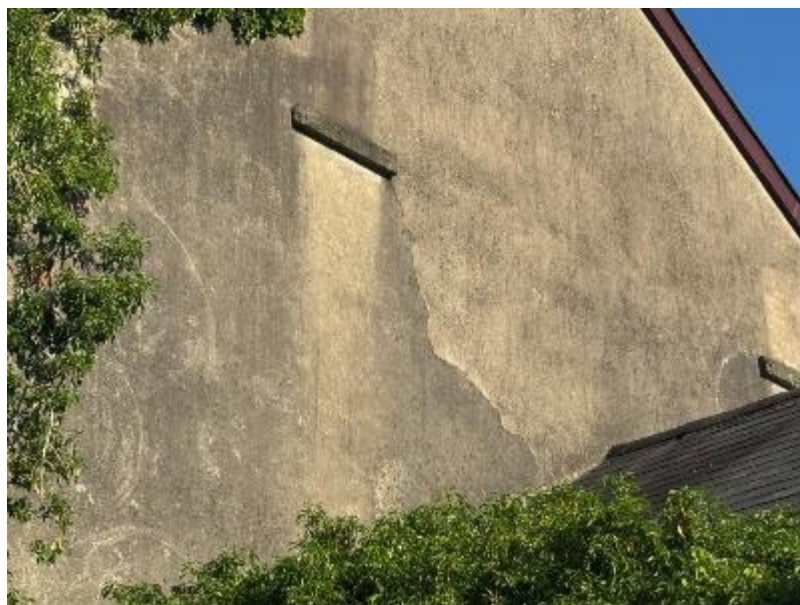
- 3.16** Externally, some of the windows had been infilled with a mixture of blockwork and render or covered over with corrugated metal sheeting. From a limited vantage point, the stone arch window heads appeared to be in a reasonable structural condition. However, there was one prominent diagonal crack to the rear gable elevation (Photograph 27), which will require further high-level inspection and repair following the demolition of the rear extensions.

**Photograph 27: Diagonal crack in the gable elevation wall**

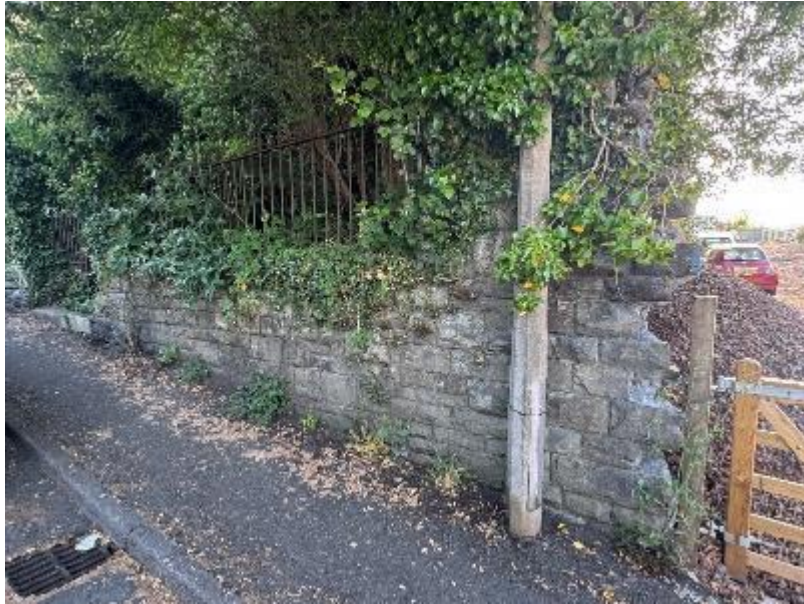
- 3.17** The low-level boundary wall, stone piers, and metal gates and railings are in a reasonable structural condition, but the wall will require repointing and minor repair works, and the gates and railings will either need to be wire brushed cleaned and repainted or replaced with new.

**Photograph 28: Low-level boundary wall to the front elevation**

- 4.19** The external boundary wall should be made good and repointed where necessary, and the railings wire brush cleaned and painted with two coats of an approved external grade paint.
