## Appendix 9.5 Part 2 of 2 - Site visit photographs

# Vaynor Quarry Site Visit: Processing Area

21 NOVEMBER 2019

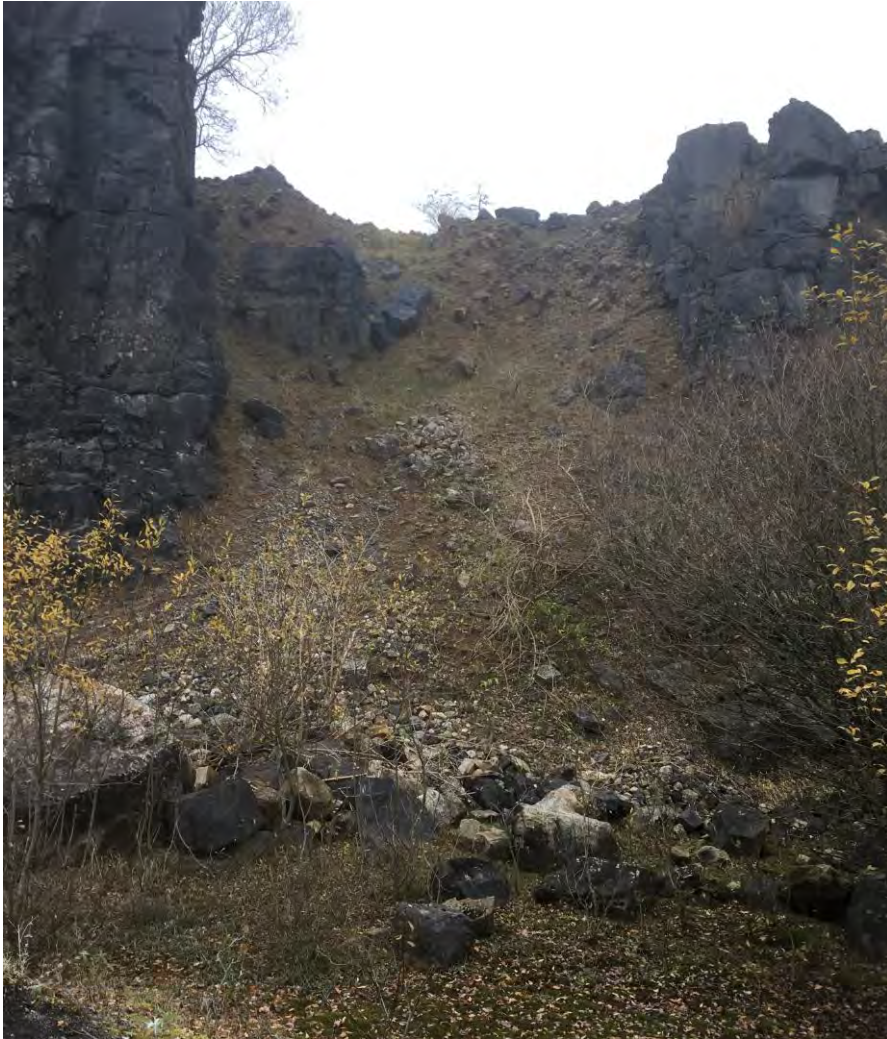
P044 – possible karstic feature

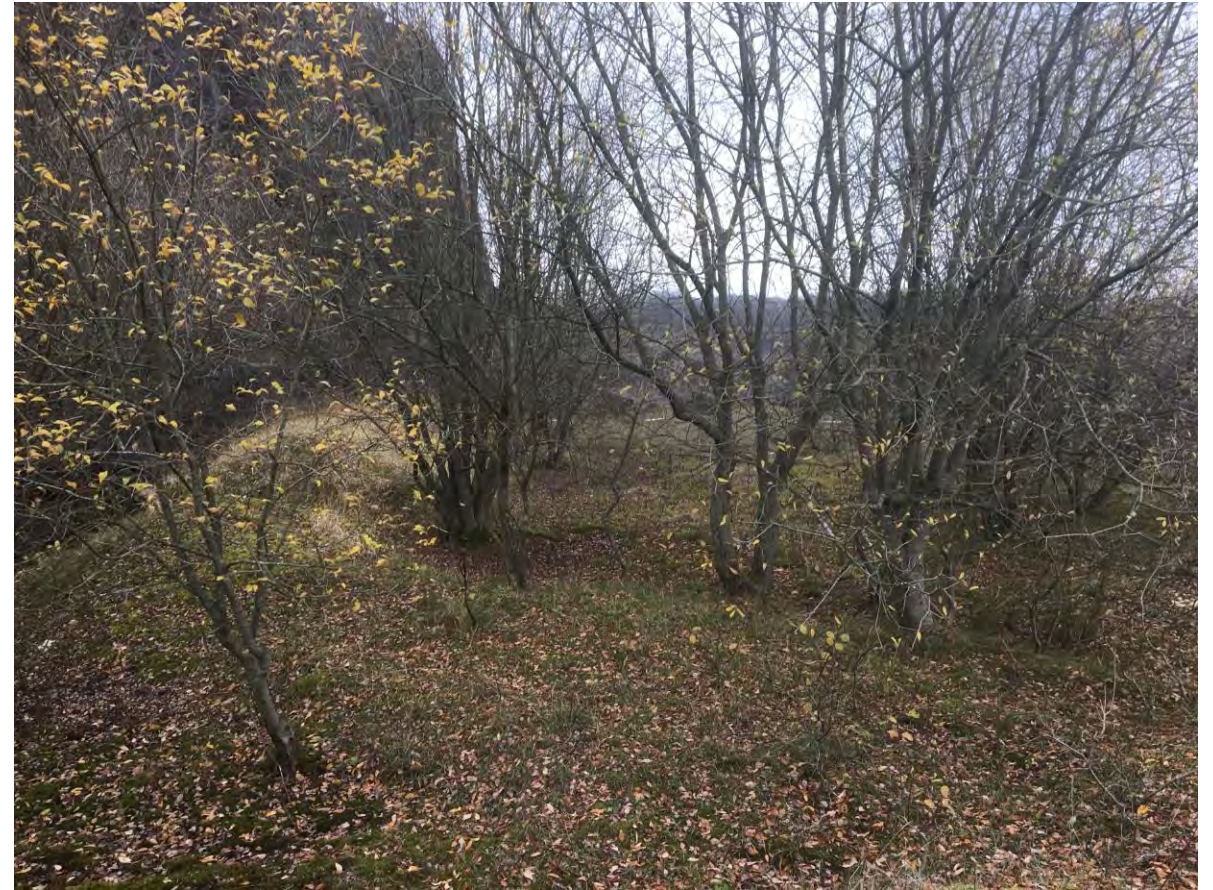
P045 – vegetation associated with ponding water

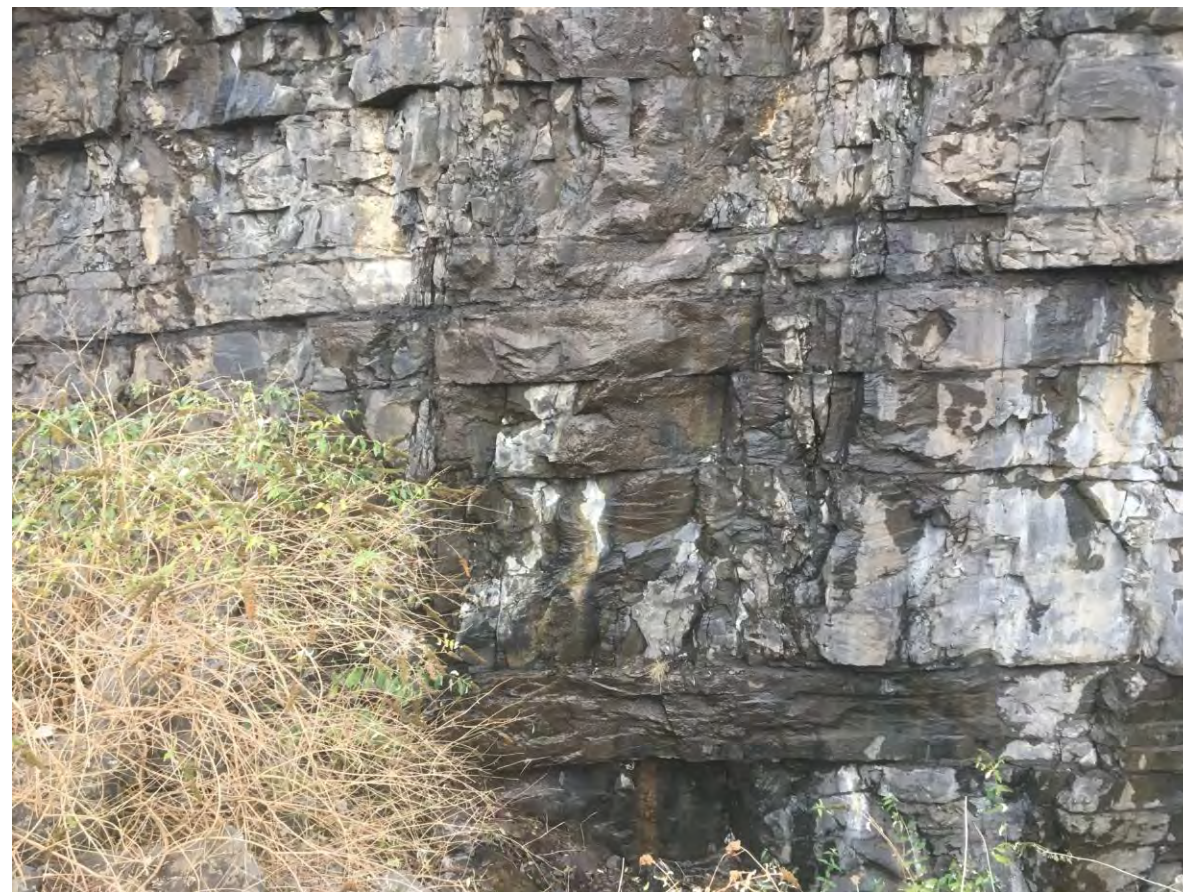
P047 – seepages in western face

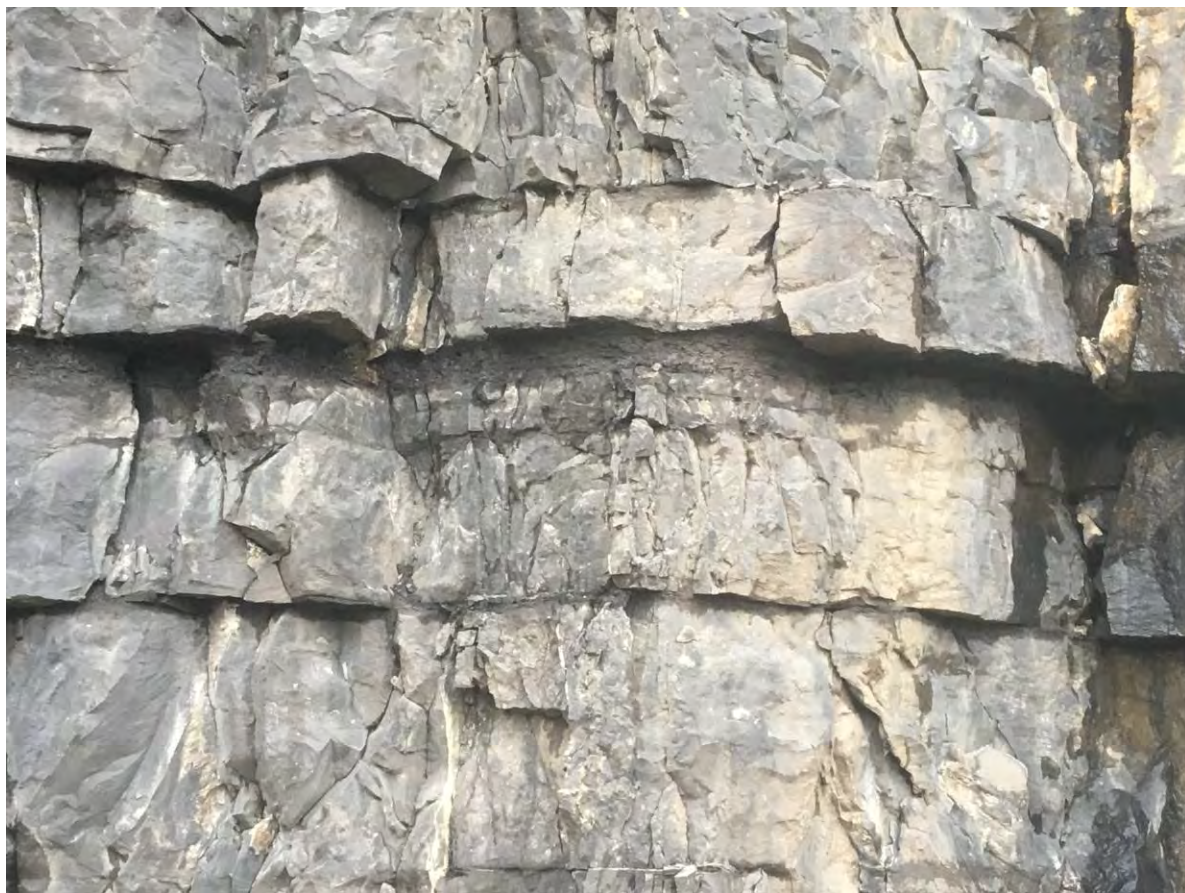
P048 – shale bed interbedded with limestone

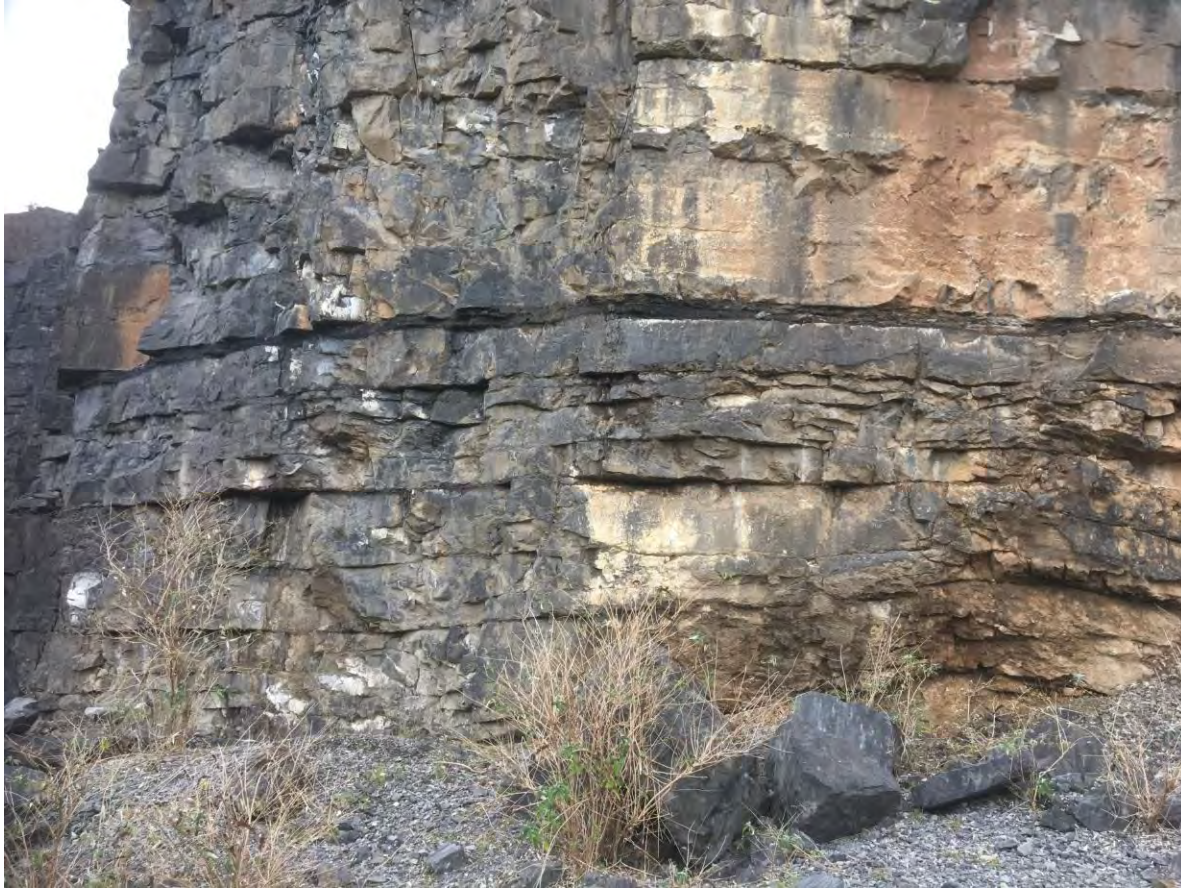
P050 – shale bed in limestone

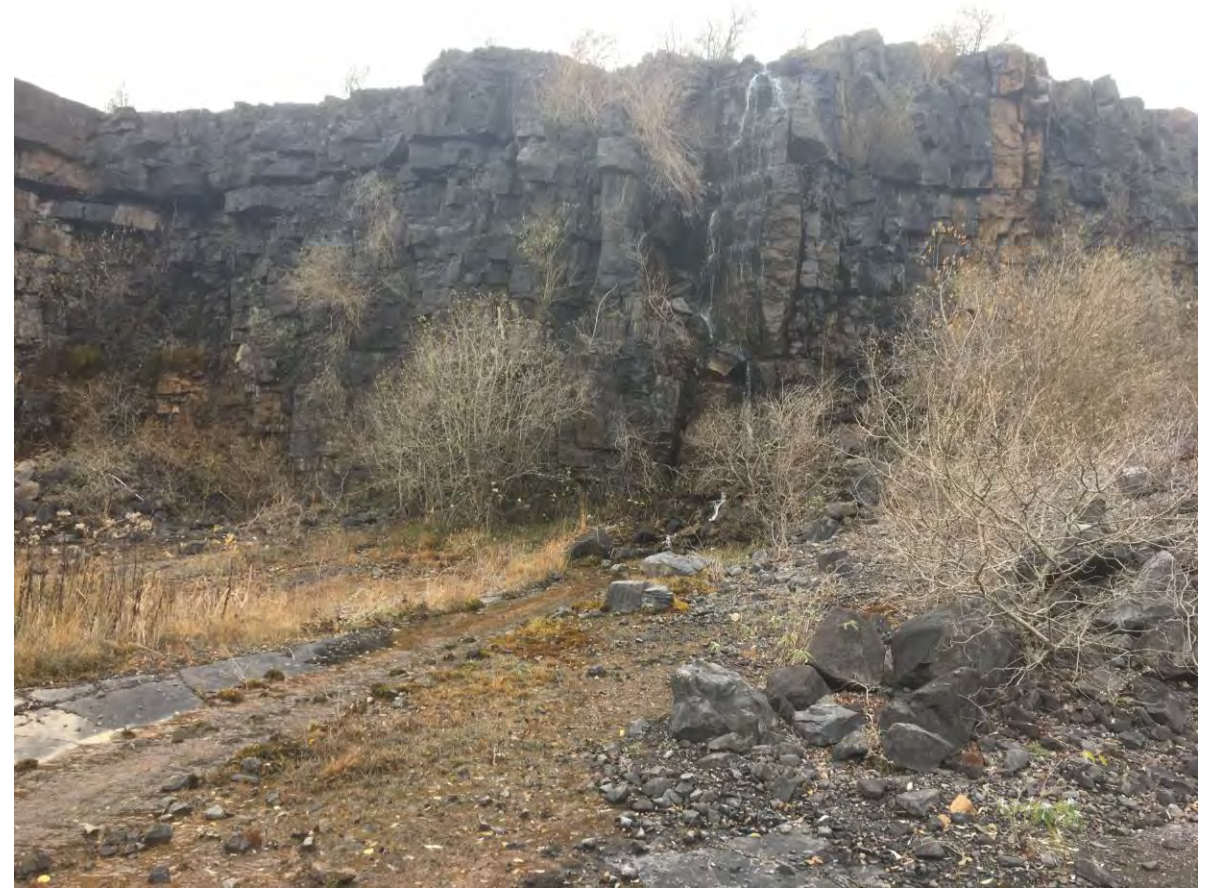
P051 – waterfall – continuation of water from northern part of eastern arm

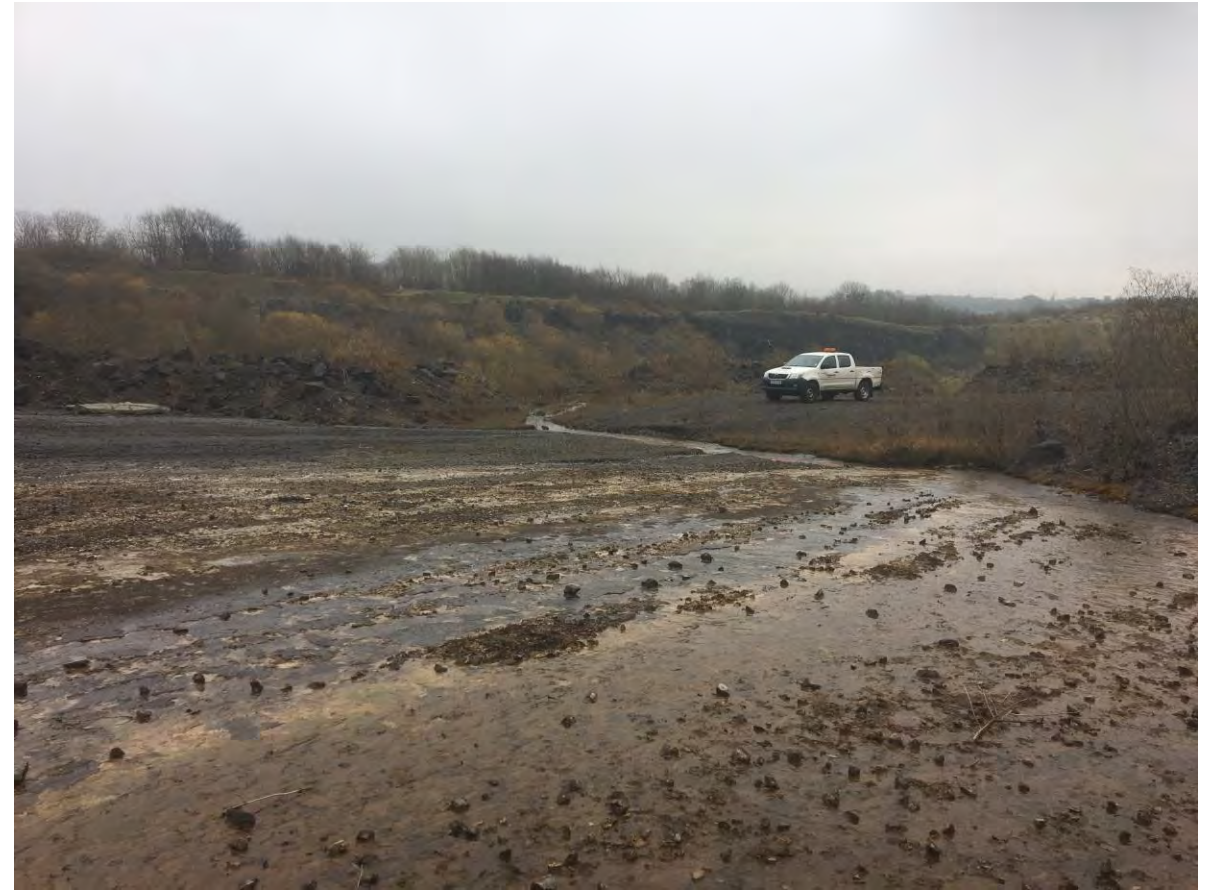
P053 – main flow of water in eastern arm

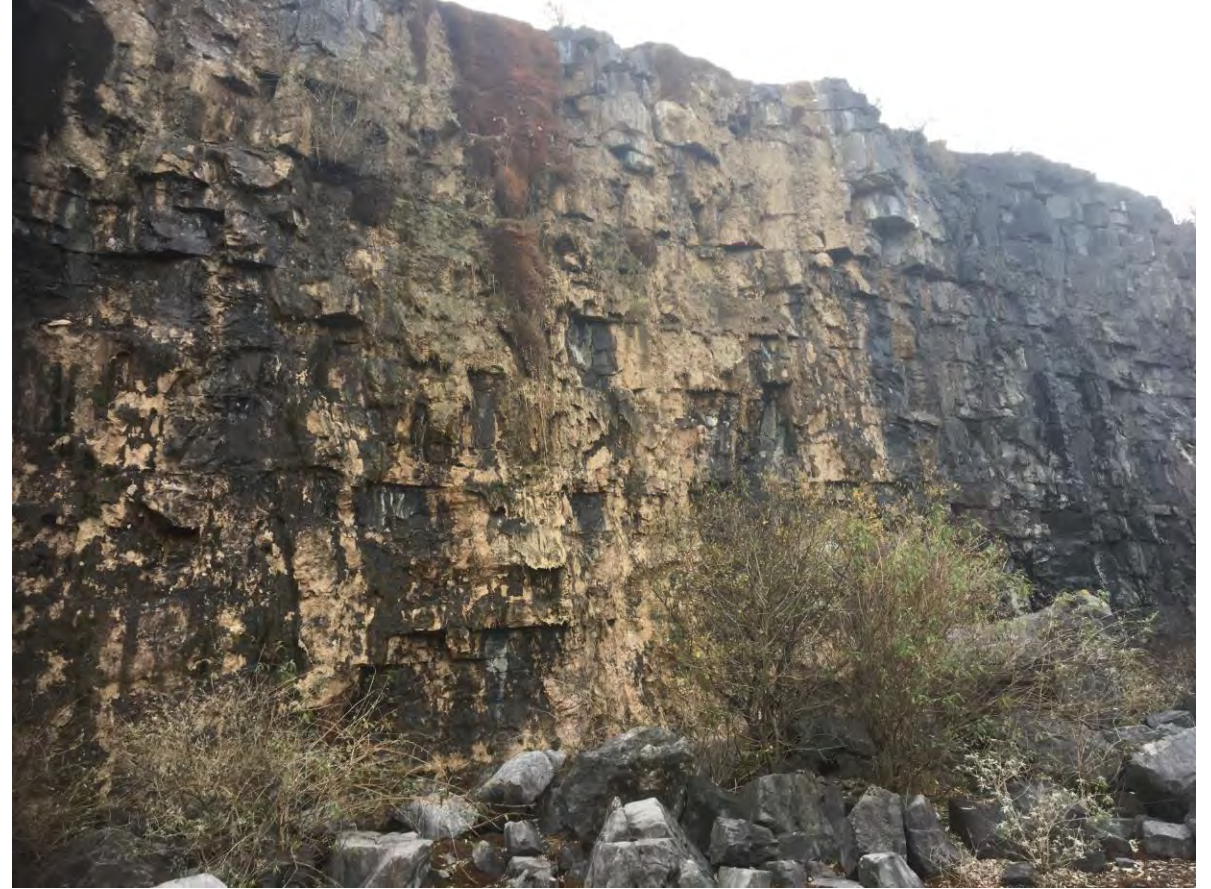
P055 – moss and vegetation on face suggest water flows during wet period

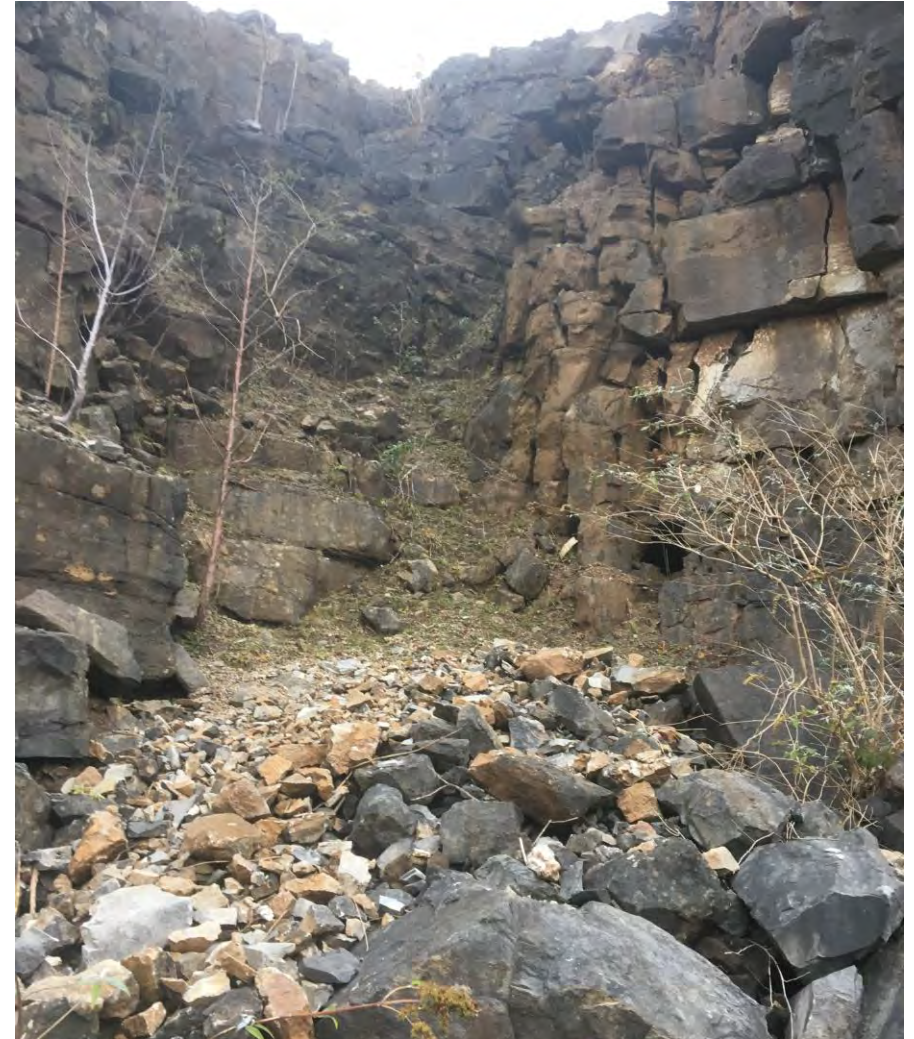
P059 – karstic feature in eastern wall

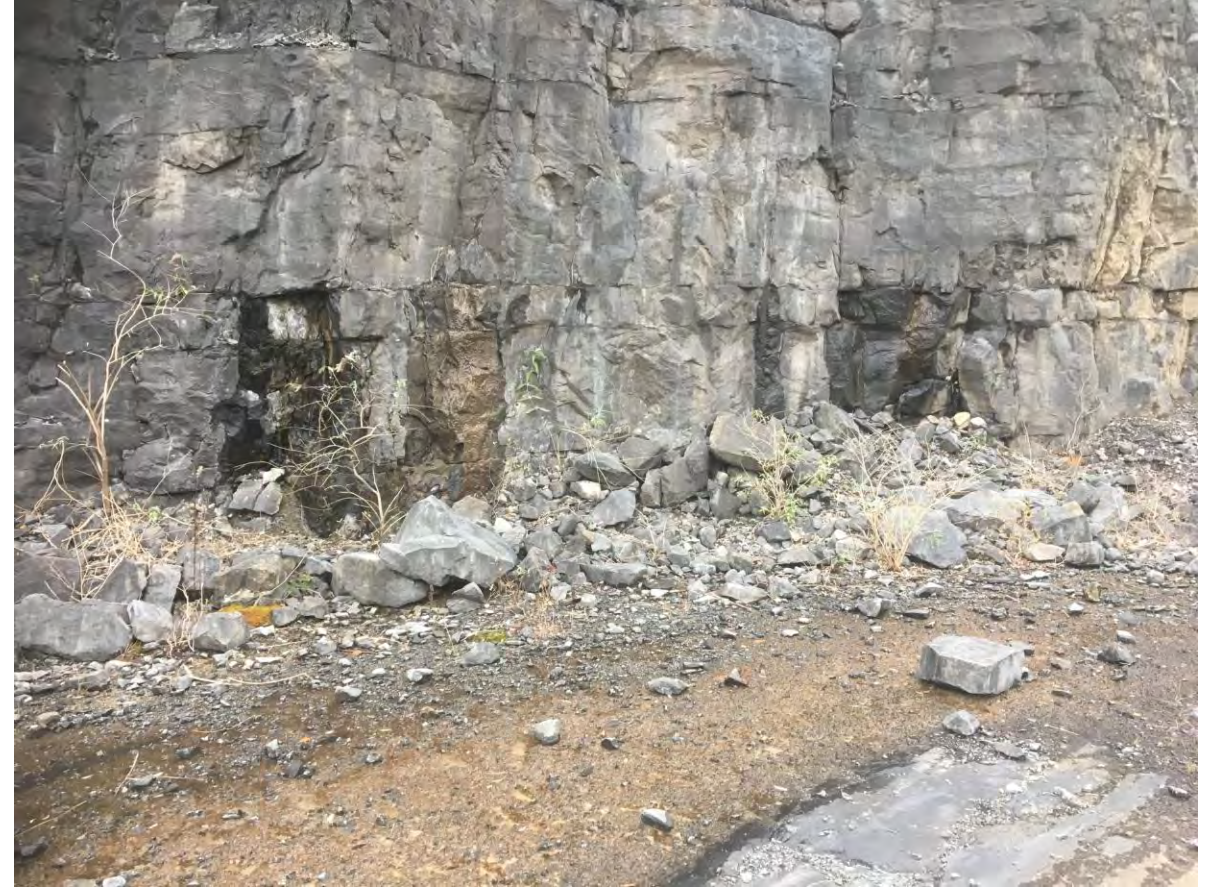
P063 – seepages along bedding planes

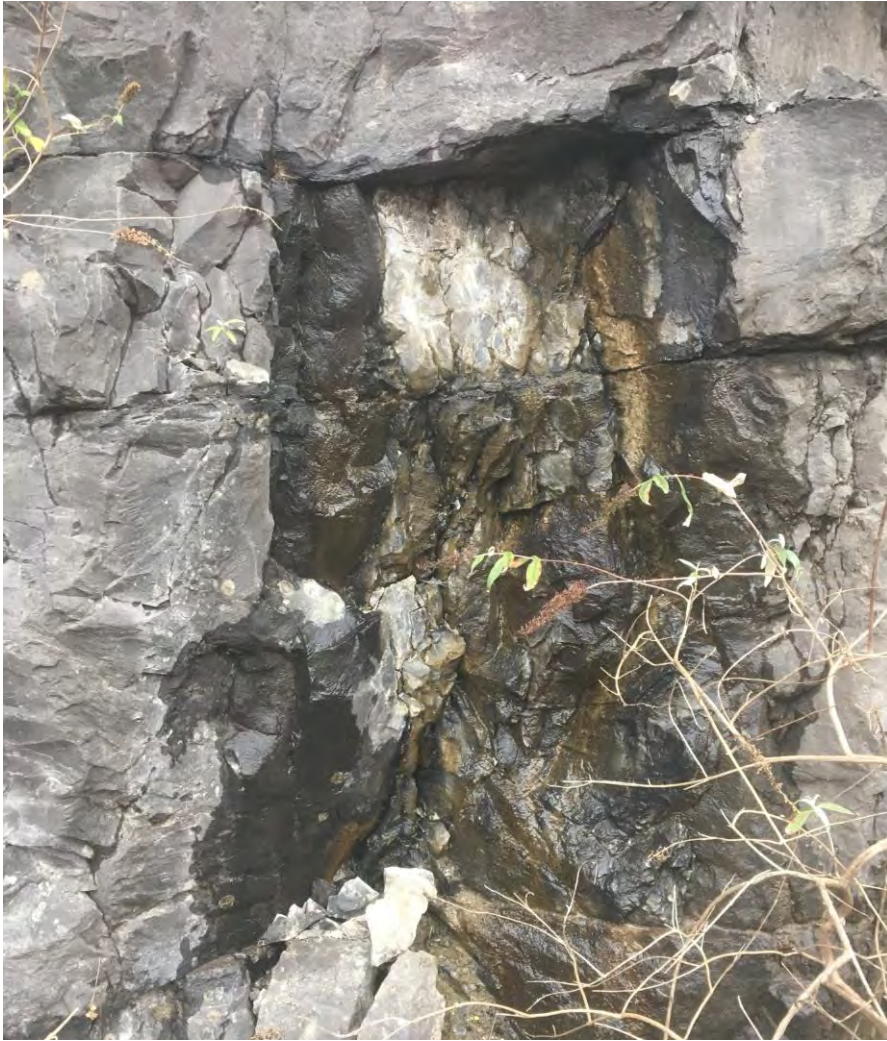
P064 – bedding plane seepage

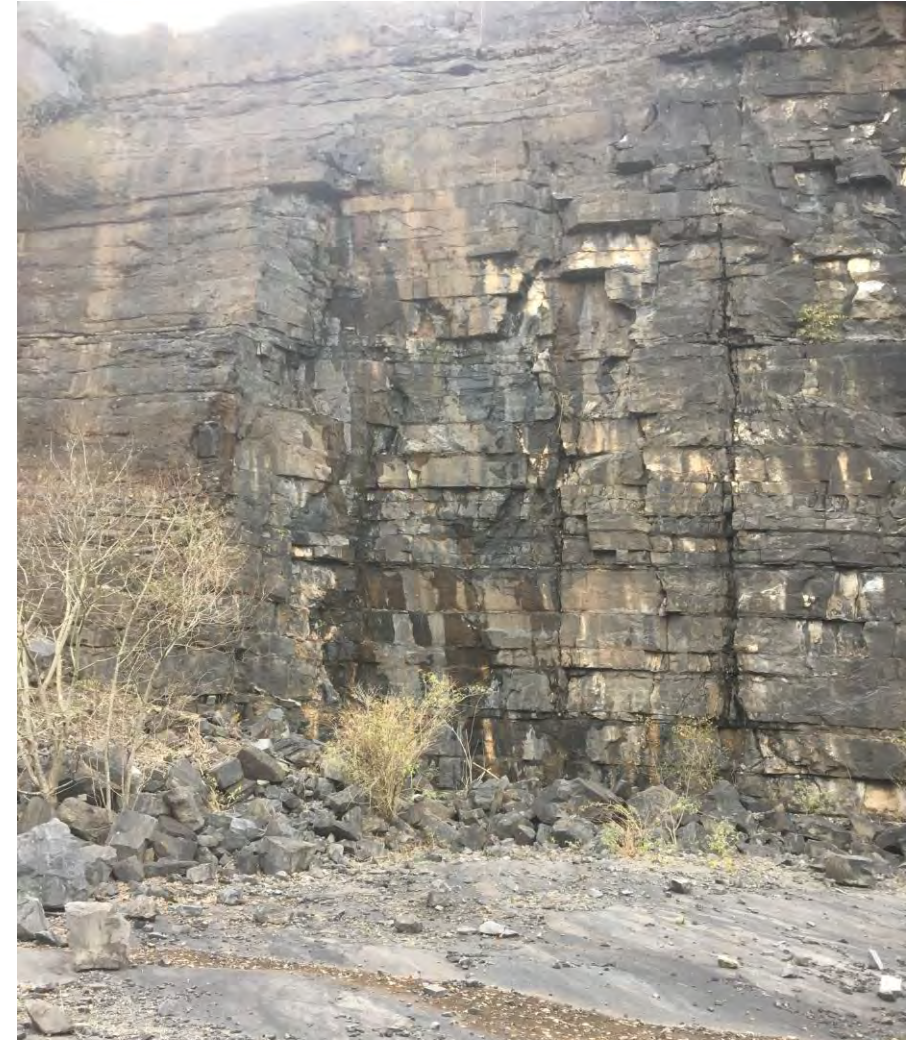
P065 – seepages and fractures

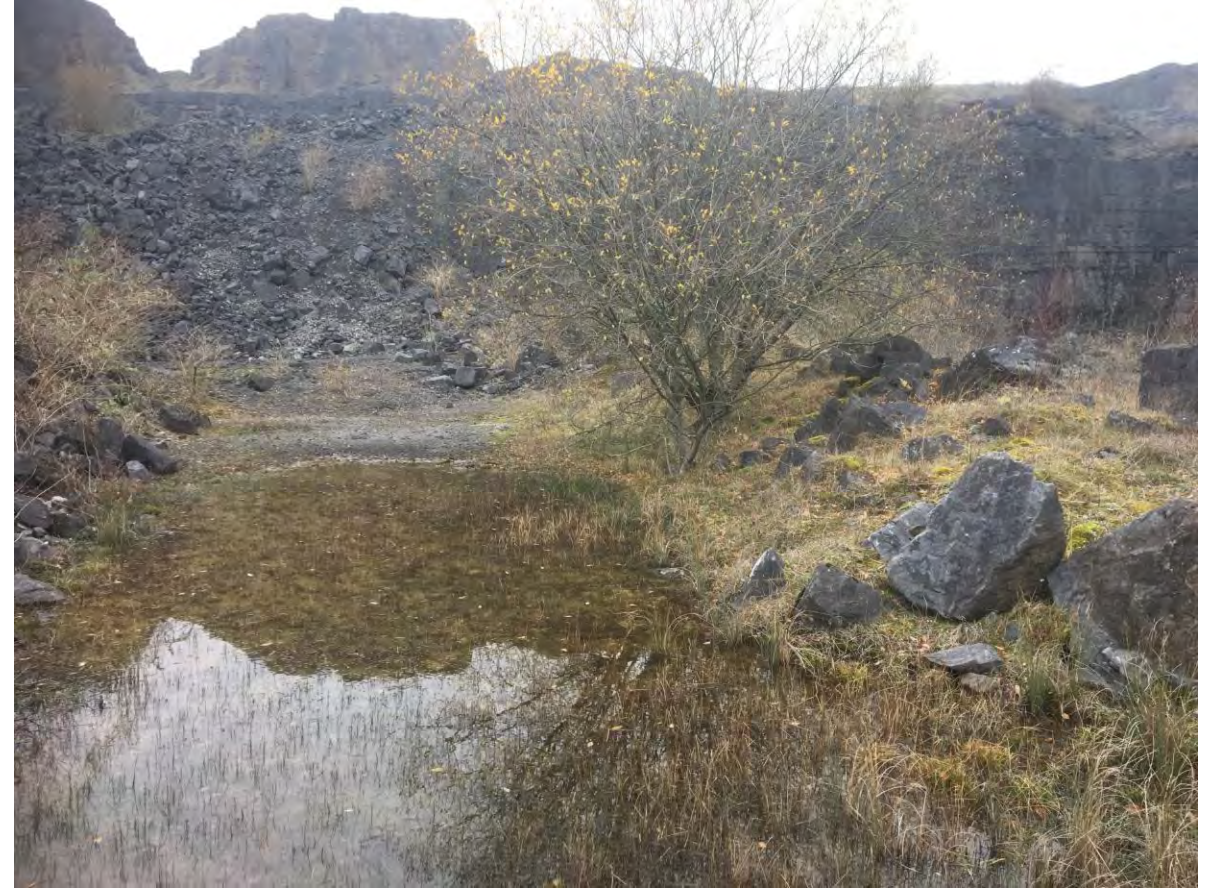
P067 – ponding of water sourced from main flow of water from north

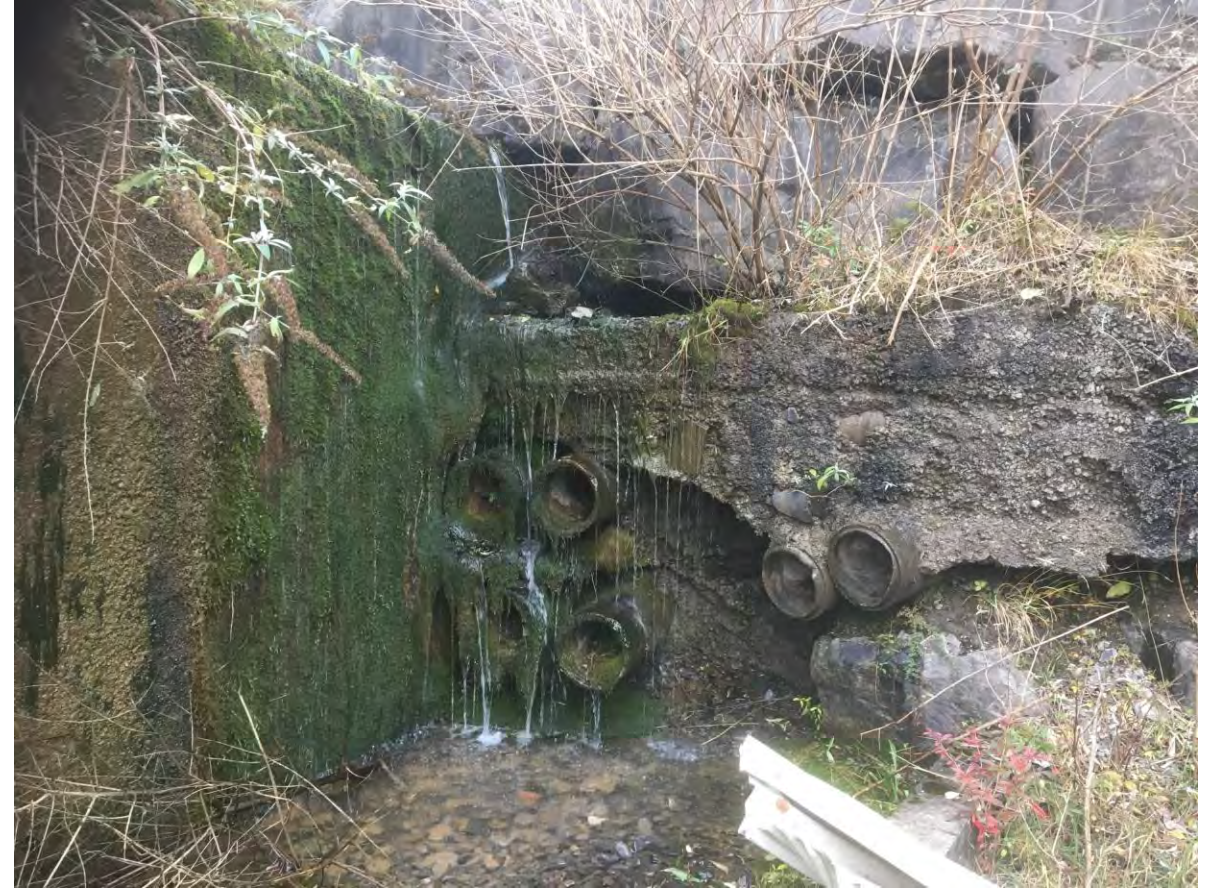
P087 – flow of water towards culvert, water mostly flowing around and not through the pipes
