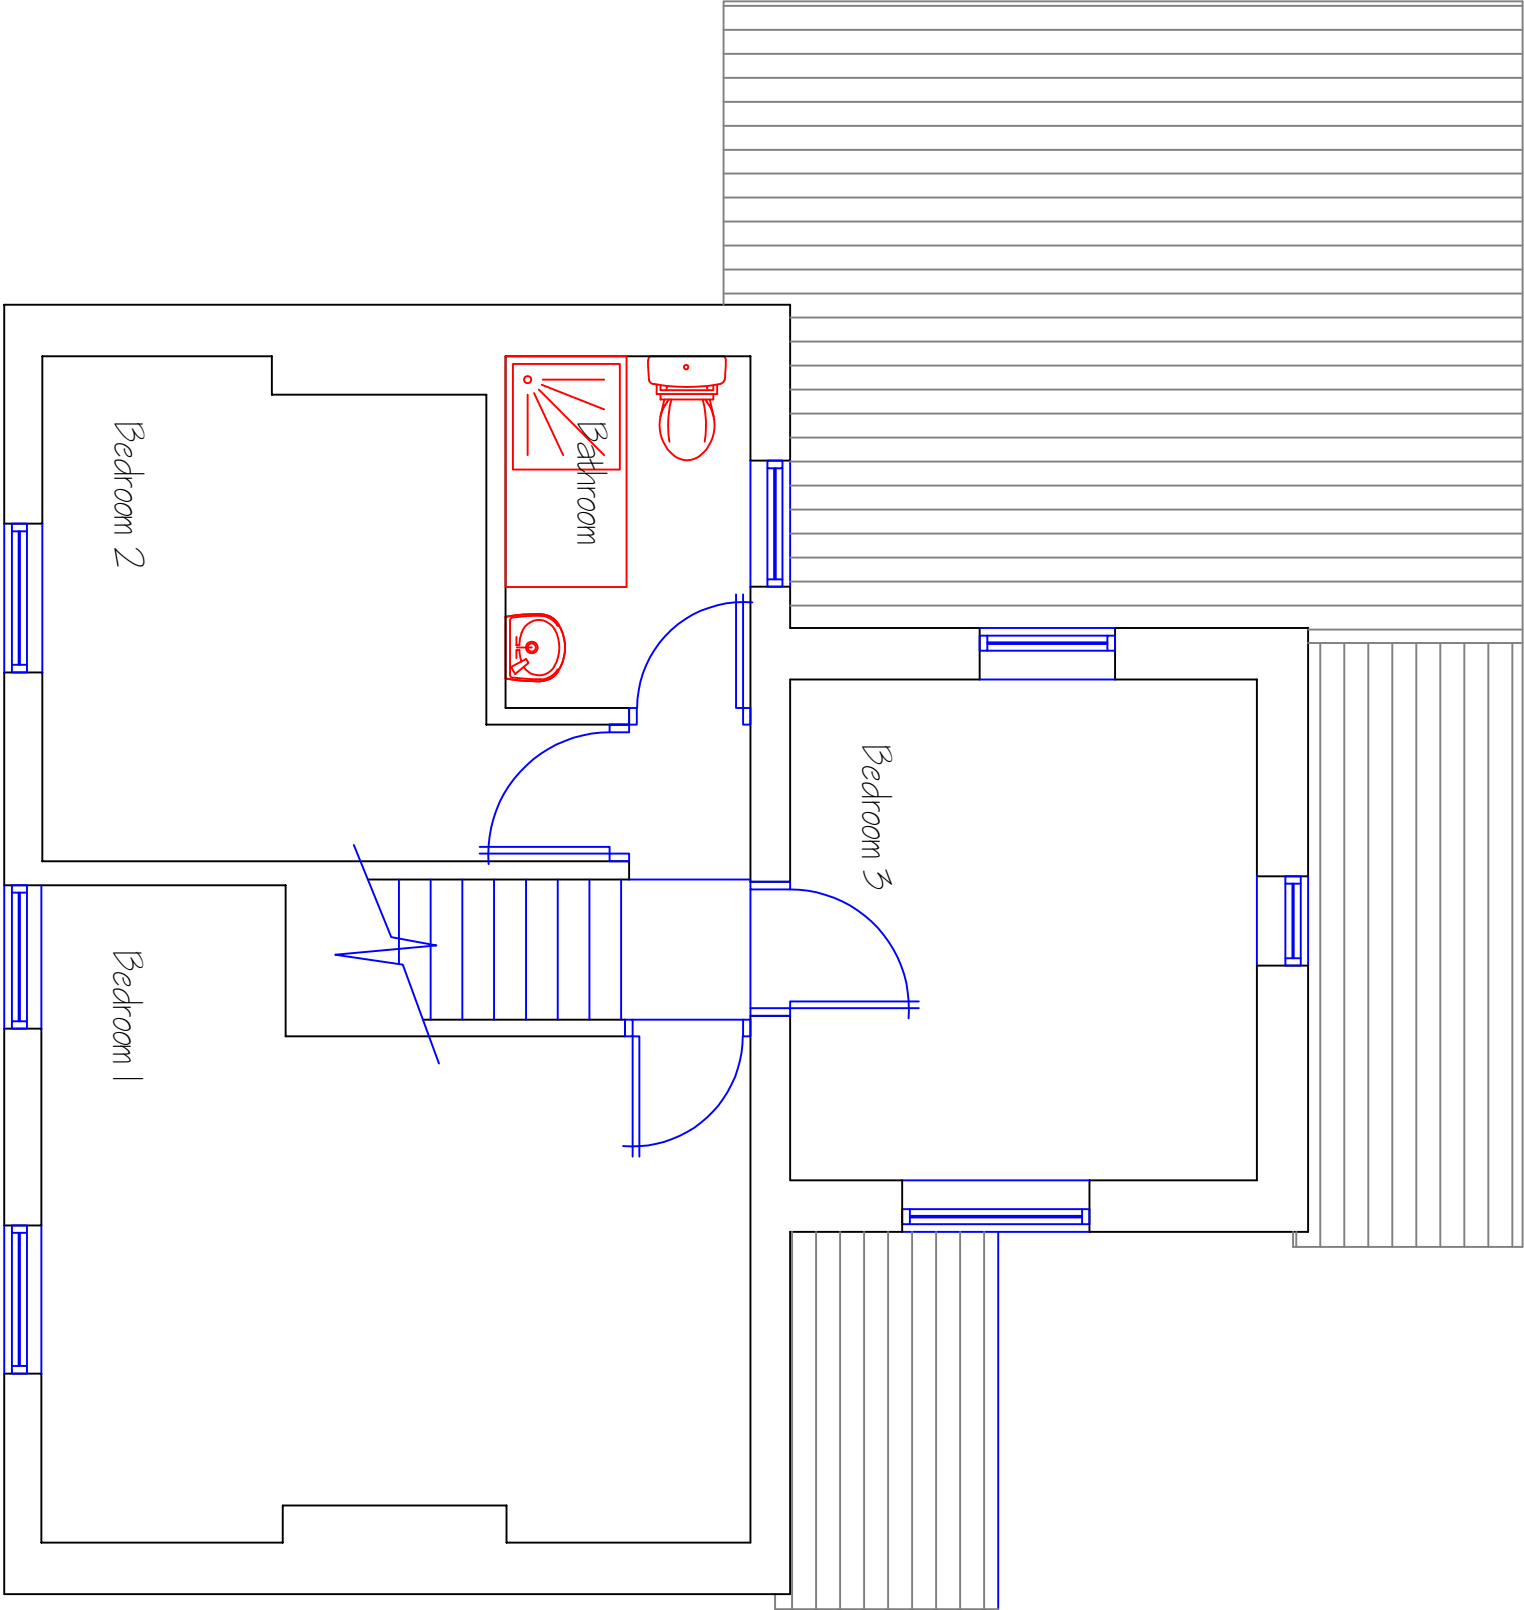
Existing FFL Plan

Existing first floor level floors uneven and sloping. Ends of floor joists to be inspected, repaired and extra support added as required to ensure sound, stable arrangement on completion of works.

Existing bathroom small, confined and dark.  
New layout and white walls to improve current arrangement.

Existing stair arrangement includes landing to top of stair with steps into each of the three bedrooms. Two of which include doors in line with each step.
