# Pandy Farm Barn

## **RIBA2 Report**

## **ACE Building Contractors**

11239.R.TH.02

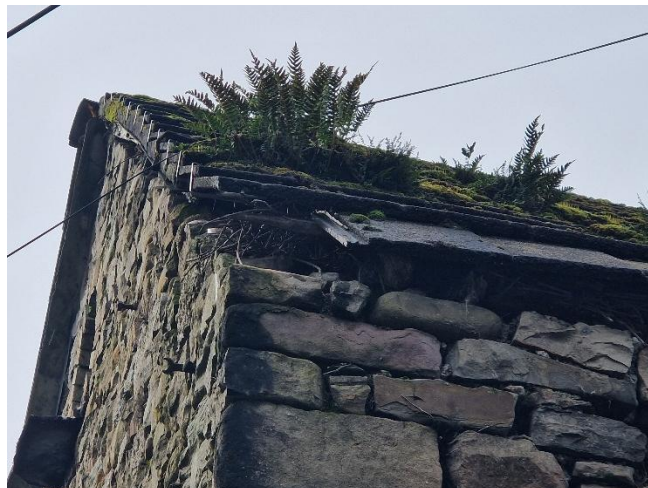
- 4.2.3 Roof finishes are non-original concrete tiles with a modern membrane beneath, generally in functional condition, with some indication of water ingress internally with limited, local, failures at the ridge, verges and eaves level adjacent to the east and west gables.

*East gable eaves failure*

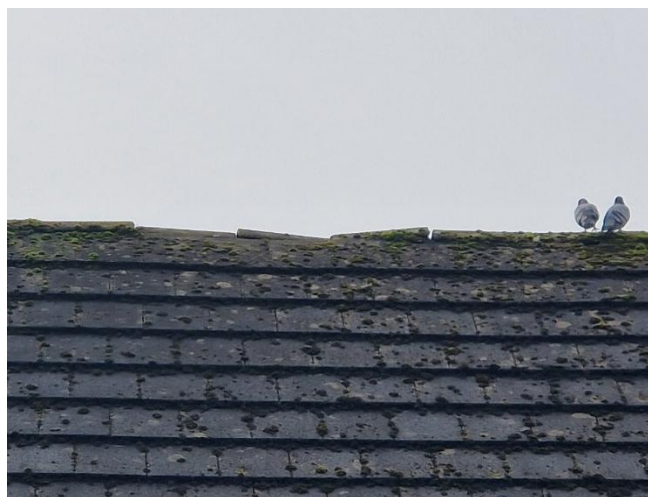
- 4.2.5 While the geometry of the roof was generally true, local failures of ridge tiles were observed in Bays B, C, & D, correlating with water damage noted internally.

*Failed ridge tiles over Bay D*

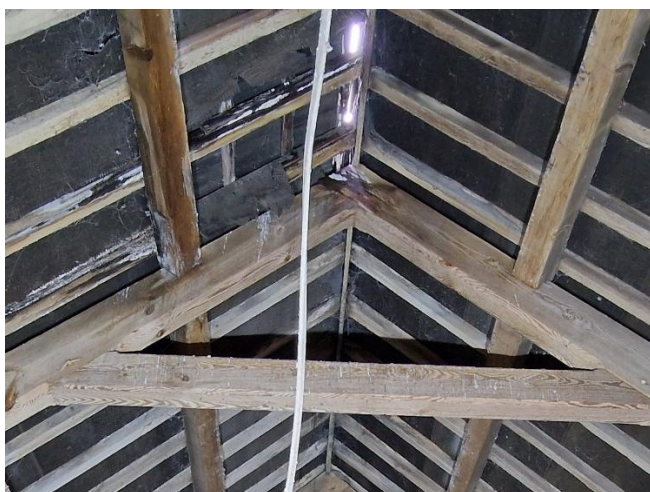
- 4.2.6 Truss 4, between Bays 4&5, corresponds with the worst water ingress, with staining on Truss 4 and the adjacent purlins and common rafters. While it would be prudent to allow for local timber repairs, there does not currently seem to be any significant structural consequences.

*Ridge tile failure and corresponding staining on Truss 4 and adjacent purlins and common rafters*

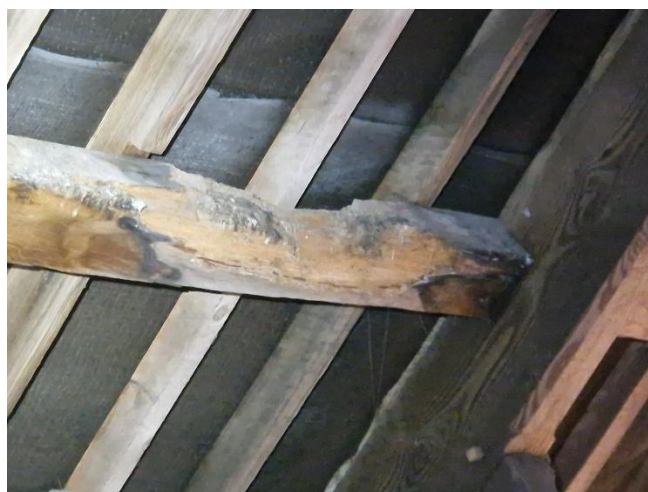
- 4.2.7 Despite water staining in Bays B, C & D and corresponding risk of decay, only one roof member exhibited evidence of significant decay, (Bay B-South-P2), which may be the loss of sapwood, but is likely to require repair, augmentation or replacement.

*Bay B, South, P2 – decayed section of purlin*

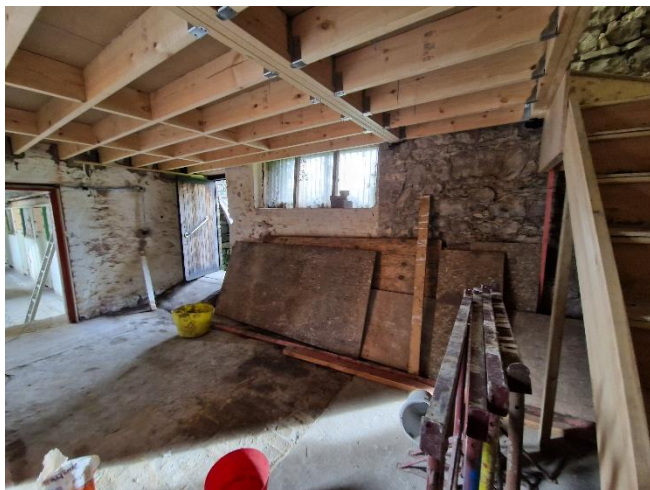
- 4.3 The suspended timber first floor is a modern replacement. Bays A & C is an entire replacement while Bays D, E & F are modern joists supported on the original timber beams beneath. The end of Bay F, adjacent to the east gable the first floor is open, maintaining the likely historic vertical link between the hay loft at first floor and the hayracks beneath, (now missing).

*Bay A & C, complete replacement floor*

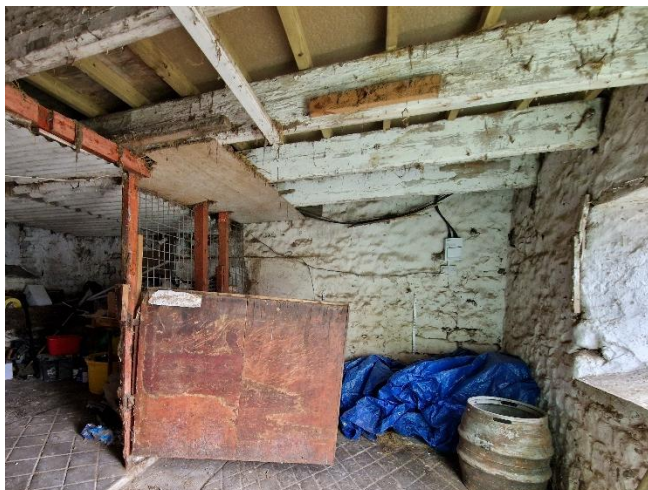
*Bays D, E & F new joists over original beams*

- 4.3.1 While no calculations have been undertaken, the first floor was generally found to be structurally adequate and robust, with no significant deflections or “liveliness” observed.
- 4.3.2 It is worth noting that the original timber beams in Bays D, E & F, spanning the full width of the barn, are likely propped by the ad hoc arrangement of partitions and posts below and may therefore require structural interventions to maintain a similar performance if these partitions are removed, as currently proposed.

- 5.4 Removal of the existing ground floor partitions in Bays D, E & F may necessitate strengthening of the original timber floor beams over, pending detailed calculation. The original timber members can be retained in full, but can be augmented and/or strengthened as required with additional timber or steel members.
- 5.5 Other than the specific items discussed above, the structural works required to the barn would be required irrespective of the proposed conversion.

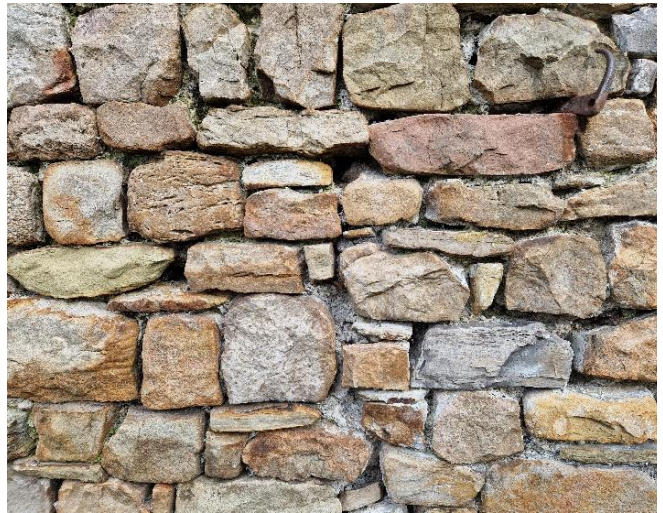
- 4.4 The masonry is generally squared, semi-coursed rubble stone with a variety of mortar/pointing, predominantly with lime mortar, but some of which was cementitious. Fenestration and the cart passage pillars and archway are constructed in varying clay brick.
- 4.4.1 The pointing of stonework is in varying condition, with widespread erosion to a significant depth and the majority of the barn will require deep re-pointing.
- 4.4.2 The masonry was generally found to be in adequate structural condition with no widespread defects associated with settlement and associated movement.

*Typical masonry*

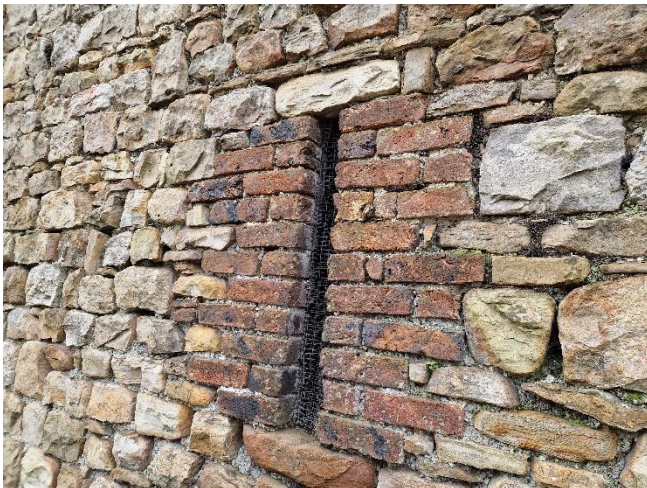
*Brickwork fenestration*

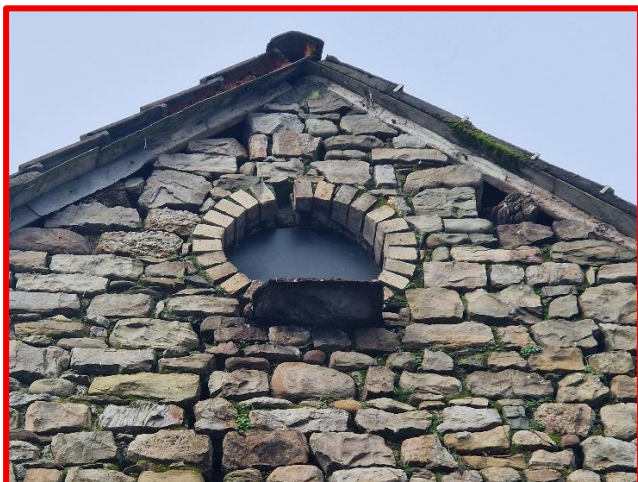
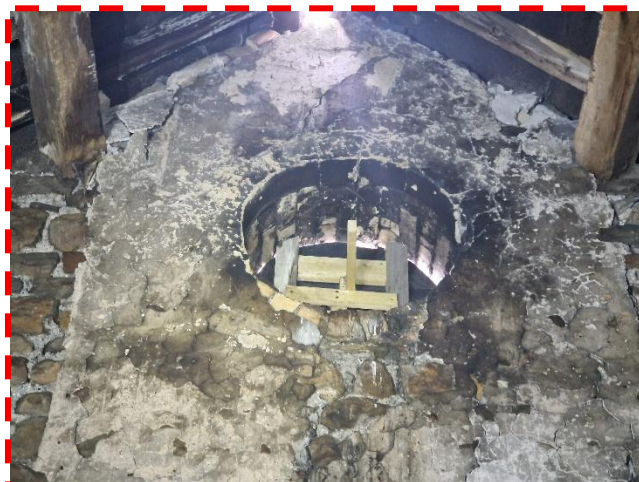
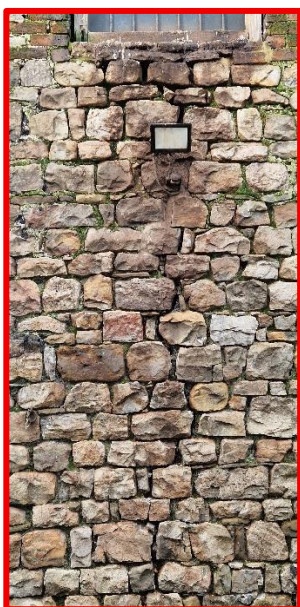
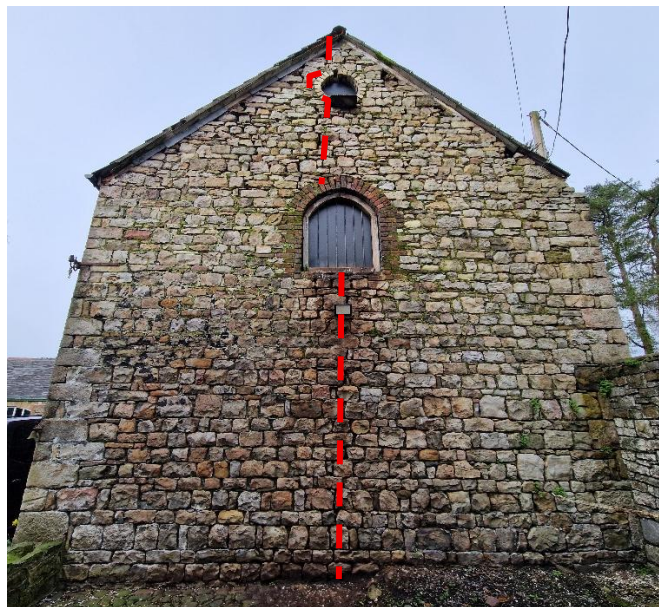
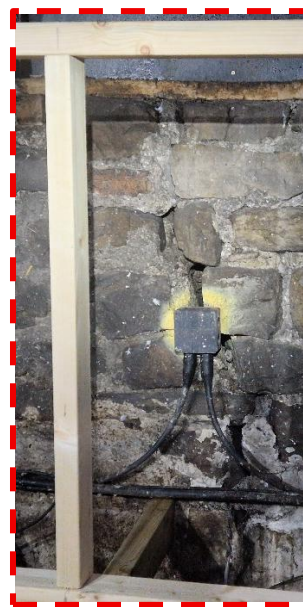
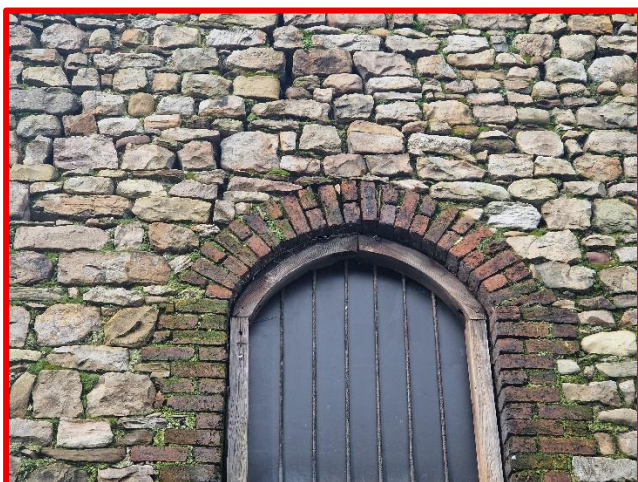
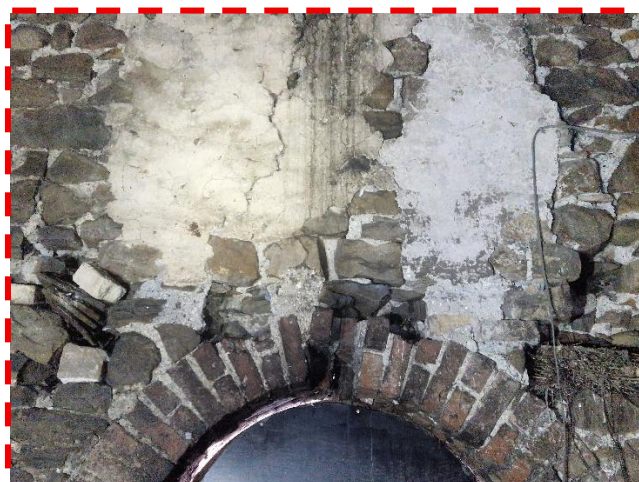
- 4.5 The most significant masonry defect which requires remediation, irrespective of potential conversion works, is located in the east gable elevation.

- 4.5.1 The discontinuity in the masonry extends over the full height and is located approximately centrally within the gable elevation. The cause of the crack is currently unknown but may be attributable to minor settlement, which conversely does not seem to have significantly affected the adjacent masonry of the north or south elevations. The relative displacement of the two sides is not immediately apparent from a visual inspection of the crack, however the crack does seem visually to increase in width over its height, suggesting a relative settlement and rotation of the south portion of the wall to the north.

- 4.5.2 Alternatively, as the original first floor beams span parallel to the east gable and the floor directly adjacent to the east gable may have been a void to pass hay to the cattle beneath, the gable may have been effectively unrestrained over its full height. This would generate a large masonry panel which might be prone to bowing outward on plan and would therefore be prone to cracking centrally, especially with the discontinuities of the oculus light and hay door. If this is the case, then the current first floor arrangement, with joists built into the gable, would improve the situation structurally which may also be improved further with relatively minor interventions providing further tying to the gable from the first floor structure.

- 5.2 The most significant intervention is the proposed ground floor doorway opening in the east gable. However, while this provides further discontinuity to the elevation, this also affords an opportunity to reinforce the masonry laterally and centrally, (where it is required), via installation of the lintels required over the doorway, say pre-cast or in-situ concrete faced in timber if required.

- 5.2.1 Vertical and lateral reinforcement of the masonry with lintels, in conjunction with the potential for improved lateral restraint provided by the first floor, will be structurally beneficial to the masonry.

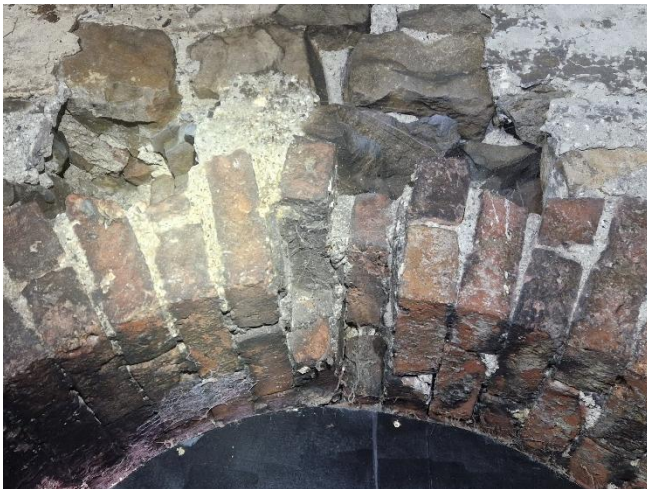
- 4.5.3 As the crack extends through the two existing features in the elevation, the circular light and hay door, it has caused damage to the structure of both associated masonry arches, which will require remediation irrespective of conversion.

*Hay door arch*

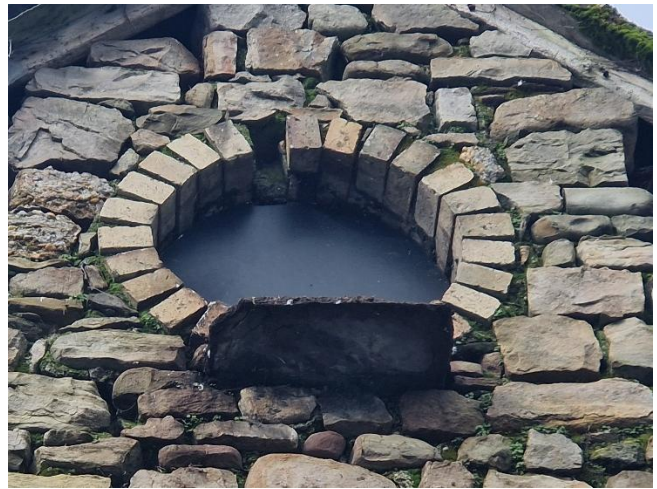
*Oculus light arch*

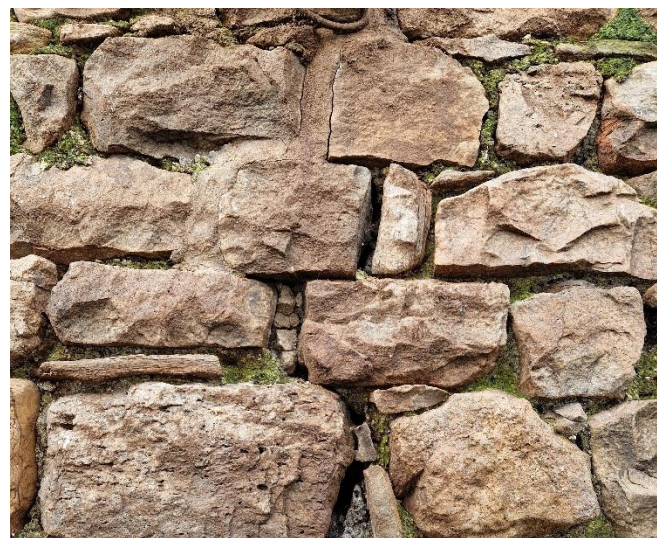
- 4.5.4 Multiple historic repairs of the crack are evident and all, including the apparently most recent, have subsequently cracked. This suggest movement is ongoing, if relatively minor.

*Previous repairs to crack*

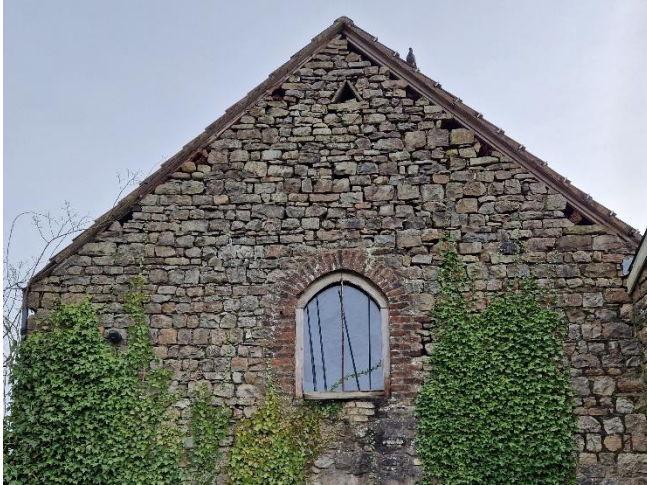
- 4.6 The west gable requires general masonry consolidation at eaves level and a timber lintel at ground floor likely needs replacement, irrespective of conversion.

*West gable high level masonry*

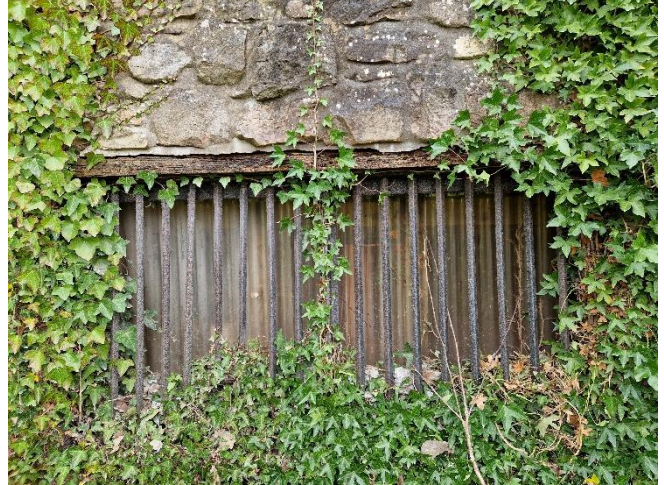
*Ground floor window lintel*
