# Rural Office

| Project | Pandy Farm |

| Reference | Window & Door Condition Survey |

### *Introduction*

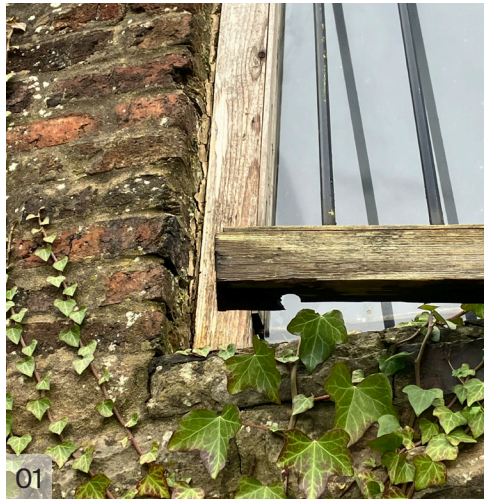
1. Loose joints within timber frames.
2. Woodworm visible within timber frames.
3. Ventilation slits with internal falls.
4. Decay at sill due to poor detailing.
5. Flaking internal finishes evidence of saturated walls.
6. Renewal being undone by disuse.

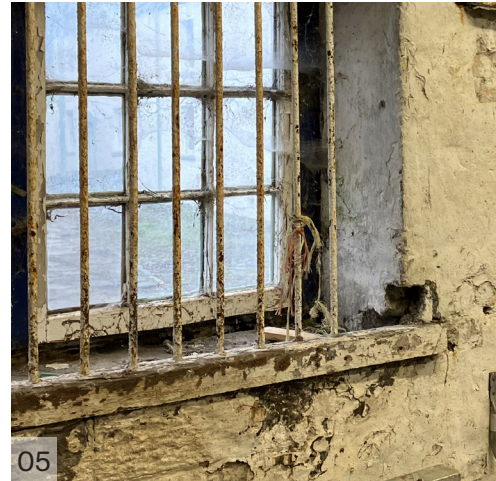
Historic poor detailing appears to have played a significant role in the repeated replacement of windows across the site. The sill detailing is generally insufficient, with falls that are ineffective in directing water away from the historic fabric. This inadequate design is widespread, and although many windows have been replaced as a consequence, several surviving examples clearly demonstrate the long-term impact of leaving these defects unaddressed.
