# **Heritage Impact Statement**

**Ammonia House  
at former Ivor Works, Dowlais  
Merthyr Tydfil**

Ammonia House, at former Ivor Works, Dowlais.

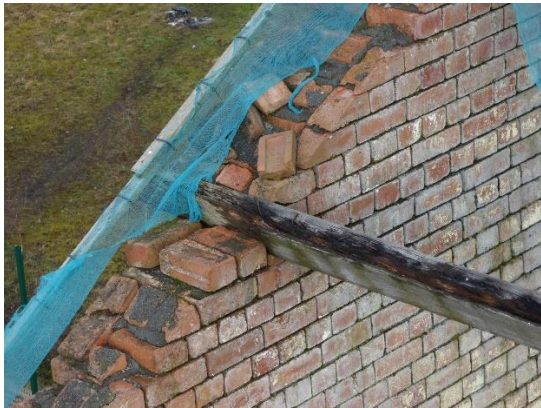
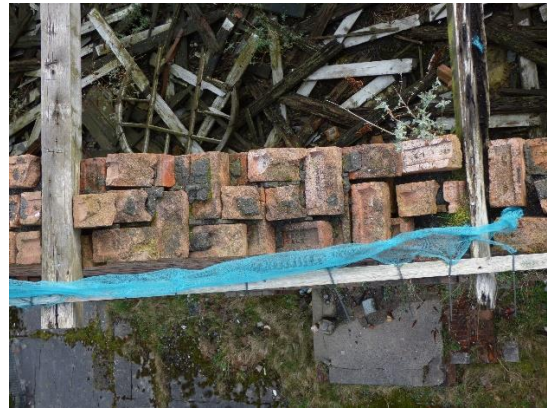
### Top of Gable Wall

The top of the gable wall which is exposed brick is not protected by the roof covering and is absorbing rainwater and starting to deteriorate. The purlins that are built into the gable wall and fixed to the trusses are also exposed and starting to deteriorate.

The issue raised from the inspection is that the wall and purlins are exposed and deteriorating, if the purlins continue to decay and lose connection to the gable wall, then this could cause the trusses to collapse. Further the gable wall will start to deteriorate.

The inspection highlighted repairs to try and reduce the extent of deterioration to the gable wall and existing roof structure. It is proposed to mechanically connect the purlins to the wall with a twisted metal strap that is screw fixed to the top of the purlins and drilled into the gable end brickwork and screwed with Rawl plugs into the brickwork. The strap will need to be drilled into the brickwork as the mortar joints are in a poor condition and will not provide the needed fixing strength.
