## **Arboricultural Evaluation**

**Oak Tree at Meadowsweet Farm Treharris CF46 6TB**

### **Introduction**

This survey was commissioned by Mr Stephen Rees with specific request to evaluate hazard/health and safety of the Oak tree on site.

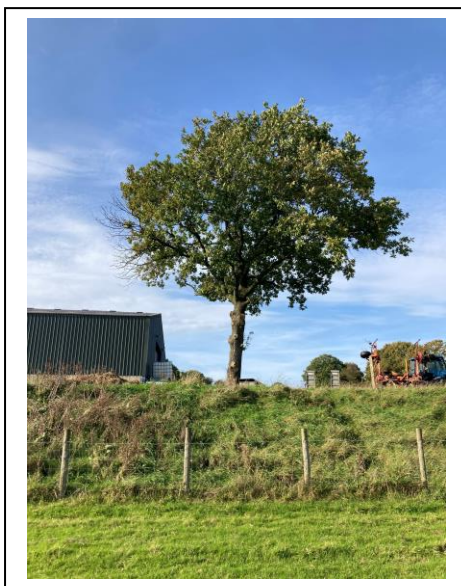
The area within the periphery of the Oak crown has been subject to heavy plant traffic and there is some evidence of compaction.

Soil levels have been altered considerably and an estimate is approximately 2.00-3.00 metres from original ground level.

Photograph shows adjacent field to the southeast and approximate original soil level.

The soil level changes have left the tree roots in anaerobic soil conditions and the upper and middle crown dieback are evidence of this.

Due to its location and the proposed new building, I would recommend removal.

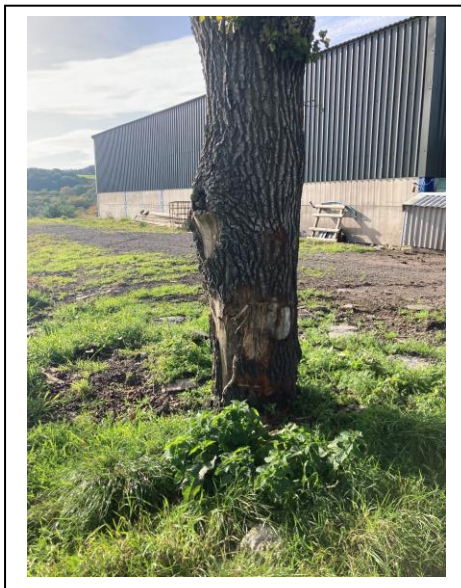
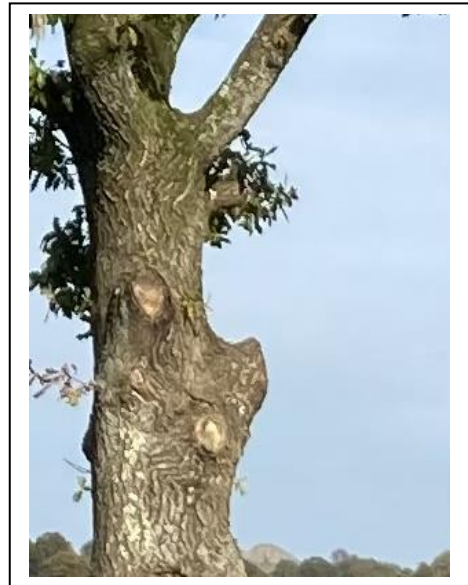
Multiple vehicle/mechanical damage to all sides of tree.

This has caused significant damage to bark and vascular tissue.

Wounding in photograph (northeast side) extends from ground level to approximately 900mm.

There are several poor pruning wounds on both the southeast and southwest side of the main stem.

The mechanical wounding has left the tree with multiple wounds, and these could be an entry point for decay and any other pathogenic activity.

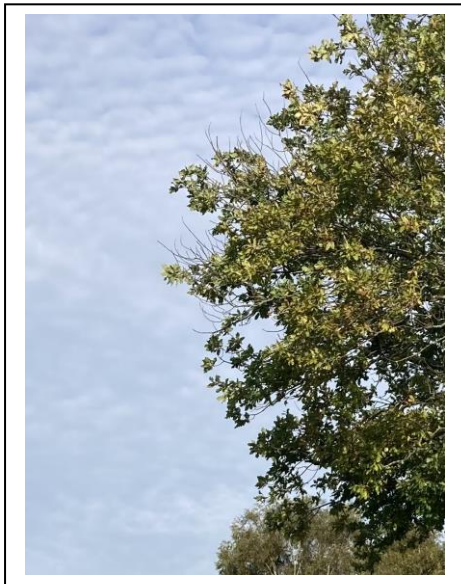
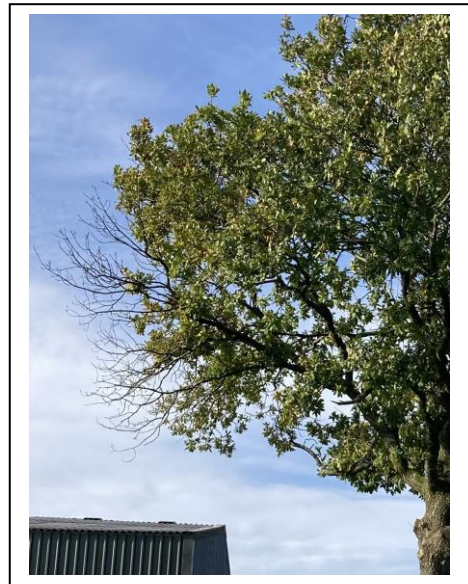
There is mechanical wounding and tears on smaller secondary limbs where vehicles/machinery have come into contact.

There is the onset of die back in the mid and upper crown.

We would recommend the planting of 5 native broadleaves to mitigate the removal of the Oak.
