| <b>Project:</b> | Park View Cottage – Roof Strip | | |
| <b>Project Ref:</b> | J002056 | | |

## 1 INTRODUCTION

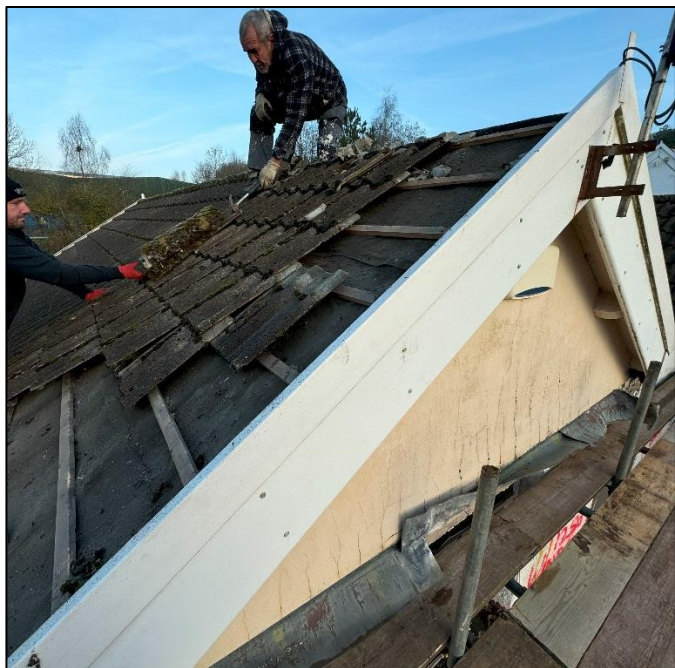
Figure 1: The beginning of the supervised soft strip.

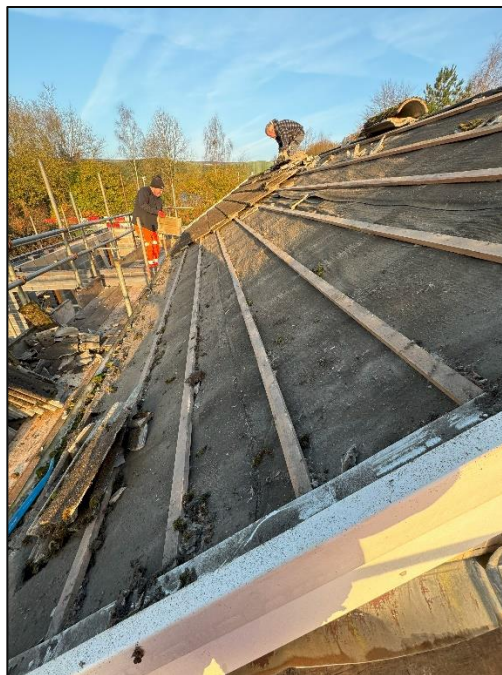
Figure 2: The process of the soft strip.

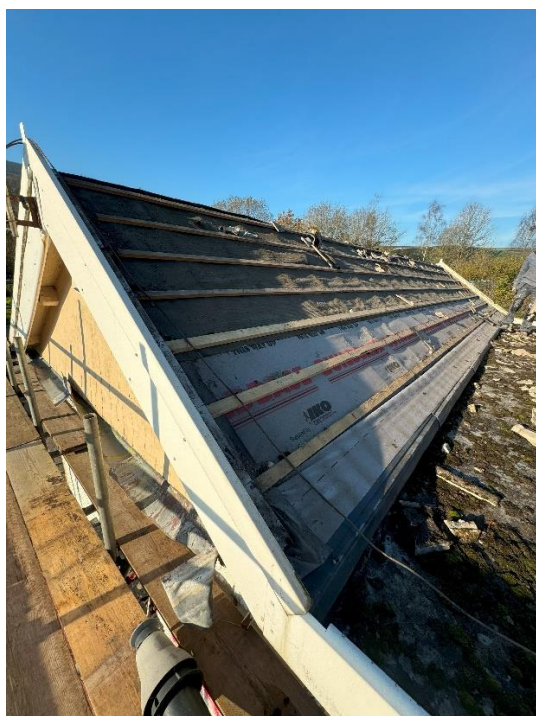
Figure 3: All tiles removed.

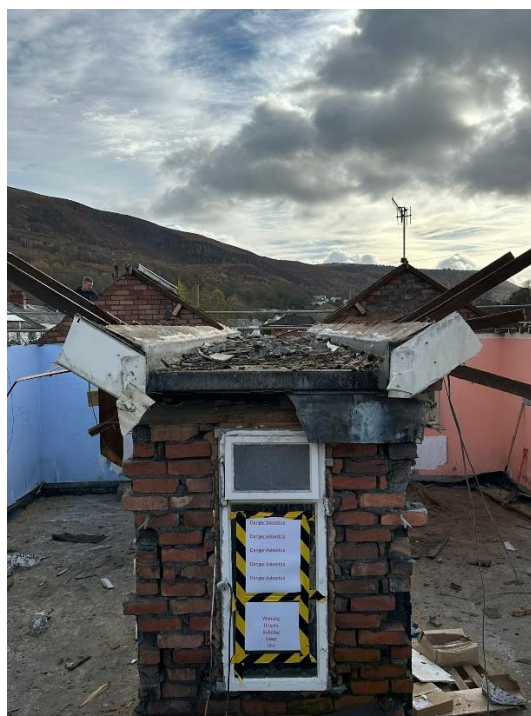
Figure 4: The soft strip and roof removal was completed.
