# Tynycoedcae Farm, Merthyr Tydfil

## Historic building survey

**August 2019**

GGAT report no. 2019/039  
Project no. P2022  
National Grid Reference:  
SO 01457 07480

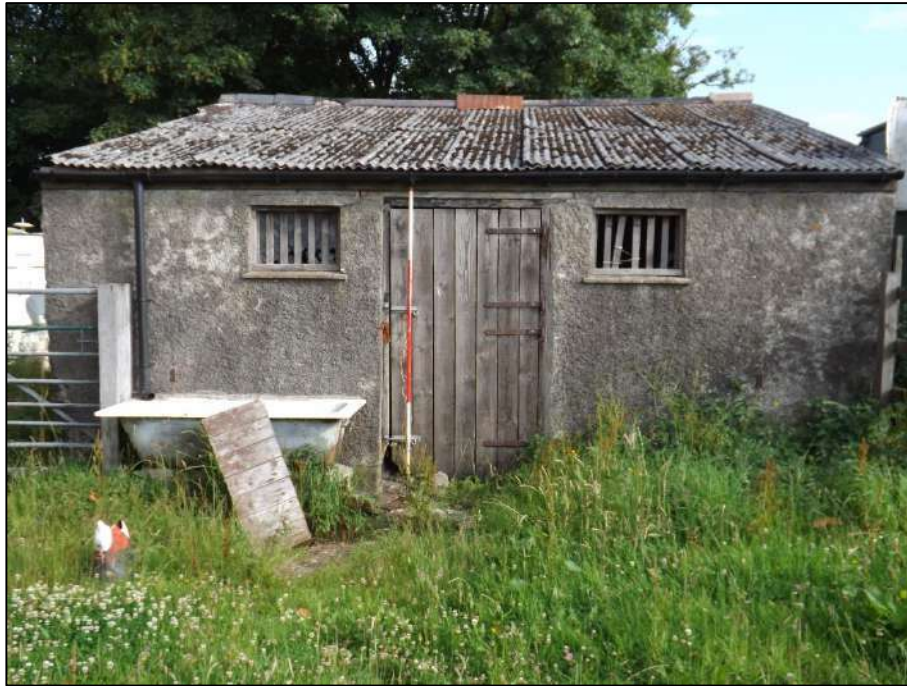
**Plate 1. South elevation of the hen house. Scale 2m.**

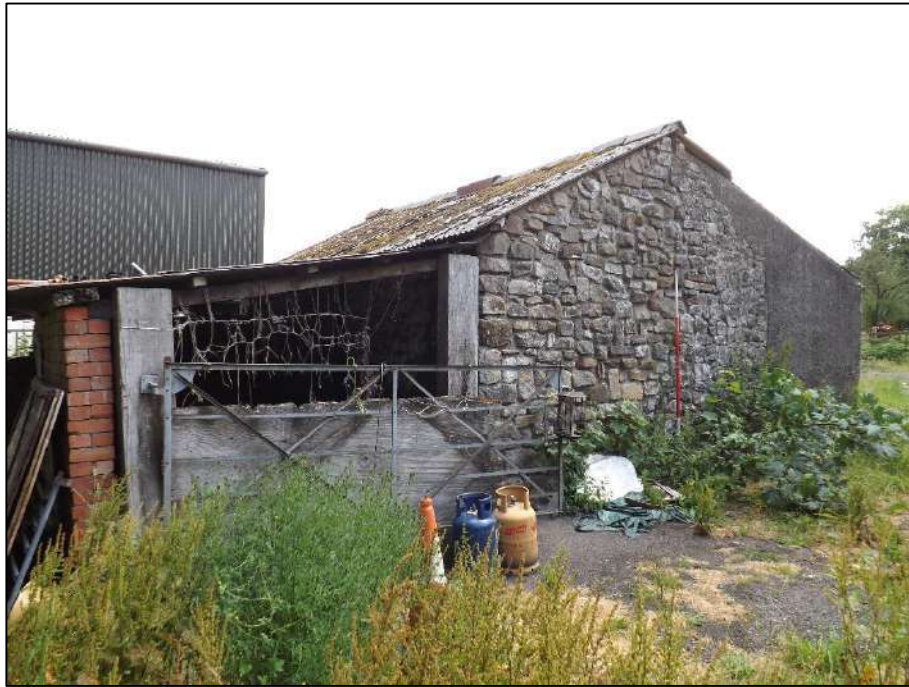
Photography of the west elevation was difficult due to the proximity of several caravans and it has been necessary to use an oblique photograph for this elevation. This elevation consisted of an asymmetric gable with evidence of two separate phases of construction. The elevation measured 10.1m in length and measured 3.45m from ground to roof apex. The first phase consisted of un-coursed local stone (sandstone and limestone) bonded with lime mortar. A possible blocked window was noted in the centre of the first phase elevation but this was not particularly clear. At least three phases of consolidation appeared to have taken place consisting of three different varieties of concrete pointing

to the stone. No trace of the original roofing method was visible but the ends of two timber purlins were visible, which were likely to be original. The second phase extension to the south was visible as an obvious separate construction, flat faced and rendered with concrete and fine pebble dash. Iron hinges were affixed to the south end of the second phase elevation for mounting a farm gate; reciprocal mounting points were noted on the north east corner of the barn for the other side of the gate. An open ended extension was present to the north of the first phase, being visible on the photograph as a red brick partition wall and two vertical timbers for mounting a farm gate. The ground outside the elevation was surfaced with worn tarmac.

**Plate 2. West elevation oblique view showing first phase construction (stone) second phase (pebble dash render) and open sided extension to the north. Scale 2m.**

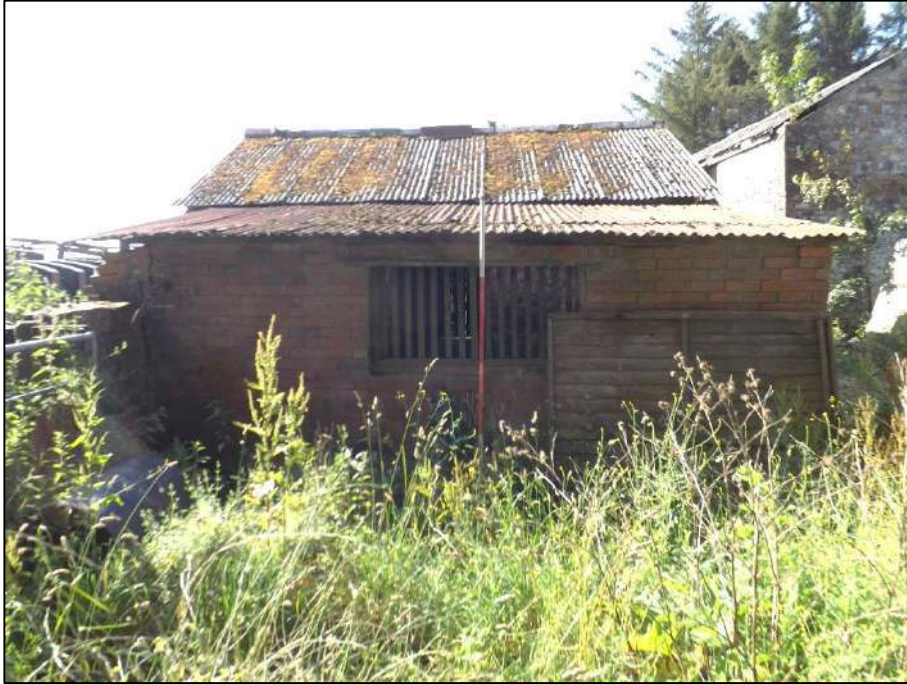
**Plate 3. North elevation, scale 2m.**

The north elevation consisted of a red brick partition wall, bonded with concrete, with its eastern end resting on an old boundary wall (left of the picture). It measured approximately 1.75m in height by 6m in width and was furnished with a rectangular window 1.5m wide by 0.8m in height. The window was of the same slatted wood style as the others in the building. The north elevation of the first phase of the building was concealed by the extension but consisted of a stone built wall covered in whitewash render. A single timber framed, stepped doorway in the centre led into the building, probably forming the original entrance into the structure.

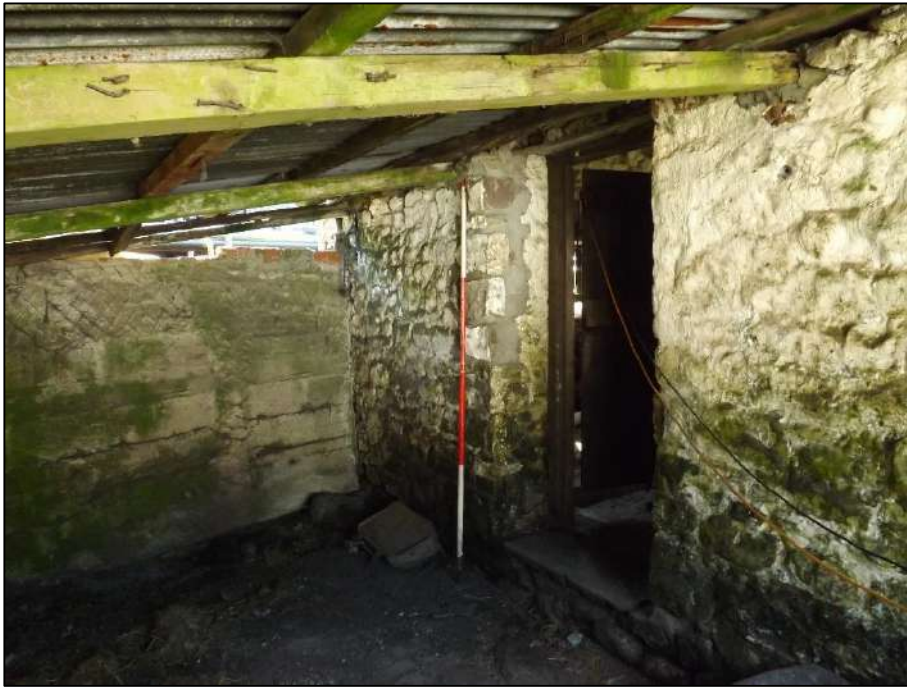
**Plate 4. Oblique view of the original first phase north elevation, now contained within a later extension. Note reinforced concrete render to reverse of the old boundary wall. Scale 2m.**

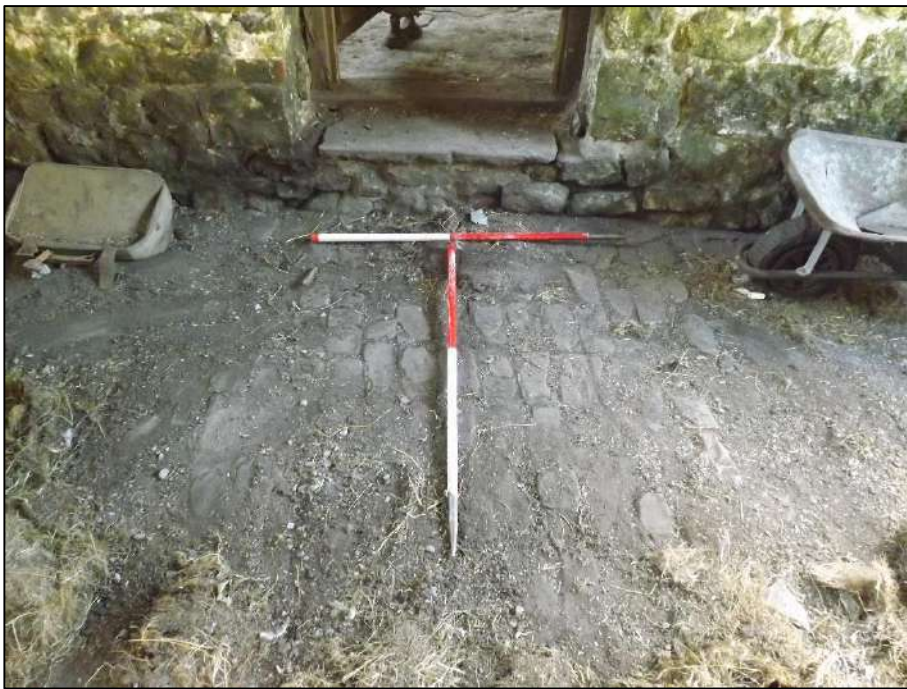
**Plate 5. Cobbled surface immediately outside the original first phase north elevation. This is likely to be the original farmyard surface in the immediate vicinity. Scale rods 1m.**

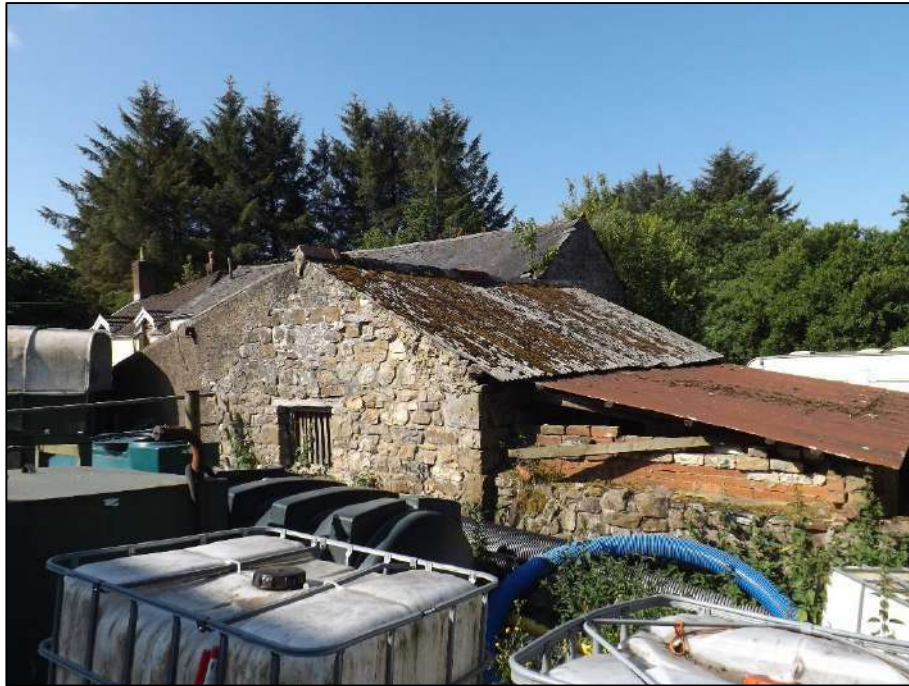
**Plate 6. East elevation. Note the extension to the right of the image that shows how the old boundary wall has been utilised.**

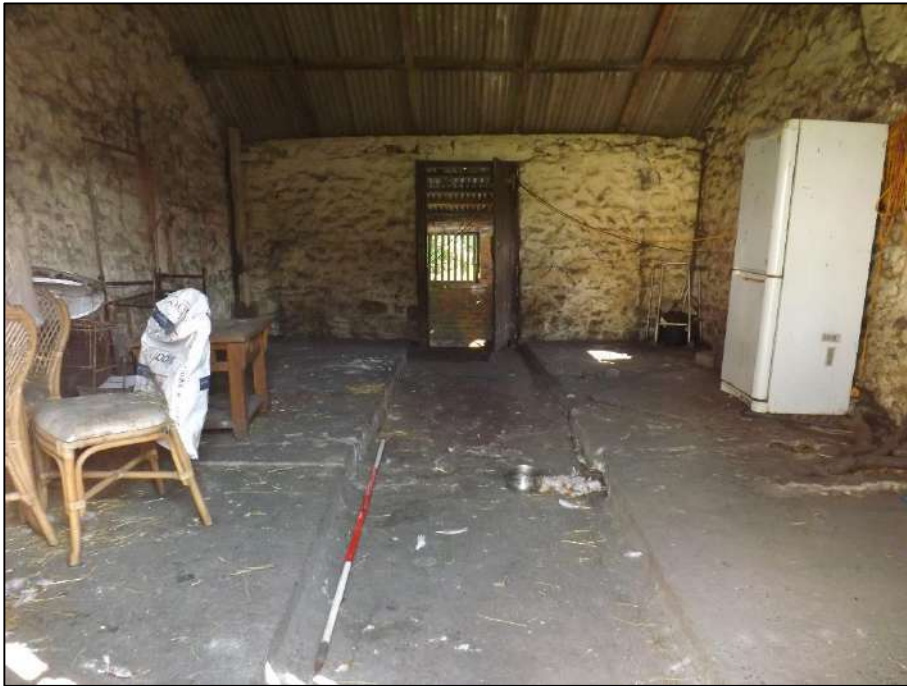
The interior of the building was relatively bare, with few visible fixtures or fittings. The first phase floor contained two timber post settings, possibly to support a partition or similar, with the remains of a vertically mounted timber affixed to the west wall. The second phase extension was clearly visible within the internal elevations and the original floor line had been used as the foundation for a breeze block partition which had been subsequently demolished. None of the roofing materials were original.

**Plate 7. Interior view of the hen house towards the north, looking towards the original doorway. Note the raised floor levels. Scale 2m.**

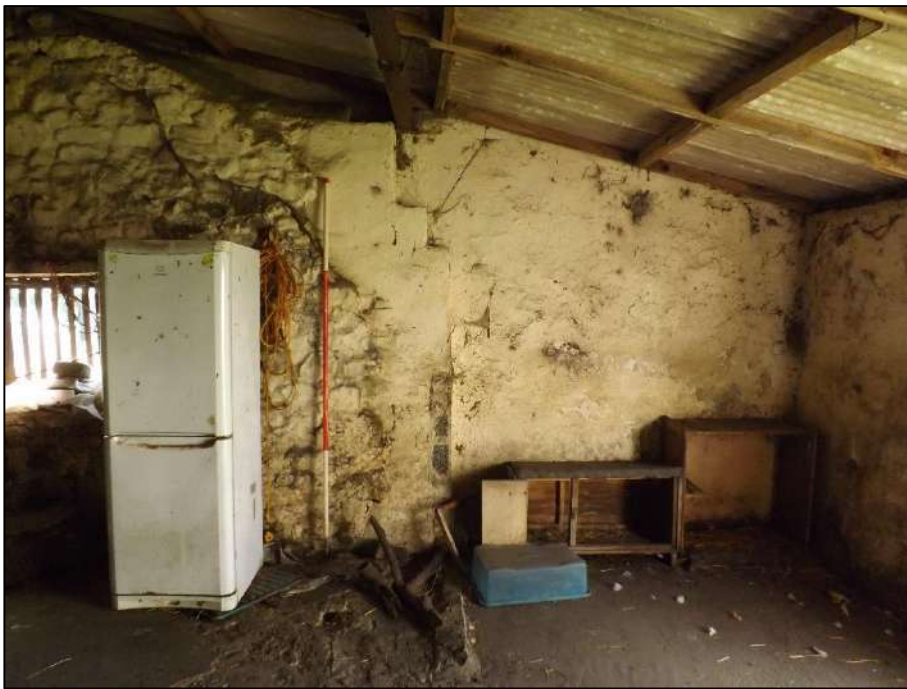
**Plate 8. Internal view of the east elevation showing the construction of the second phase extension. Note the remains of a breeze block partition to the left of the blue box. Scale 2m**

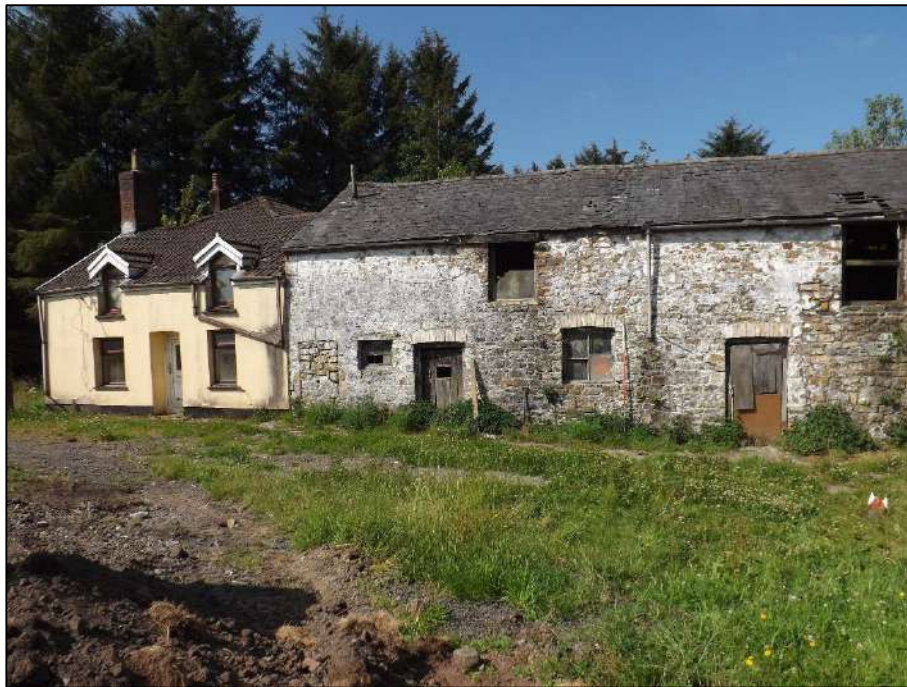
**Plate 9. General view of the east elevations of both the barn (right) and cottage. Scale 2m.**

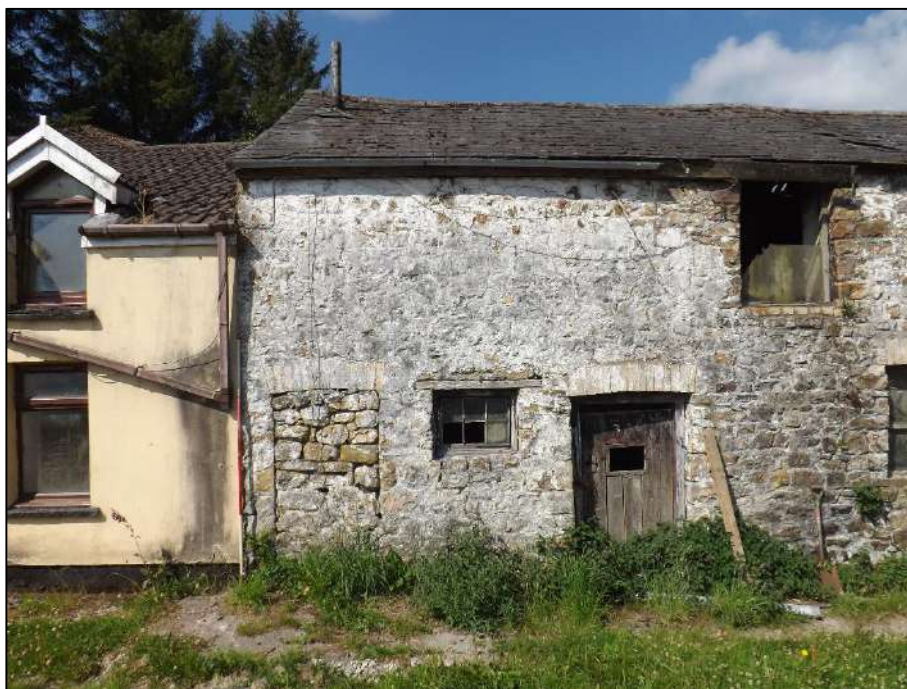
**Plate 10. Southern end of the barn showing the blocked doorway. Scale 2m.**

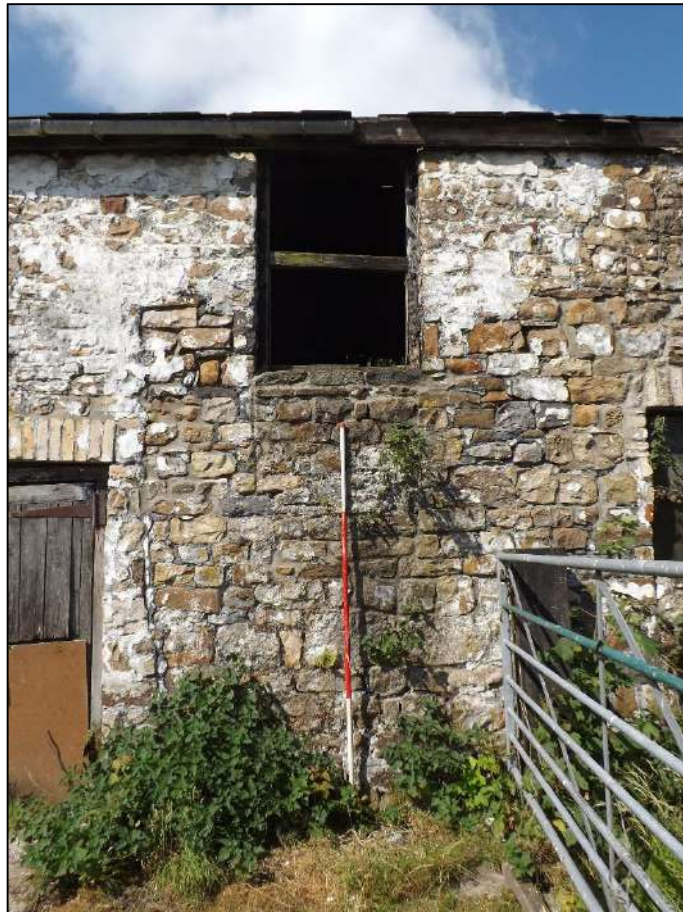
**Plate 11. The northernmost upper window created by partially blocking a previous window or doorway, probably when the roofline was raised. Scale 2m.**

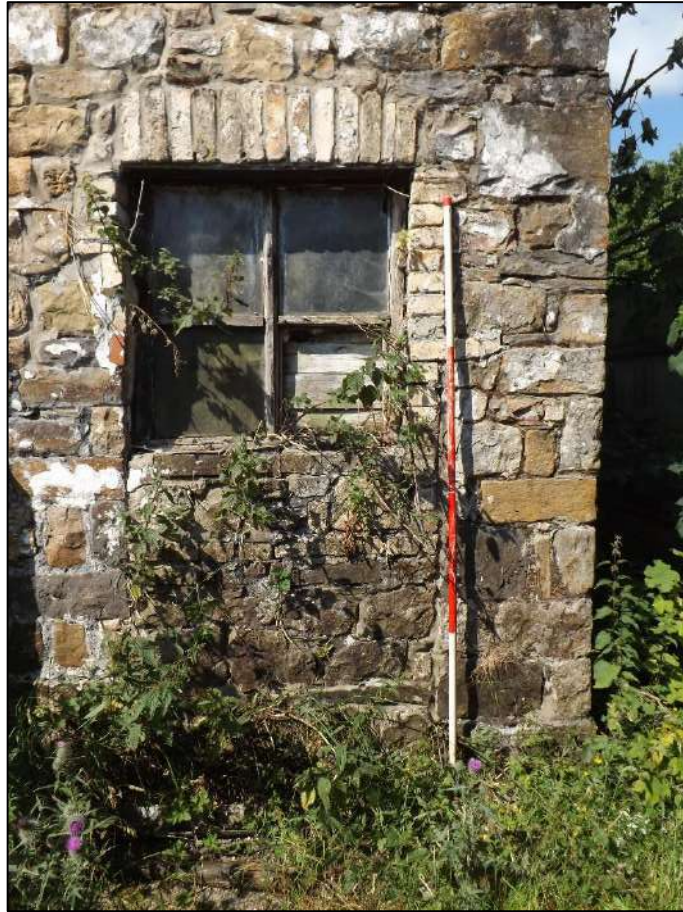
**Plate 12. Blocked doorway at the north of the east elevation. Unlike the blocked doorway to the south, this was converted to a window. Scale 2m.**

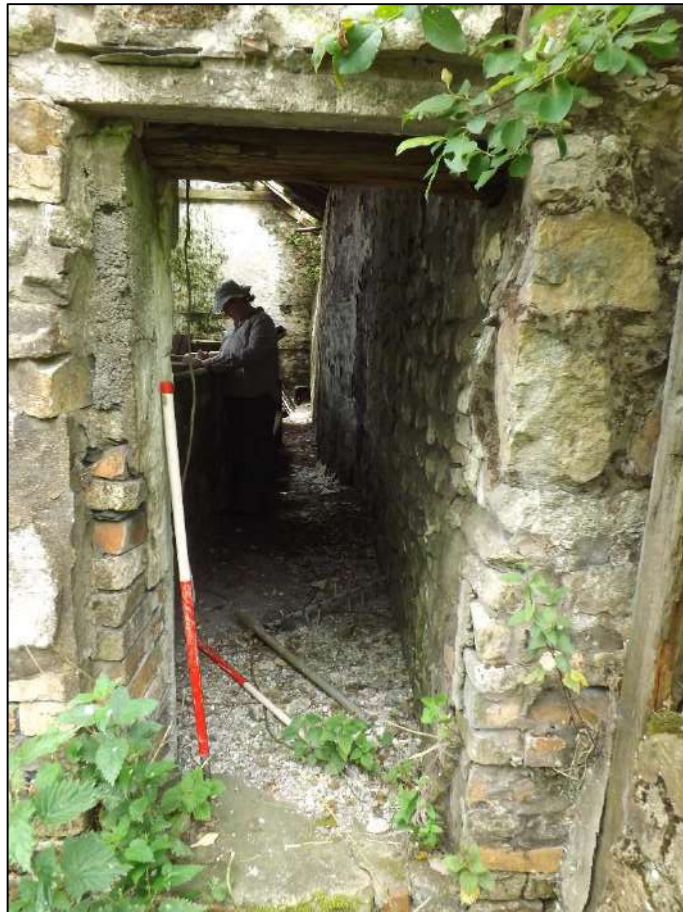
**Plate 13.** General picture of the doorway set into the north elevation of the barn. Note the breeze block and brick elements and the fact that there is no framing for a doorway. Scale 1m.

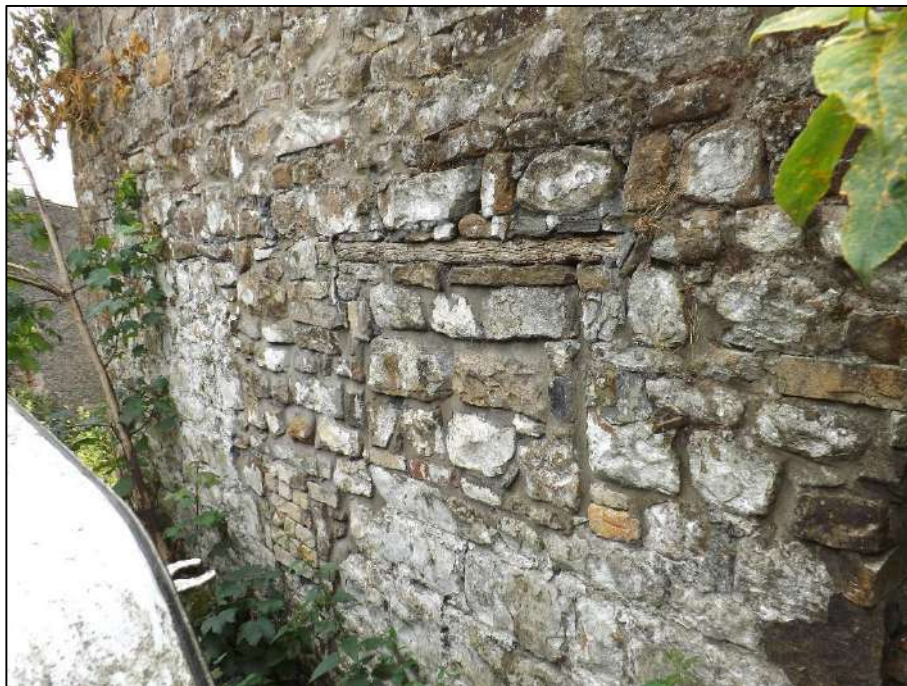
Blocking was visible in two discrete areas in the elevation. The first was at ground level, where the remains of a timber lintel marked the upper edge of a window in the centre of the gable end. The blocking consisted of local stone and yellow refractory brick and had been pointed with concrete. The blocking measured approximately 2m in width by 0.5m in height. At an upper level, a possible window had been blocked with stone and yellow refractory brick elements.

**Plate 14.** General oblique view of blocking of a window at the lower level of the north elevation of the barn. Note the timber lintel.

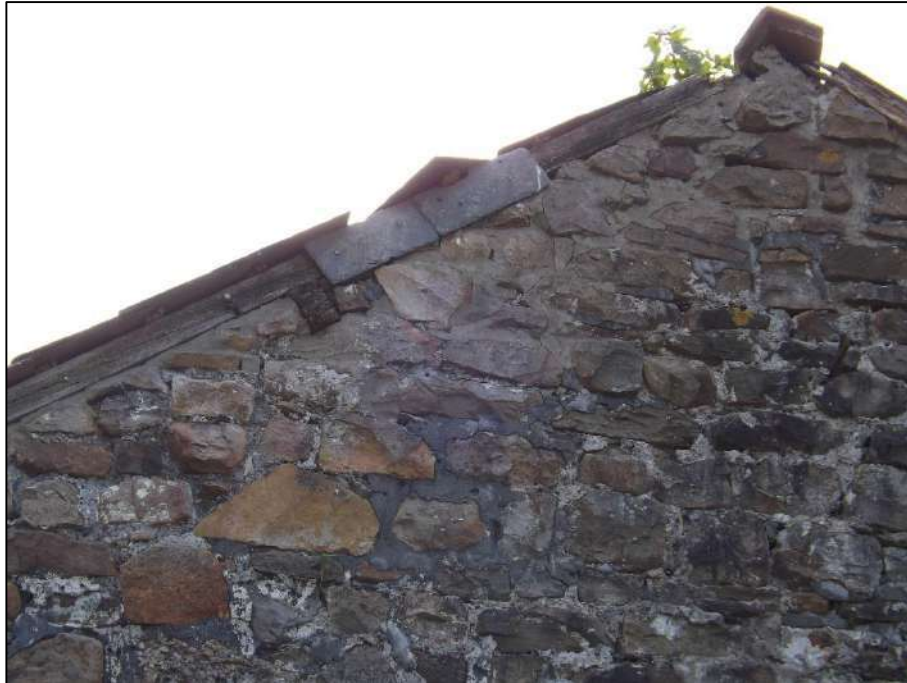
The most interesting feature noted in the north elevation was a series of triangular stones marking the original roof line for the barn. These had been retained and incorporated into the raised roof and provided the most compelling evidence that the roof level had been indeed been raised. The feature was too high to measure but is shown on elevation drawings.

**Plate 15. The former roofline was visible in the north gable of the barn. Note the remains of two slates nailed to the end roof joist as a weather board.**

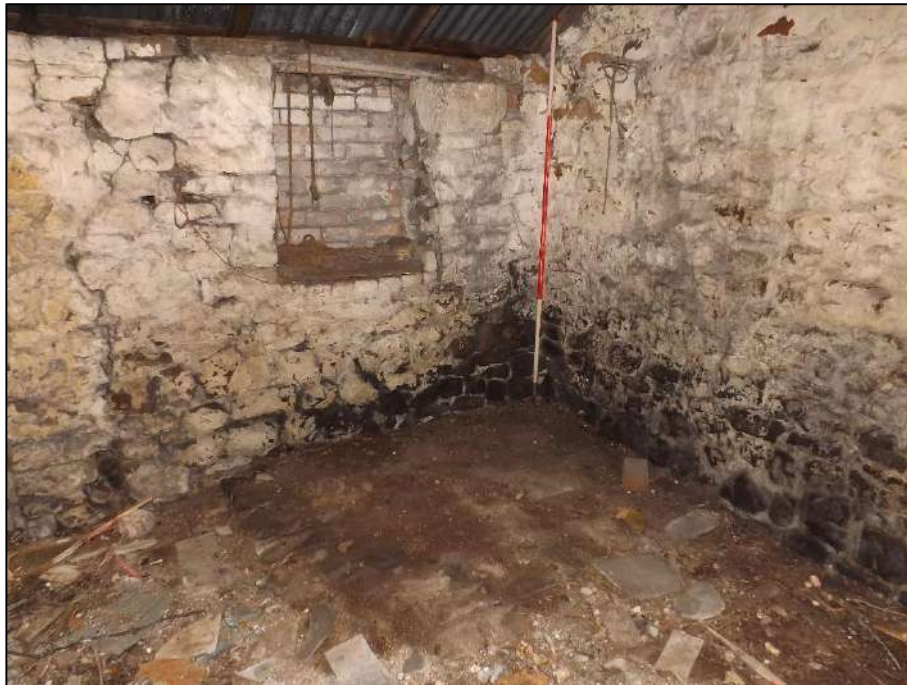
**Plate 16. North west corner of Annexe 1 showing the blocked window and raised floor. Just visible is the modern corrugated iron roof. Scale 2m.**

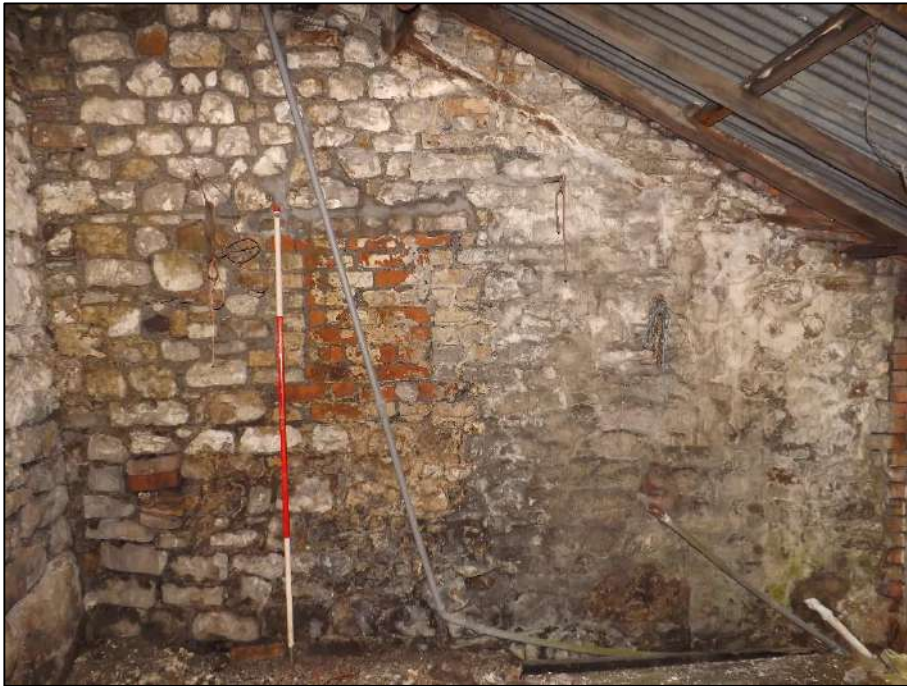
**Plate 17. South wall of Annexe 1 showing possible blocked window and old roof line. This wall, which forms part of the north wall of the cottage, was not keyed into the barn wall. Scale 2m.**

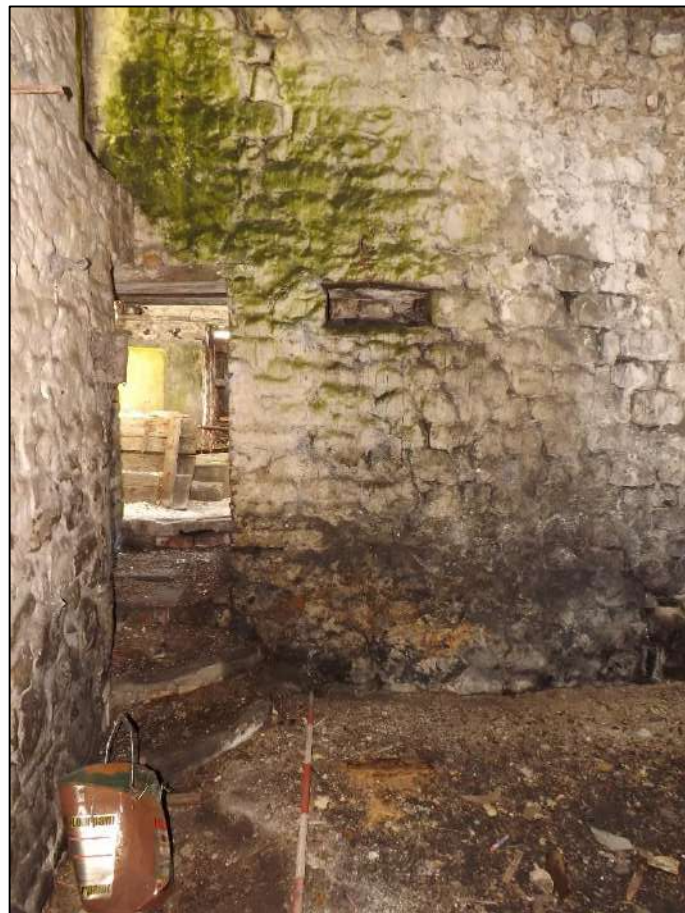
An internal doorway leading to the interior of the barn was present in the north east corner of the annexe. This had a highly unusual appearance, being set within a curving section of wall and being provided with two semi circular and two square stone steps up into the barn. The doorway was relatively small at 0.9m in width and 1.3m high but possessed no door. The final feature of note was a deliberately engineered recess, 1.6m above the floor level, in the west elevation just south of the door into the barn and at the same level as the top of the doorway. The recess measured 0.7m x 0.3m and had an approximate depth of 0.3m. A photograph of the interior of the recess revealed the presence of timber at the top and bottom and the rubble core of the barn wall but little else that might be useful for identifying it.

**Plate 18. West elevation of the barn inside Annexe 1 showing the access doorway into the barn interior and the engineered recess in the wall. Note the line of stones at the top of the image indicating the line of the former roof of the barn prior to its level being raised. Scale 2m.**

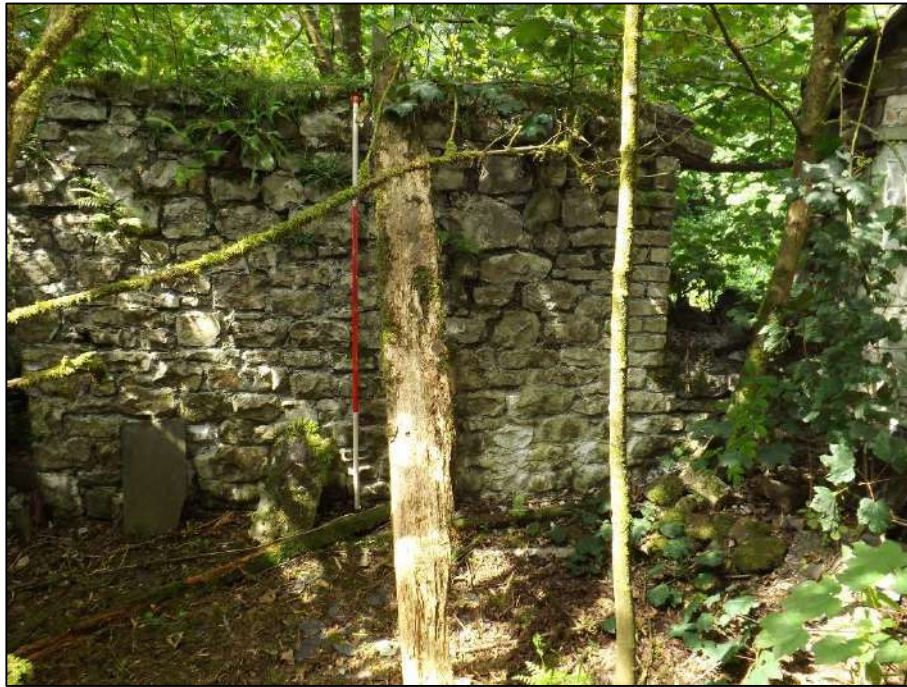
**Plate 19. Interior view of annexe 2 showing the west wall and damaged window on the right as well as trees growing in the interior space. Scale 2m.**

Of the two windows, the one in the west wall was edged with yellow refractory brick and badly damaged, whilst the other was intact high in the adjoining wall of Annex 1.

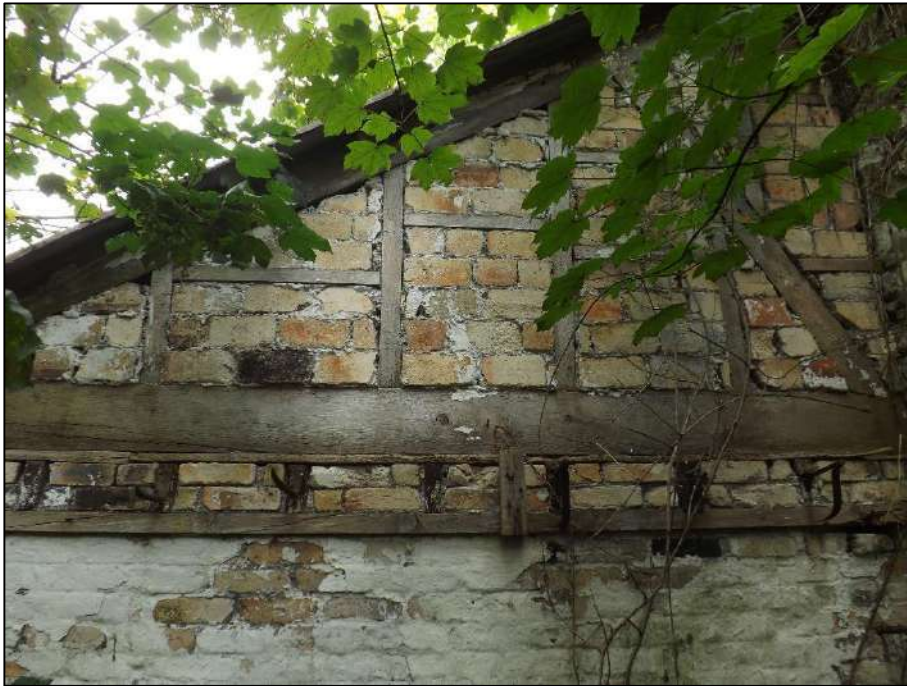
**Plate 20. North wall of Annexe 2 showing timber frame and brick infill construction of the upper part of the wall. Note the metal fixings which may have been for hanging implements.**

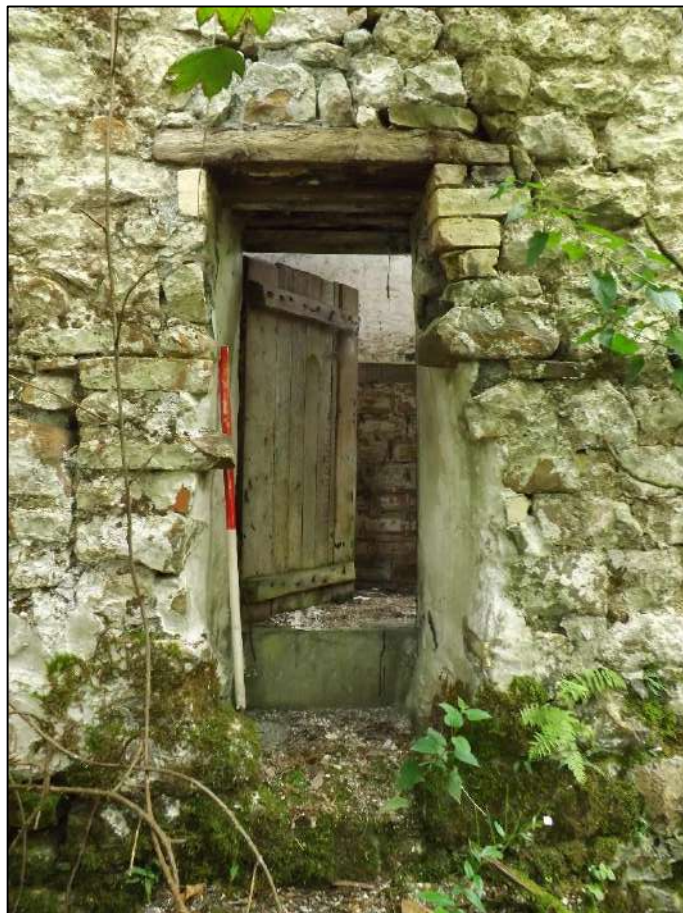
**Plate 21. Interior door from Annexe 2 to the barn showing the step and doorway. Scale 1m.**

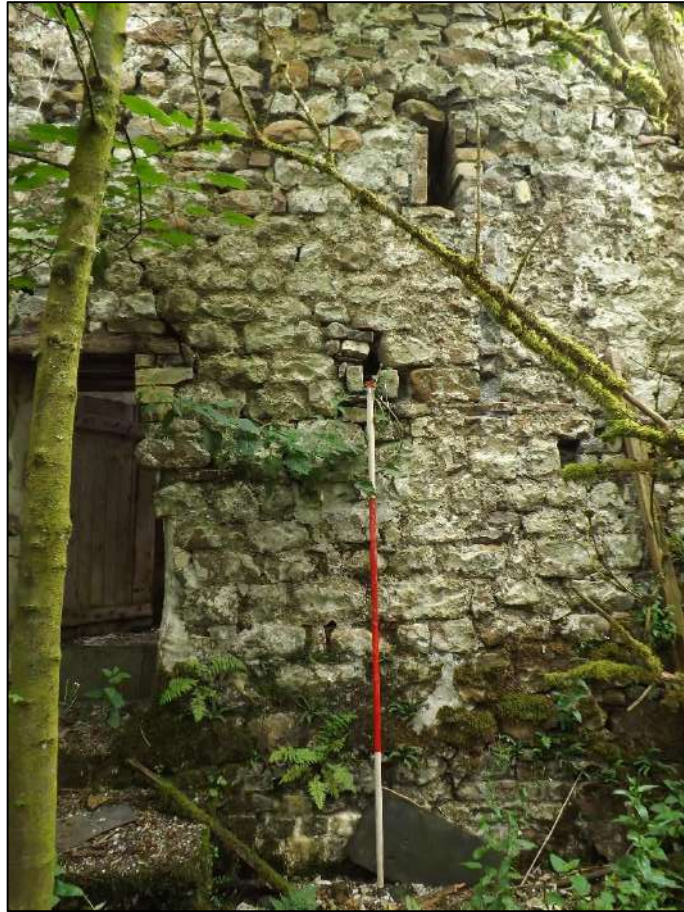
**Plate 22. Detail of the west elevation on the barn showing possible air vent and possible scaffolding hole. Scale 2m.**

The west elevation of the barn featured a possible ventilation window edged with stone and yellow refractory brick, together with a possible scaffolding hole. The ventilation window was of note as this was the only feature of this nature to be noted and there is therefore a possibility that the slot may have served as a socket for a roof timber. Unfortunately the feature was located too high to closely inspect.

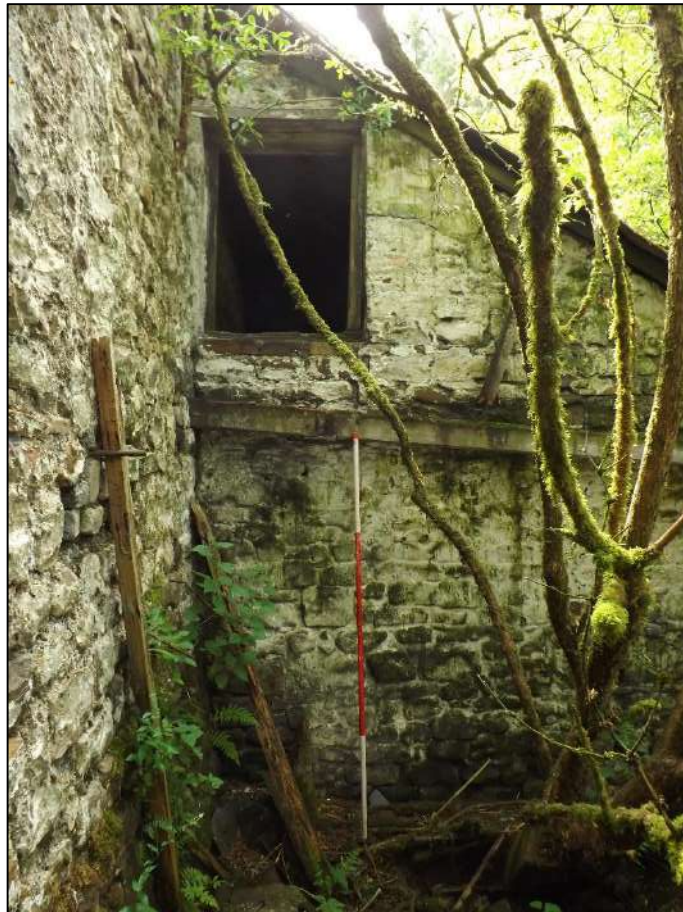
**Plate 23. North elevation of Annexe 1 which also formed the south wall of Annexe 2. Note the window with surviving framing. Scale 2m.**

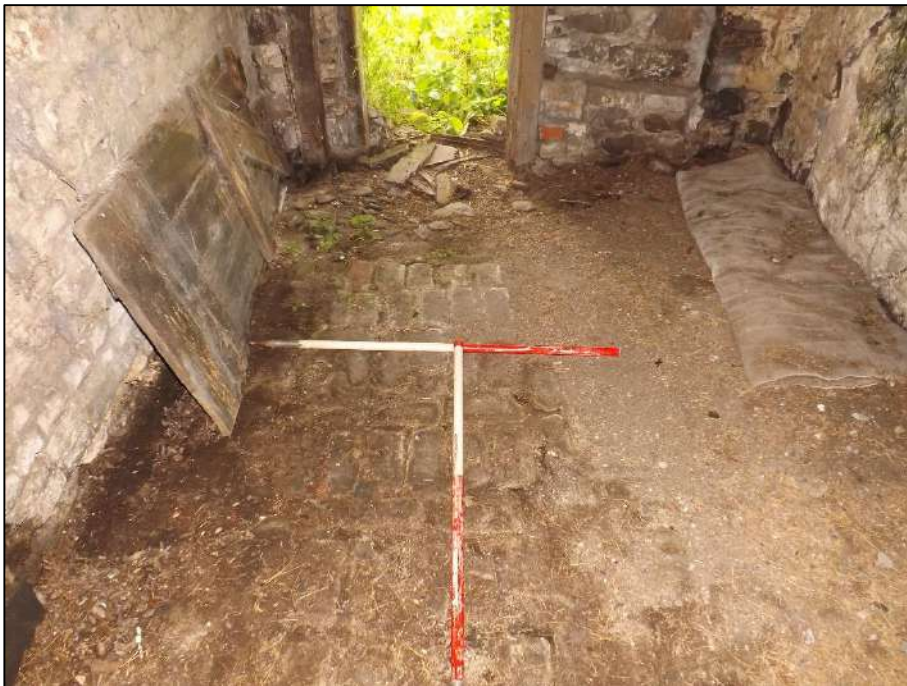
Plate 25. Brick and cobble floor of Annexe 3. Scale 1m.

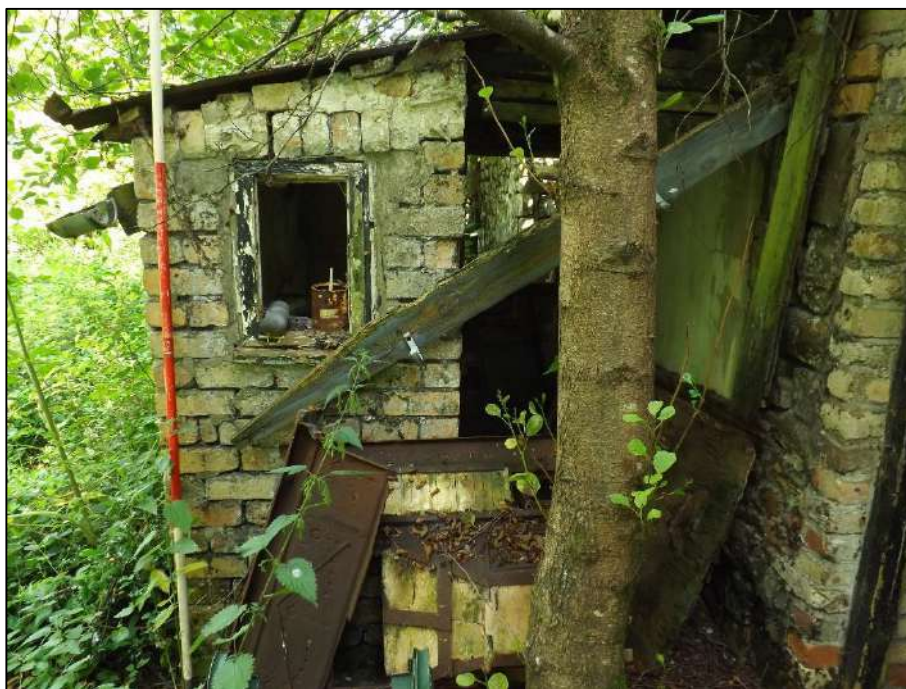
**Plate 26. Outhouse abutting Annexe 1. The only visible interior features were shelving. Scale 2m.**

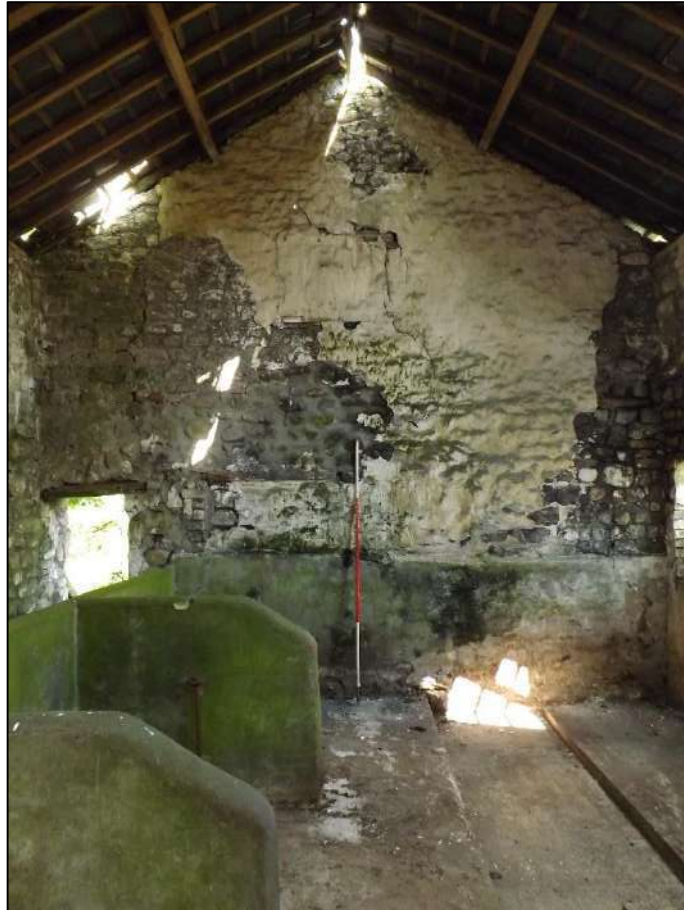
Plate 28. North wall of the barn interior. Note the blocked window in the upper level of the gable and the concrete render that extended round from the byre. Scale 1m.

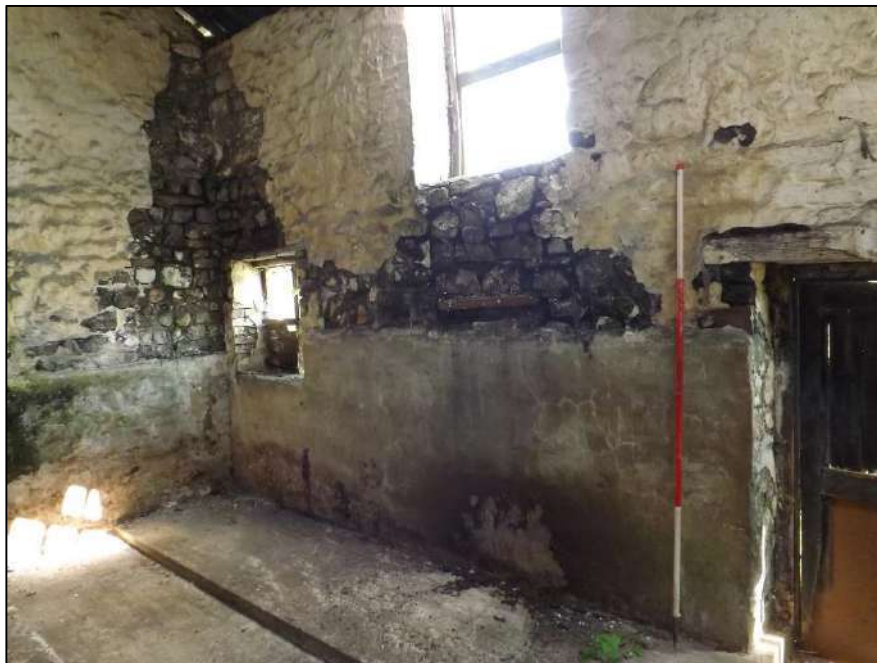
Plate 29. Oblique view of the north east interior of the barn. Note the original sill for the partially blocked upper window and the former doorway in the corner that had been converted into a window. Scale 2m.

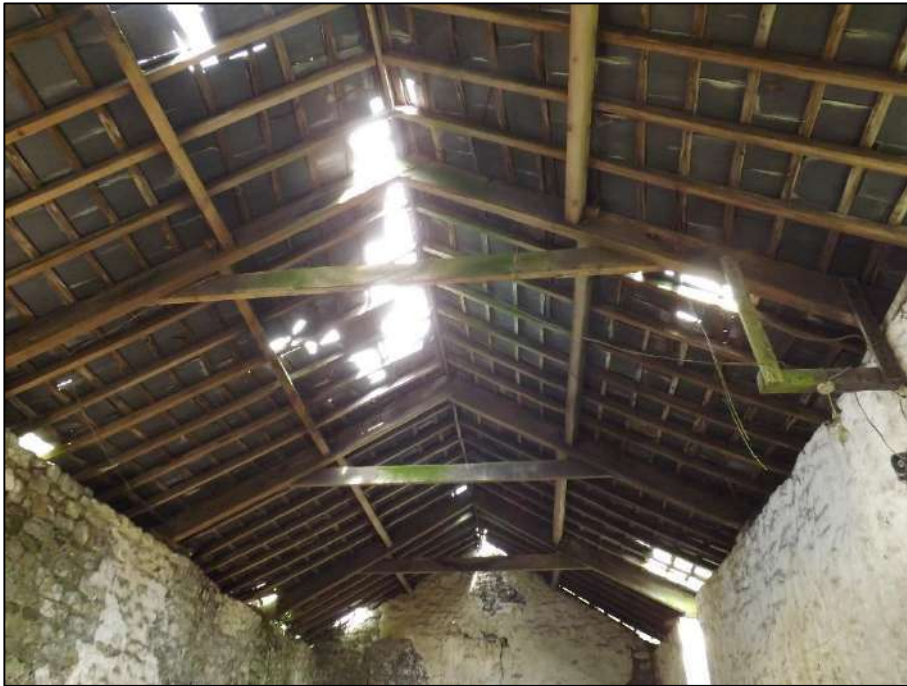
**Plate 30. Detail of the roof construction of the barn interior. Note the slates have been affixed directly onto the timber. It is unclear as to whether this is the original roof but it is certainly of some age and may date to the re-modelling of the farm before 1875.**

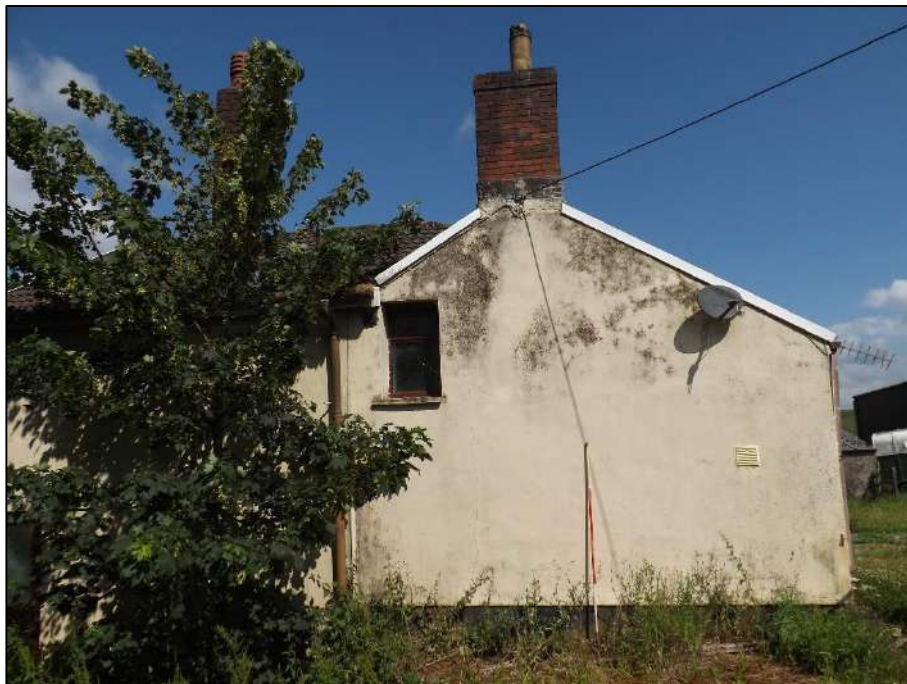
The south elevation was partly obscured by trees but was, in any case rendered with concrete. A single window for the first floor bathroom was located to the west of the chimney stack. Little else can be said regarding the elevation.

**Plate 32. South elevation of the cottage. Scale 2m.**

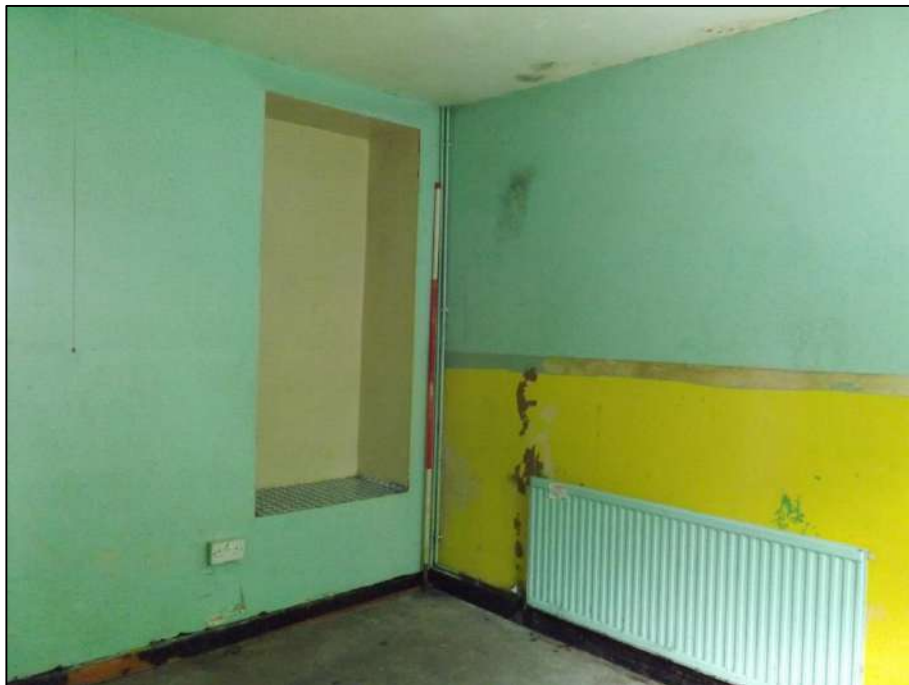
**Plate 35. Rectangular recess in the south east corner of the kitchen. This was almost certainly a blocked doorway that once led into the barn that was repurposed for storage.**

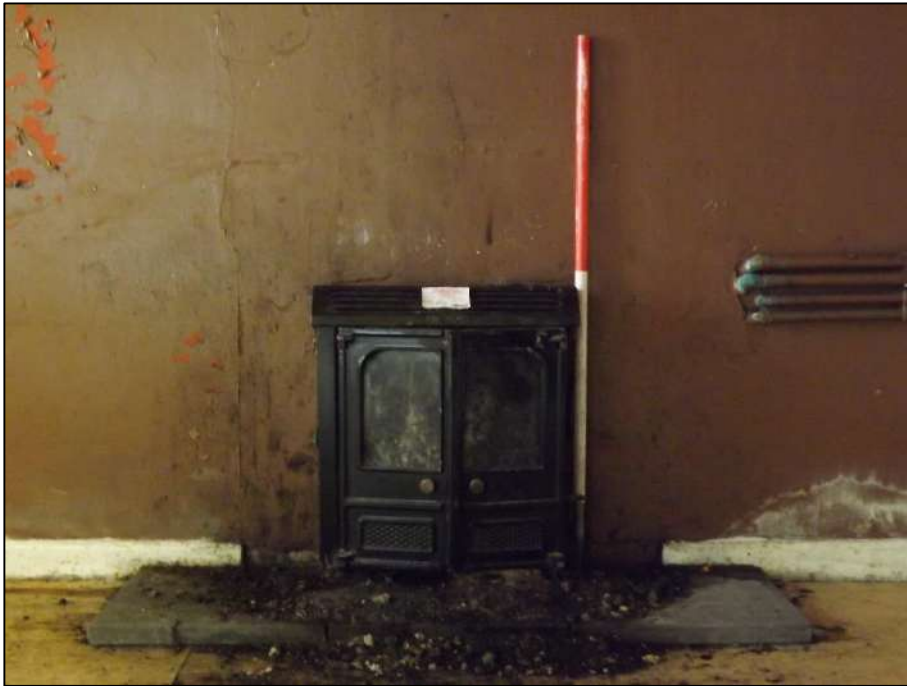
**Plate 39.** The fireplace in the living room. This is a later addition as fractures in the render and the gaps in the skirting board indicate the presence of an earlier fireplace behind the grate. Scale 1m.

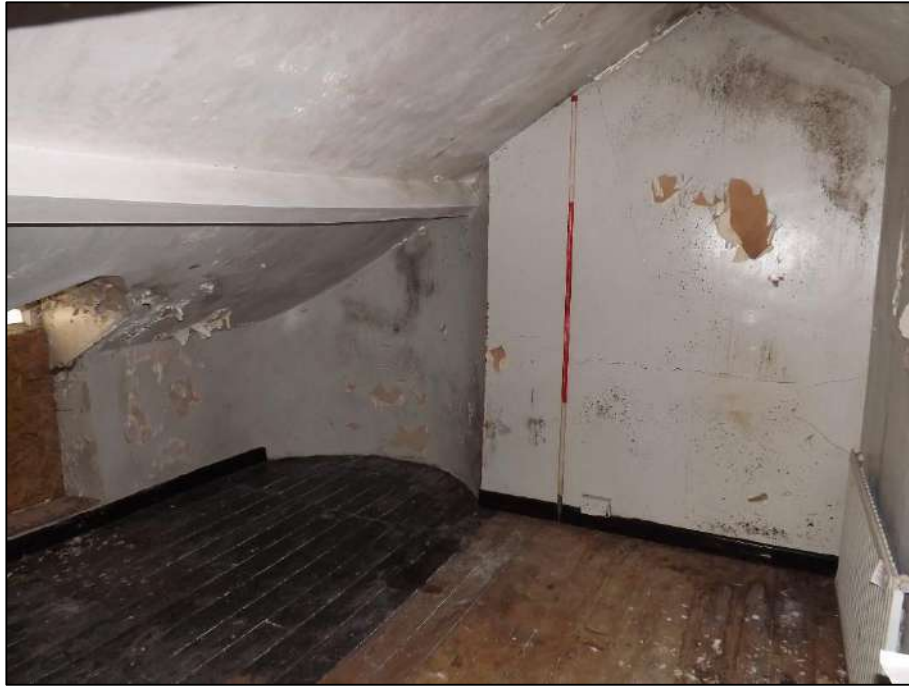
**Plate 41. Semi-circular feature in the south east corner of the main bedroom. Note the cut line in the floorboards. This feature may be the vestigial remains of a stairwell. Scale 2m.**
