# Tynycoedcae Farm, Merthyr Tydfil

## Historic building survey

**August 2019**

GGAT report no. 2019/039  
Project no. P2022  
National Grid Reference:  
SO 01457 07480

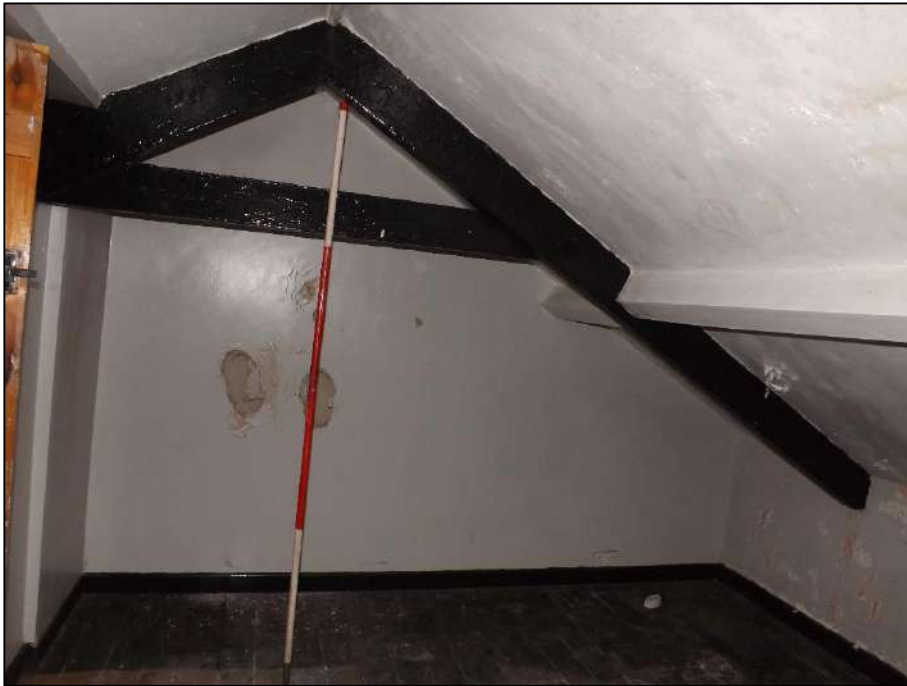
**Plate 42.** Heavily painted roof beams in the south east bedroom. The beams were tied with metal bolts but although hidden under layers of paint, they are likely to be original beams dating to creation of the cottage. Scale 2m.

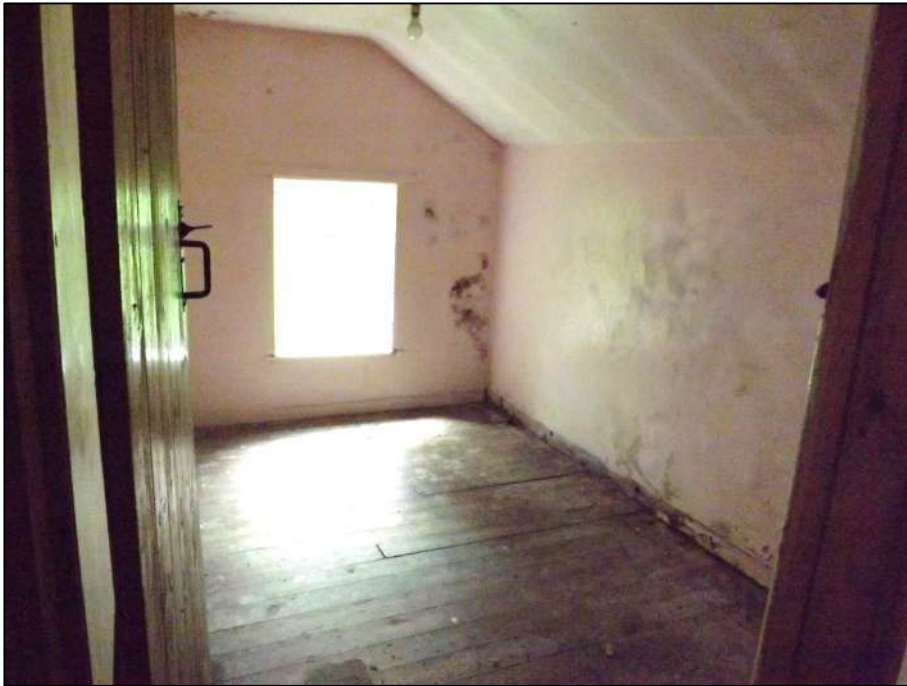
**Plate 44. View into the north west bedroom. Rotten floorboards prevented entry into the room.**

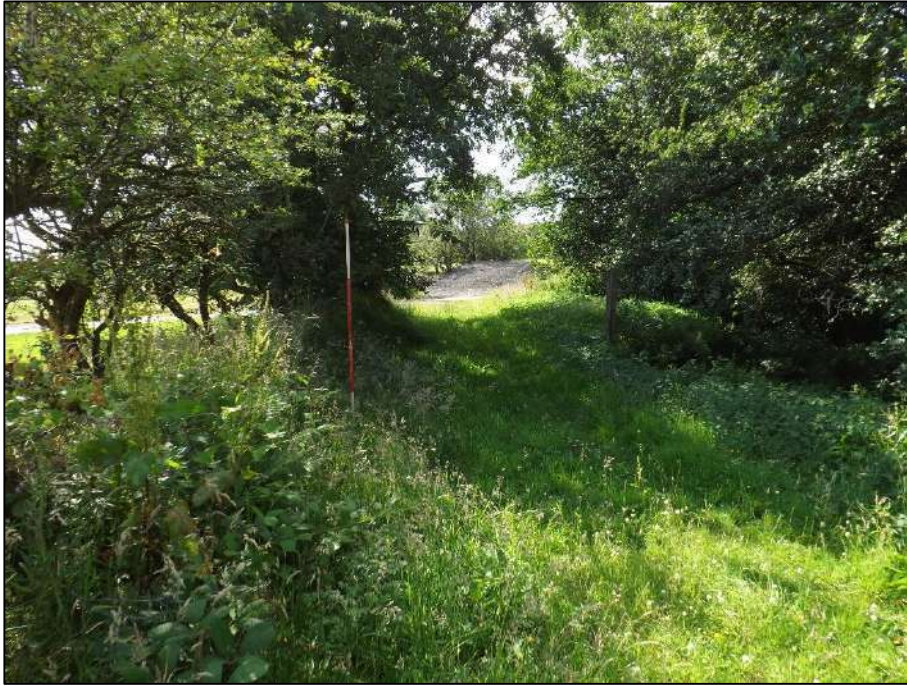
**Plate 48. The overgrown original access road to the farm looking south. The low stone banks either side are only partly visible Scale 2m.**
