# VALIDATION REPORT

M.T.C.B.C. PLANNING PERMISSION P/19/0064

47-50 MARDY STREET

## **INTRUSIVE INVESTIGATION VALIDATION REPORT**

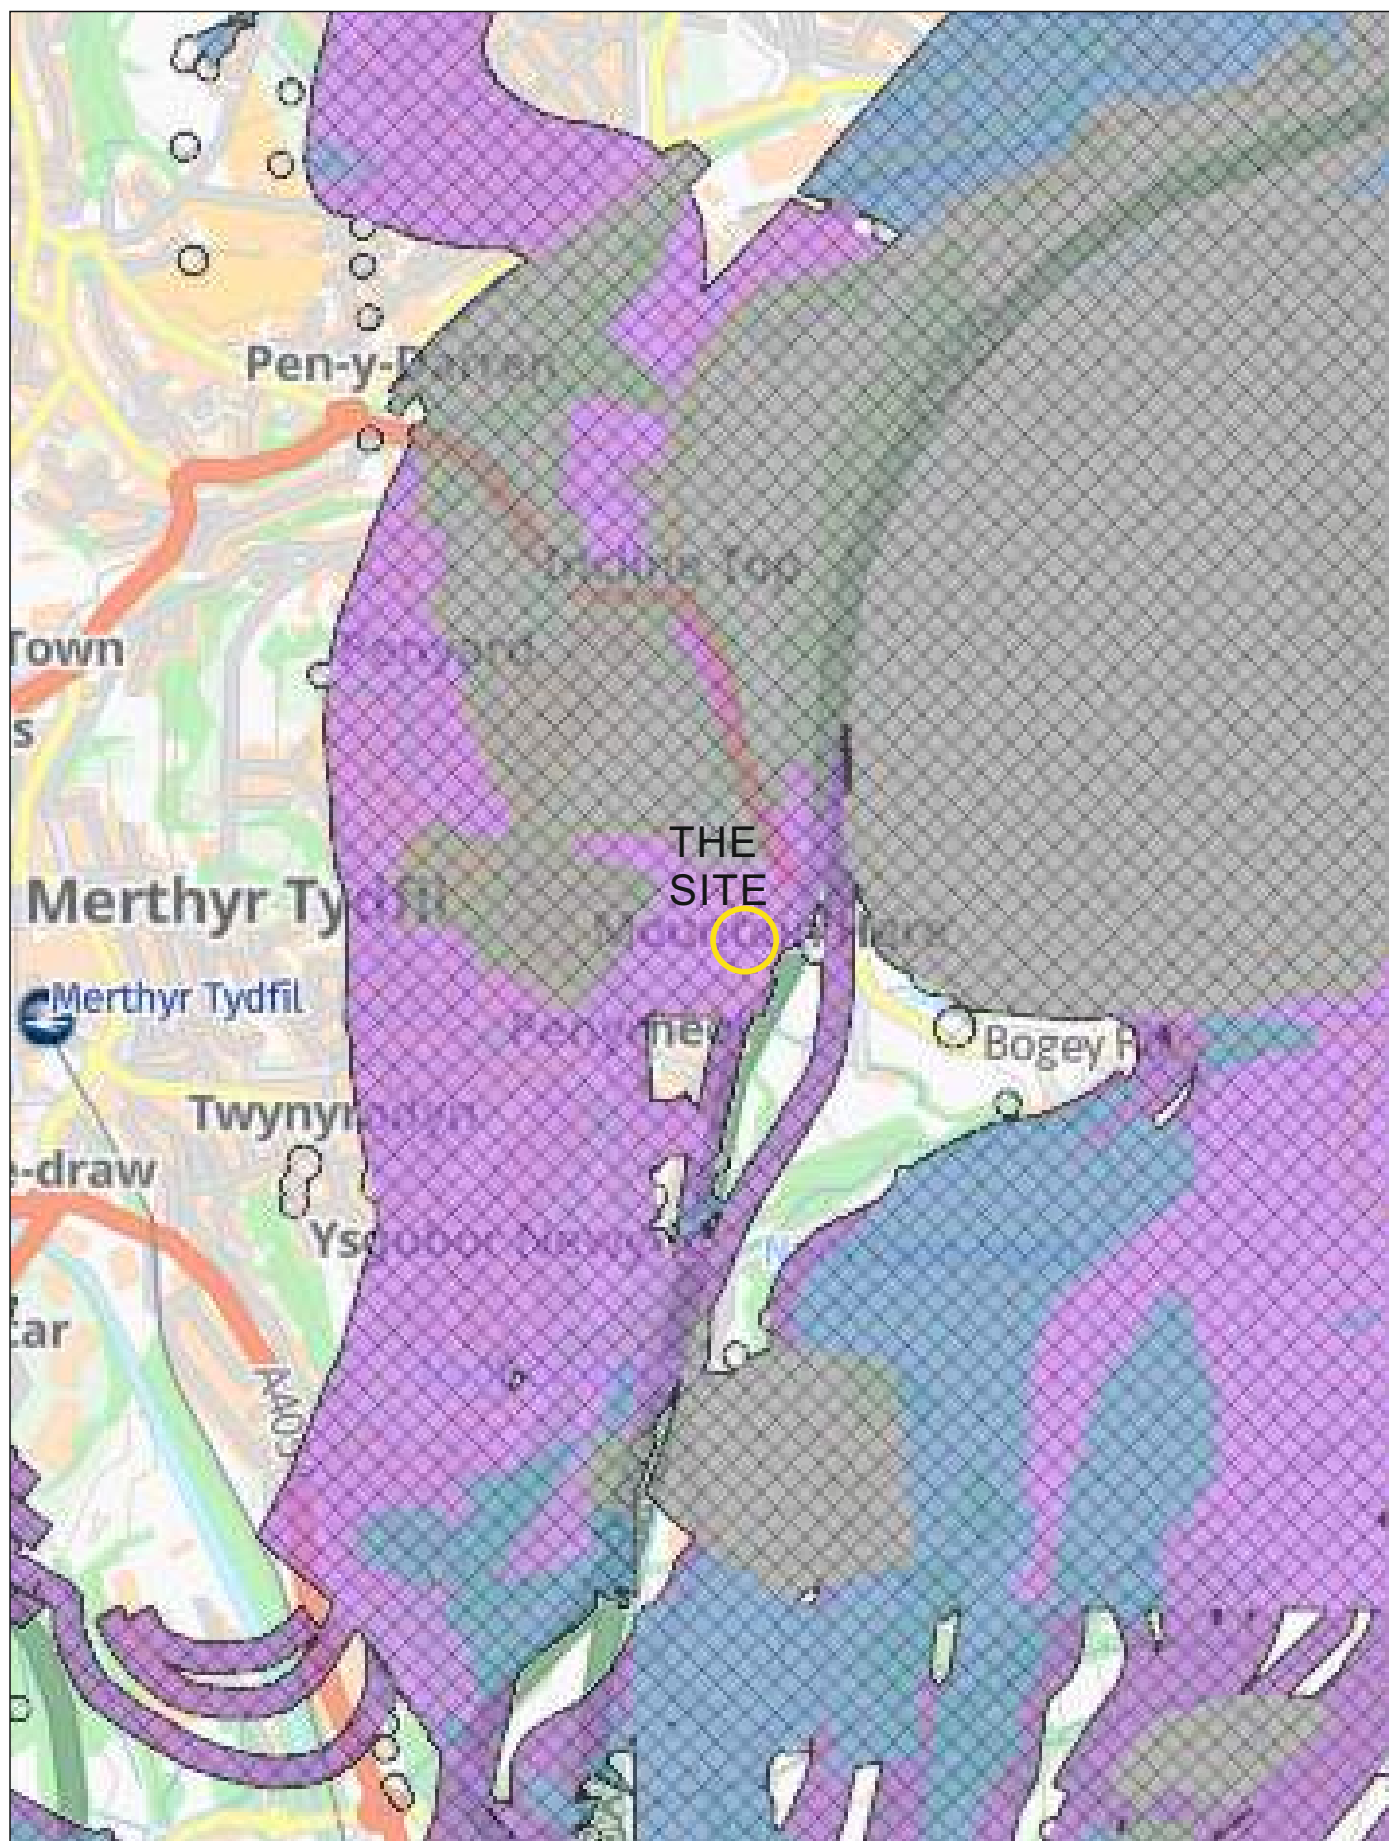
The C.A. interactive viewer contains a vast amount of information from various sources, particularly on the mining data window. An extract from the planning window can be seen in Figure 3. Although difficult to distinguish at such a small scale, the area of the site has been circled and is entirely within an area of Development High Risk. The grey areas represent opencast mining, the blue areas denote recorded shallow mining. The site sits within a purple area. This colour represents an area of suspected unrecorded shallow mining. The isolated circular areas are 20m exclusion zones around mine entries not connected to seam outcrops. An extract from the Mining Data Window is reproduced as Figure 4 overleaf. The nearest outcrops to the site have been annotated with their C.A. codes. The fact that the seam codes are ascending to the east is partly influenced by the topography. It could also indicate the strata is dipping to the east or southeast. According to the C.A. Seam Code Directory the seams are:-

FIGURE 3  
COAL AUTHORITY INTERACTIVE VIEWER, PLANNING WINDOW.  
HATCHED AREAS ARE DEVELOPMENT HIGH RISK

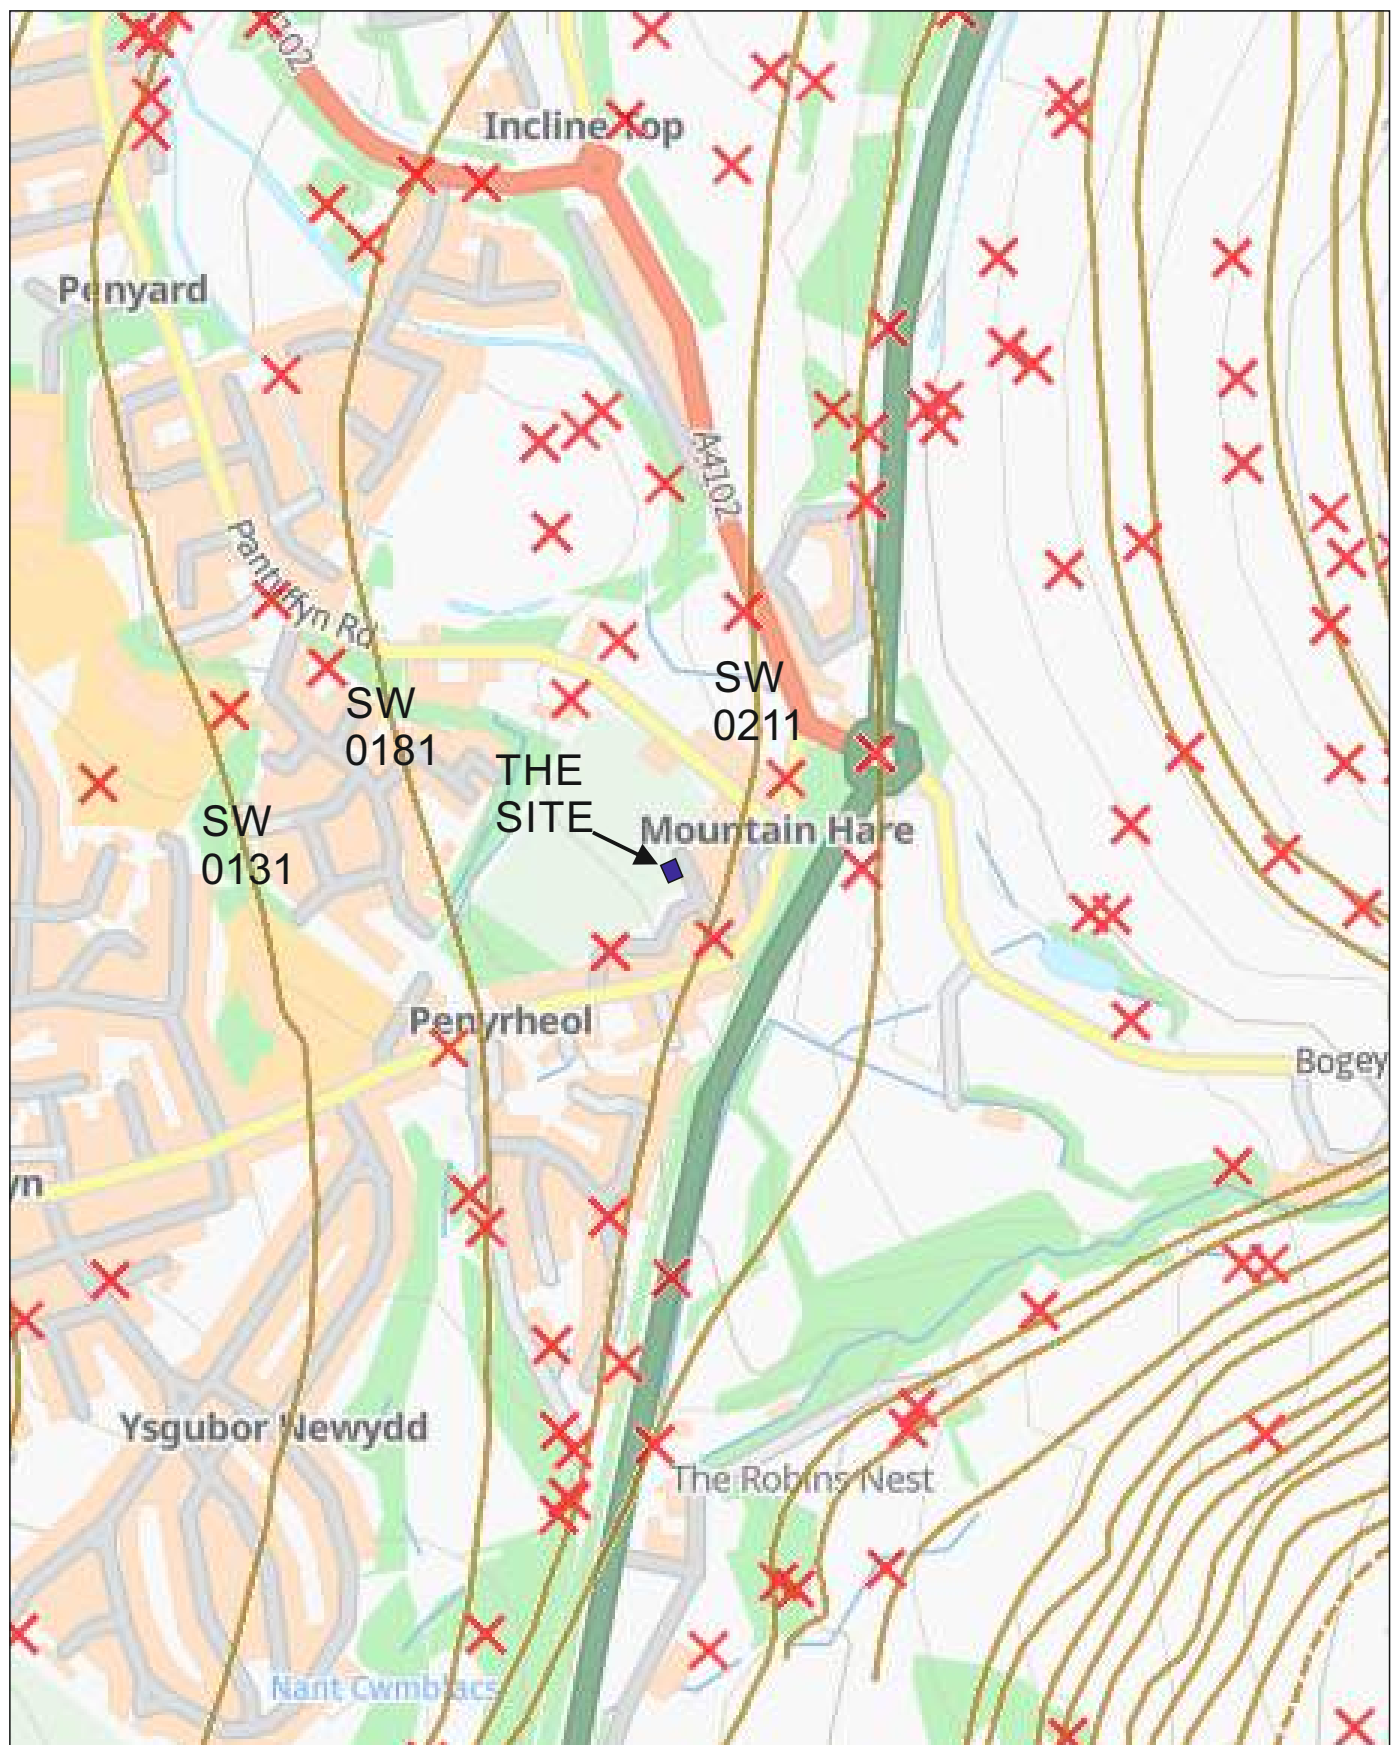
descending order) the Spotted, Yellow, Red, Blue, Big, Lumpy and Rough together with the Rosser Veins beneath the Garw. Coal was mined for fuel for the voracious ironworks, but the mining of “sale coal” did not develop until much later. None of the mine entries are within influencing distance of the site but could indicate the possibility of mining beneath the site.

FIGURE 4  
C.A. VIEWER, MINING DATA WINDOW. RED CROSSES  
ARE MINE ENTRIES, BROWN LINES ARE SEAM  
OUTCROPS. THE SITE IS SHOWN IN BLUE.

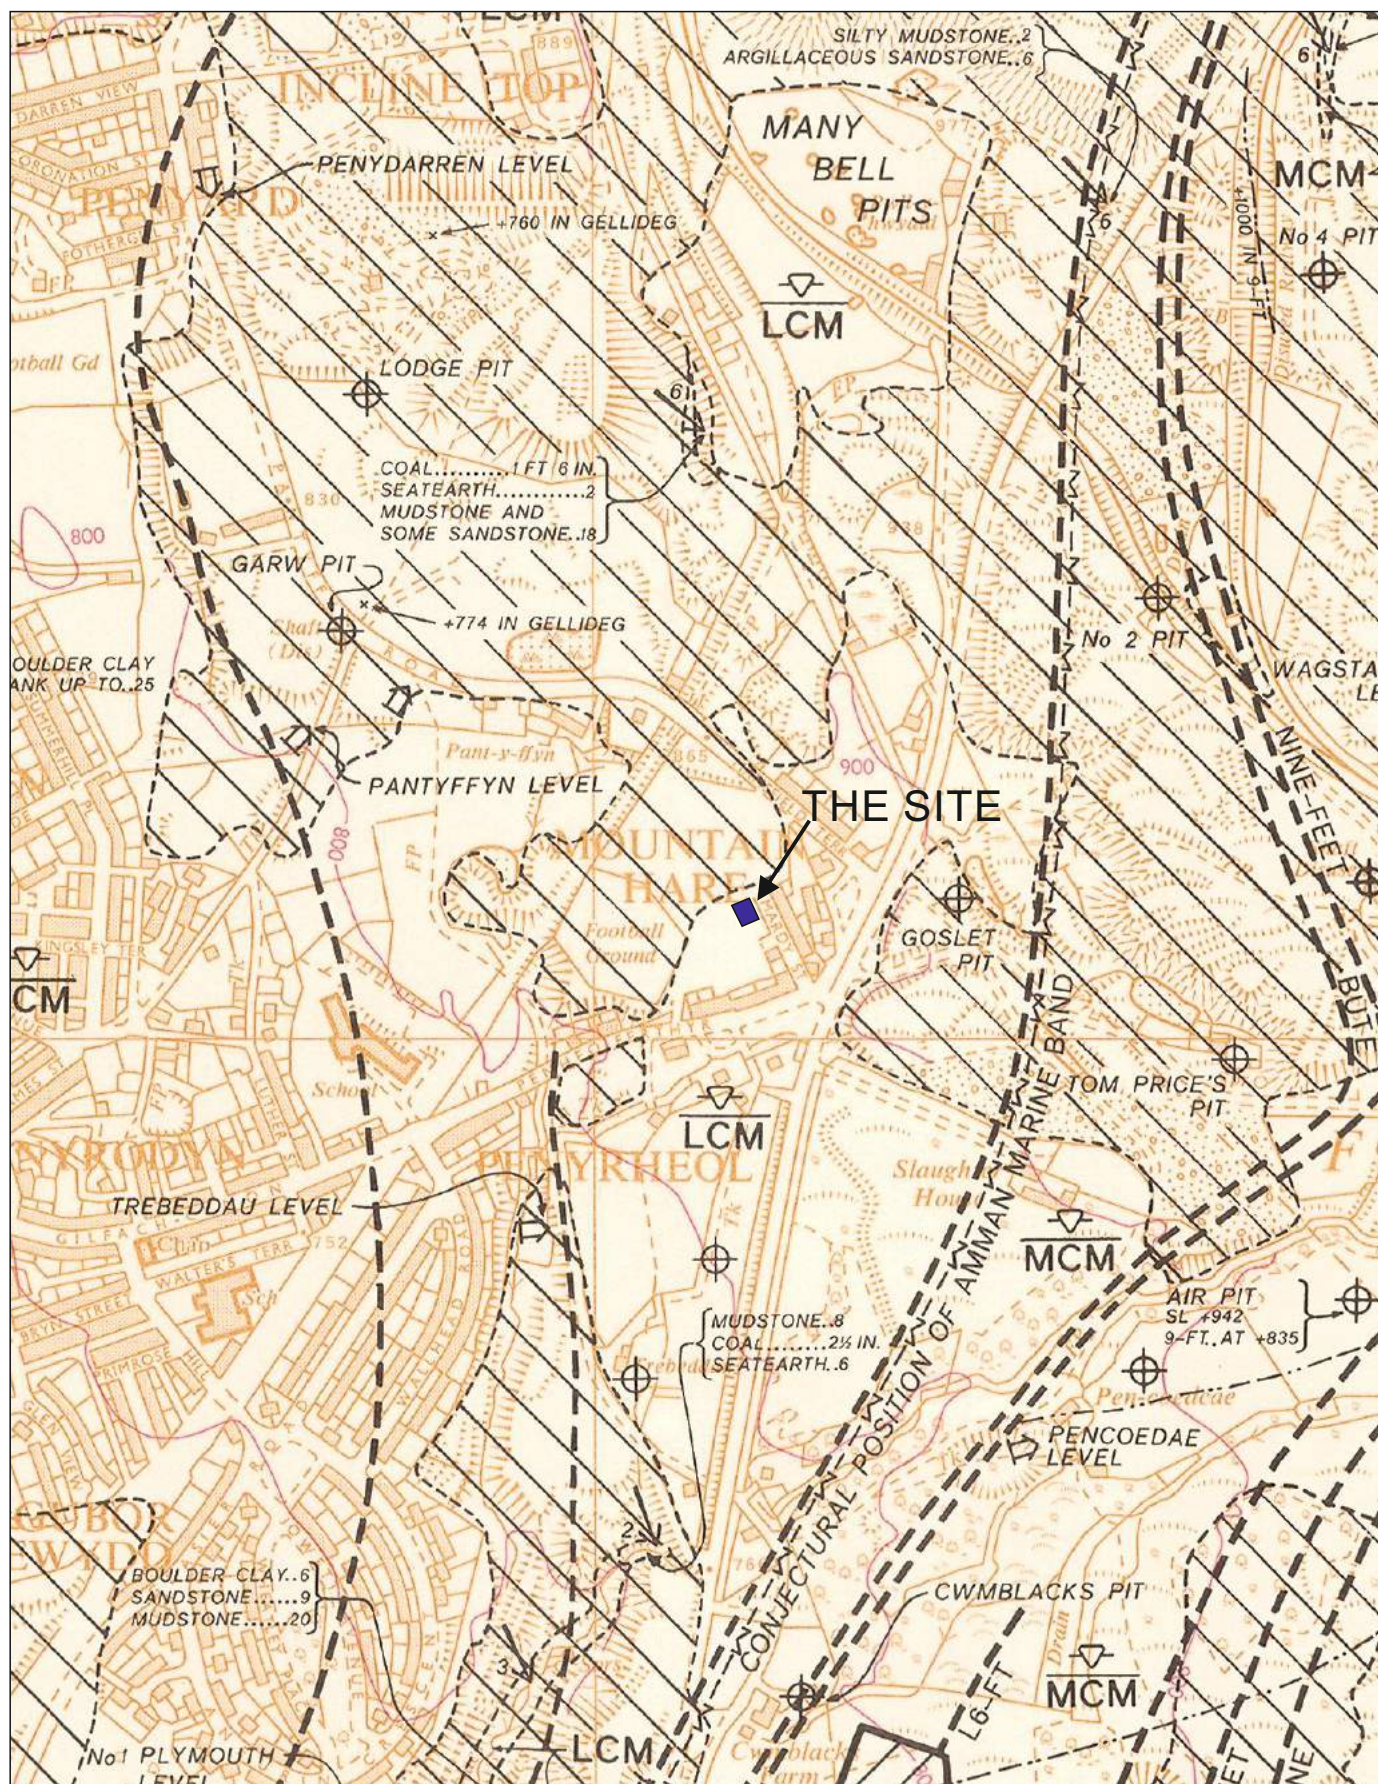
The six inch to the mile Geological Survey sheet SO 00NE covers the area around the site. An extract of the Survey Sheet has been reproduced as Figure 5 overleaf with the site outlined. A section of the stratigraphic column from the map is shown in Figure 6, with the approximate site level marked. The outcrop pattern for the Gellideg in Figures 4 and 5 is identical. This is not surprising as the primary source for the Interactive Viewer is the British Coal Development Plan which largely drew on the Geological Survey. The outcrop of the Lower Seven Foot has the same orientation as in Figure 4 but the outcrop is not shown from a point just south of the site. This coincides with the right sloping diagonal hatching. This indicates thick Made Ground, mainly coal and ironstone spoil (left sloping hatching indicates opencast mining). The outcrop of the Upper Seven Foot is not shown at all. To avoid overcomplicating a map the Geological Survey will often only show the most economically or stratigraphically important seams. In addition, the Memoirs make it clear that the ground is so disturbed and covered with spoil or urban development that first hand observation of the outcrops is impossible. This also means that there are few observed strata dips. Two low angle ( $2^{\circ}$  and  $3^{\circ}$ ) dips to the southeast are recorded 400m south of the site, and this general trend is confirmed in recorded underground survey levels. On the eastern side of Merthyr there is considerable variation in the coal seams underlying the site from what might be considered the normal. The Gellideg is very closely spaced from the two seams making up the equivalent of the Five Foot. The resulting composite seam was known the Lower Four Foot and was extensively mined. So, to summarise, there is no recorded mining beneath the site. Underground coal mining in Merthyr predates the 1874 compulsory keeping of mine plans by 60-70 years. However, the fiercely competitive nature of the four massive ironworks meant that commercial records were kept from a very early date, mainly to prevent incursions into rival mineral rights. There are probably mineable coal seams at shallow to medium depth beneath the site. These are the Lower Seven Foot and the Five Foot Gellideg (known locally as the Lower Four Foot). The Lower Seven Foot could be as shallow as 20m underground. The depth of superficial deposits is unknown and so the recommendation for intrusive works is justified.

FIGURE 5  
SECTION OF GEOLOGICAL SURVEY SHEET SO 00NE.  
THE SITE IS OUTLINED IN BLUE.

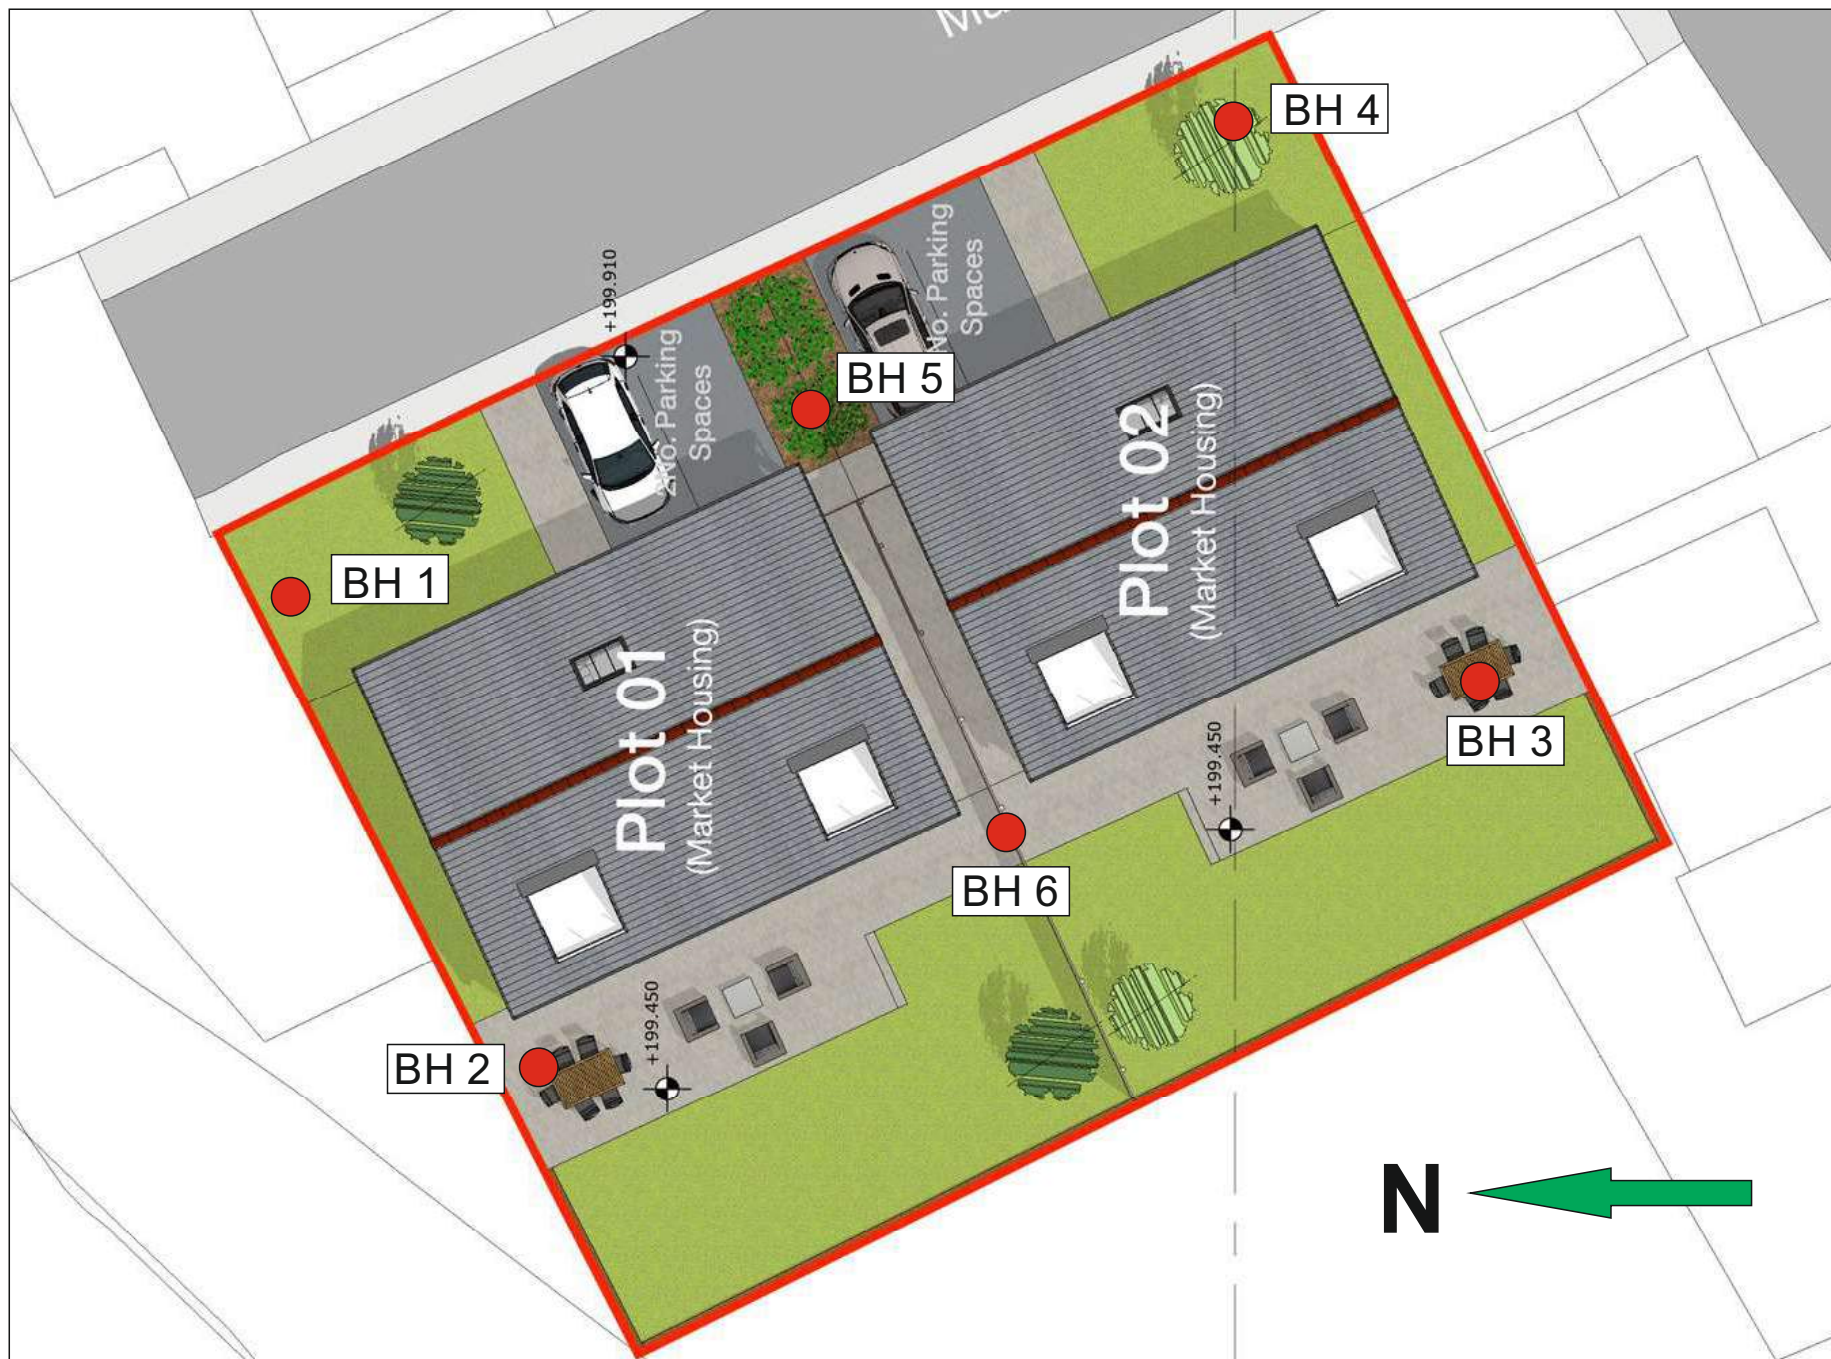
FIGURE 7 BOREHOLE POSITIONS AS DRILLED AT MARDY ST.

The site investigation proved the only evidence of mining was in the southwest corner of the site. There is no potential for a 0.5m void to migrate to the surface from a depth of 27m. The broken ground beneath the void presumably represents collapsed material from above. No gas was detected coming from the void. Because water flush was being used it was difficult to assess the water table during drilling. On completion of the borehole the water level was at 18m b.g.l. indicating the void was flooded.

As a precaution it is the recommendation of this report that the houses should be built on raft foundations designed by an experienced structural engineer. The rafts should be capable of bridging a 3m void and cantilevering over a 2m void.
